Docket No. 272 – Development and Management Plan Inspection

Beseck Switching Station Inspection

Date: October 10, 2007

Location: Beseck Switching Station

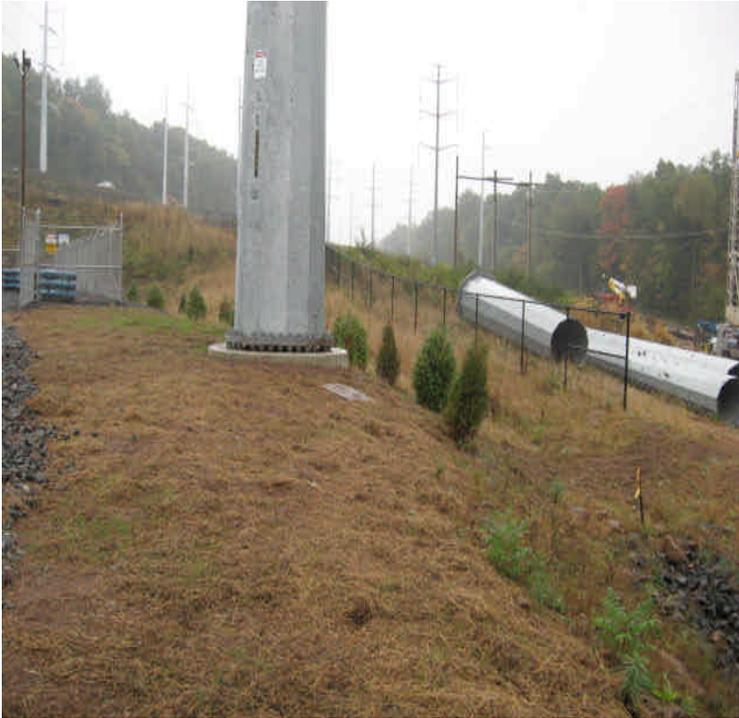
View along the eastern access road (1A crews working in the ROW to the right). Continue to promote cover in any sparsely vegetated areas.

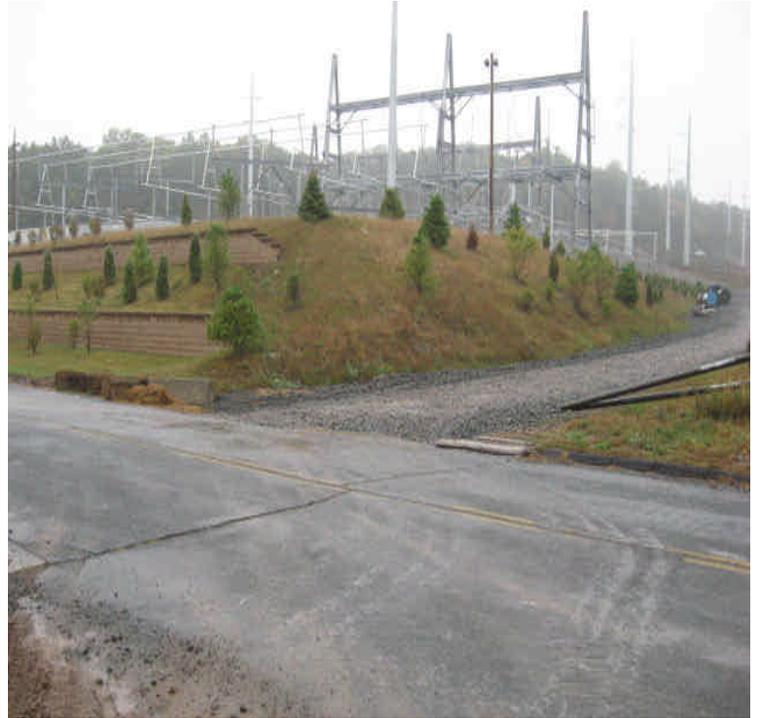
View of the switching station and eastern access road off Carpenter Lane.

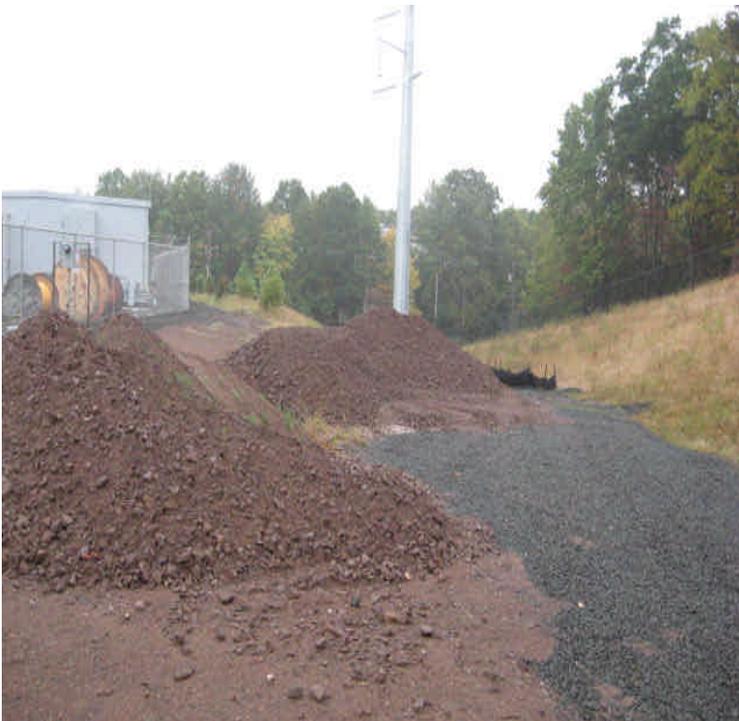
Soil stockpiles located on the western access drive. Silt fence was in place across the access road.

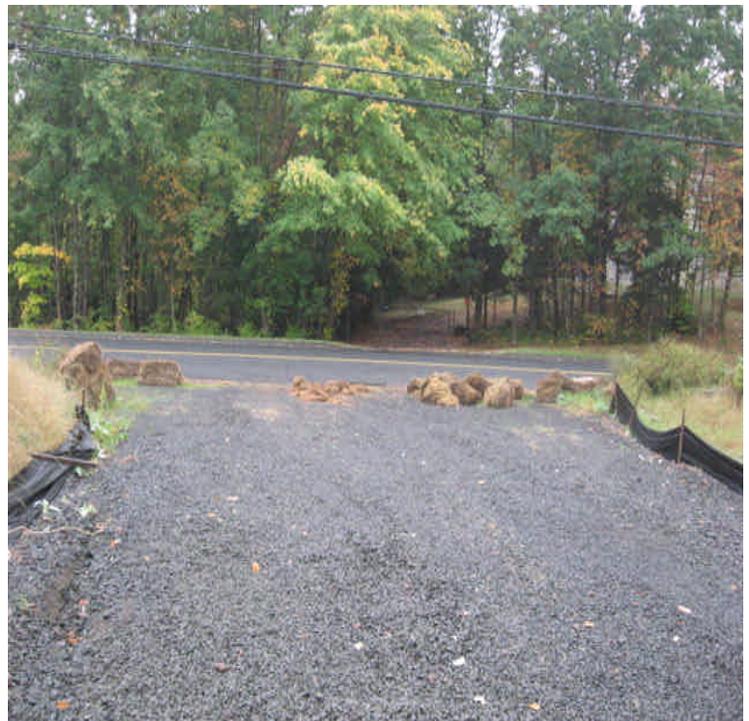
Haybales were removed from the western site entrance but silt fence is in place further upgradient. Ensure that all run-off is contained.
