Docket No. 272 – Development and Management Plan Inspection

Segment 1a Inspection

Date: October 1, 2007

Location: Segment 1a – Scovill Rock Switching Station to Chestnut Junction, Oxbow Junction to Beseck Switching Station (excluding Royal Oak Bypass), and Black Pond Junction to Beseck Switching Station

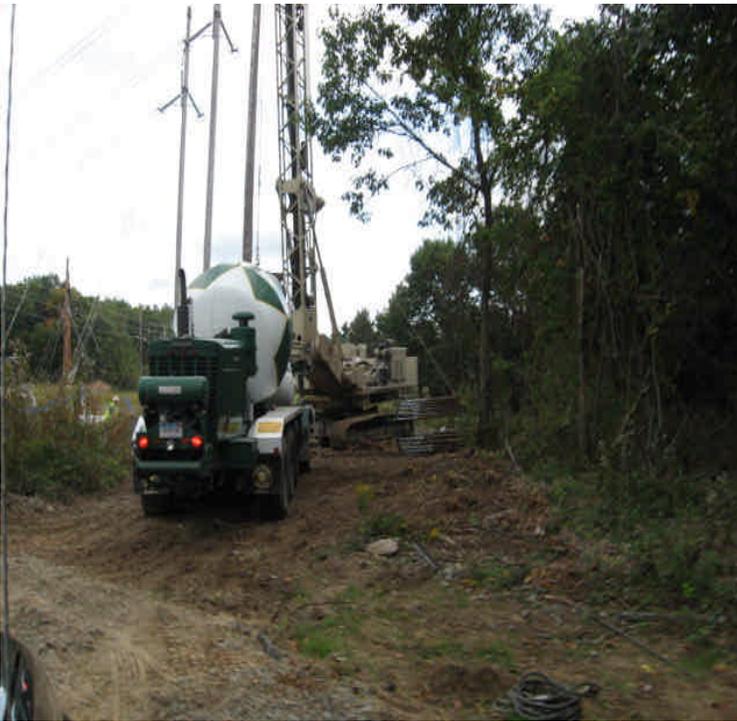
Oxbow Jct: Concrete pouring was underway.

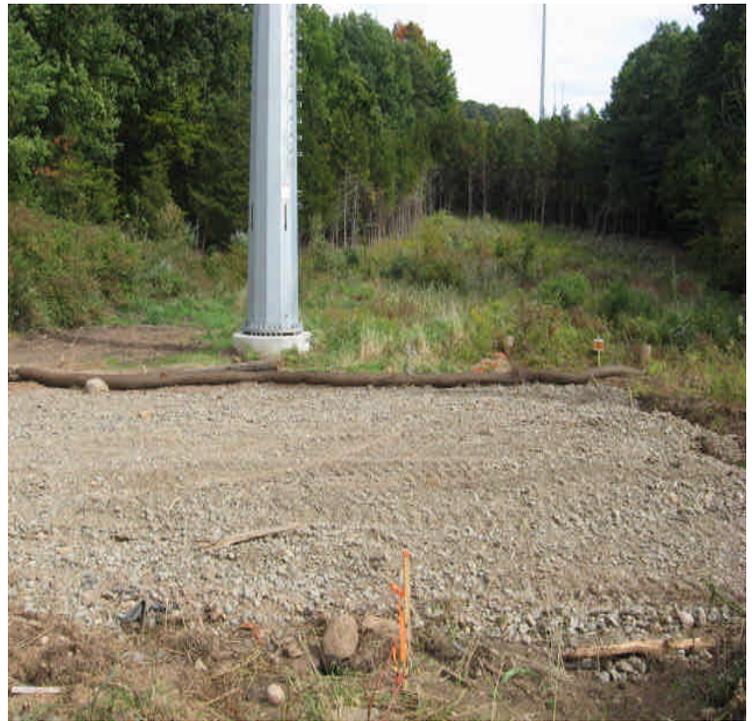
Carpenter Ln (near Beseck): A new pad site was in place upgradient from wetlands. Fiber socks were in place but monitor for any sediment migration.

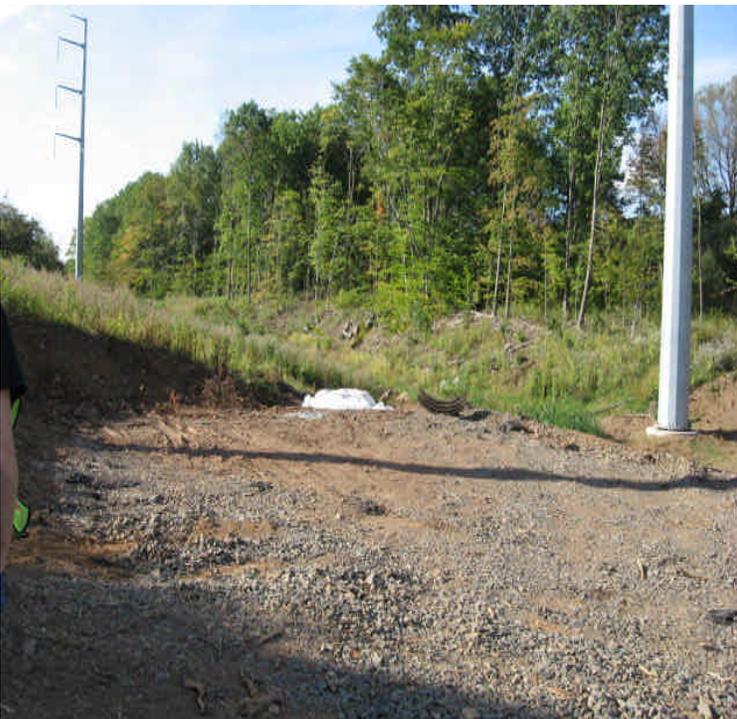
North of E. Meriden SS: Foundation installed near wetland at stream bypass.

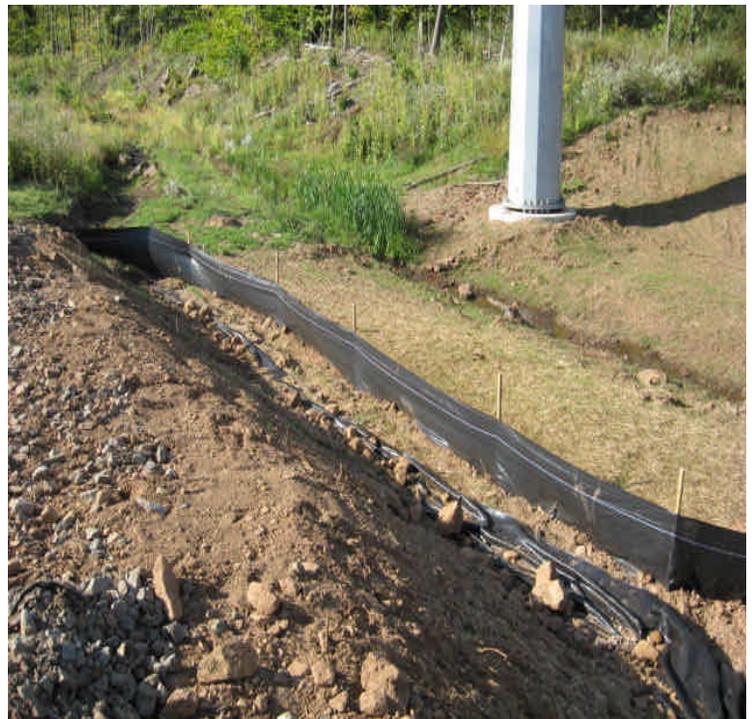
North of E. Meriden SS: Timber mats and soils remain over the stream bypass channel. Controls are installed and the original stream channel was restored with some grass cover noted. Consider blocking off the bypass so sediment is not directed into the stream.

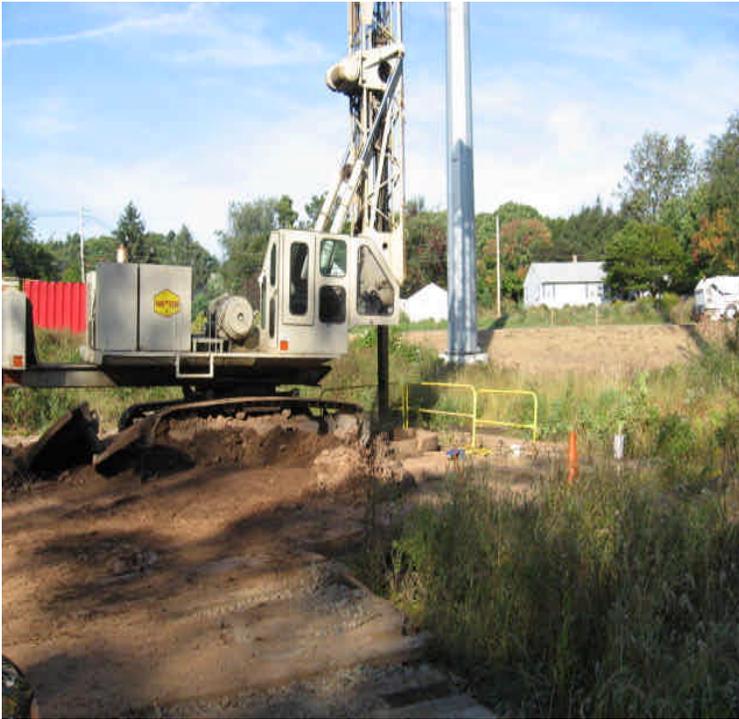
North of High Hill Rd: Drilling within the wetland is underway. Sediment was being removed from the timber mats during drilling.

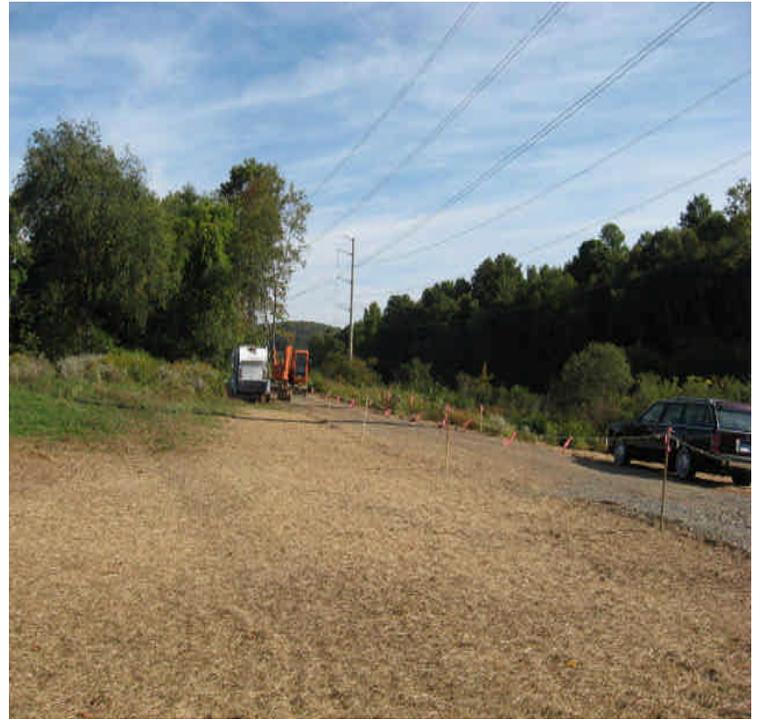
North of High Hill Rd: Previous staging area and access road. Timber mats were removed from the wetlands and the adjacent uplands were graded. The entire restored area was then seeded.

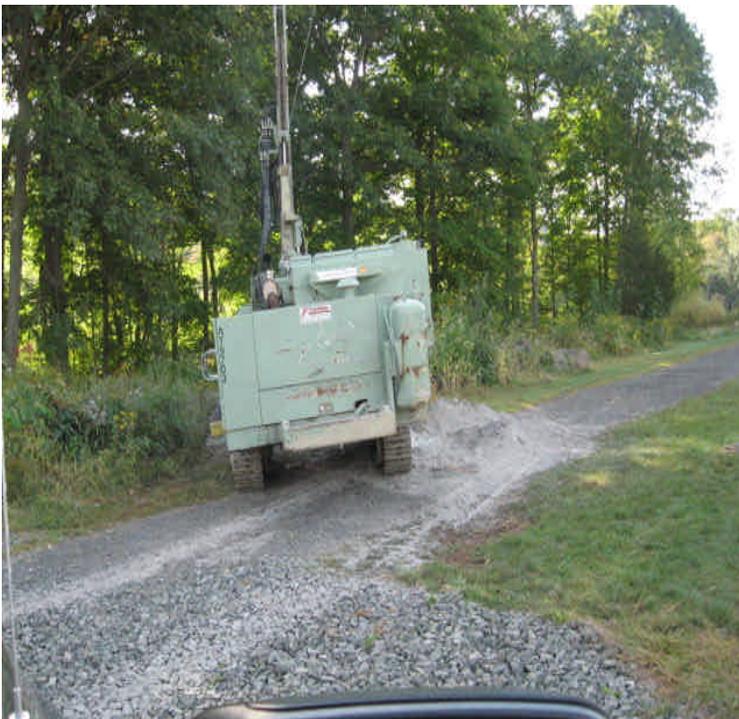
East of Meriden P.B.A: Air drilling for the next foundation was underway.

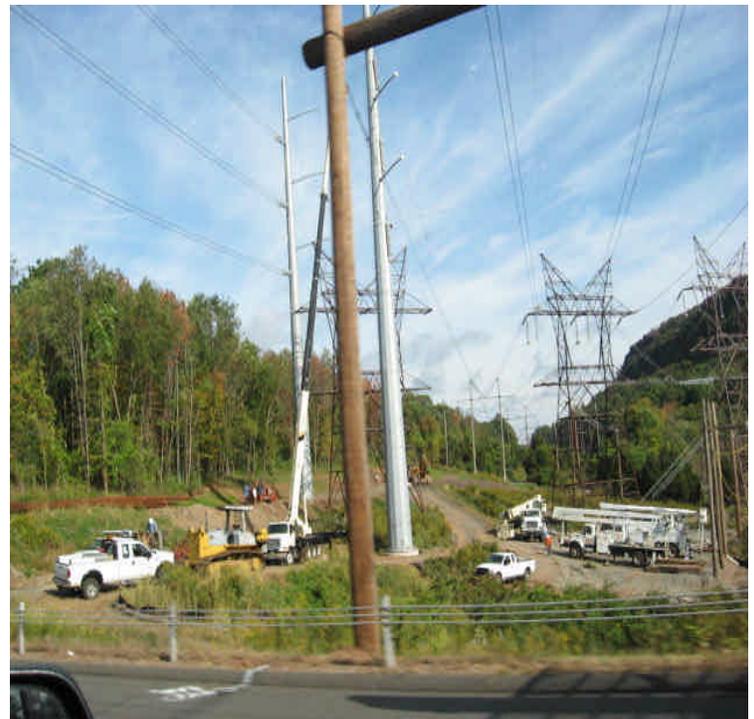
Black Pond Jct: Crews were installing lines.
