**Docket No. 272 – Development and Management Plan Inspection**

**Segment 1a Inspection**

**Date:** October 22, 2007

**Location:** Segment 1a – Scovill Rock Switching Station to Chestnut Junction, Oxbow Junction to Beseck Switching Station (excluding Royal Oak Bypass), and Black Pond Junction to Beseck Switching Station

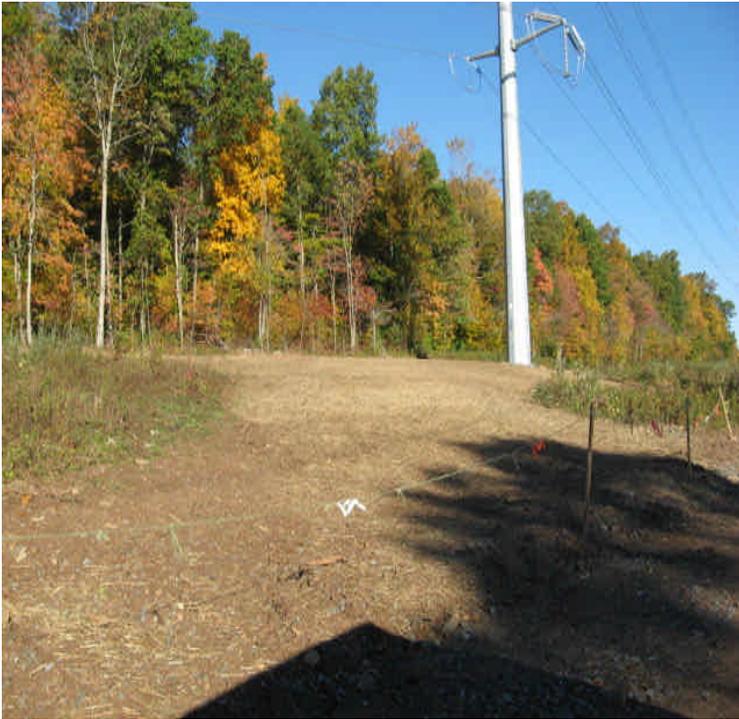
**North of Beseck SS: An old pad site was graded and seeded and cordoned off from further vehicle disturbance.**

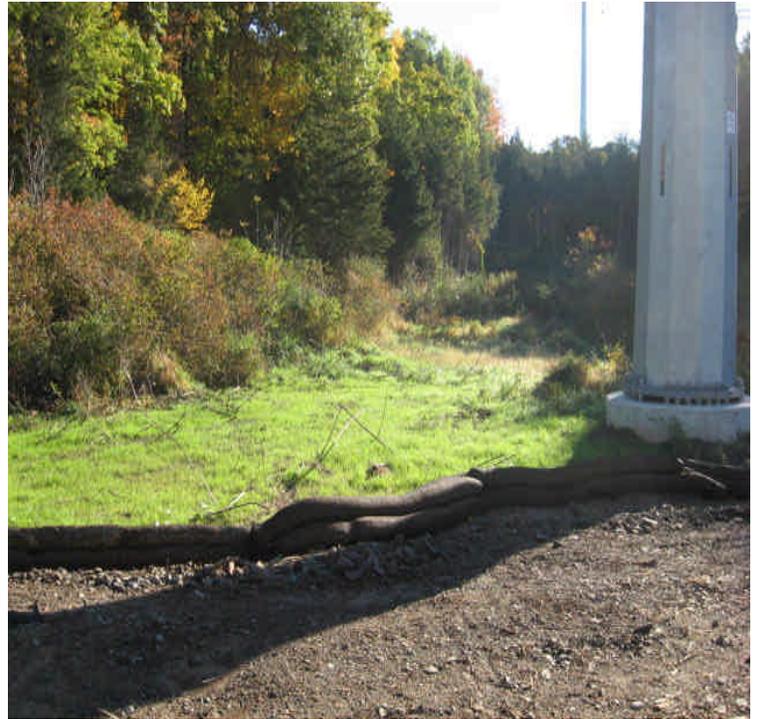
**North of Beseck SS: Controls reinforced upgradient from wetlands. At a new foundation. Old stone and fill from the previous foundation needs to be removed from the wetland during final stabilization.**

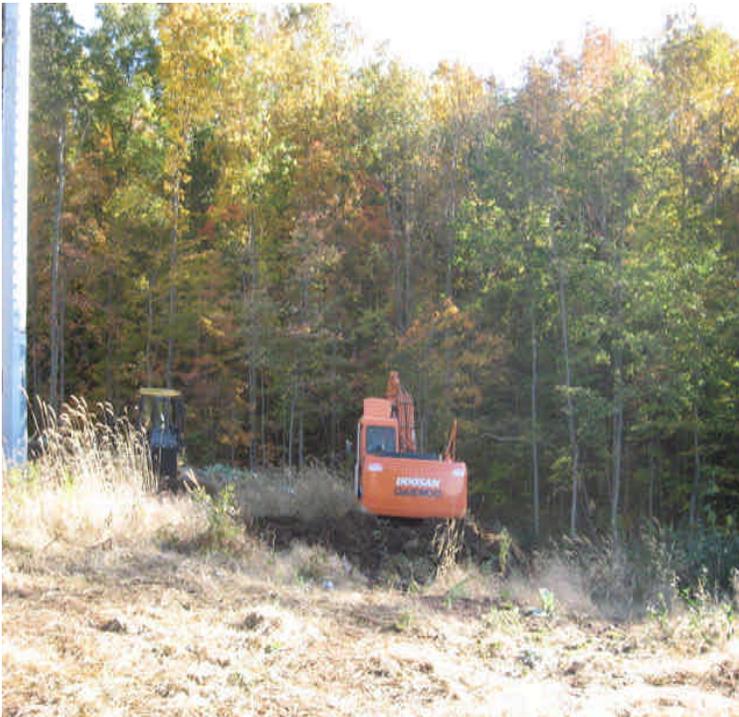
**North of Beseck SS: Crews were reclaiming old pad sites and removing fill from the site.**

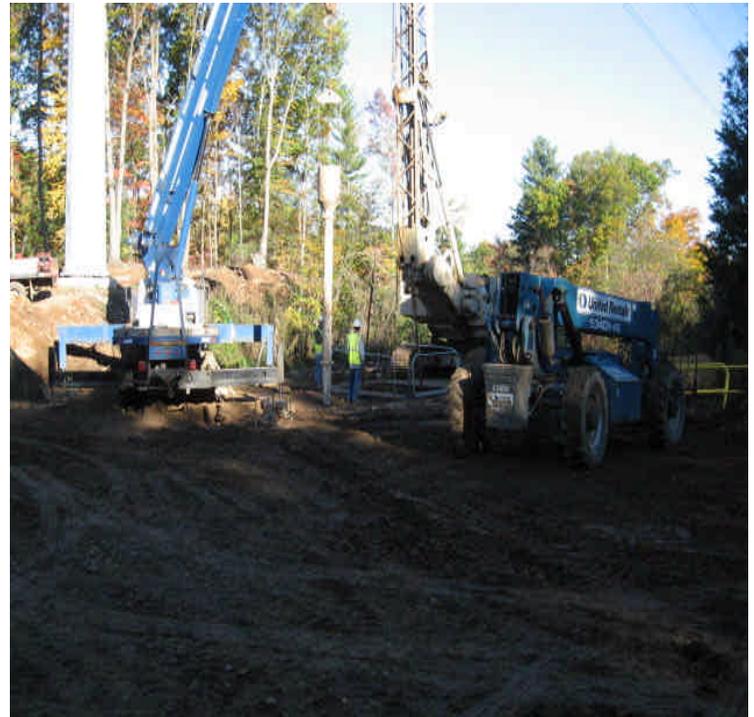
**North of High Hill Rd: Foundation installation is underway. Controls are in place. Continue to monitor carefully due to wetlands in the area.**

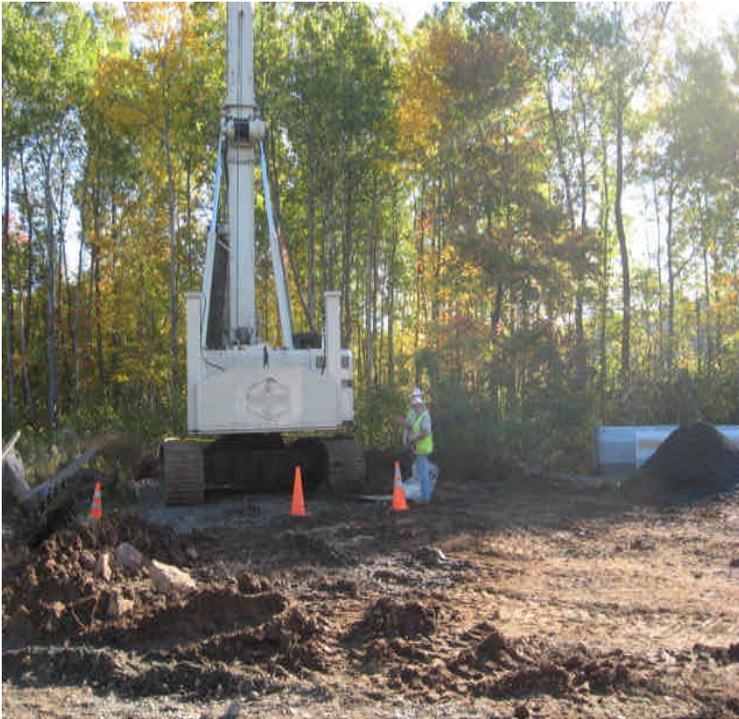
**South of E. Main St: Foundation drilling underway. Controls in place. Continue to monitor carefully.**

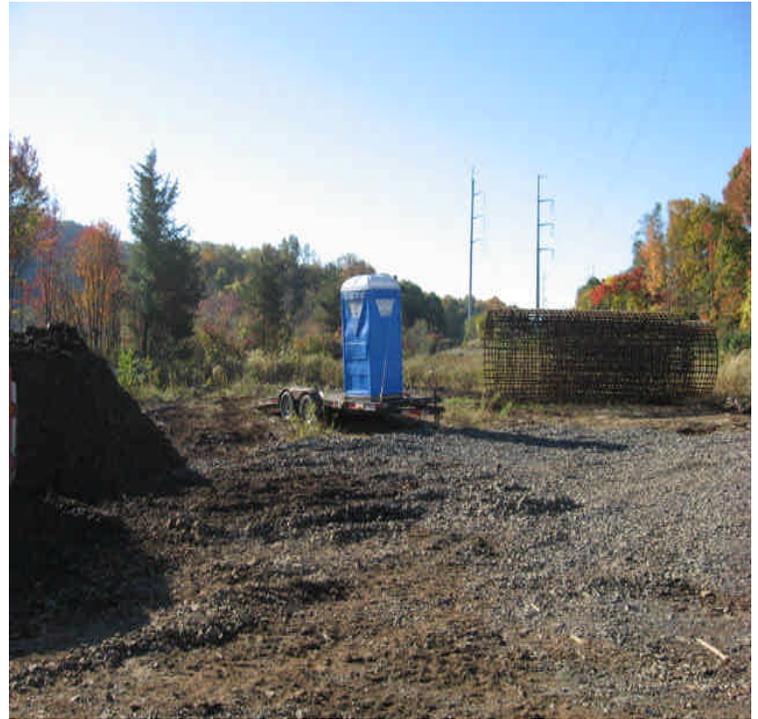
South of East Main Street	The portable sanitary facility placed adjacent to wetlands behind the condo units last week has been relocated away from the wetlands. 10/22/07	Avoid storing facilities within 100 feet of wetlands. 10/22/07	Sanitary facility was relocated.
Additional Observations	None. 10/22/07	None. 10/22/07	NA

**South of E. Main St: Sanitary facility was relocated further away from wetlands.**

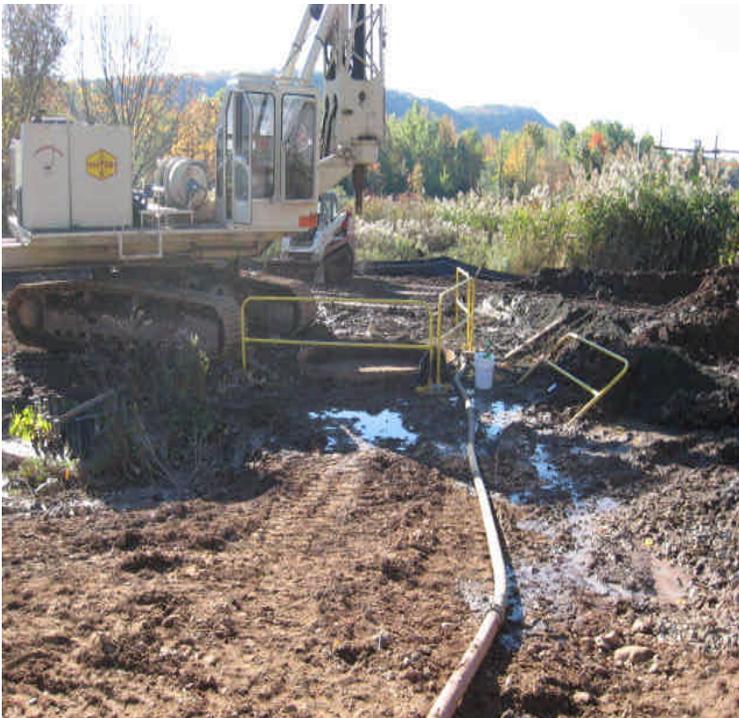
**North of E. Main St: Foundation installation underway. Crews were pumping slurry into a settling tank onsite. Controls are in place. Continue to monitor carefully due to wetlands in the area.**

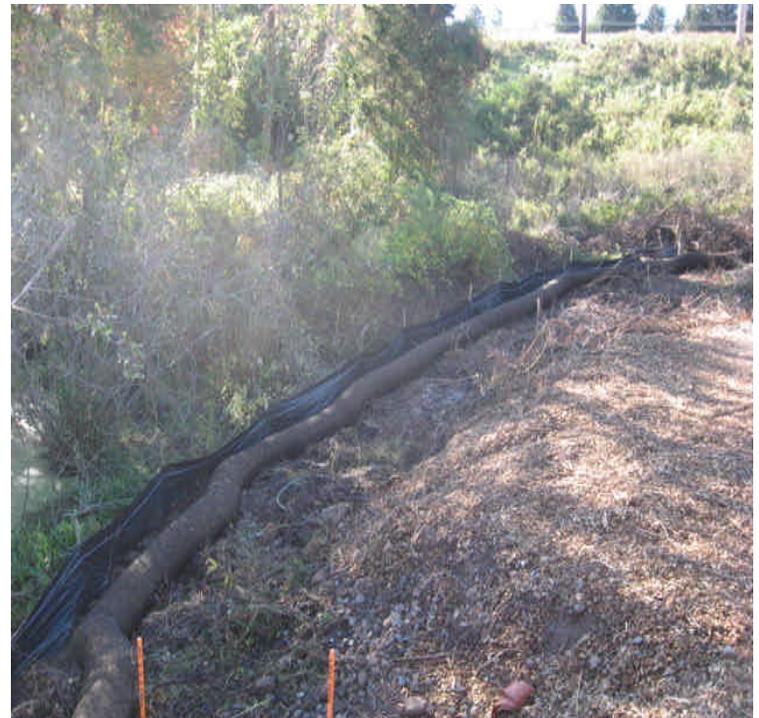
**Black Pond Jct: Controls have been replaced and reinforced to protect wetlands at the base of a steep slope.**
