Docket No. 272 – Development and Management Plan Inspection

Segment 1b (Royal Oaks Bypass) Inspection

Date: October 1, 2007

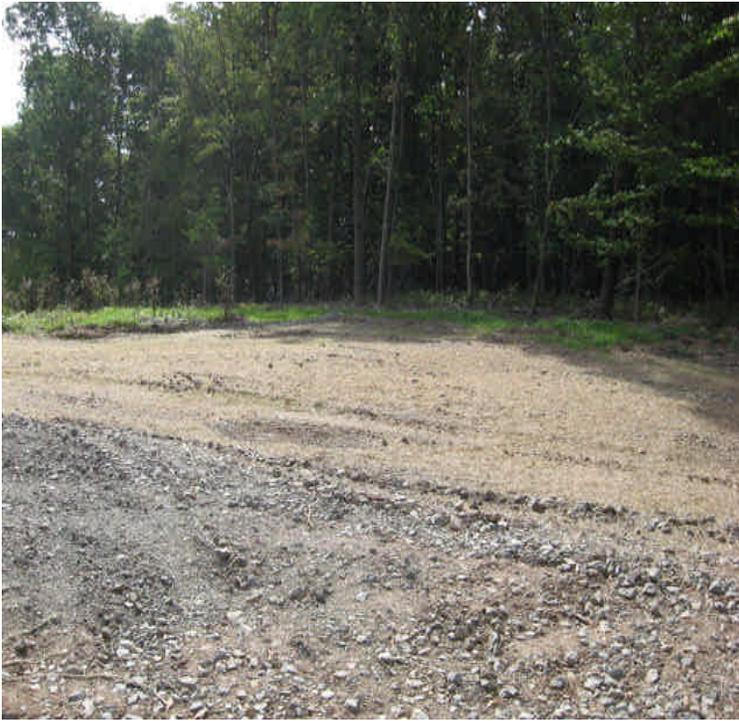
A section of the access road stone has been removed at Black Walnut Dr. west. The disturbed area along the road was regraded, mulched and seeded.

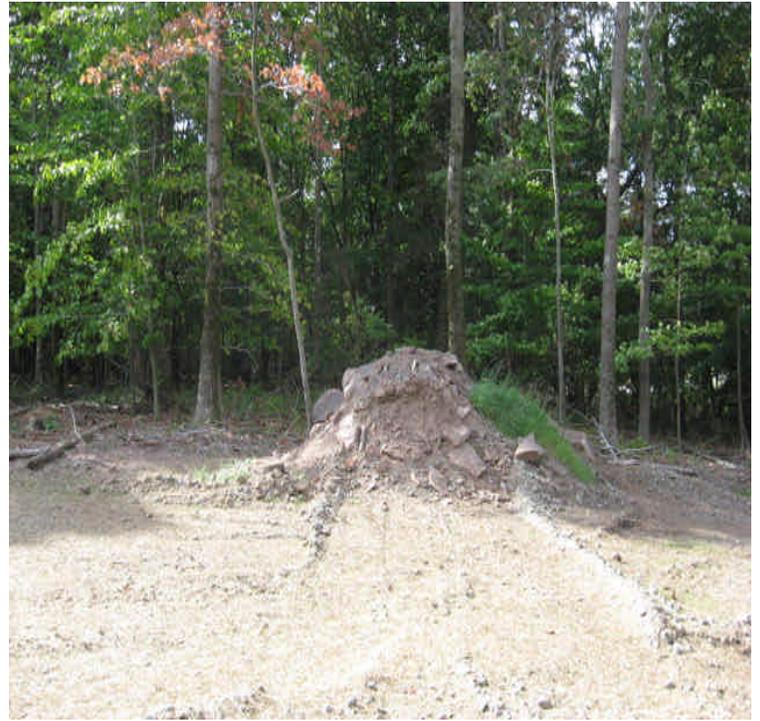
A soil stockpile remains west of Black Walnut Dr. access. Remove pile or add appropriate controls.

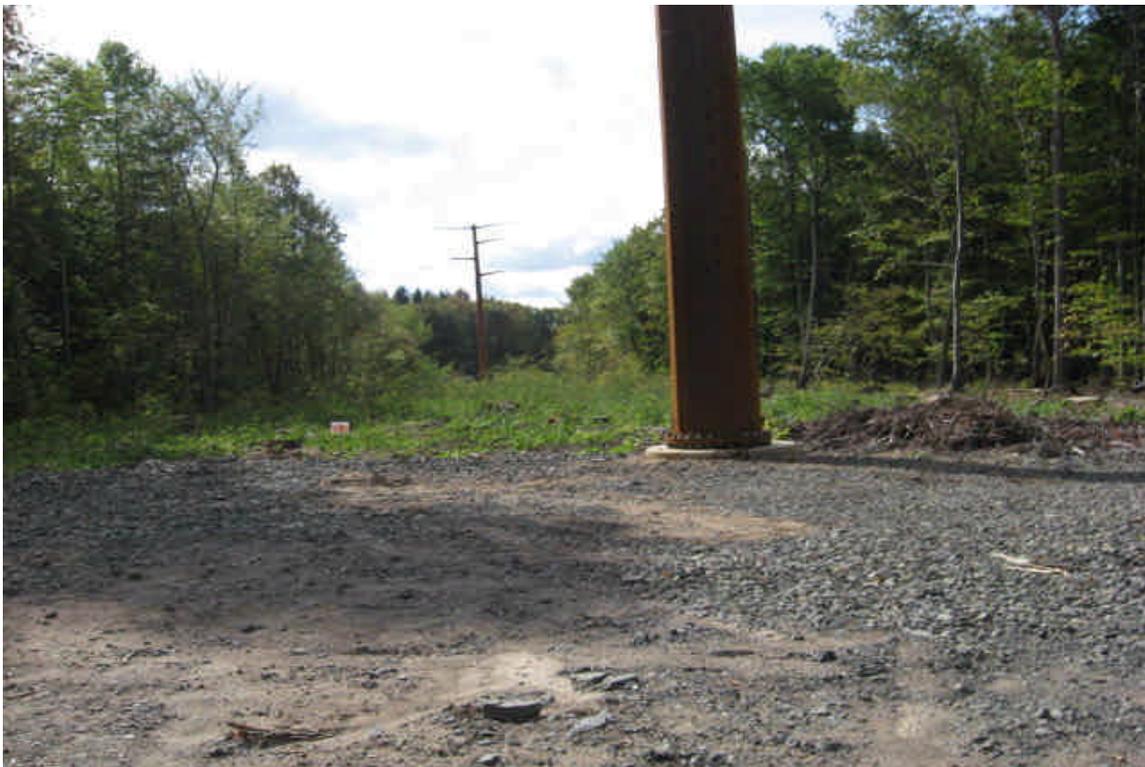
Sediment was observed the edge of the no access area near the contractor receiving yard. Continue to monitor and add controls as needed. Restore the pad and remove stone when feasible.
