Docket No. 272 – Development and Management Plan Inspection

Segment 2b Inspection

Date: October 26, 2007

Location: Segment 2b – Cheshire/Hamden Town Line to East Devon Substation

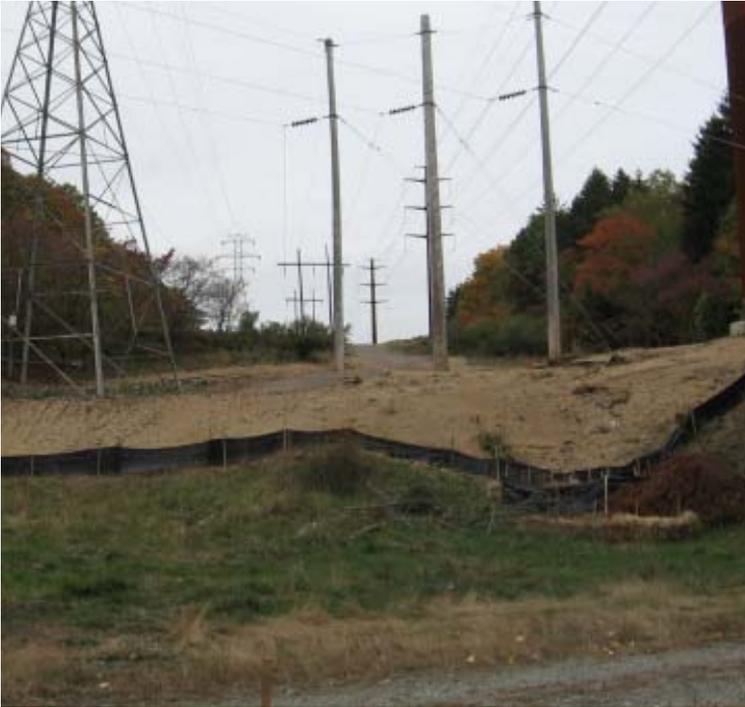
Dogburn Rd South (Orange): Pad Reclamation is complete. Additional erosion controls have been installed near structure #3890.

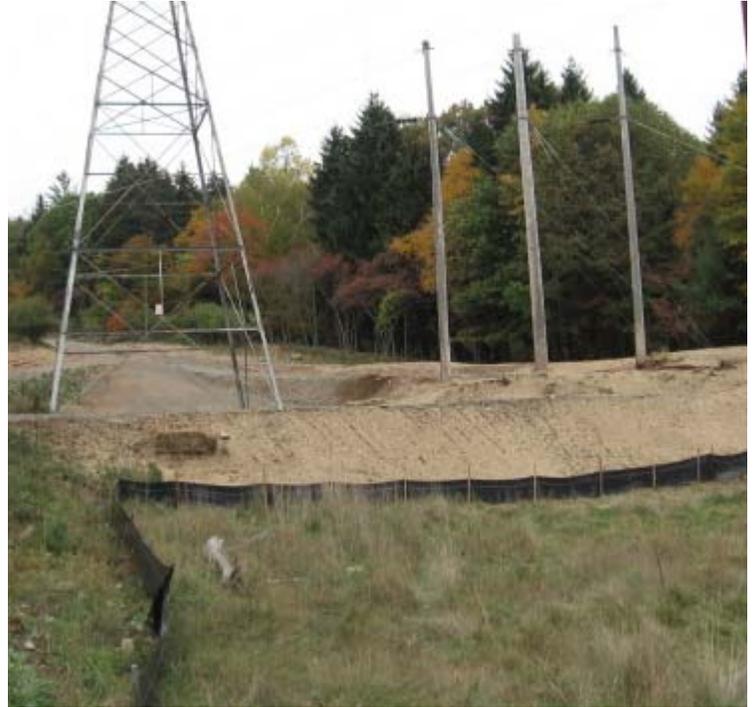
Dogburn Rd South: Additional view of controls installed near structure #3890.

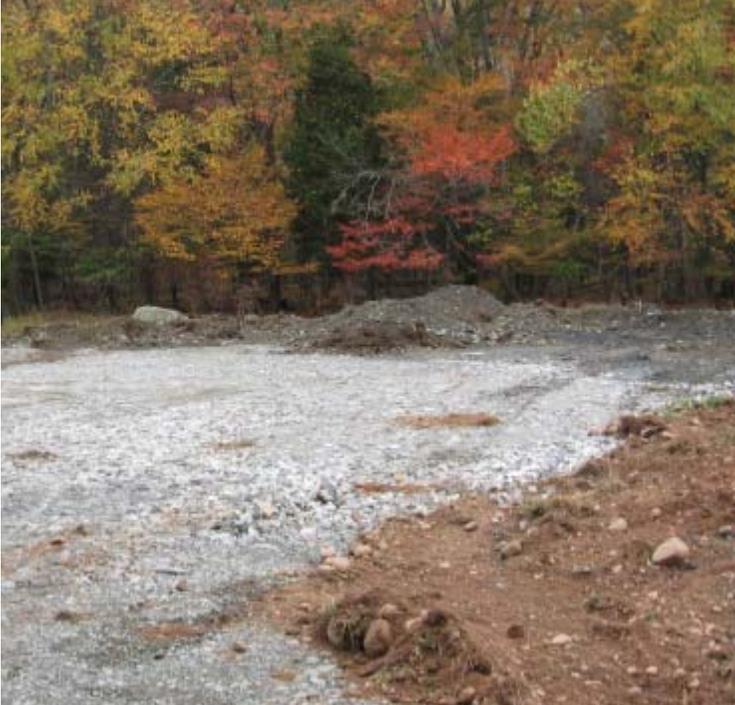
Clearview (Woodbridge): Pad Reclamation continues at structure #3899.

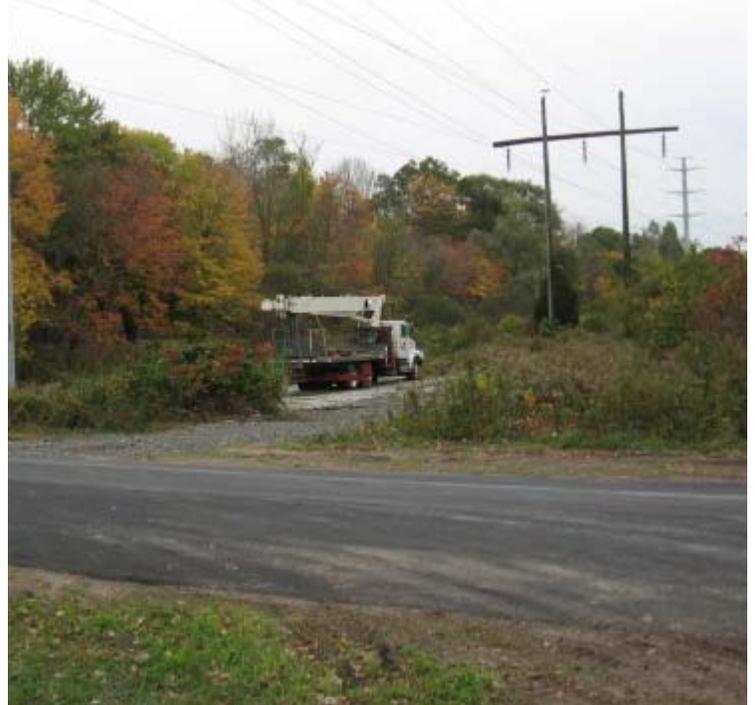
Manville Rd South (Woodbridge): Equipment was parked in a wetland area. No leaks were observed.

Areas of Inspection	Observation	Recommended Action	Corrected Action
Spills, soils and material storage.	Contractor receiving yard is set up near Shelland St. in Milford. See segment 3 report. 10/26/07	In general, store materials and equipment appropriately. Ensure that vehicles are equipped with spill kits. All construction vehicles should be parked at least 100 feet from a wetland or waterbody when feasible. 10/26/07	NA
Woodbridge, CT Manville Rd (North)	A hydraulic oil leak was observed within the wetland buffer along the access road here. 10/26/07	Remove the affected soil/stone and dispose of it appropriately. In general, proactively check equipment for leaks and use spill control materials when performing maintenance and during refueling. 10/26/07	Needs attention
Manville Rd (South)	Equipment was noted parked in a wetland area. No leaks were observed. 10/26/07	All construction vehicles should be parked at least 100 feet from a wetland or waterbody when feasible. 10/26/07	Needs attention

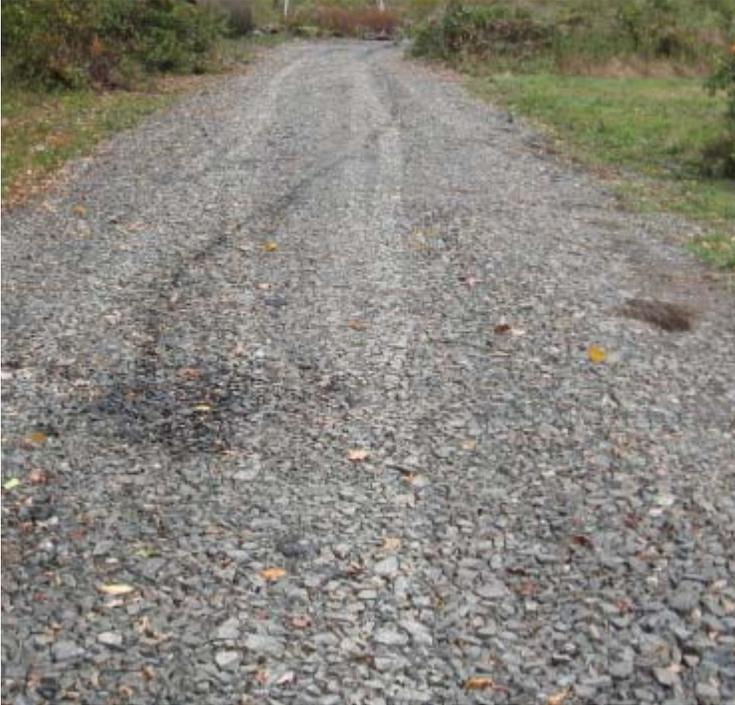
Manville Rd North: A hydraulic oil leak was noted along the access road here. The leak was not observed in the wetland area.

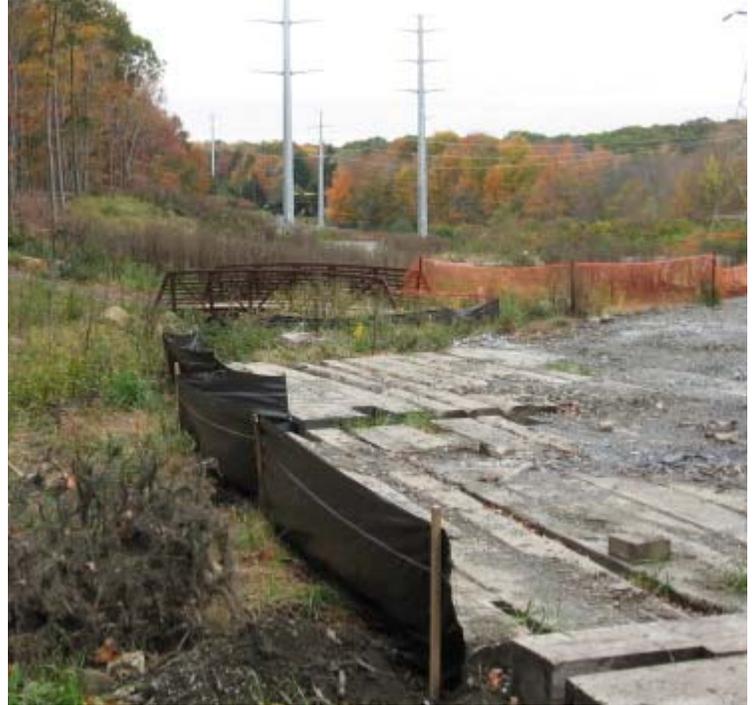
JCC (Woodbridge): Silt fence was repaired near structures #3932 and #24119.

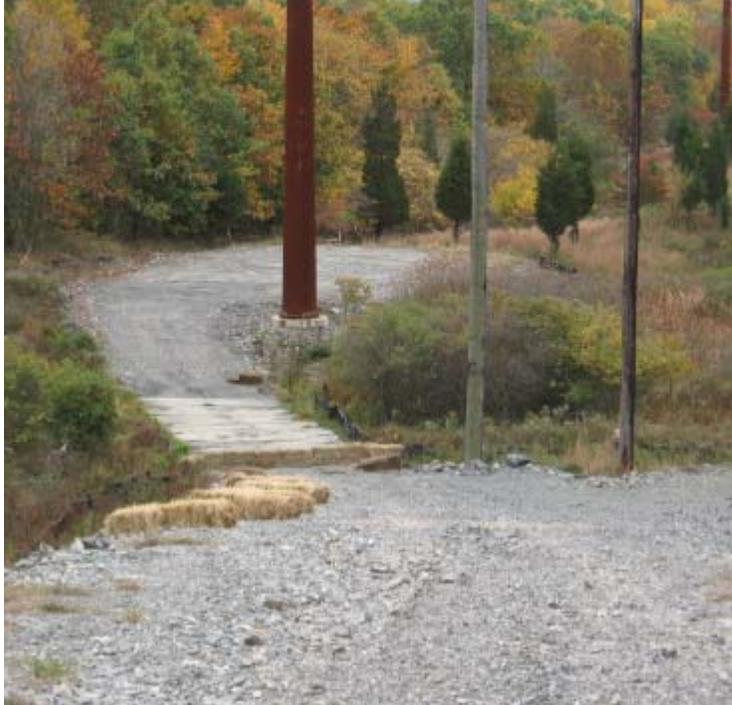
<p>Bethany, CT Litchfield Turnpike</p>	<p>A line of haybales was placed across the access road at the timber mat crossing within wetland #119. These controls, along with the haybale check dams, were installed in an effort to filter stormwater flowing into the wetland from the access road. 10/26/07</p>	<p>Continue to monitor and evaluate the need for additional controls. 10/26/07</p>	<p>Needs evaluation</p>
	<p>Excess sediment has accumulated on the timber mat wetland crossings within the access road here. Sediment was observed within the wetlands at several crossings. 10/26/07</p>	<p>Continue to monitor. Sediment should be removed from the timber mats as soon as possible controls should be installed to prevent further sedimentation to the wetlands. See Wetlands Section. 10/26/07</p>	<p>Needs attention/evaluation.</p>

Excess sediment has accumulated on the timber mat crossings within the access road here. Sediment has seeped through the mats and into wetlands #119 (near structure #3961), #116 (between structures #3964 and #3965), #115 (between structures #3965 and #3966) and #114 (between structure #3966 and #3967). 10/26/07	Carefully remove sediment from wetland areas when timber mats are removed. See EC Section. 10/26/07	Needs evaluation/attention
	Temporary stone access roads and timber mats remain in some of the wetland areas in these sections. 10/26/07	Continue to monitor. 10/26/07	NA at this time
Sediment remains in wetland #94. 10/5-10/26/07	Continue to monitor and add/maintain controls as necessary. Carefully remove sediment from the wetland if it is greater than 2' in depth. See EC	Needs evaluation/attention

Litchfield Turnpike (Bethany): A line of haybales was placed across the access road at the timber mat crossing within wetland #119.
