Docket No. 272 – Development and Management Plan Inspection

Segment 3 Underground Line

Date: October 18, 2007

Location: East Devon Substation to the Housatonic River Crossing

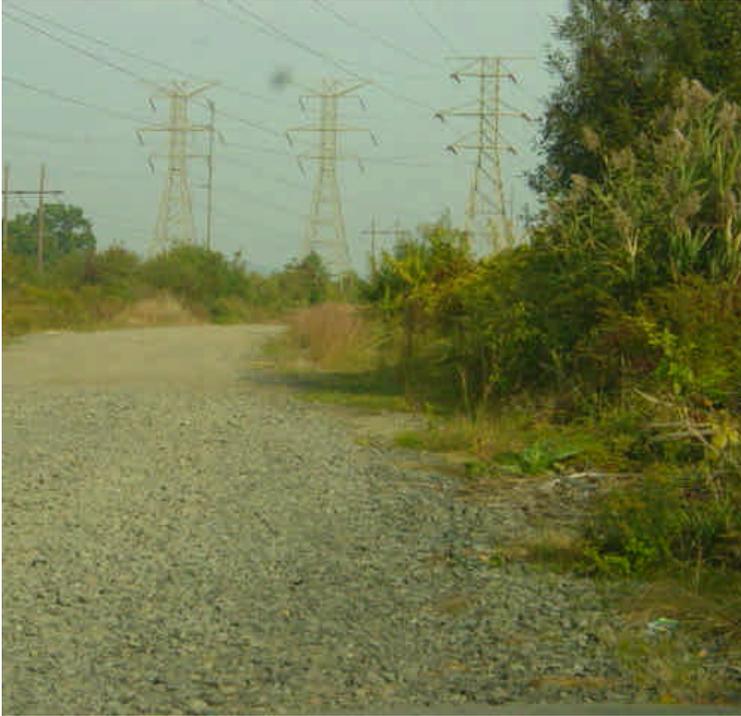
The equipment previously stored at sta. #1051 near the entrance the to ROW and less than 100' from the adjacent resource area has been relocated. (This equipment appeared to be related to work on the overhead wires.)

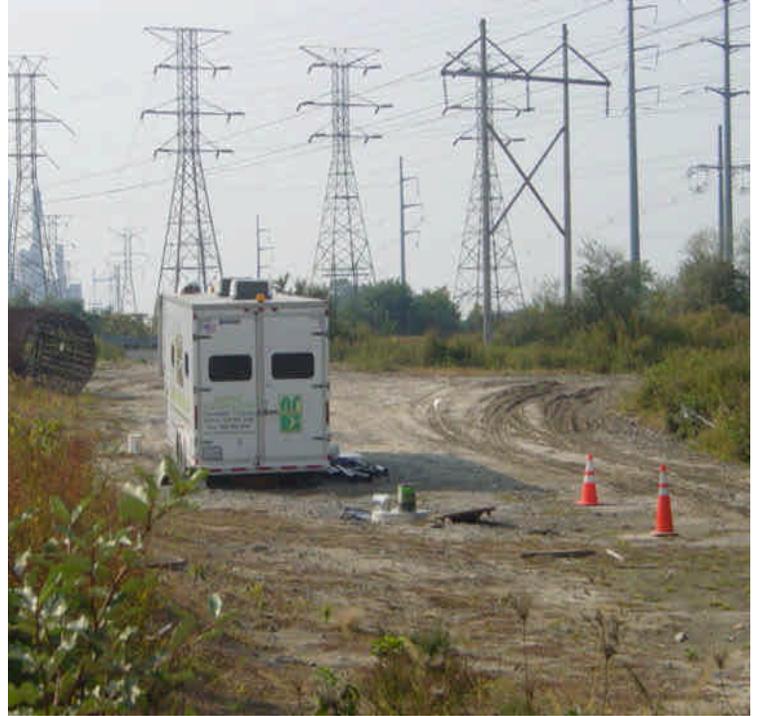
Electrical vault work continues near vault #5.

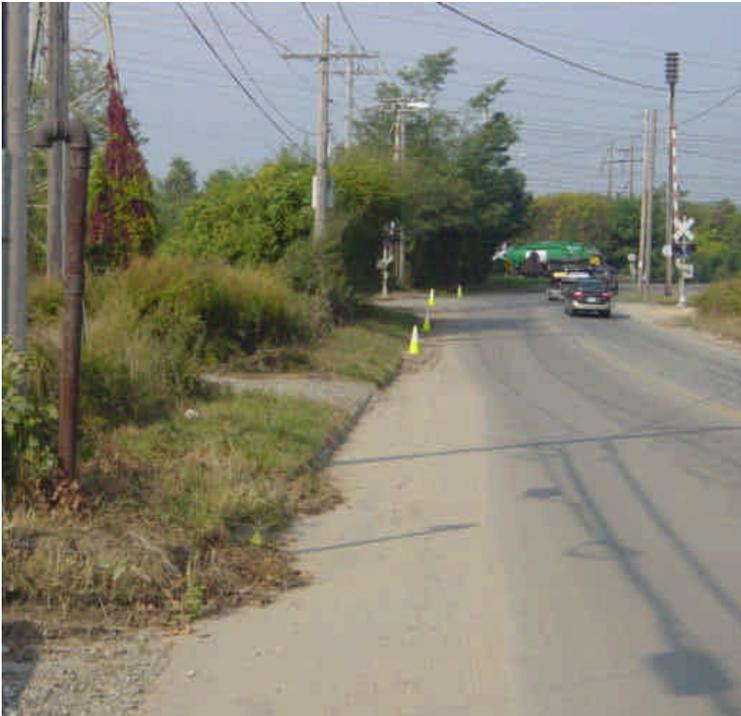
Tracking was evident along Caswell Street, but does not appear to be associated with this portion of the project.

Areas of Inspection	Observation	Recommended Action	Corrected Action
	<p>10/18/07</p> <p>Tracking was evident along Caswell Street but did not appear to be associated with this portion of the project. Noted for the record. 10/18/07</p>	<p>Roadway should be swept by the responsible party as necessary to reduce tracking. 10/18/07</p>	<p>NA (Does not appear jurisdictional to this portion of the project.)</p>

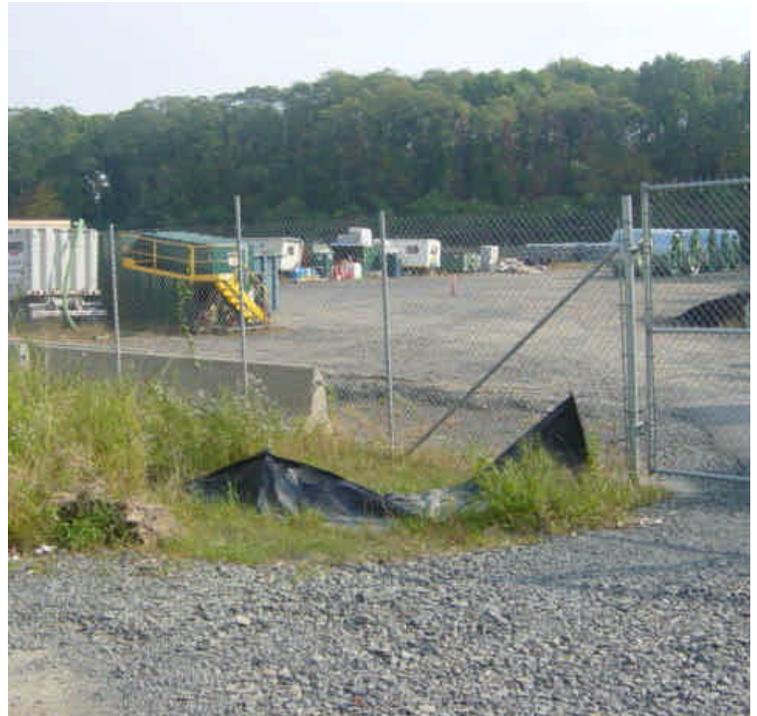
A small section of silt fence near the entrance to the Shelland St. laydown yard is sagging. The area is well vegetated and the silt fence continues to function. This yard appears to be idle as work has shifted to other areas of the project.

Areas of Inspection	Observation	Recommended Action	Corrected Action
	A small section of silt fence near the entrance to the yard is sagging but continues to function. The area is partially vegetated and stable. 10/18/07	When feasible, repair sagging section of silt fence. 10/18/07	Needs proactive maintenance when feasible.
Inland Wetland and Watercourse encroachment and mitigation	Inland Wetland resource areas are located near station from #1012 to 1021, # 1051, and #1053. Stations #1117 to 1118 are located in a resource area. 10/18/07	Monitor resource areas to ensure that non-permitted encroachment or impacts do not occur 10/18/07	NA
Staging, Storage, and Parking Areas	A contractor lay-down yard is located in Milford off of Shelland St. Jersey barriers are set up as bins to contain stockpiled materials. Stone is in place throughout the yard to reduce mud and subsequent tracking. Yard has been idle for several weeks as work has shifted to other areas of the project. 10/18/07	See erosion control section and spills and material storage section for more details. Contain material within established storage area and limits of the yard. 10/18/07	NA
