Docket No. 272 – Development and Management Plan Inspection

Segment 4a Underground Line

Date: October 11, 2007

Location: Singer Substation to Fairfield/Westport Town Line

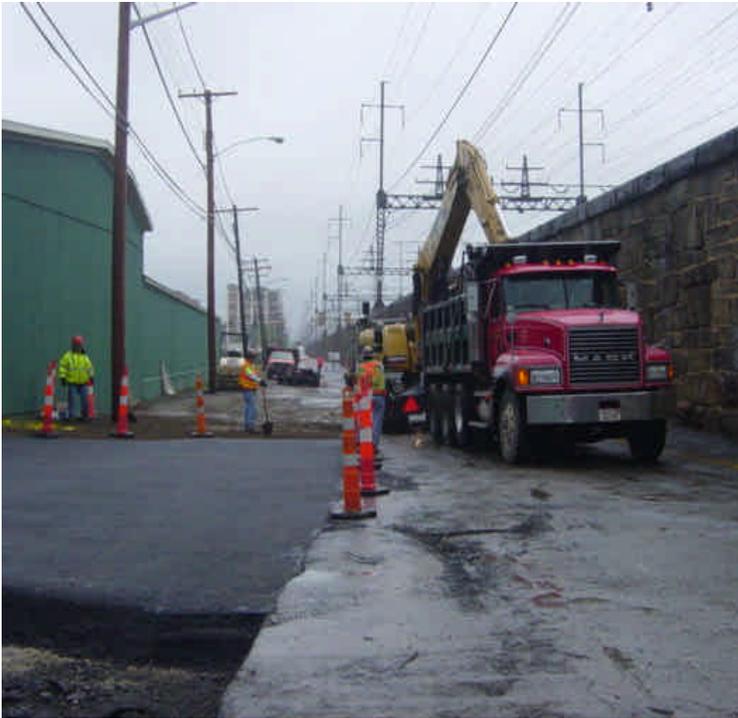
Restoration work is occurring near sta. #759.

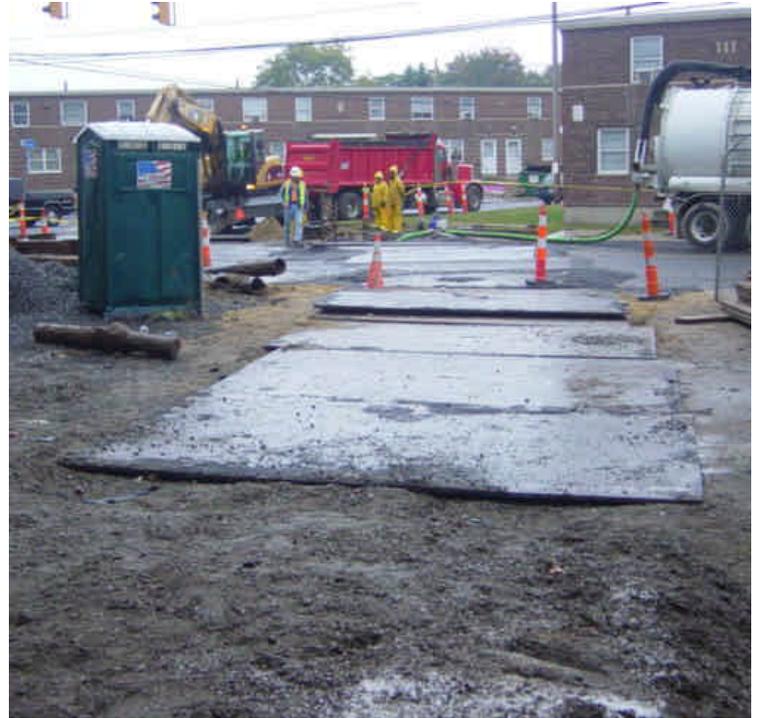
The small concrete washout previously observed near sta. #771-#772 has been cleaned-up and properly disposed of. Trench work continues in this area.

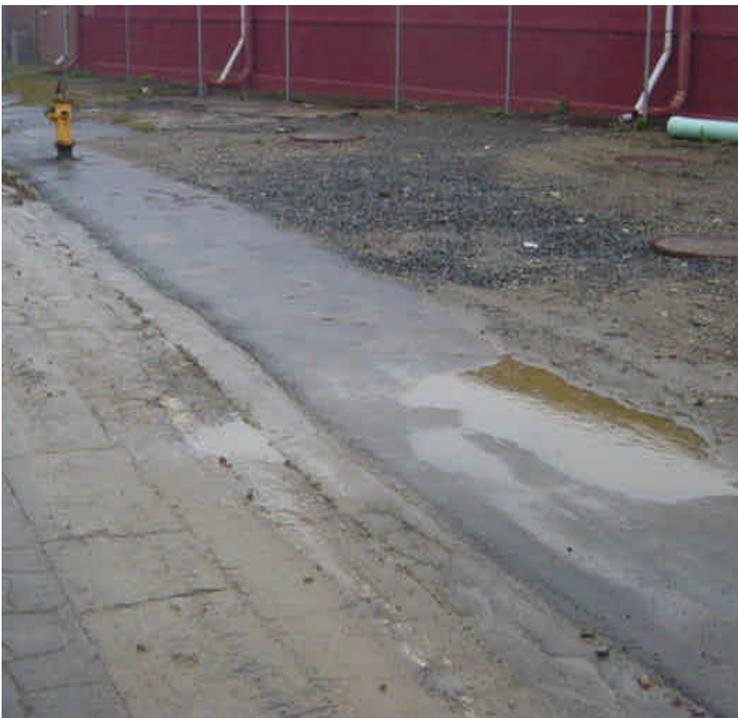
Accumulated sediment was observed along the roadway near sta. #790. During last week's inspection runoff was being generated from the vault work, but the source of the sediment was unclear. The downgradient catch basin was not protected with controls.

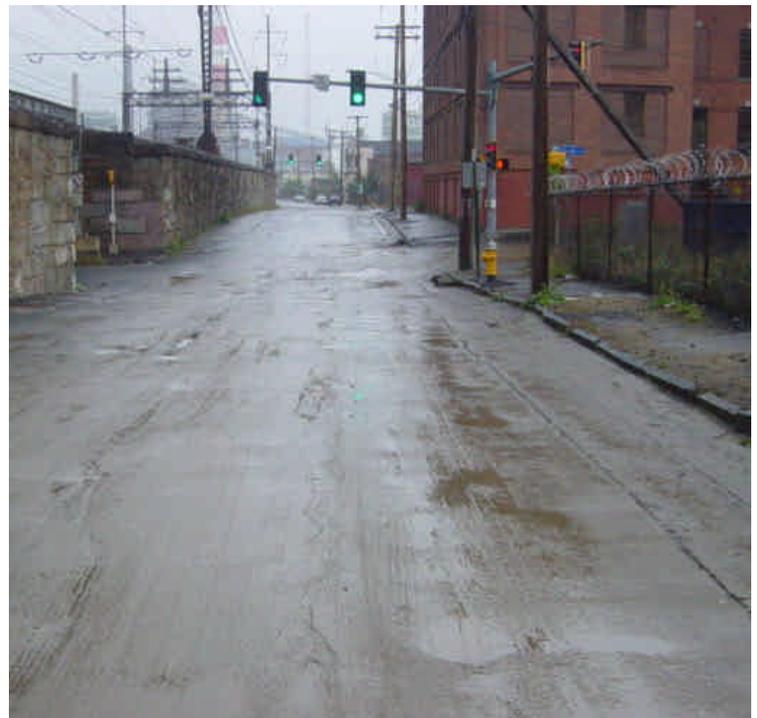
<p>The downgradient catch basins near the storage yard at Railroad Ave. and Myrtle Ave., associated with the Glenbrook Cable project remain protected with silt sacks. The road appeared to have been recently swept, but wet conditions reduced the effectiveness of the sediment removal. 10/11/07</p> <p>Accumulated sediment was observed along the roadway near sta. #790. During last week's inspection, runoff was being generated from the vault work, but the source of the sediment was unclear. The down gradient catch basin was not protected with controls. 10/11/07</p>	<p>Noted for the record since a portion of the project route overlaps this area. This yard is not jurisdictional to the M/N project. 10/11/07</p> <p>Sweep roadway as necessary, catch basin should be protected with a gutter buddy (or similar) to prevent sediment from entering basin. Runoff or dewatering from future vault work activities should be contained. 10/11/07</p>	<p>NA</p> <p>Needs attention.</p>

The downgradient catch basins near the storage yard at Railroad Ave. and Myrtle Ave., associated with the Glenbrook Cable project remain protected with silt sacks. (This area is not related to the M/N project but is located along a portion of the route.)
