Docket No. 272 – Development and Management Plan Inspection

Segment 4b Underground Line

Date: October 11, 2007

Location: Fairfield/Westport Town Line to Westport Avenue in Norwalk

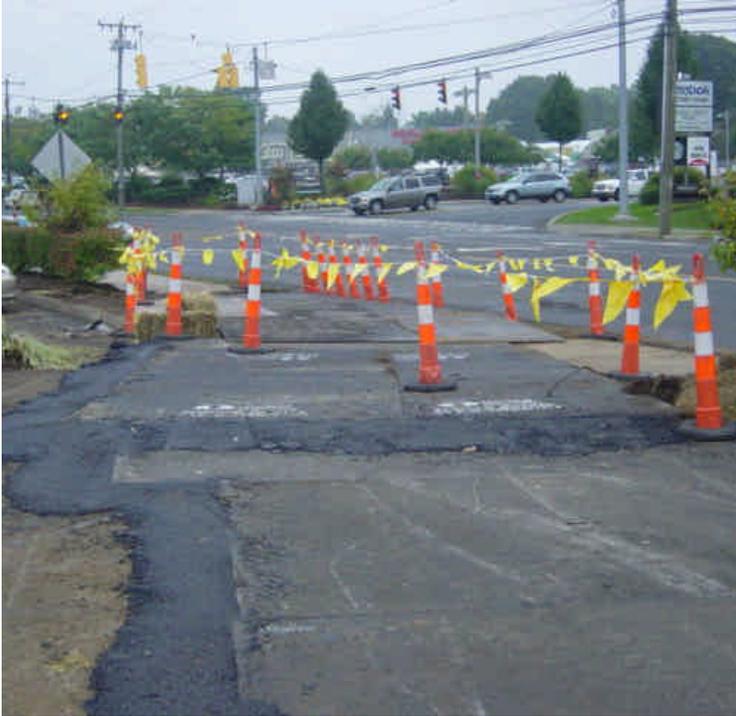
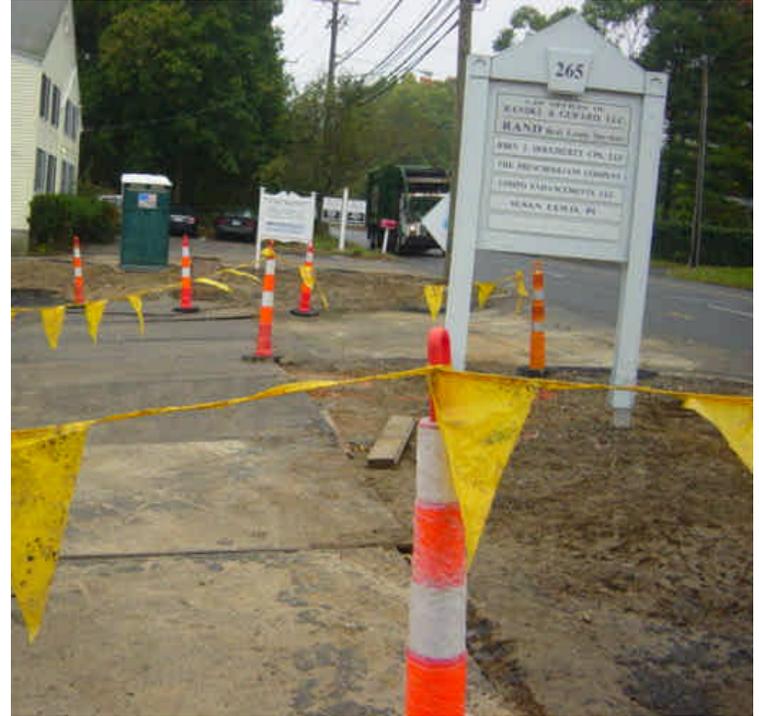
Tie-in work continues near sta. #99-101 (vault #6) (left) and sta. #201-202 (vault #12) (right). Some sediment was observed near the steel plates but tracking was limited to the parking lot area.

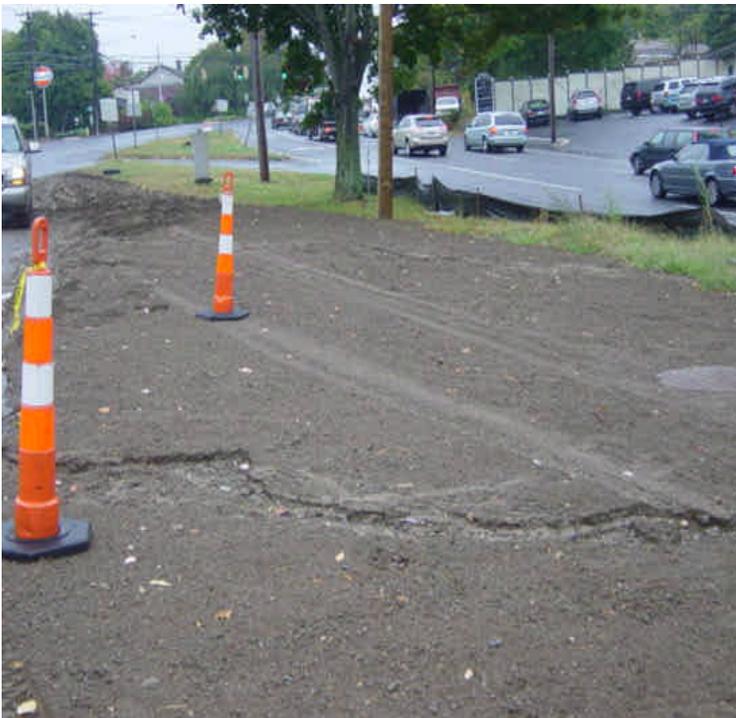
Topsoil was previously spread near sta. #316-318 (vault #19). Vehicle traffic has caused ruts in several areas and a small gully has formed. Area needs to be regraded, seeded, and mulched.

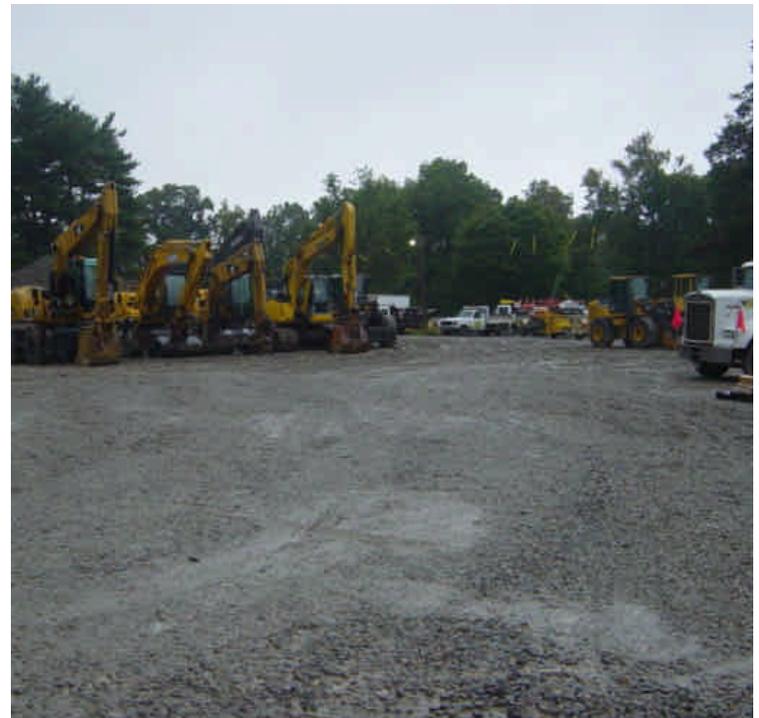
No issues were observed at Sherwood Island lay-down yard at the time of the inspection. Yard was becoming muddy with the rainy conditions and sediment tracking may become an issue.
