Docket No. 272 – Development and Management Plan Inspection

The Connecticut Light and Power Company Certificate of Environmental Compatibility and Public Need for the construction of a new 345-kV electric transmission line and associated facilities between Scovill Rock Switching Station in Middletown and Norwalk Substation in Norwalk, Connecticut, including reconstruction of portions of existing 115-kV and 345-kV electric transmission line, the construction of Beseck Switching Station in Wallingford, East Devon Substation in Milford, (and Singer Substation in Bridgeport), modifications at Scovill Rock Switching Station and Norwalk Substation, and the reconfiguration of certain interconnections.

Segment 4b Underground Line

Date: October 18, 2007

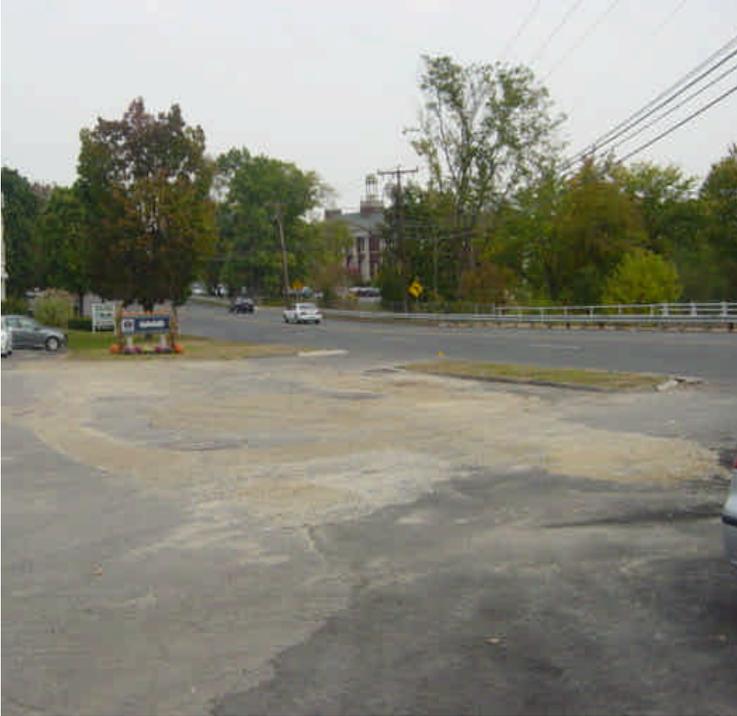
Work has been completed in the area adjacent to Stony Brook (sta. #217). Contractor is working with landowner to reach agreement on final restoration measures. It is anticipated that the lot will be re-paved this fall. Sweep as needed.

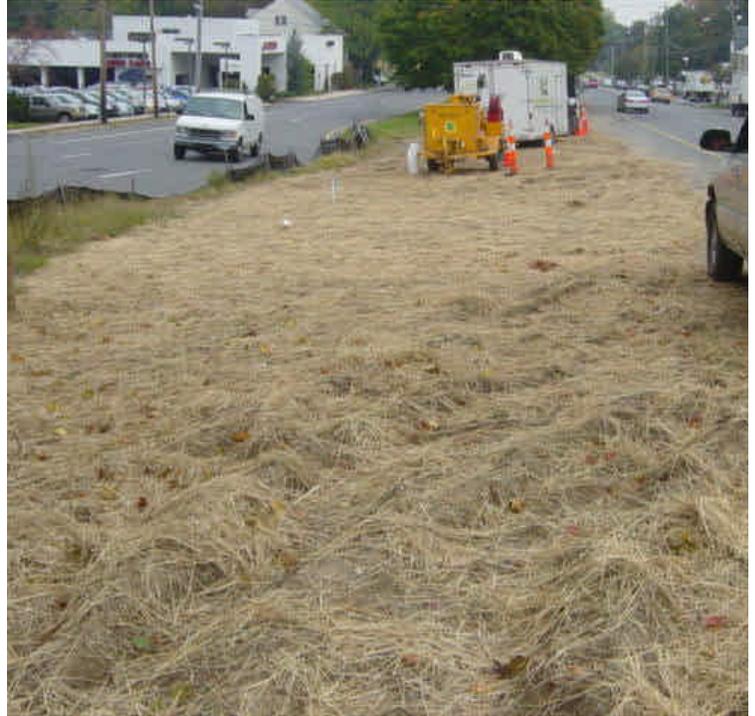
The area at sta. #316-318 (vault #19) was previously graded with topsoil, and hay mulch has been applied. Construction activity in the area had caused ruts in several areas. Continue to stabilize.

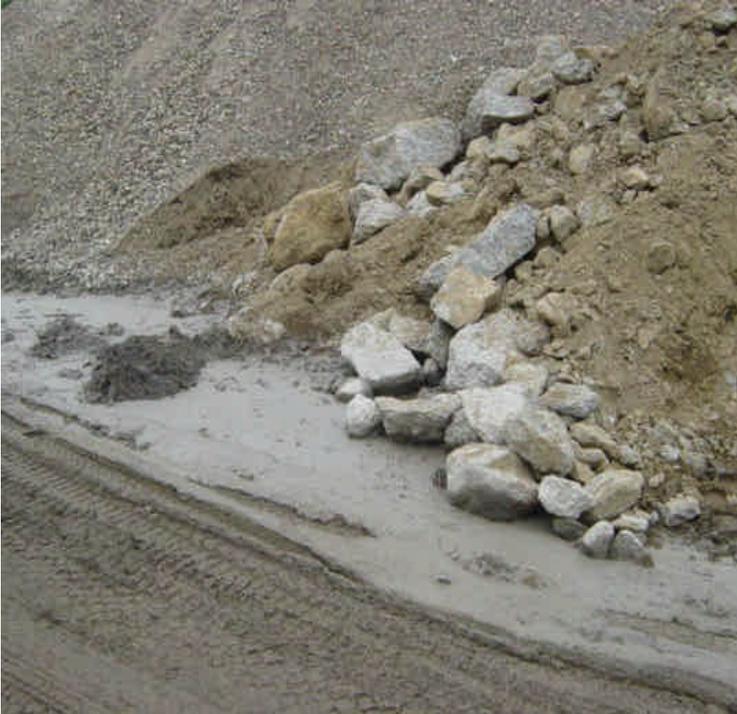
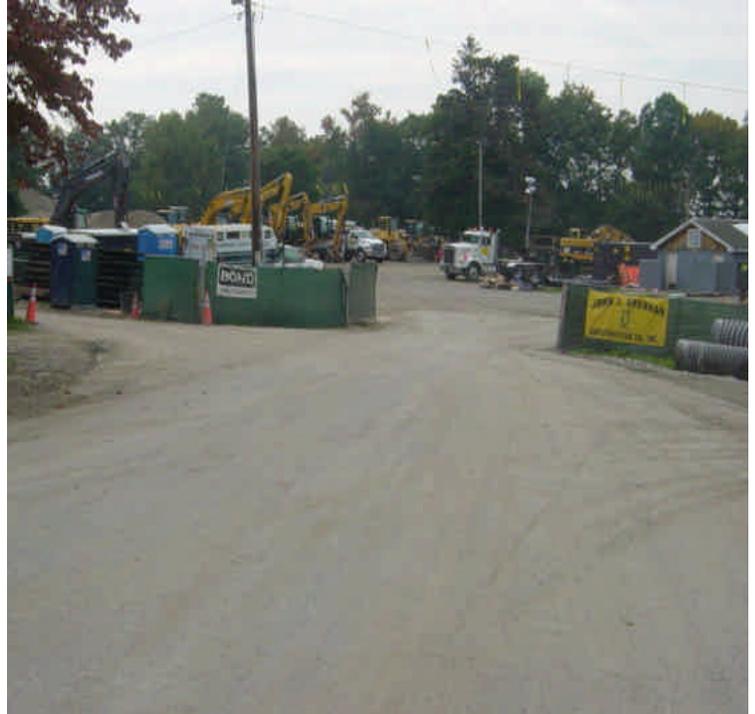
Saw cutting slurry was dumped near the edge of the debris pile awaiting processing in the Sherwood Island lay-down yard (left). The slurry should be placed in a contained area to reduce the potential for run-off or tracking. Sediment tracking was an issue at the entrance to the yard (right) and sediment accumulation was evident along the roadway shoulders of the Sherwood Island Connector.
