Docket No. 272 – Development and Management Plan Inspection

Segment 4b Underground Line

Date: October 25, 2007

Location: Fairfield/Westport Town Line to Westport Avenue in Norwalk

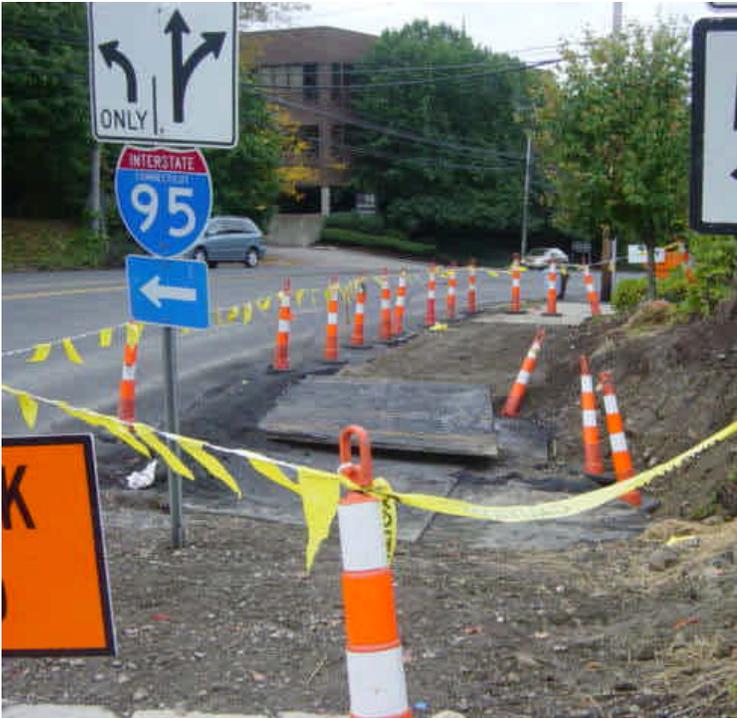
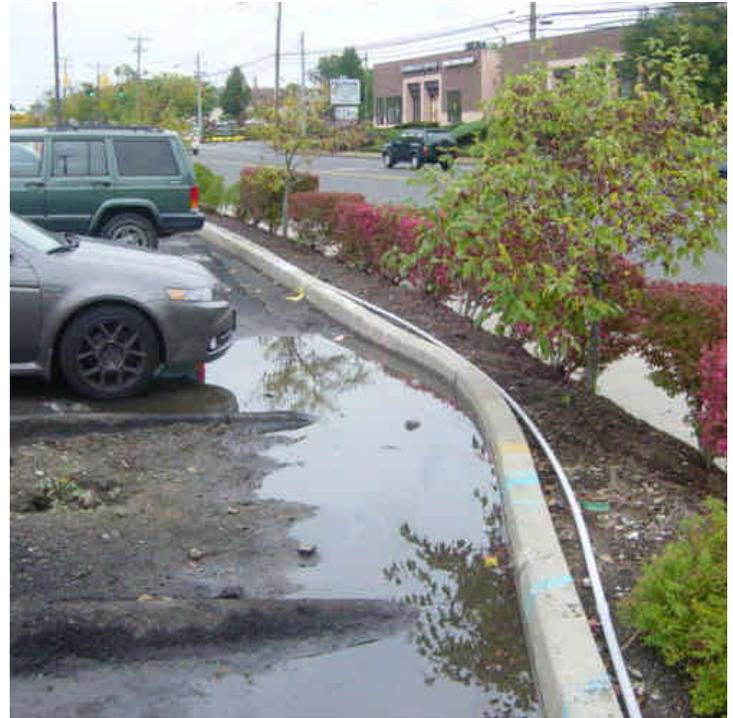
Steel plates are in place over the exposed trench near sta. #96, as tie-in work continues at vault #6 (left). The catch basin in the parking lot was protected with a silt sack but appears to be plugged (right). Remove accumulated sediment from the controls to increase the catch basin function.

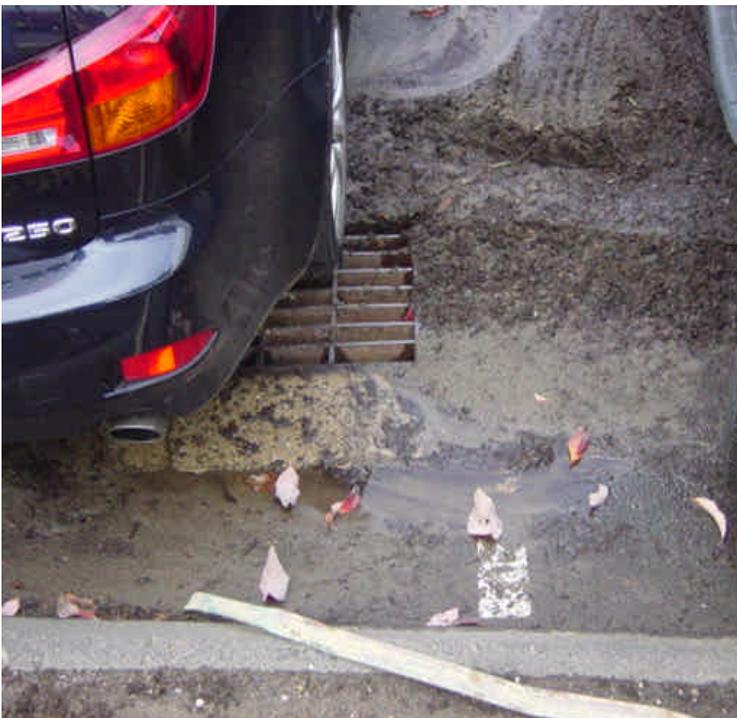
Heavy sediment accumulation was observed near sta. #146 (vault #9). Sediment appeared to have been washed out of the adjacent landscaped areas as a result of heavy rains. The receiving catch basin was not protected. 10/25/07	Clean/sweep catch basin and parking lot area. Install silt sack to protect catch basin and provide additional stabilization to adjacent landscaped areas and work sites. 10/25/07	Needs attention
	Silt fence between sta. #316-#318 is heavily frayed, sagging, and in need of repair. The surrounding area remains temporarily stabilized with hay mulch. Ruts remain. 10/25/07	Removed damaged sections of silt fence and install new fence between sta. #316+50-317+25. Locate and toe-in fence in a way that avoids impacts to existing vegetation along curb line. 10/25/07	Needs attention.
Kings Highway Lay-down Yard (Fairfield)	Perimeter controls remain in place. Dust migration	Implement dust control measures and sweep	NA

Heavy sediment accumulation was observed near sta. #146 (vault #9). Sediment appeared to have been washed out of the adjacent landscaped areas. The catch basin was not protected. Sweep the roadway and provide additional stabilization.

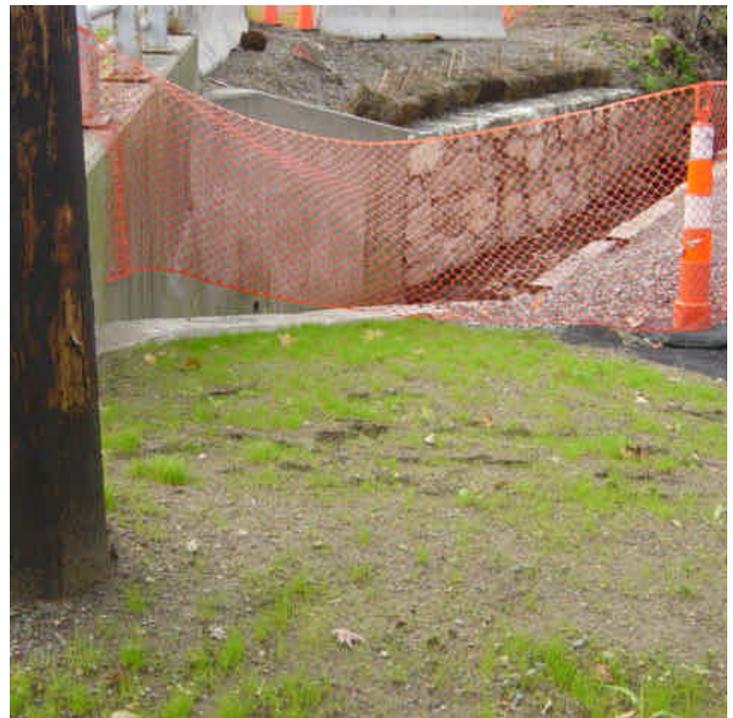
Work has been completed in the area adjacent to Stony Brook (sta. #217). Area near the entrance drive is has approximately 50% new grass cover. Contractor is working with owner to reach agreement on final restoration measures. 10/25/07	Cleared trees were removed in accordance with the D&M plan. Implement final restoration plan once agreement is reached. See the Erosion Control and Inland Wetlands sections for more details 10/25/07	NA
	Vault #12 work area is temporarily stabilized with hard-pack and hay mulch. Trees were previously removed to accommodate work. 10/25/07	Cleared trees have been approved for removal in accordance with the D&M plan. Restore as required by the D&M plan when feasible. 10/25/07	NA
	Silt fence is in place near vault #20 but acts more as a barrier to prevent vehicles from parking on seeded areas. The area is approximately 75% vegetated. 10/25/07	The area can be considered stable as it has reached 75% cover. 10/25/07	NA

Work has been completed in the area adjacent to Stony Brook (sta. #217). The area near the entrance drive is approximately 50% vegetated.

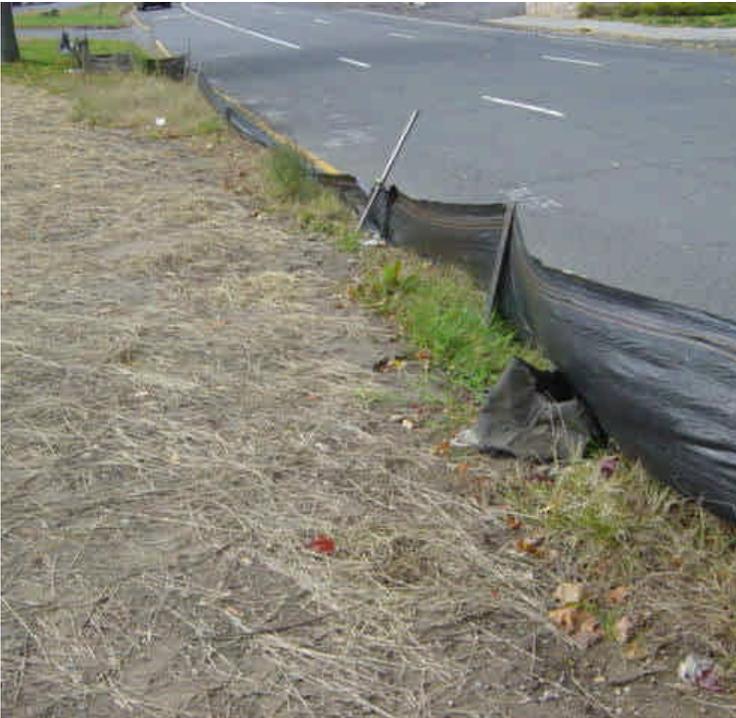
The silt fence remaining between sta. #316-#318 is heavily frayed and in need of repair. The surrounding area remains temporarily stabilized with hay mulch. Replace silt fence between sta. #316+50-317+25

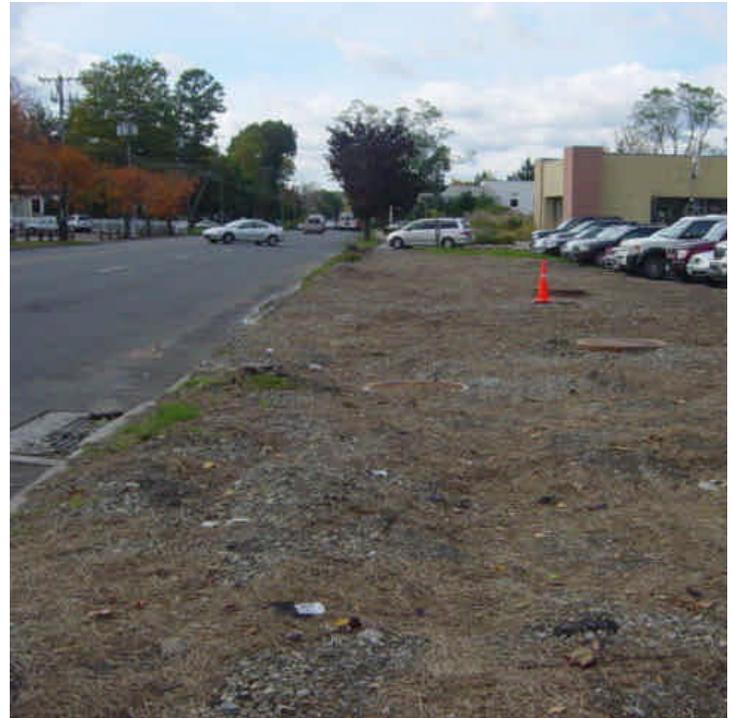
A minor amount of sediment eroded and was visible along the curb near sta. #383 (vault #23). Eroded material was removed from along the curb line and the area was stabilized with haybales at this point.

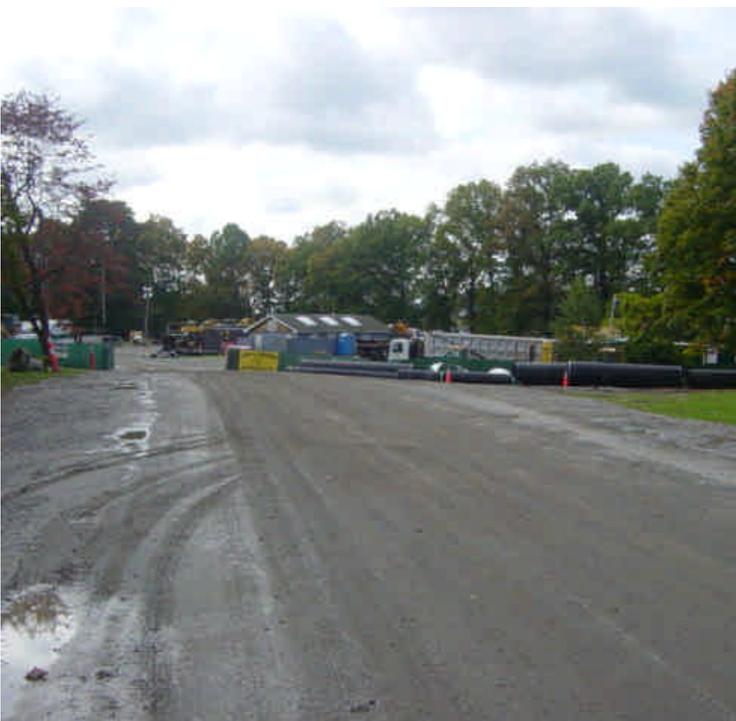
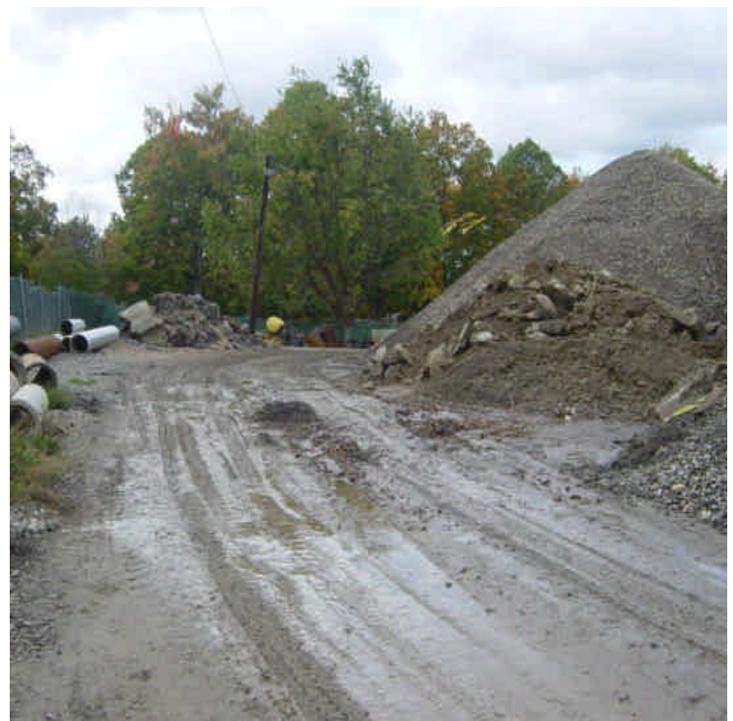
Areas of Inspection	Observation	Recommended Action	Corrected Action
<p>down Yard (Fairfield) (Currently being used for Segment 4a and 4b operations.)</p> <p>Sherwood Island lay-down yard</p>	<p>and tracking were not an issue. 10/25/07</p> <p>Access roads within the yard are becoming very muddy and ruts are beginning to form. 10/25/07</p> <p>Stockpile of debris material is very large. Saw cutting slurry was dumped near the edge of the debris pile, increasing the potential for tracking. Perimeter controls remain in place. 10/18-10/25/07</p>	<p>roadway as necessary. Continue to monitor and maintain controls as necessary. 10/18/07</p> <p>Stabilize access roads and surfaces within yard to remove mud/ruts and reduce tracking. Sweep the access driveway to reduce tracking. 10/25/07</p> <p>Manage the debris material stockpile to reduce tracking and to facilitate the emptying of street sweeping equipment in a contained area. 10/25/07</p>	<p>Needs regular attention.</p> <p>Needs regular attention.</p>

Access roads within the Sherwood Island lay-down yard are becoming very muddy and ruts are beginning to form. Heavy tracking was an issue at the entrances to the yard and along the access driveway. Materials and equipment continue to be stored outside the fenced limits of the yard (left). Stockpile of debris material is growing very large. Saw cutting slurry was dumped near the edge of the debris pile on the access road within the yard (right), increasing the potential for tracking.
