**Docket No. 272 – Development and Management Plan Inspection**

**Beseck Switching Station Inspection**

**Date:** September 18, 2007

**Location:** Beseck Switching Station

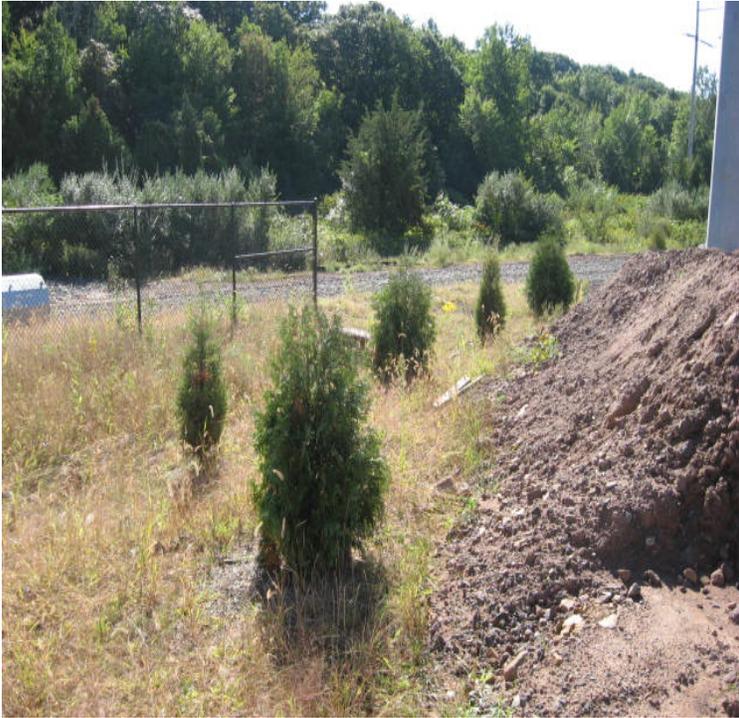
View of the soil stockpile remaining along the eastern access road (1A responsibility).

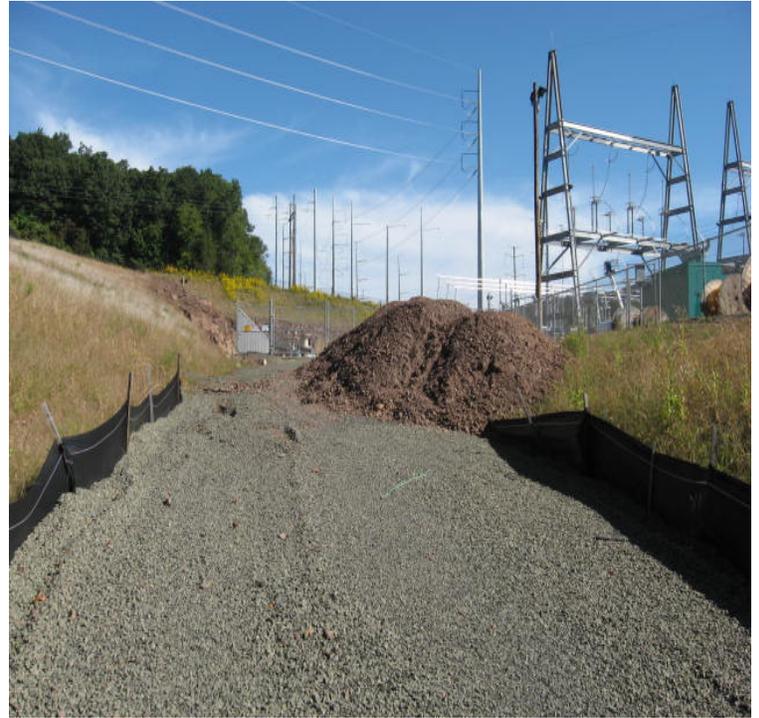
View of the stockpile and small washouts/eroded channels at the western access drive.

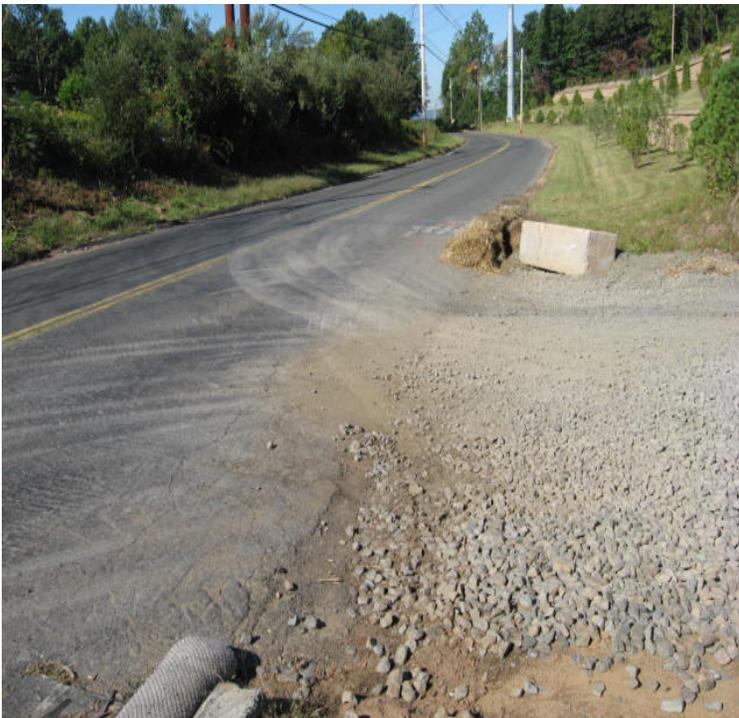
View of the eastern site entrance. The roadway had been recently swept and no run-off was observed.

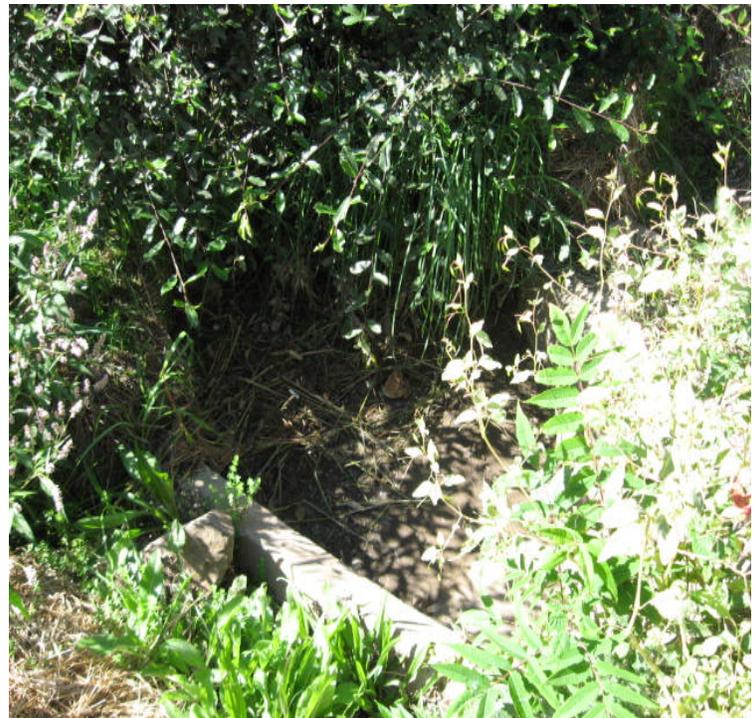
View of the dry storm drain at Carpenter Lane. Continue to remove sediment as needed.
