**Docket No. 272 – Development and Management Plan Inspection**

**Segment 1a Inspection**

**Date:** September 4, 2007

**Location:** Segment 1a – Scovill Rock Switching Station to Chestnut Junction, Oxbow Junction to Beseck Switching Station (excluding Royal Oak Bypass), and Black Pond Junction to Beseck Switching Station

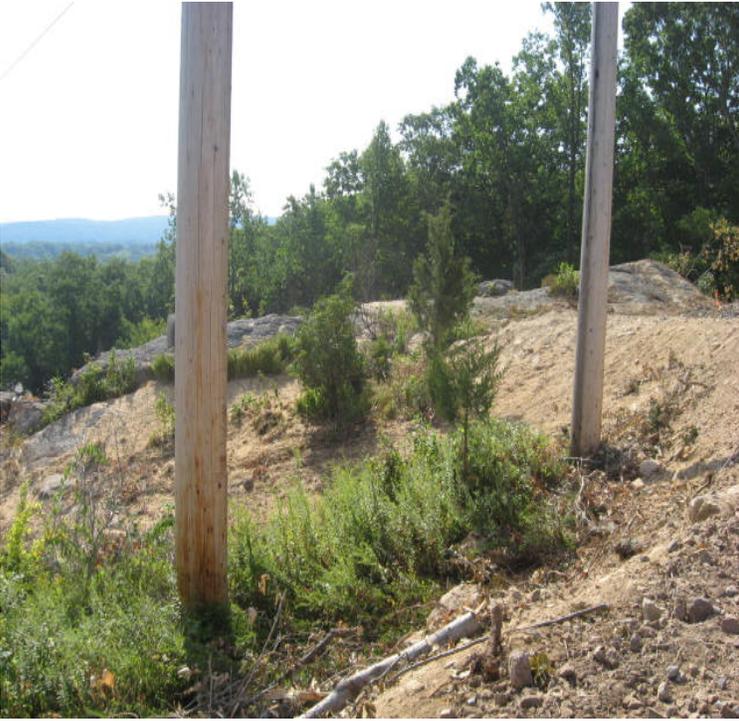
Shunpike Rd: Controls installed.

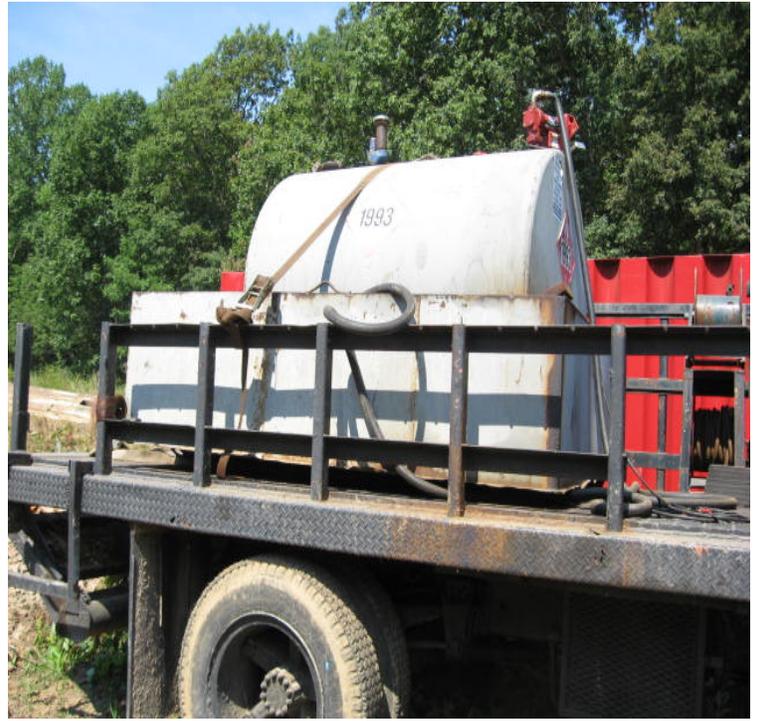
Shunpike Rd: Refueling tank with nozzle in bucket.

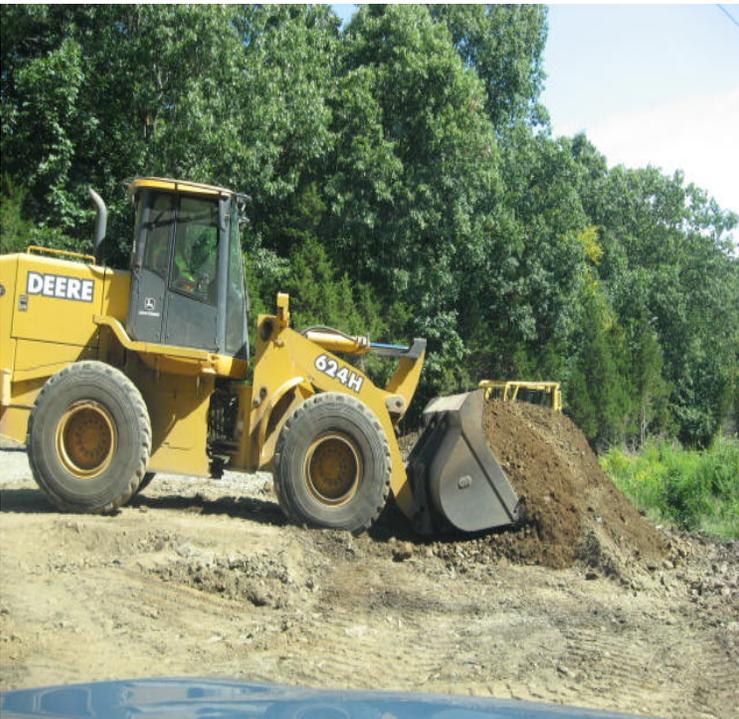
Black Walnut: Removing soil stockpiles.

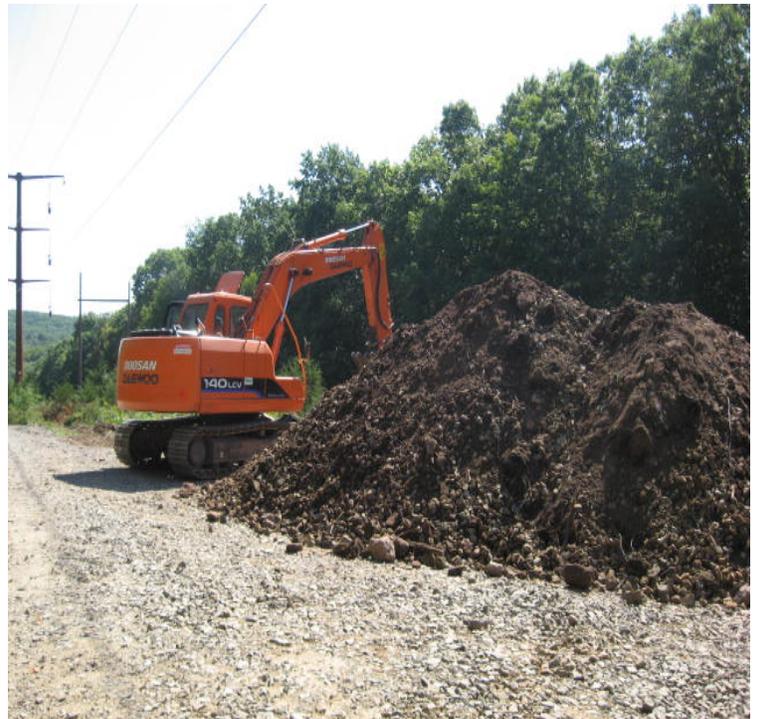
Black Walnut: Removing old pads and grading.

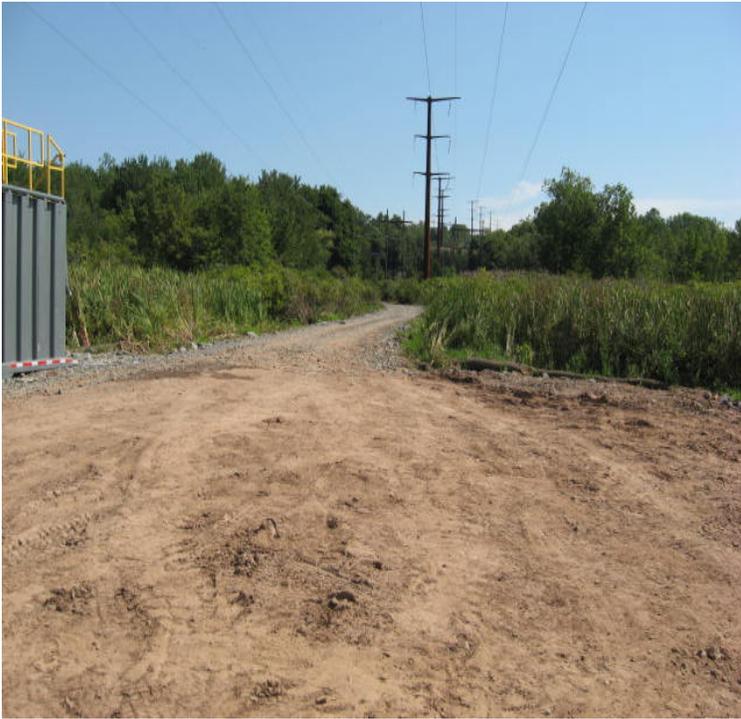
Durham Rd	Stone Access road/pads are in place to structure # 24521. Timber mats remain in place for accessing pads in wetlands. A culvert has been installed to reduce ponding. Access road stone is sinking in some locations within the wetland area. 9/4/07	Sweep Durham Rd. as needed. Add stone as needed to stabilize access road. See erosion control section. 9/4/07	Needs attention
Durham Rd. to Elihu Dr.	Access roads and pad site installation on hold until winter. 9/4/07	Add controls as needed during access road installation. 9/4/07	NA
Rte. 157 (west) Private Driveway	Private dirt driveway being used to access a pad site. A section of lawn was damaged from equipment accessing the ROW. 9/4/07	Maintain and adjust controls as needed. Work with landowner to repair the area of lawn as needed. 9/4/07	Needs attention and evaluation at the completion of work in the area
West of Beseck SS	A stone access road is in place where the old off-site driveway was, in order to pull lines. 9/4/07	Remove stone, regrade, and seed area upon completion of work. See erosion control section for more detail. 9/4/07	Needs regular attention.

Durham Rd: Pad area installed within a wetland. Stone is sinking in some areas.

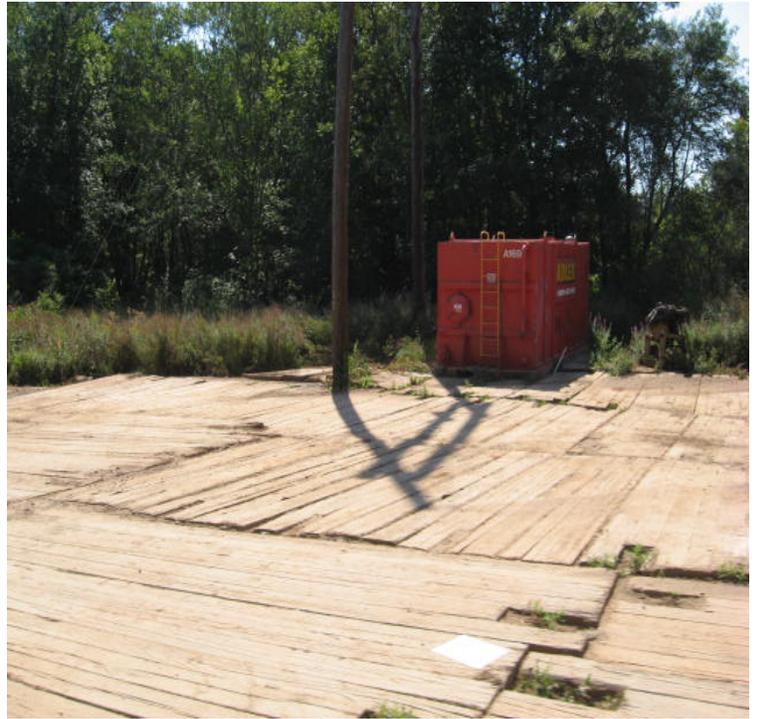
Durham Rd: Equipment was removed from wetland area and sediment was removed from timber mats.

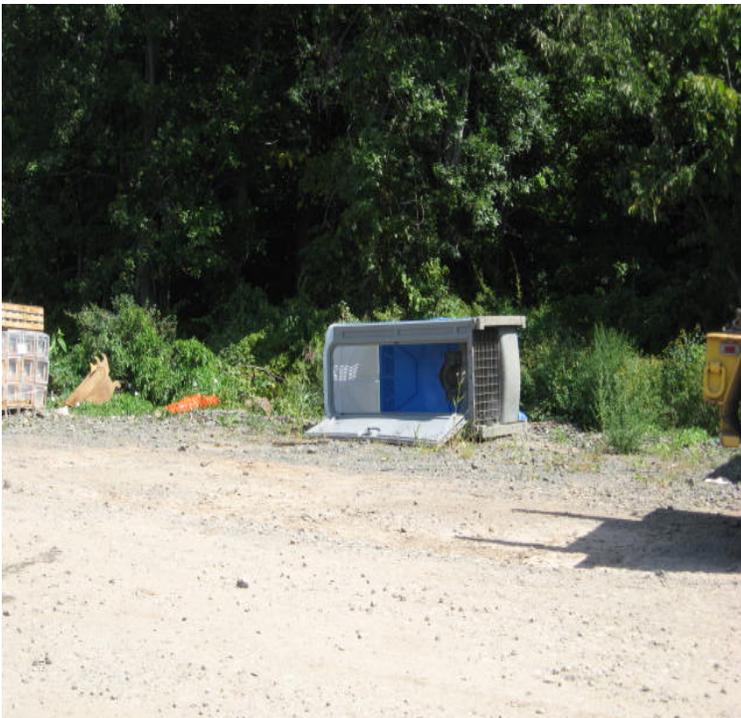
East Meriden SS: Sanitary facility knocked over.

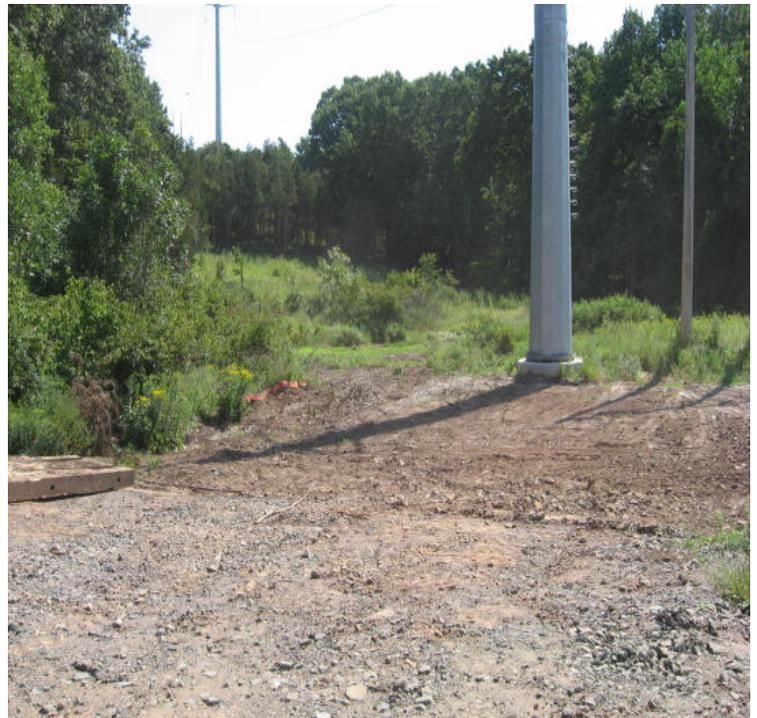
Carpenter Ln: Timber mats were removed and soils graded and seeded east of Besock SS.
