**Docket No. 272 – Development and Management Plan Inspection**

**Segment 1a Inspection**

**Date:** September 17, 2007

**Location:** Segment 1a – Scovill Rock Switching Station to Chestnut Junction, Oxbow Junction to Beseck Switching Station (excluding Royal Oak Bypass), and Black Pond Junction to Beseck Switching Station

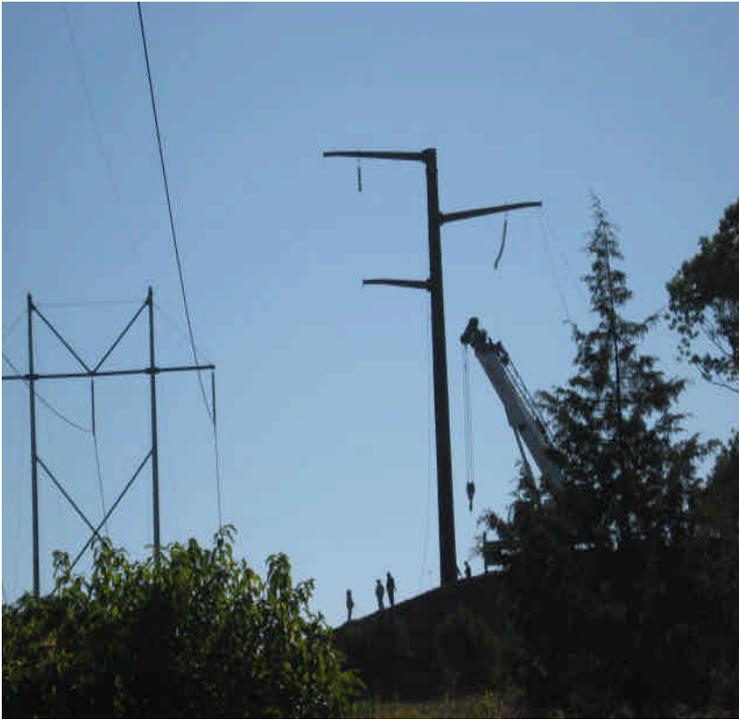
**Shunpike Rd:** Crews were working to install a pole structure.

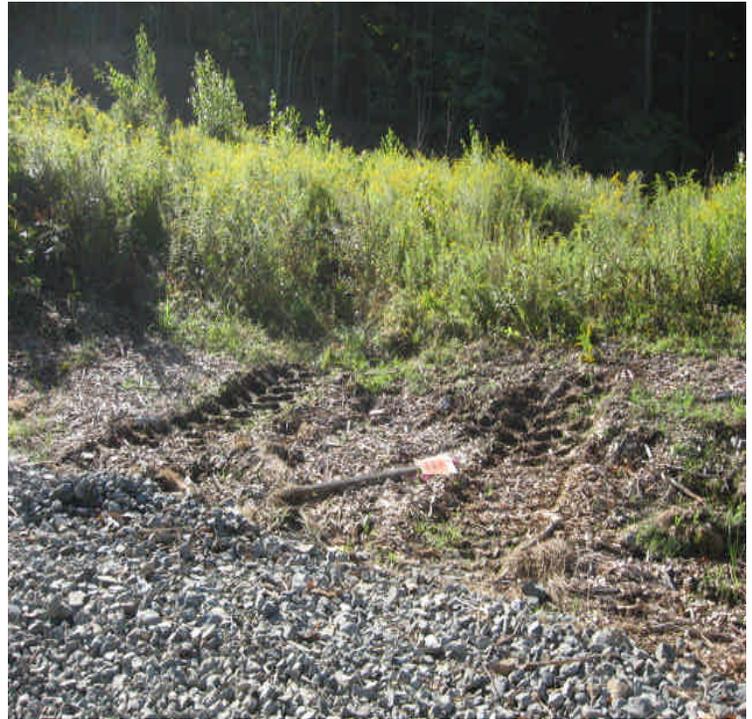
| Areas of Inspection | Observation | Recommended Action | Corrected Action |
|---|---|--|---|
| | A vehicle apparently | Carefully regrade the | Needs attention. |

| Areas of Inspection | Observation | Recommended Action | Corrected Action |
|---|---|--|--|
| <p>Oxbow Junction to Beseck SS</p> <p>Haddam Quarter Rd. (Oxbow Junction); Johnson Ln; Foot Hills Rd.; Arbutus Street; Little Ln.; Cherry Hill Rd.; Elihu Dr.; Rte. 157 (west) Private Driveway; Valley View Dr.; East of Beseck SS</p> | <p>backed into a wetland area, knocking over the wetland boundary sign. 9/17/07</p> <p>All access roads and pad sites have been installed along the majority of this section of ROW. Timber mats are in place at wetland crossings. Controls have been installed at all wetlands and no issues have been noted. 9/17/07</p> | <p>ruts, re-establish the boundary sign and install erosion controls as needed adjacent to the stone fill. 9/17/07</p> <p>Continue to add controls where needed, i.e. mulch, check dams, silt fence, to control sediment and prevent erosion. Sweep roadways as needed. See erosion control section. 9/17/07</p> | <p>NA</p> |

**Shunpike Rd:** Equipment apparently backed into wetlands, knocking over the wetland boundary sign. Carefully regrade, install obvious controls and re-establish the sign.

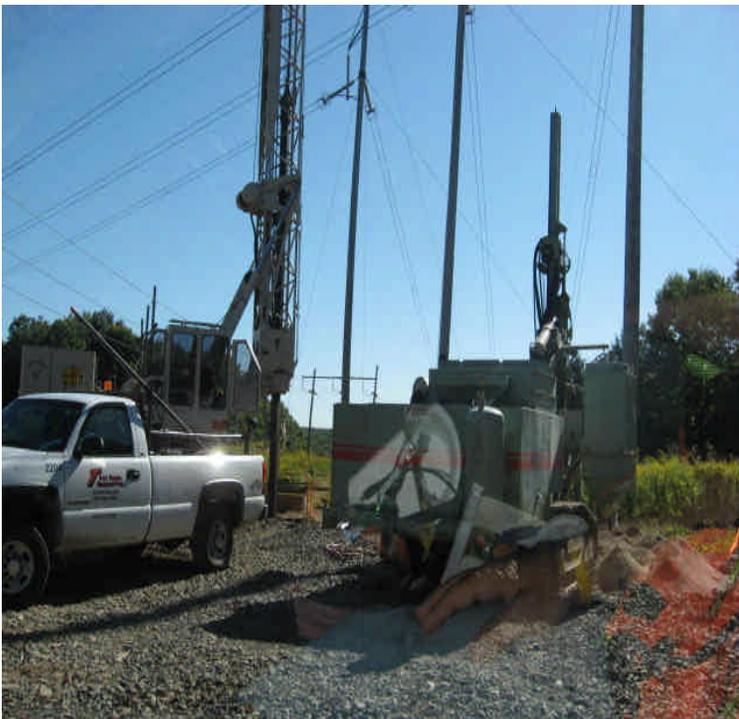
**Bartholomew Rd.:** Crews continue to drill new foundations.

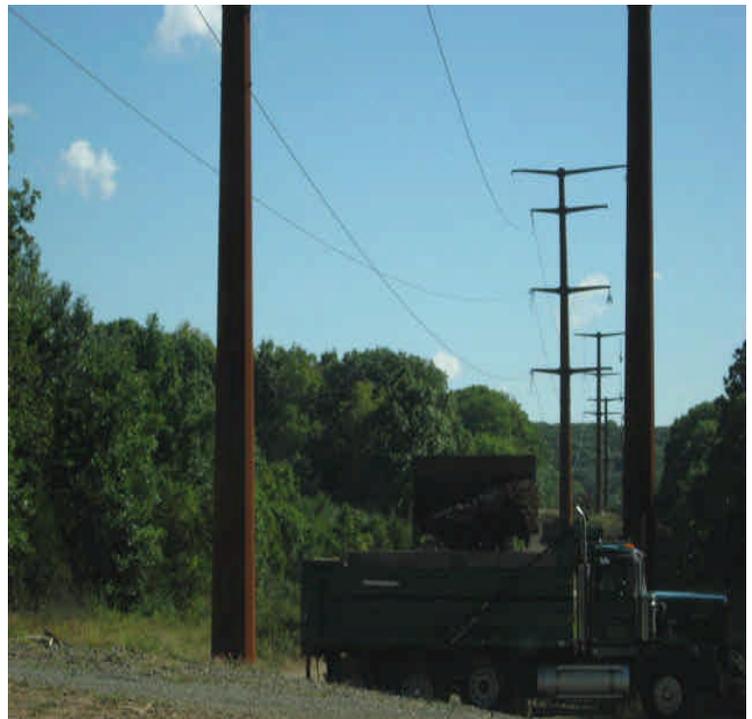
| Areas of Inspection | Observation | Recommended Action | Corrected Action |
|---|---|---|---|
| Black Walnut Dr. | Bark mulch, haybales and filter socks remain along the steep slope of the pad upgradient of Ball Brook. 9/17/07<br><br>Contractors continue to remove some stone along access roads and pads in an effort to restore the areas. 9/17/07 | Continue to monitor and adjust controls to protect the resource area downgradient. 9/17/07<br><br>Continue to remove stone in areas where work is complete and monitor this area for stabilization. 9/17/07 | NA<br><br>Stone was removed and areas were seeded and mulched. |

**Black Walnut Dr:** Crews were reclaiming/restoring portions of access road and were removing stone.

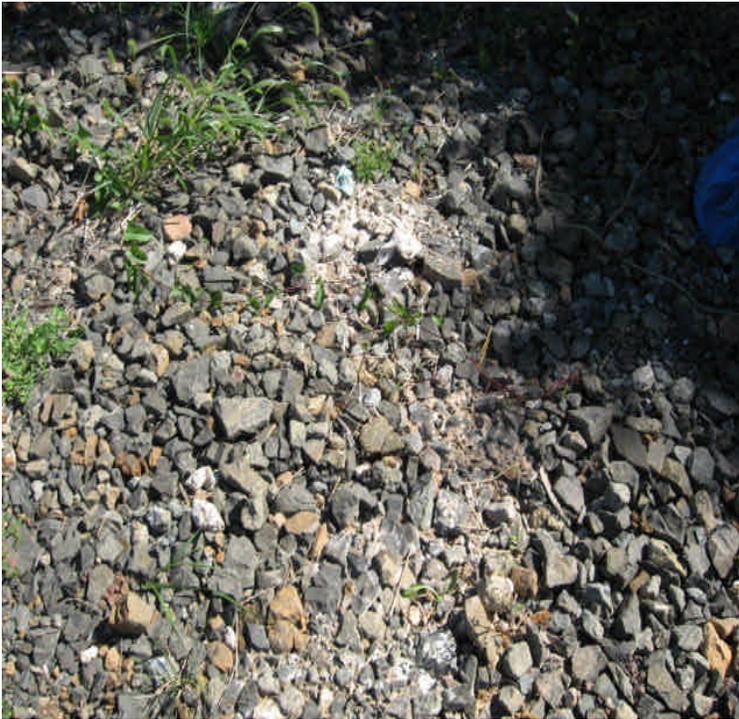
| Areas of Inspection | Observation | Recommended Action | Corrected Action |
|--|---|--|--|
| <p><b>Black Pond Junction to Beseck SS</b></p> | <p><b>Some equipment and supplies are being stored here. A large spill kit is stored onsite. 9/17/07</b></p> <p><b>The portable sanitary facility tipped over next to East Meriden SS has been righted. However, the spill and affected have not been cleaned properly. 9/17/07</b></p> | <p><b>Always store equipment and supplies away from sensitive areas. Monitor and maintain equipment as needed and provide housekeeping on a regular basis. 9/17/07</b></p> <p><b>Provide appropriate clean-up in the spill area. 9/4-9/17/07</b></p> | <p><b>NA at this time</b></p> <p><b>Needs immediate attention.</b></p> |

**E. Meriden SS: Remains of the spill on the ground as a result of the tipped over sanitary facility. Provide appropriate clean-up asap.**

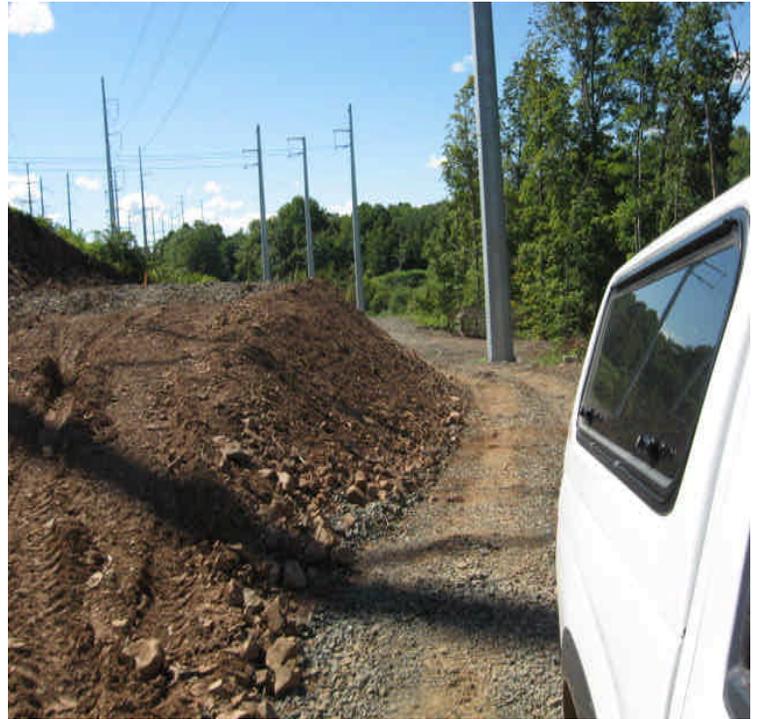
| Areas of Inspection | Observation | Recommended Action | Corrected Action |
|---|--|--|--|
| | <p><b>A new pad site was graded near East Meriden Substation but controls were not observed. 9/17/07</b></p> | <p><b>Install controls adjacent to the work area. 9/17/07</b></p> | <p><b>Needs attention.</b></p> |

**E. Meriden SS: A new pad site needs adjacent controls. Stabilize the soils.**

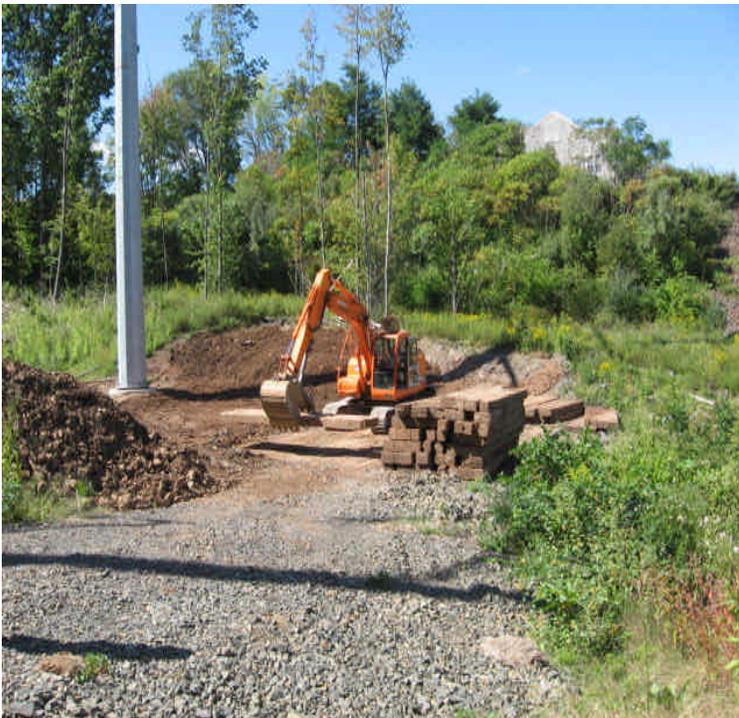
| Areas of Inspection | Observation | Recommended Action | Corrected Action |
|---|--|--|--|
| | <p><b>This area was actively being worked to remove fill from the re-established stream channel. Soils remain exposed and disturbed along the channel. 9/17/07</b></p> | <p><b>Continue to stabilize the banks of the restored stream area as soon as possible. Use erosion control blankets if necessary to further stabilize. 9/17/07</b></p> | <p><b>Stream channel was being reclaimed, stabilization is needed.</b></p> |

**E. Meriden SS (North): Reclaiming/restoring the original stream channel. Remove the fill and stabilize the exposed soil as soon as possible. Remove the riprap bypass before using the new pad site to avoid additional sedimentation.**

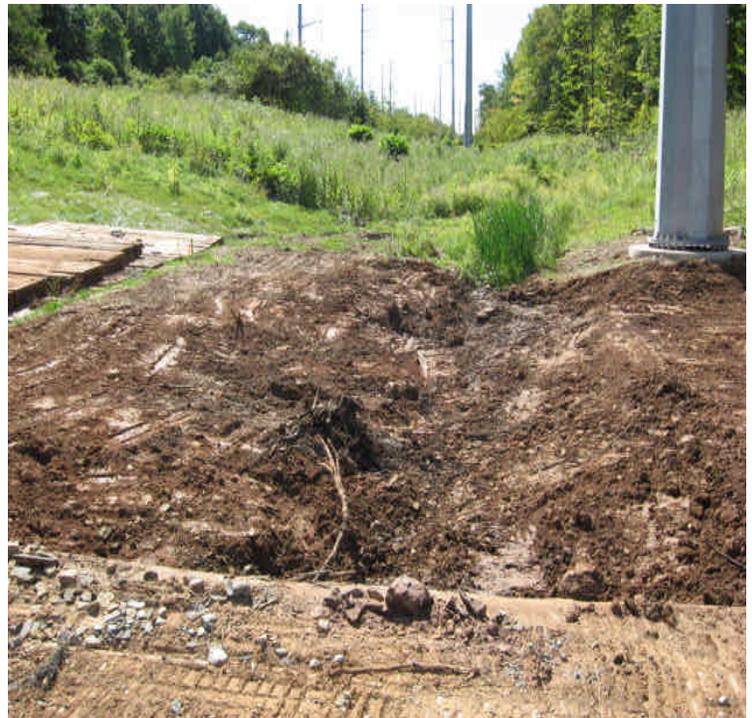
| Areas of Inspection | Observation | Recommended Action | Corrected Action |
|---|--|--|--|
| | <p><b>The timber mat pad in the area of the redirected stream was relocated over the riprap channel which had previously diverted the flow. Sediment from the underside of the mats had accumulated in the channel. 9/10-9/17/07</b></p> | <p><b>Stabilize all soils along the original channel, remove any remaining fill, and remove the diversion riprap channel if it is no longer needed to avoid additional sources of sediment from crews working over it. 9/17/07</b></p> | <p><b>Needs attention/evaluation.</b></p> |

**E. Meriden SS (North): View of the stone removal in the original stream channel after the timber mats were relocated. Stabilize soils as soon as possible.**
