Docket No. 272 – Development and Management Plan Inspection

Segment 1a Inspection

Date: September 24, 2007

Location: Segment 1a – Scovill Rock Switching Station to Chestnut Junction, Oxbow Junction to Beseck Switching Station (excluding Royal Oak Bypass), and Black Pond Junction to Beseck Switching Station

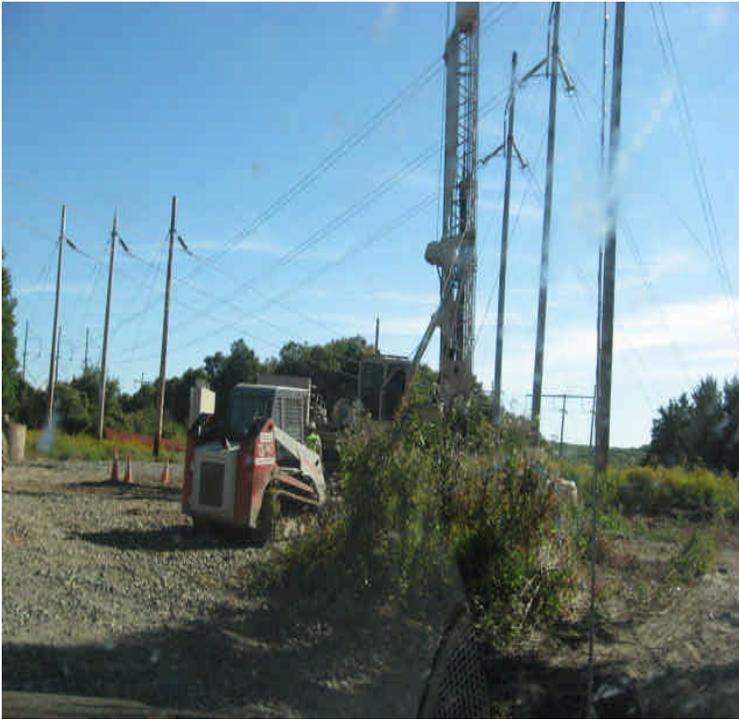
Oxbow Jct: Foundation drilling was underway.

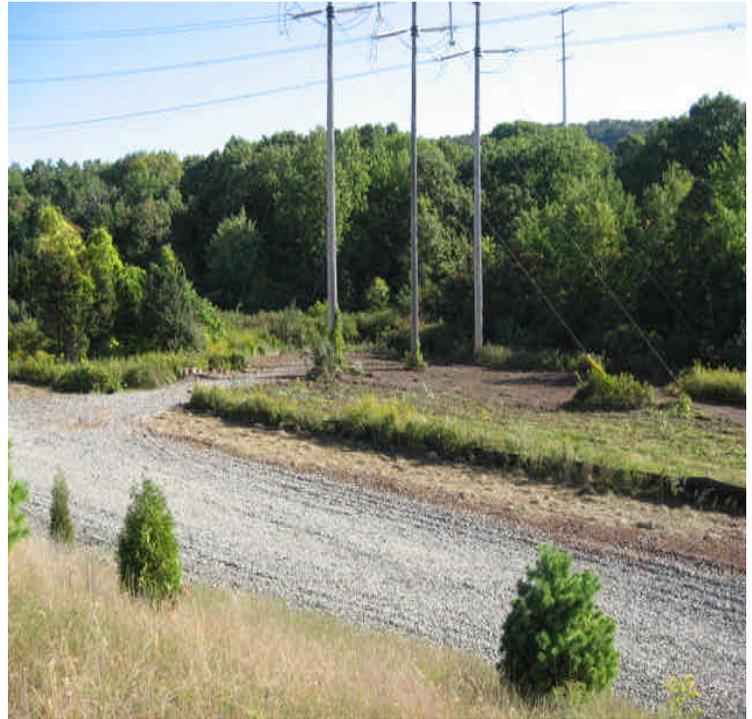
Carpenter Ln (near Beseck): New pad site was installed upgradient from wetlands.

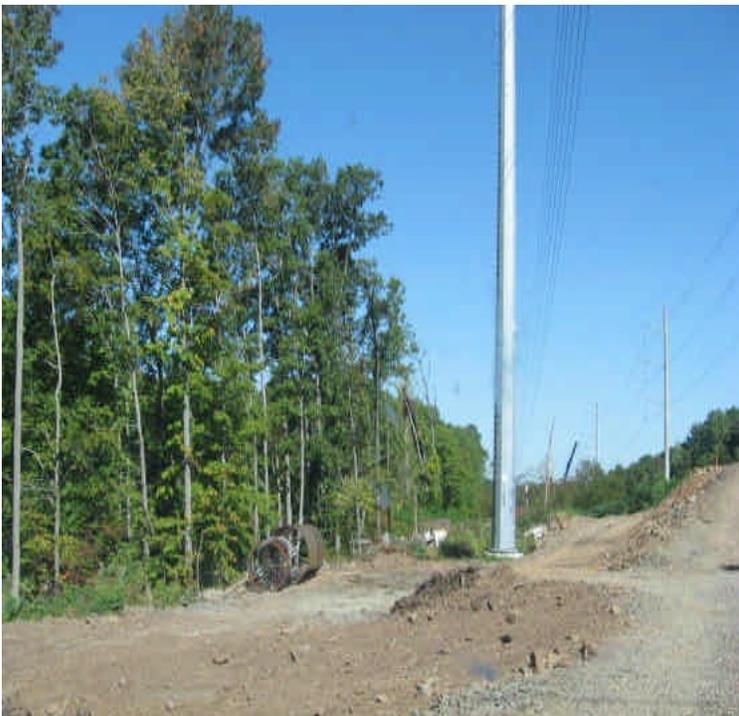
West of E. Meriden SS: Soils were exposed at a new pad site.

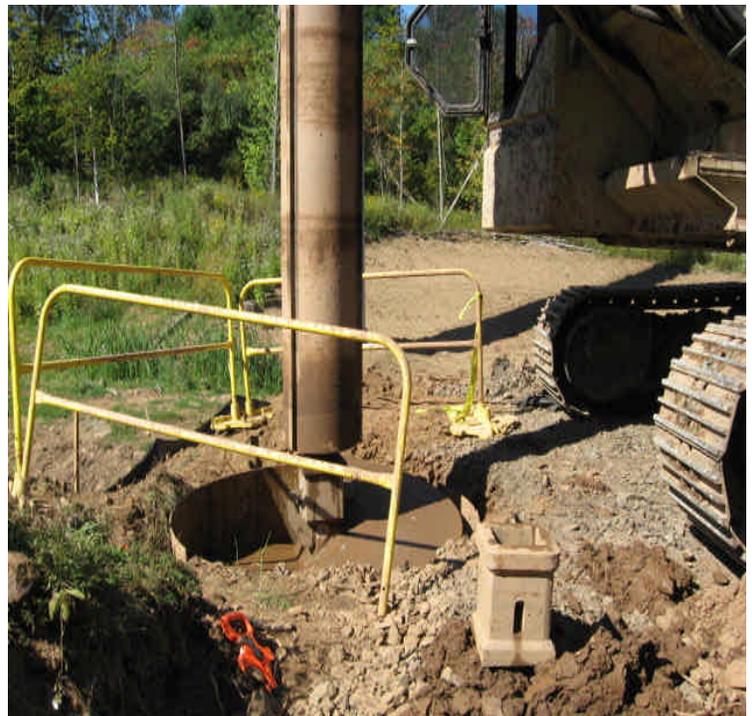
E. Meriden SS: Drilling was occurring adjacent to a pond. Monitor carefully and provide adequate containment for any spoils.

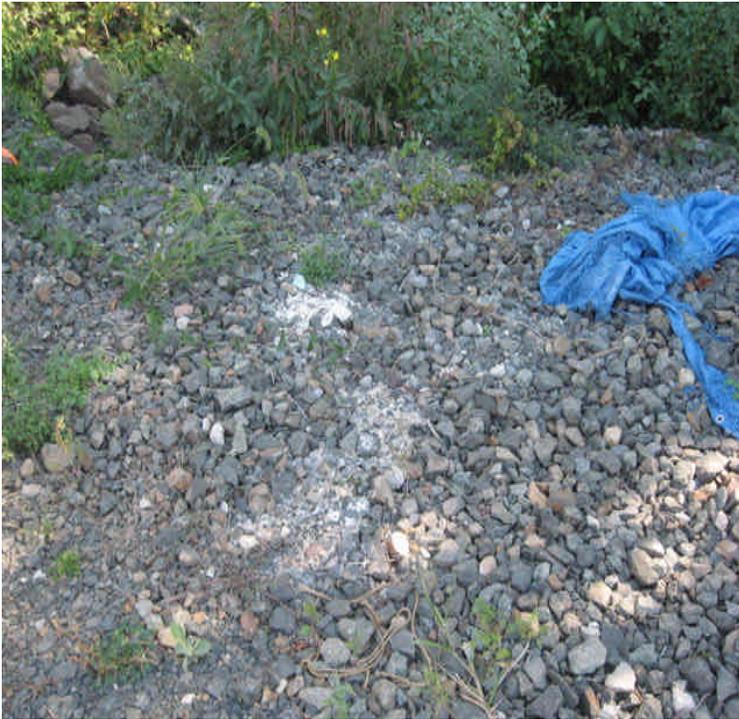
E. Meriden SS: Remains of the spill on the ground as a result of the tipped over sanitary facility from several weeks ago. The facility was righted but appropriate clean-up is needed asap.

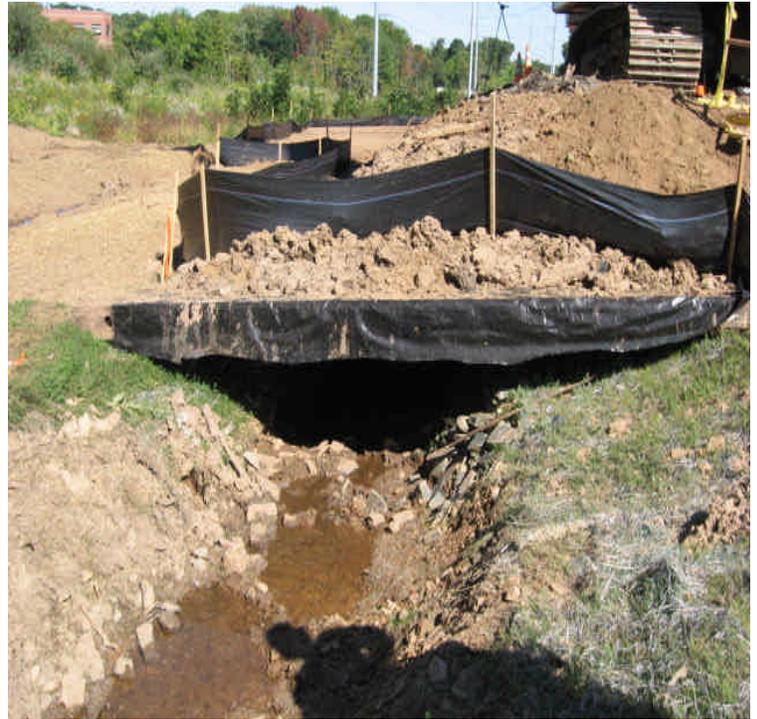
E. Meriden SS: A new pad site needs more controls to contain the disturbed area.

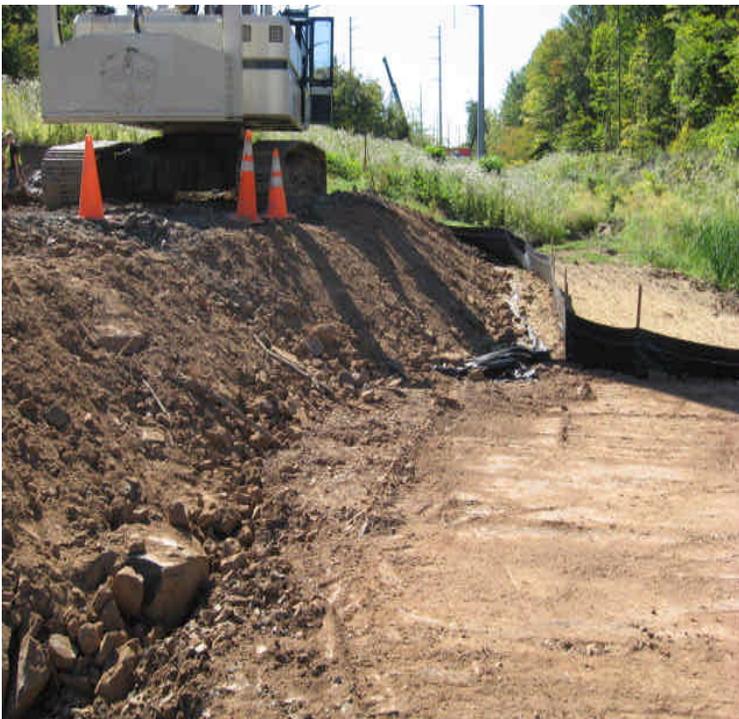
E. Meriden SS (North): Crews were preparing to drill upgradient from the riprap bypass. A previous pad site from the first line construction has been restored and mulched/seeded. Controls were installed.

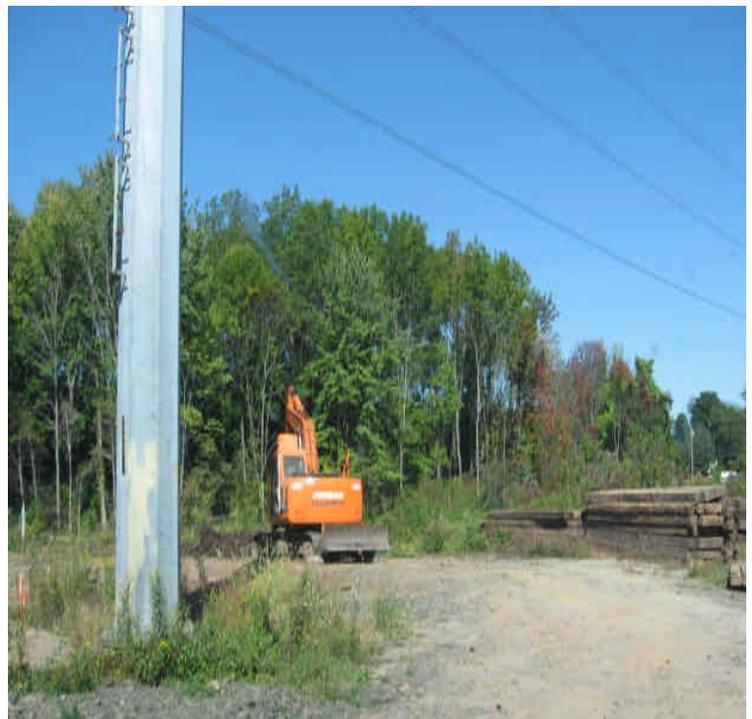
E. Meriden SS (North): Crews were restoring a pad site from the first line construction and moving timber mats to a new location on the second line.
