**Docket No. 272 – Development and Management Plan Inspection**

**Segment 2a Inspection**

**Date:** September 6, 2007

**Location:** Segment 2a – Beseck Switching Station to Cheshire/Hamden Town Line

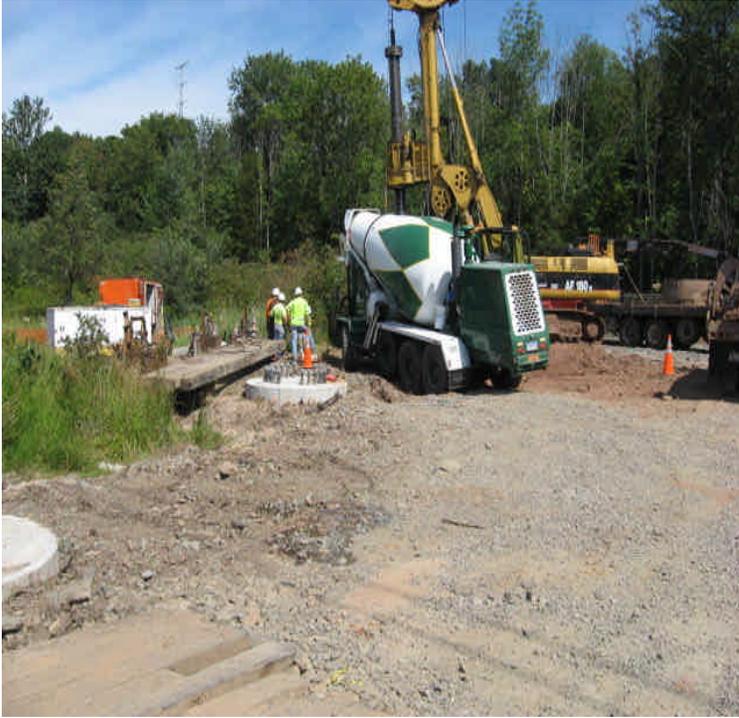
**Carpenter Ln: A view of foundation work. Maintenance is needed along some erosion controls (e.g. removal of sediment accumulation)**

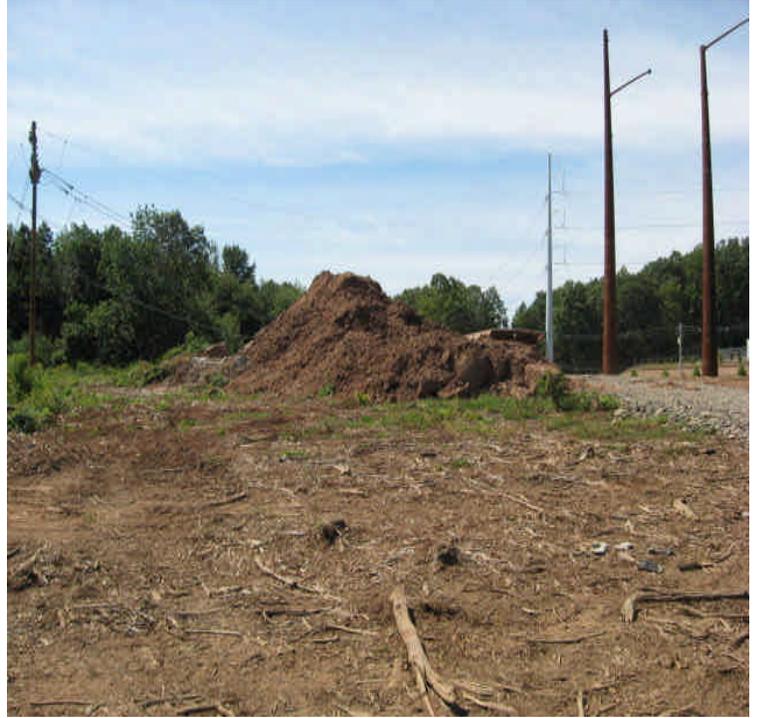
**Carpenter Ln: A stockpile was observed without controls in place.**

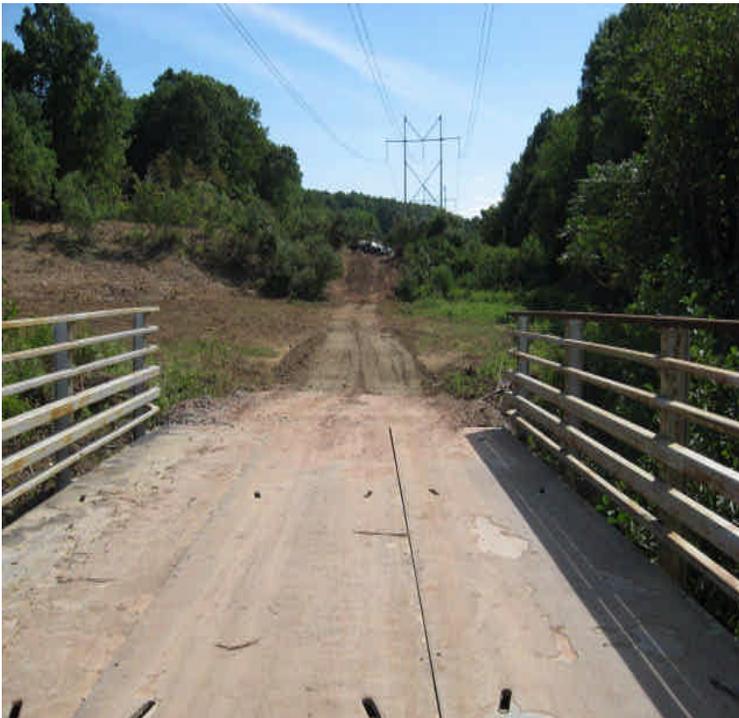
**Durham Rd: New bridge and access road construction across a tributary to Muddy River. The bridge was in good condition. Monitor the surface for sediment tracking**

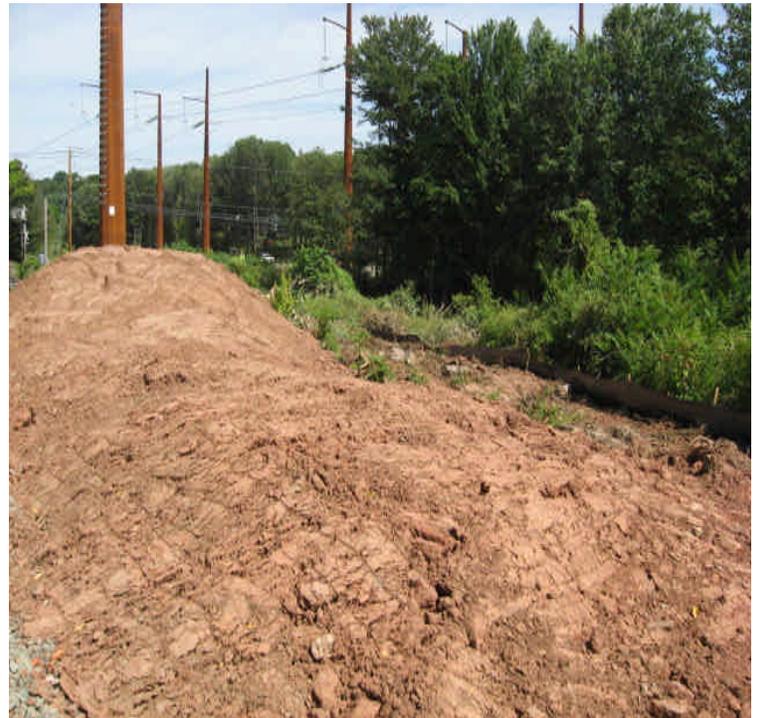
**Woodhouse Ave: The slurry containment area was graded and controls were installed.**

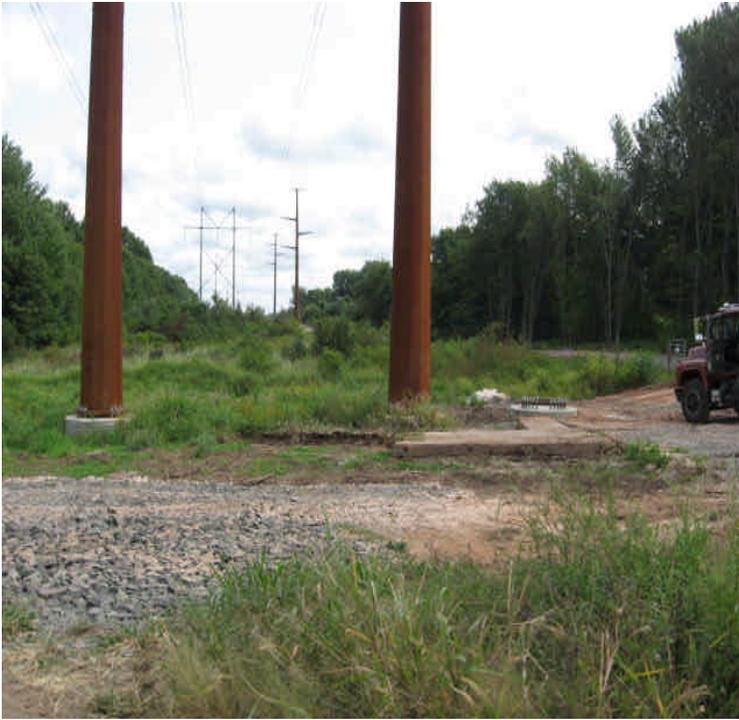
**Powers Rd: Timber mats were being removed from the wetlands. Attend to exposed soils and areas where sediment was pushed over the controls.**

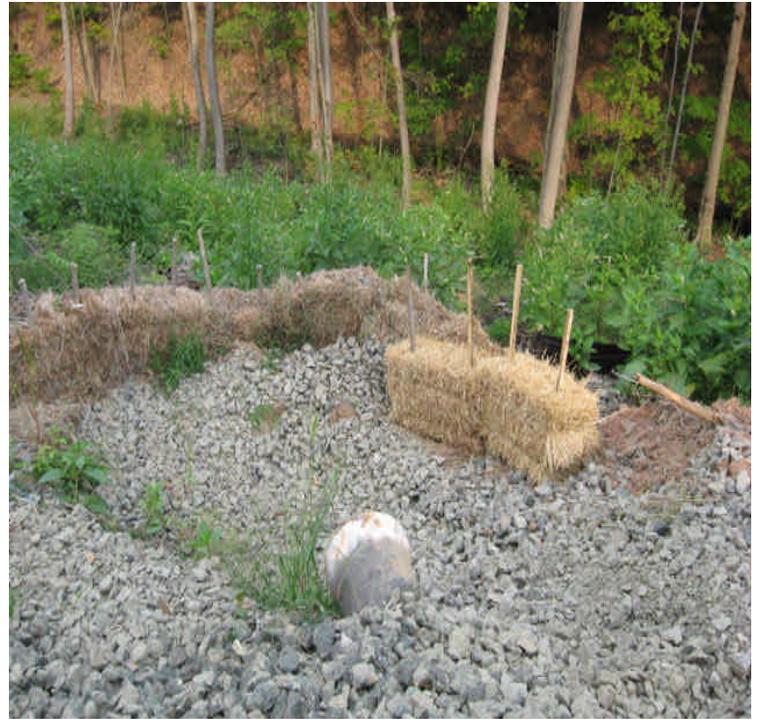
**Harrison Rd: New haybales were installed in the sediment trap.**

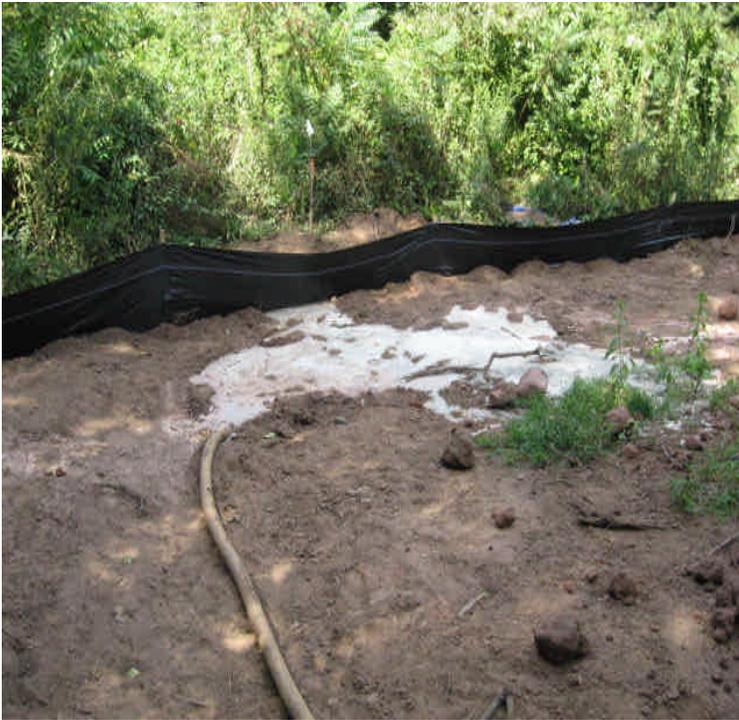
**Docker Dr: A dewatering hose was directing slurry washout towards the silt fence and adjacent wetlands. Provide better containment for slurry.**

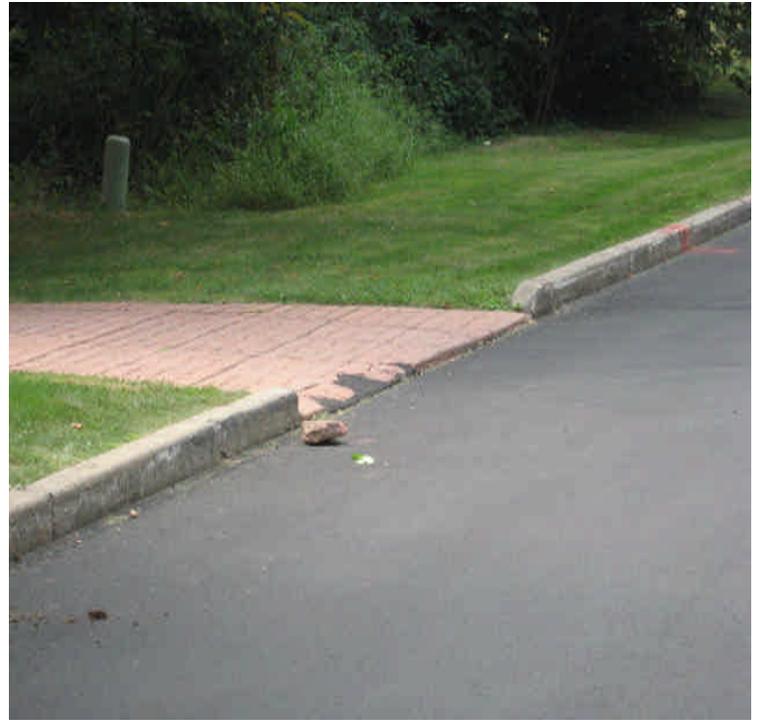
**Old Farms Rd: A brick paver on an adjacent driveway was broken off and patched with asphalt. Remove stone from roadway and work with the landowner to determine if additional attention is required.**
