Docket No. 272 – Development and Management Plan Inspection

Segment 2a Inspection

Date: September 11, 2007

Location: Segment 2a – Beseck Switching Station to Cheshire/Hamden Town Line

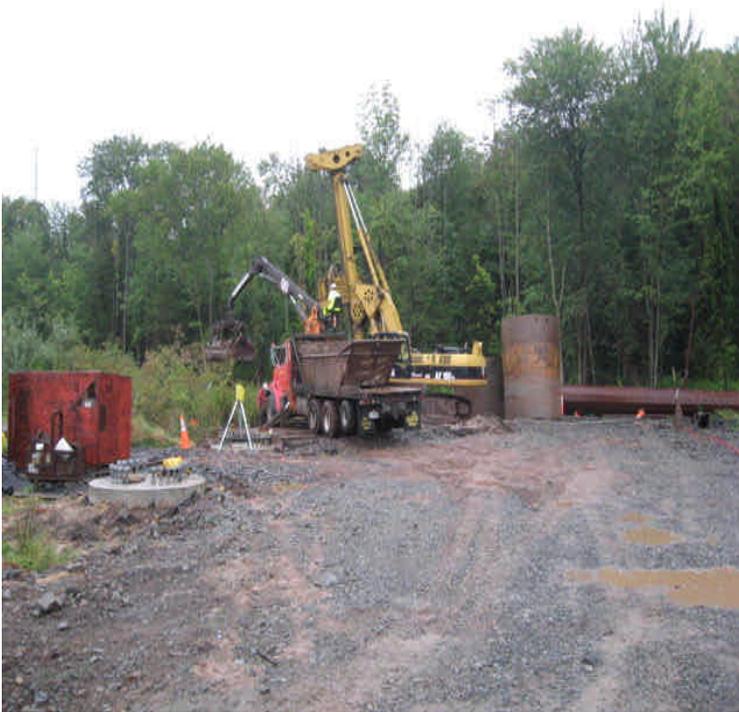
Carpenter Ln: A view of foundation work. Maintenance is needed along some erosion controls (e.g. removal of sediment accumulation)

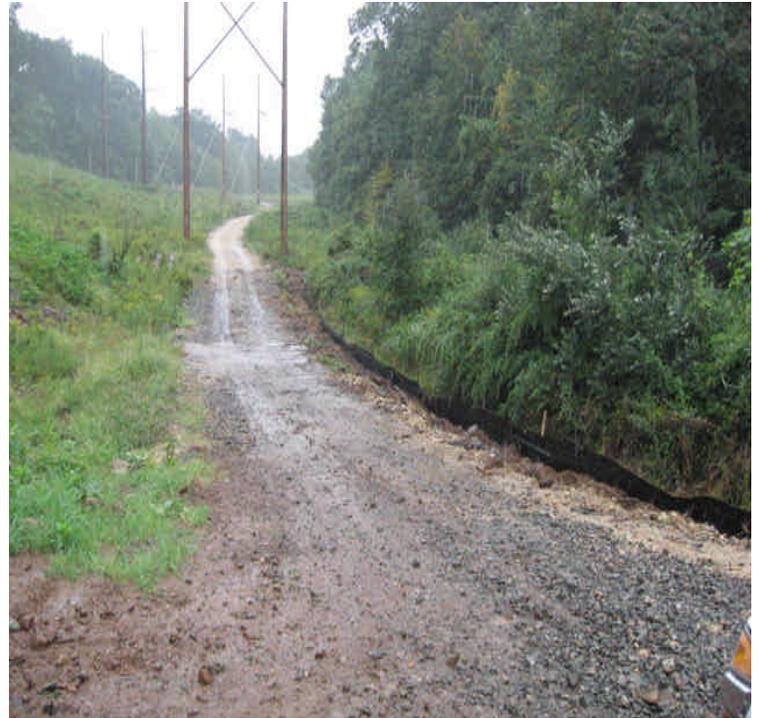
High Hill Rd: New controls were installed along the timber mat crossing

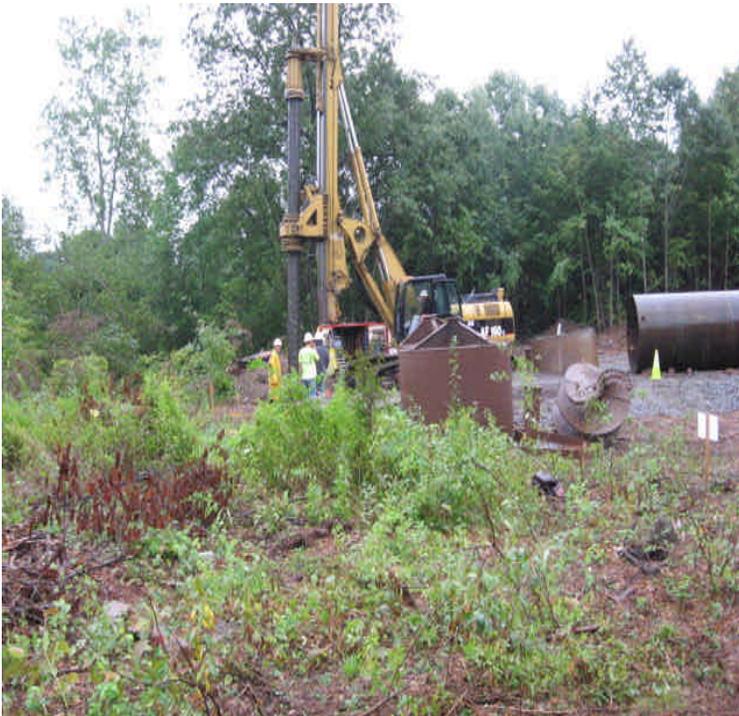
Durham Rd: Crews were drilling foundations.

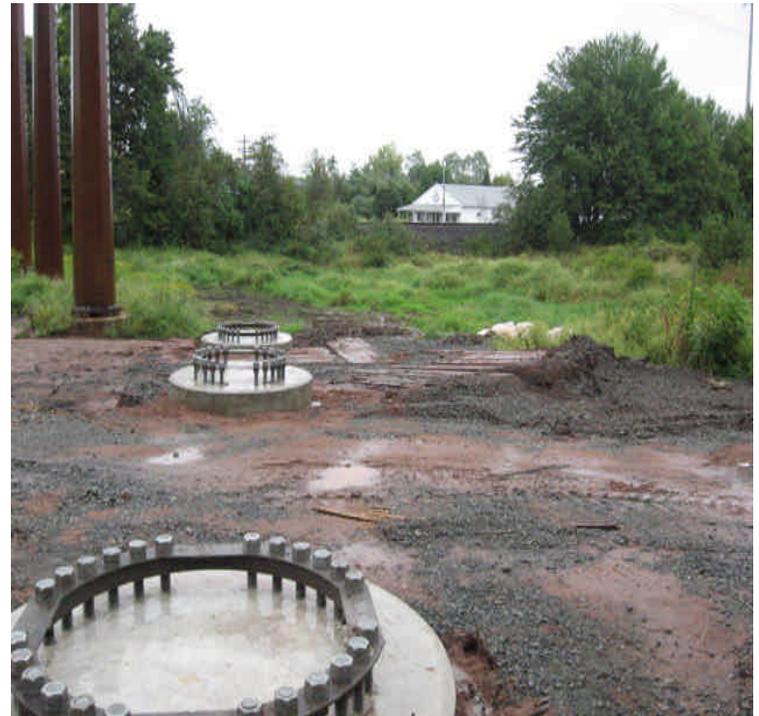
Powers Rd: New foundations are in place. Sediment controls and restoration efforts are needed for the adjacent wetlands.

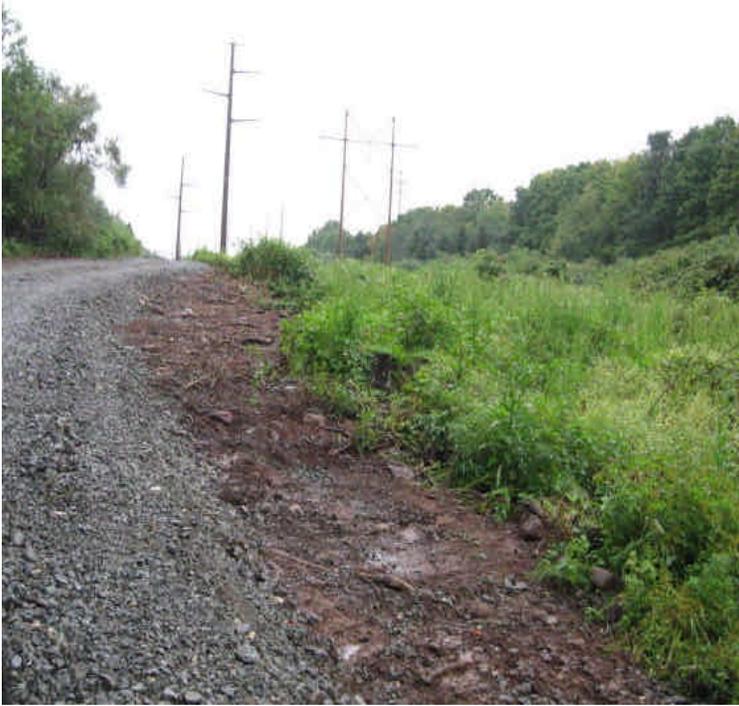
Powers Rd: Crews were reclaiming/restoring areas along the access by removing stone and narrowing the road.

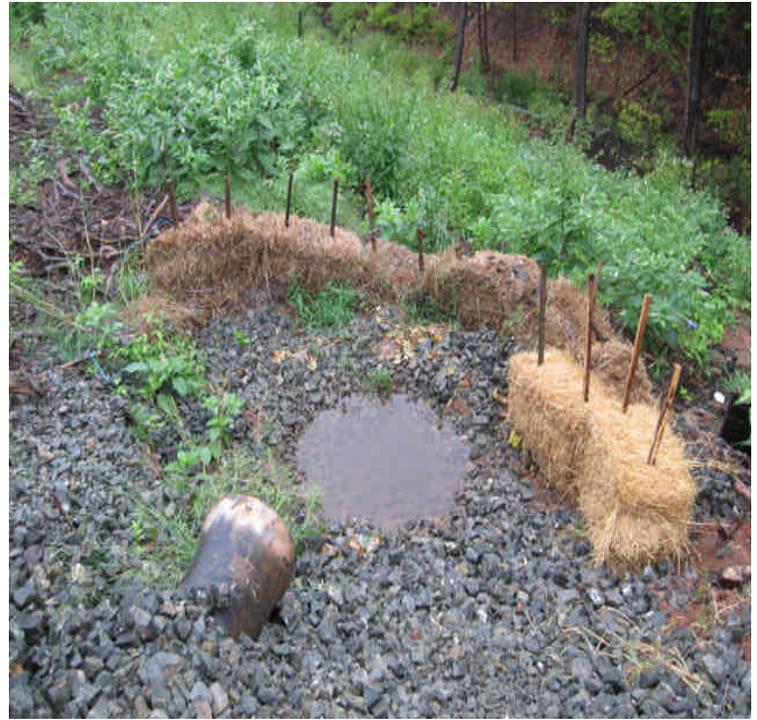
Harrison Rd: New haybales remain in the sediment trap below the existing roadway catch basin.

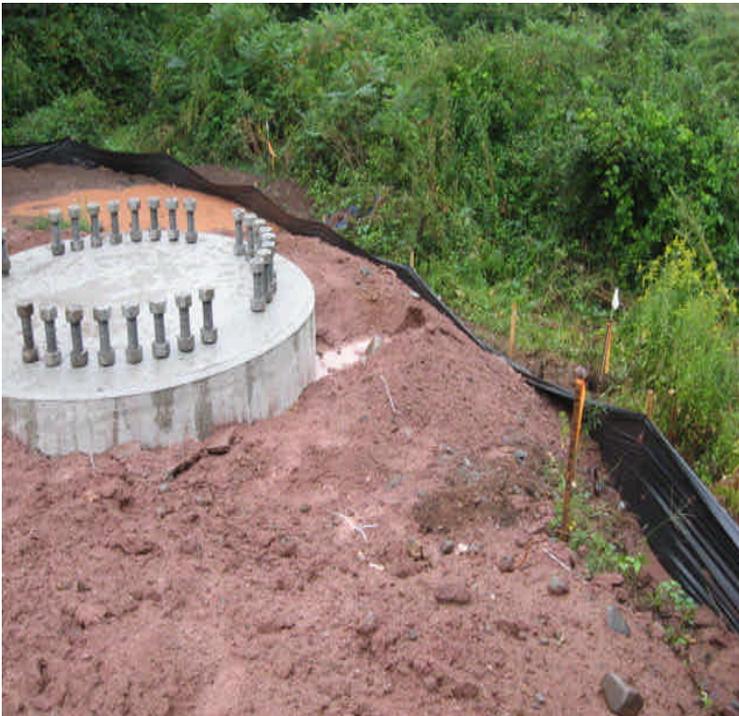
Docker Dr: Exposed soils from foundation installation were stressing the erosion controls. Turbid water was noted beyond the controls. Repair and reinforce the controls in this area.

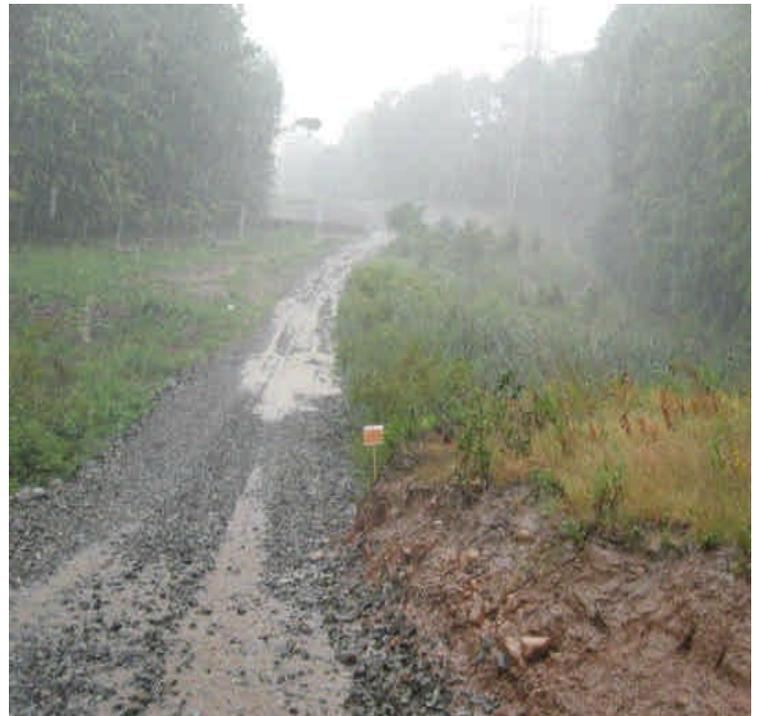
Tuttle Ave: Turbid water was noted flowing down the access road and into a stream channel. Install diversions along the road and controls at the stream.

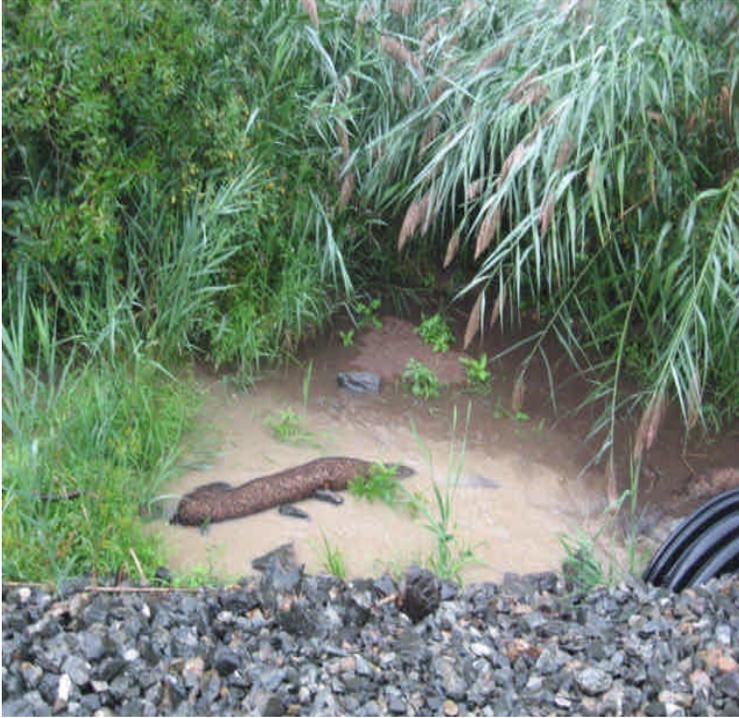
Tuttle Ave: Turbid water was observed entering the wetlands from the culvert. Existing controls (fiber rolls) were overwhelmed. Address exposed soil upgradient and reinforce controls.

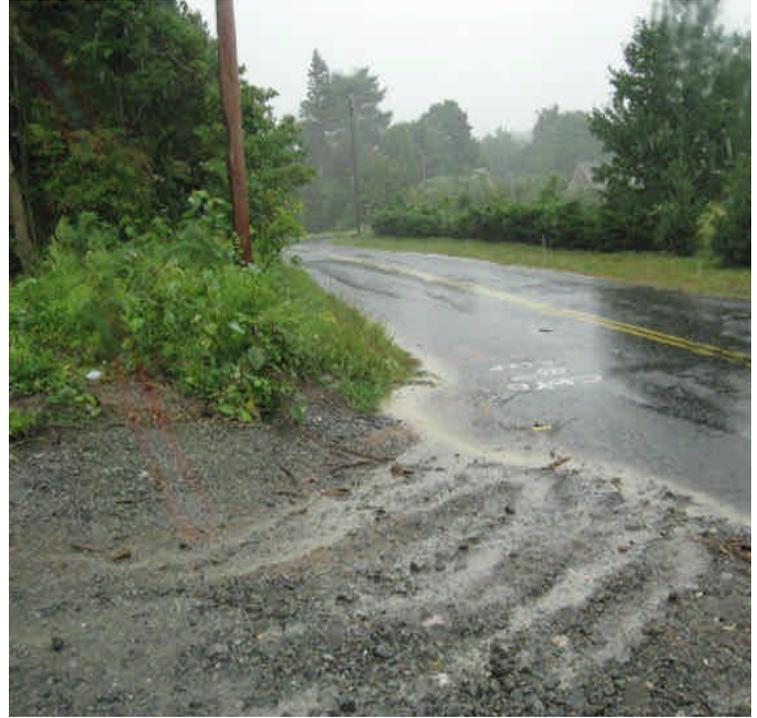
Tuttle Ave: Turbid run-off was also entering the roadway. Inspection occurred during a storm that brought over 1" of rain.

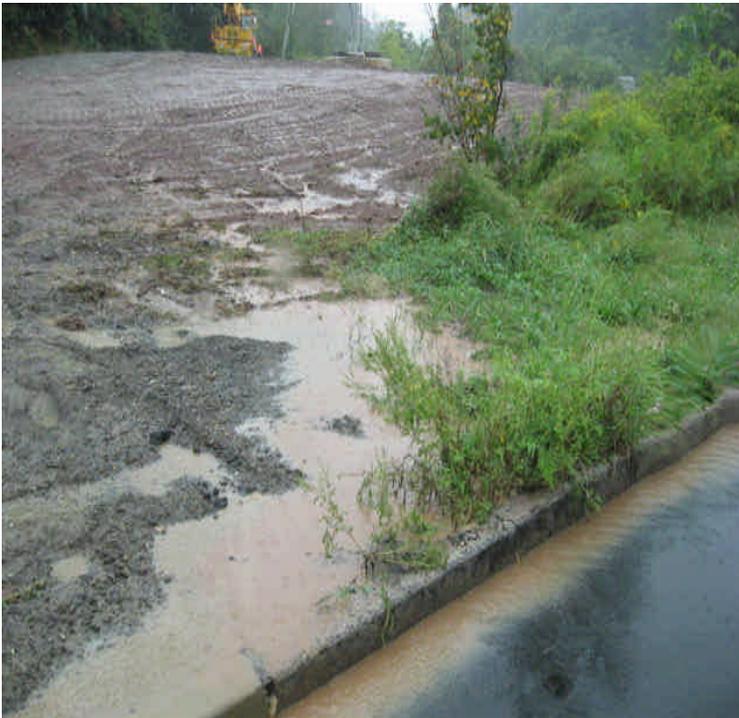
Old Farms Rd: Turbid run-off entering the roadway from exposed soils in the pad site in the ROW. Install controls to prevent sedimentation off-site.

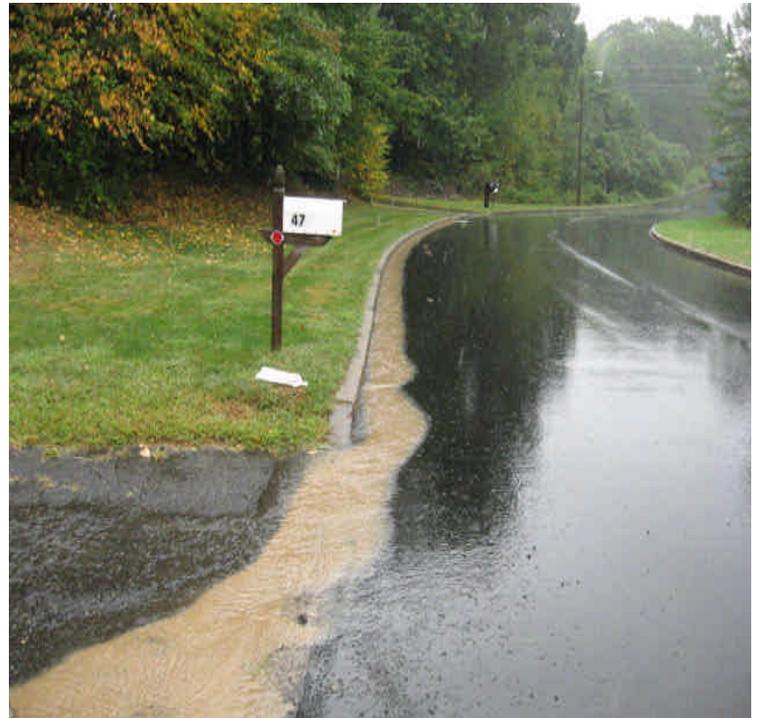
Old Farms Rd: Turbid run-off entering the roadway from driveway crossing
