Docket No. 272 – Development and Management Plan Inspection

Segment 2a Inspection

Date: September 18, 2007

Location: Segment 2a – Beseck Switching Station to Cheshire/Hamden Town Line

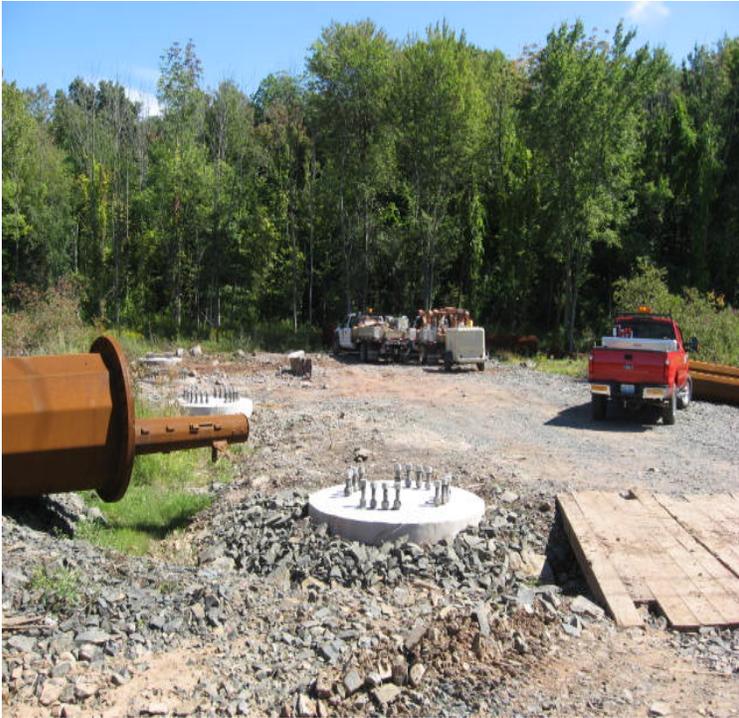
Carpenter Ln: View of foundation work. Erosion control maintenance is needed in some areas (e.g. removal of sediment accumulation).

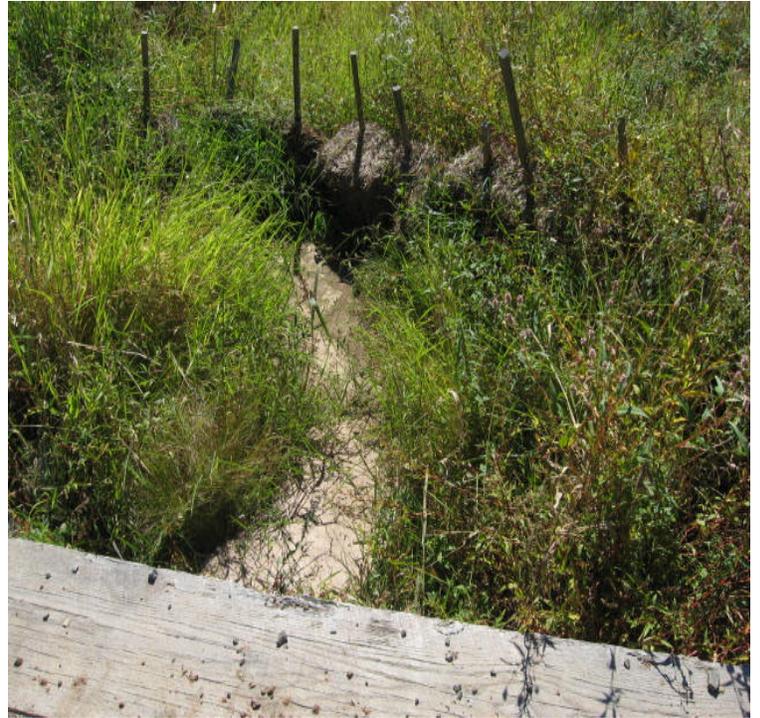
Carpenter Ln: View of sediment within the controls at the timber mat crossing.

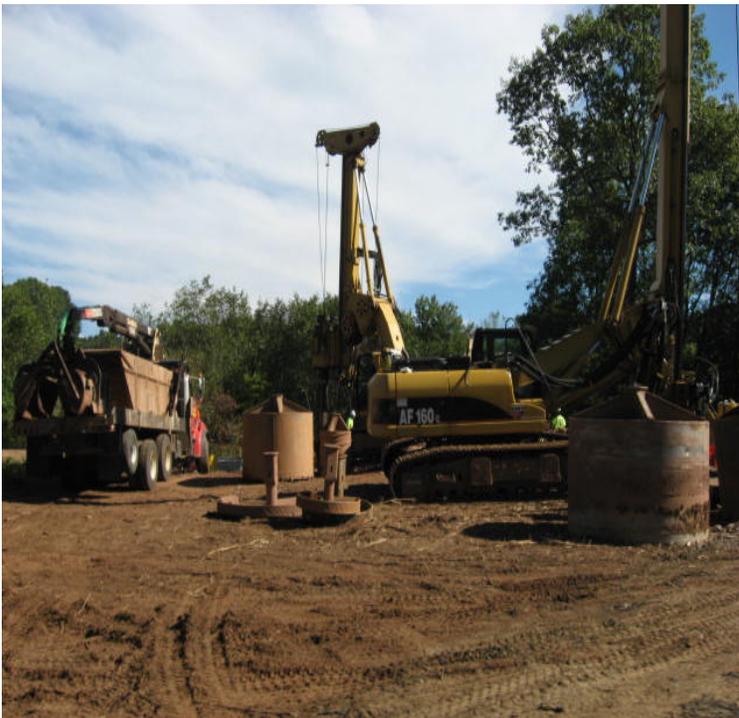
Durham Rd: Foundation drilling continues here.

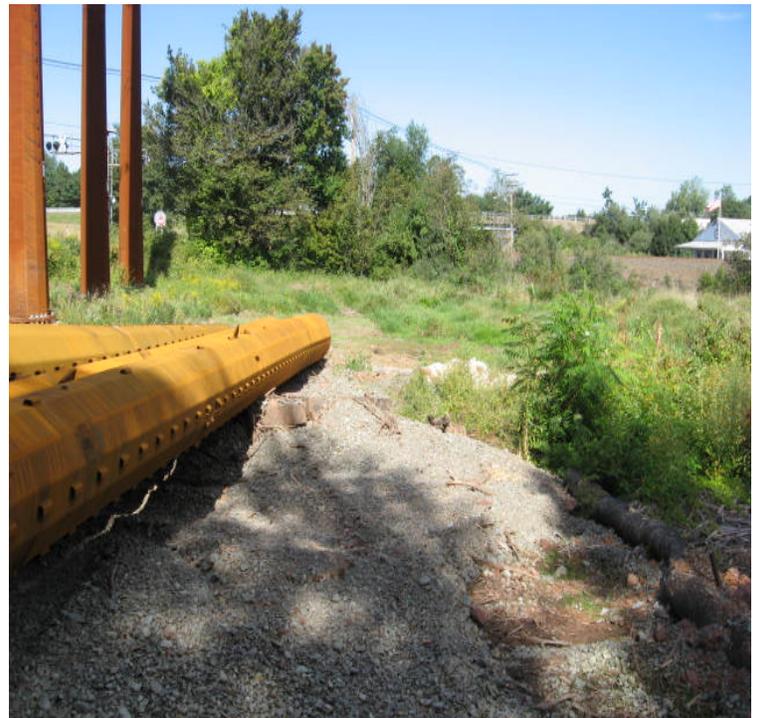
Powers Rd: New foundations are in place. Sediment controls and restoration efforts are needed for the adjacent wetlands.

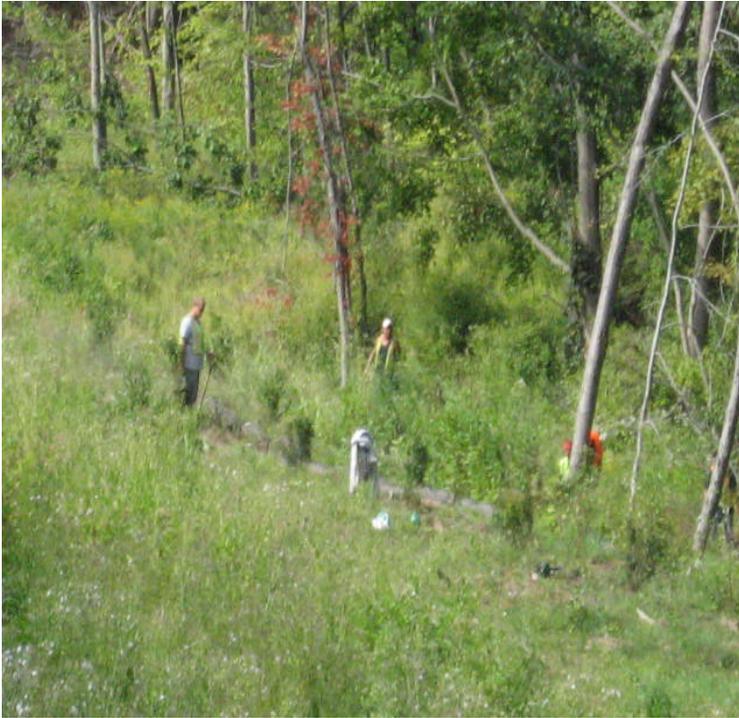
Harrison Rd: Shrubs are being planted by hand along the stream here.

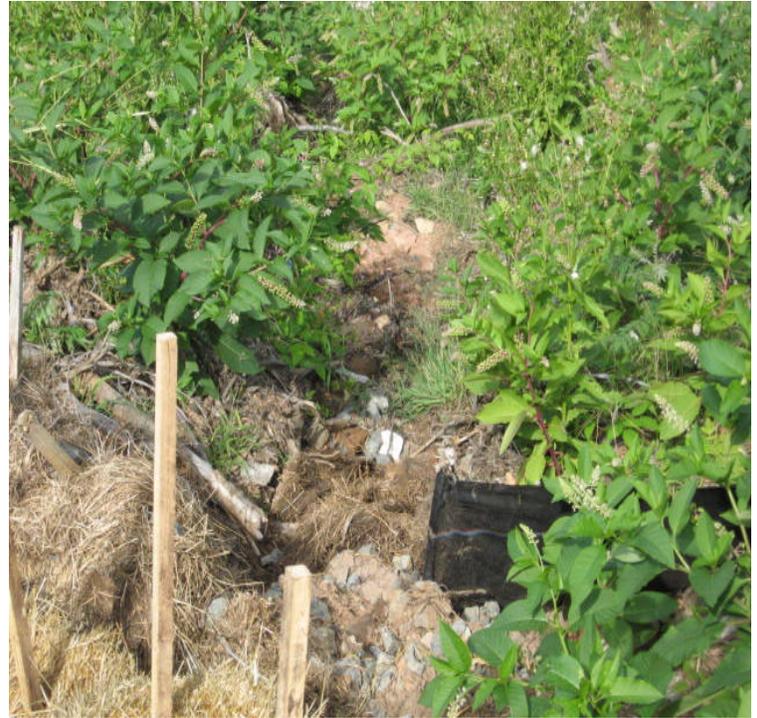
Harrison Rd: Haybales remain in the sediment trap below the existing roadway catch basin.

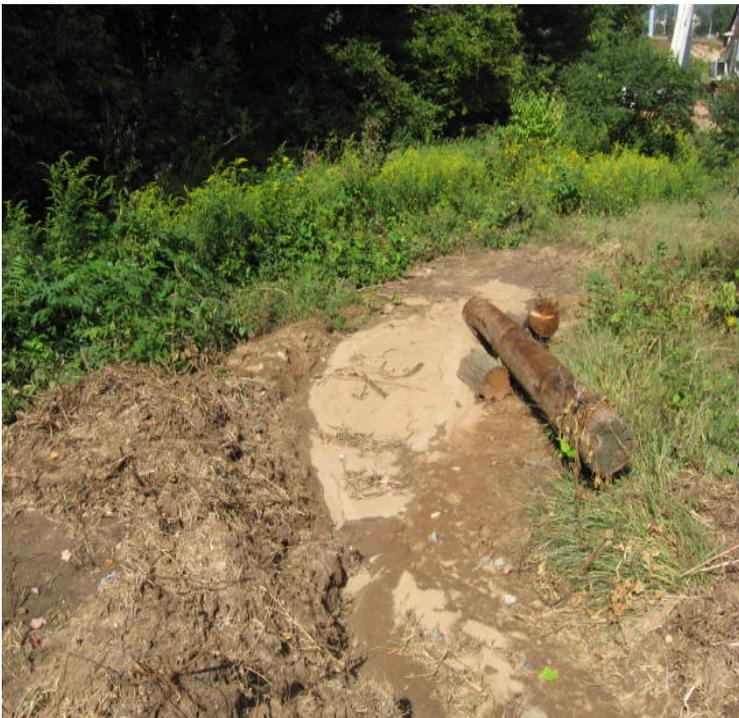
Docker Dr: Exposed soils resulting from recent foundation work have eroded during recent storm events.

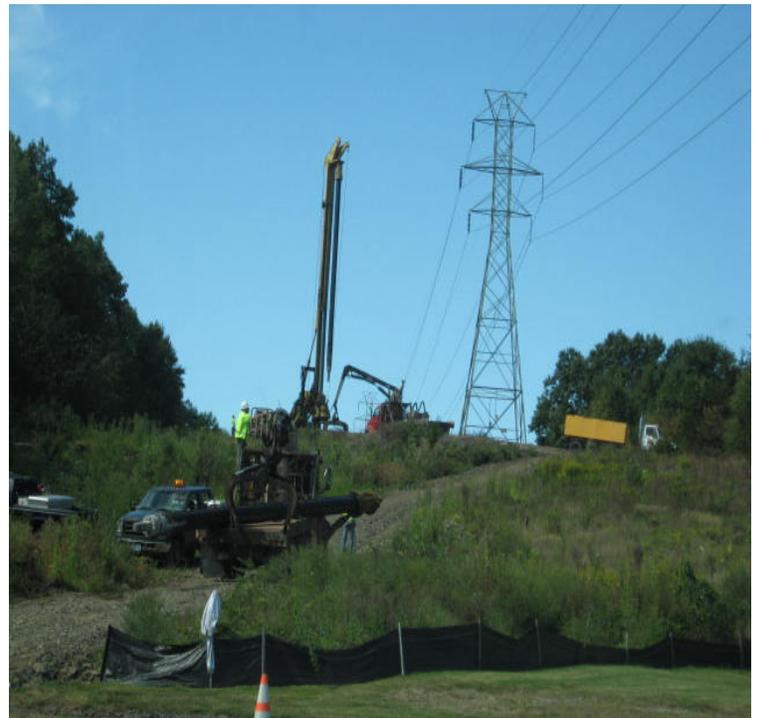
South Turnpike: Foundation drilling has begun in this section. Controls are in place.

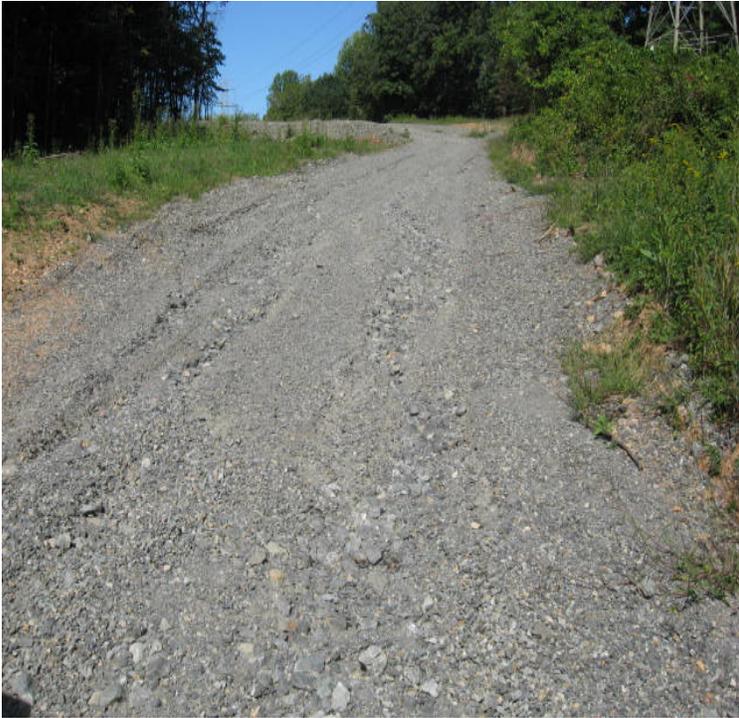
Tuttle Ave: View of erosive gullies created during heavy rains along the access road.

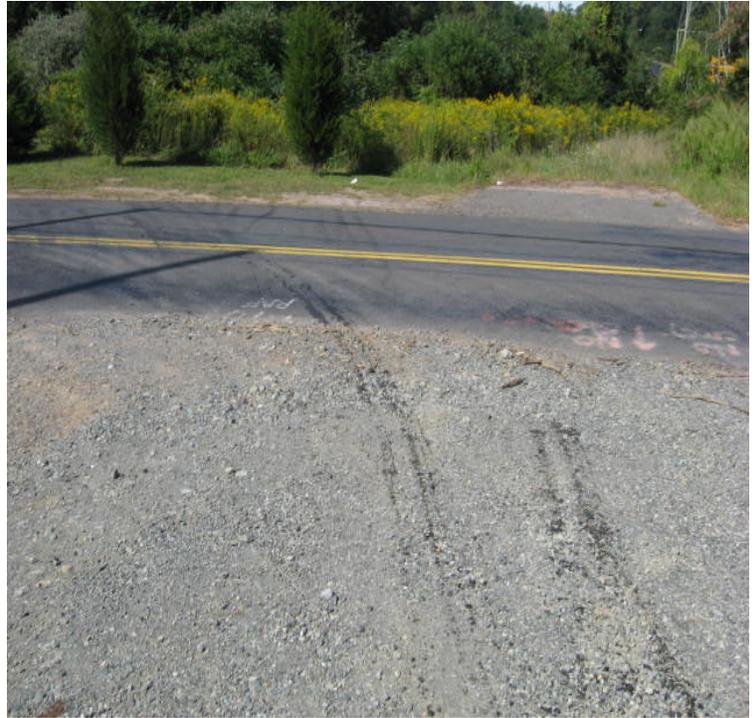
Tuttle Ave: Leaking equipment had traveled the length of the ROW access road, including multiple wetlands, and onto the roadway here.

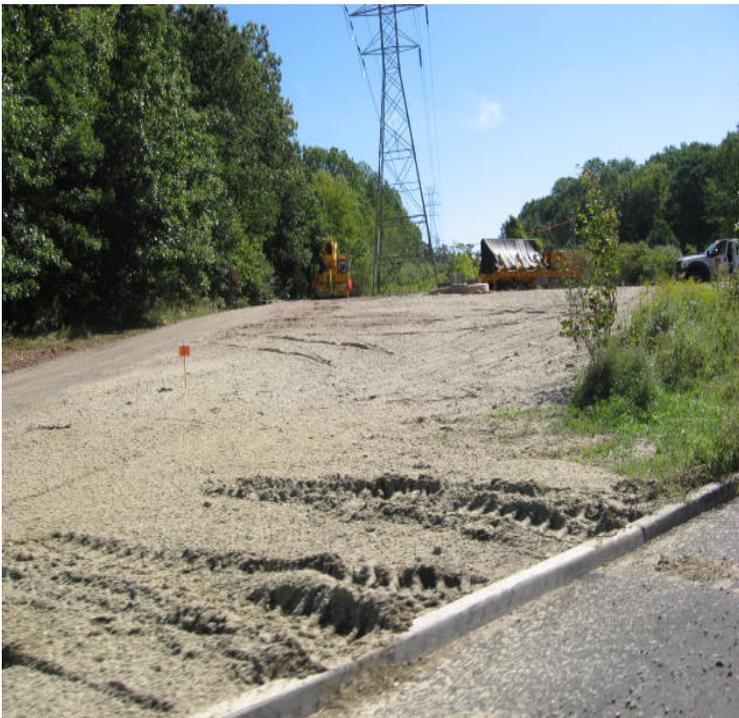
Old Farms Rd: View of the hydroseeded area rutted by equipment.

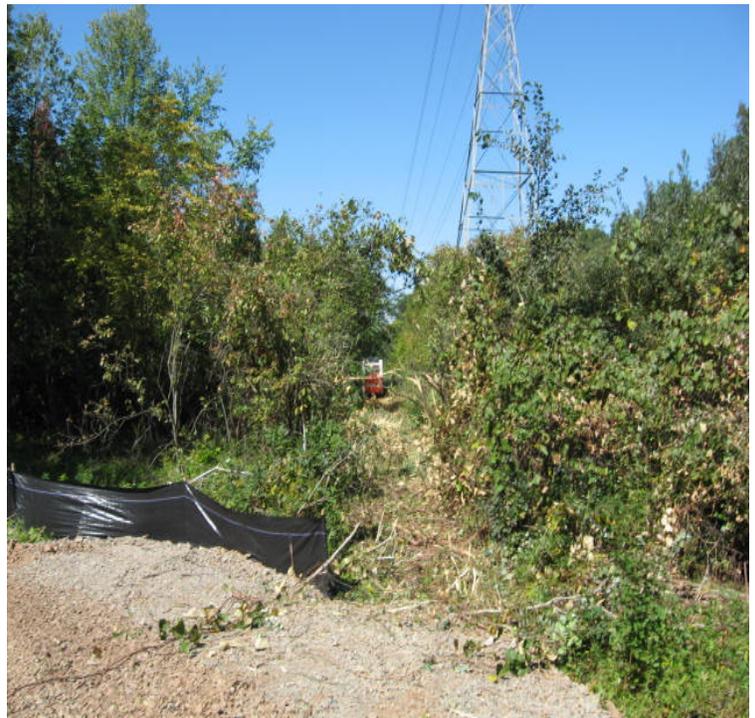
Old Farms Rd: Selective clearing has begun within wetlands along the ROW here.
