Docket No. 272 – Development and Management Plan Inspection

Segment 2b Inspection

Date: September 14, 2007

Location: Segment 2b – Cheshire/Hamden Town Line to East Devon Substation

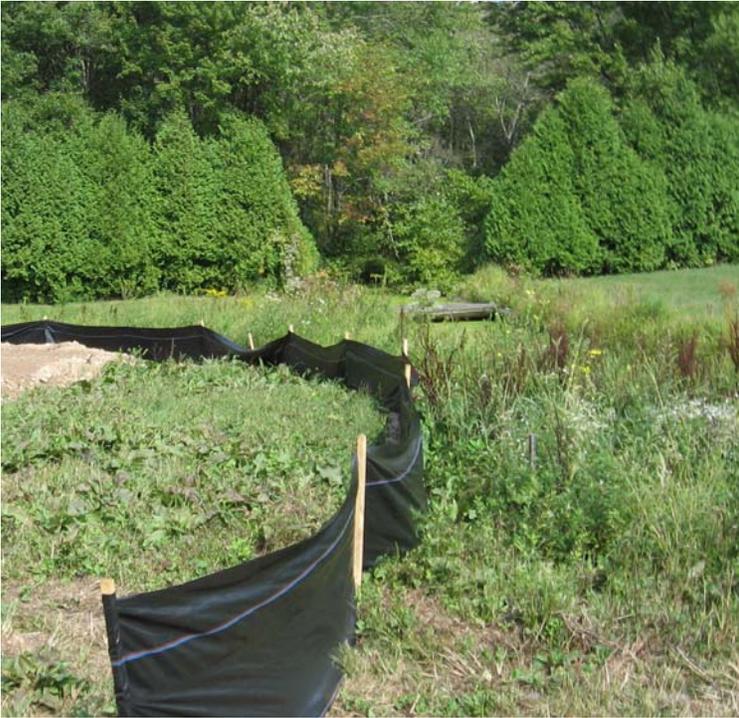
Dogwood Rd (Orange): Pad reclamation is complete and silt fence is in place at proposed structure #24065.

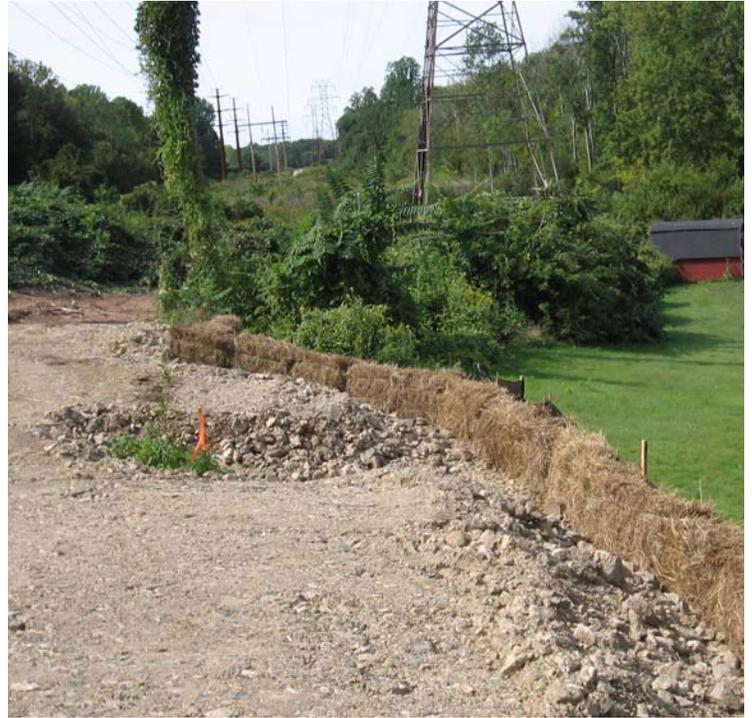
Hunting Hill Place (Orange): Erosion controls have been installed along the limit of work here to prevent sedimentation to the abutting property. Wood chips have been spread within the ROW at a depth of less than 3".

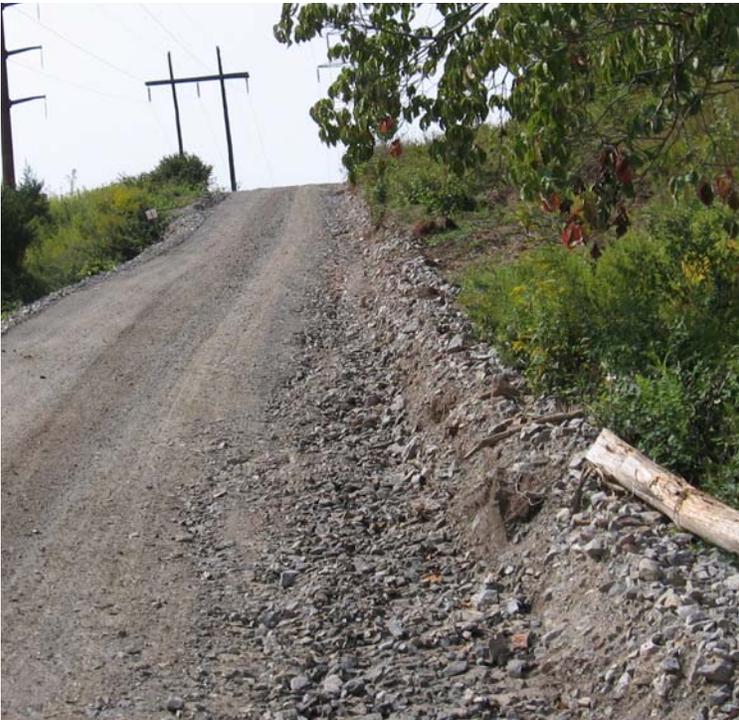
Brooksvale Ave (Hamden): This section of access road has been graded in an effort to divert flow away from wetland #100.

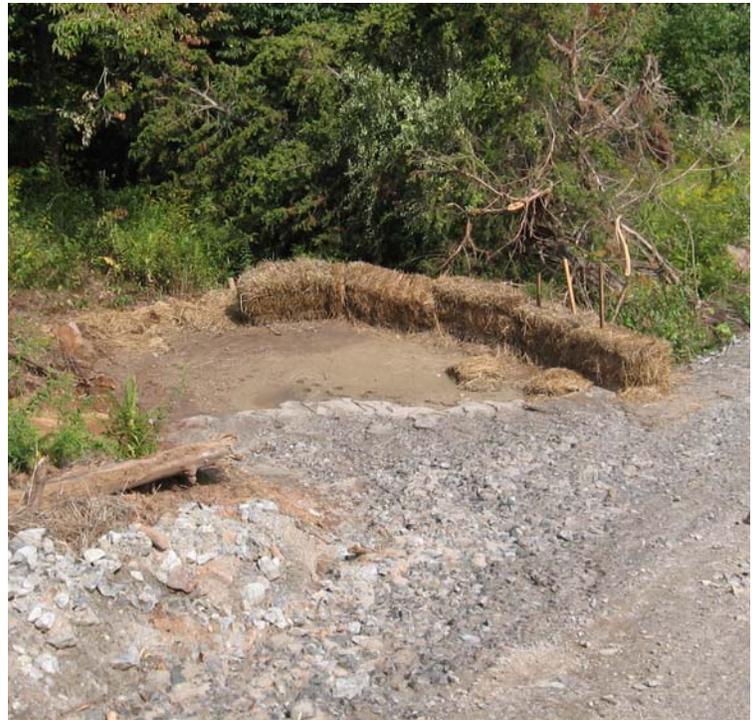
Brooksvale Ave: Diverted runoff from the access road is now directed toward a sediment trap with haybale controls.

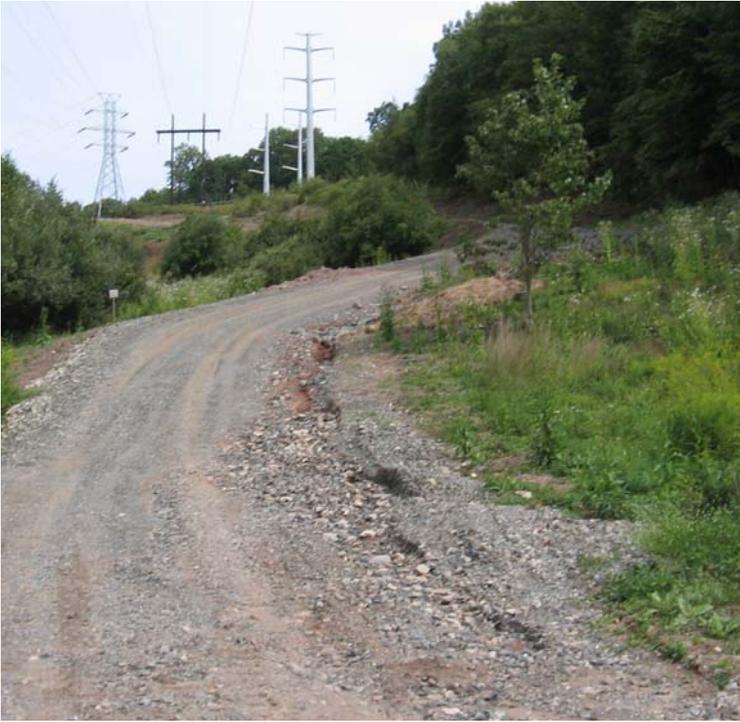
Old Lane Rd (Hamden): Due to recent heavy rains, washouts have occurred in the access road here.

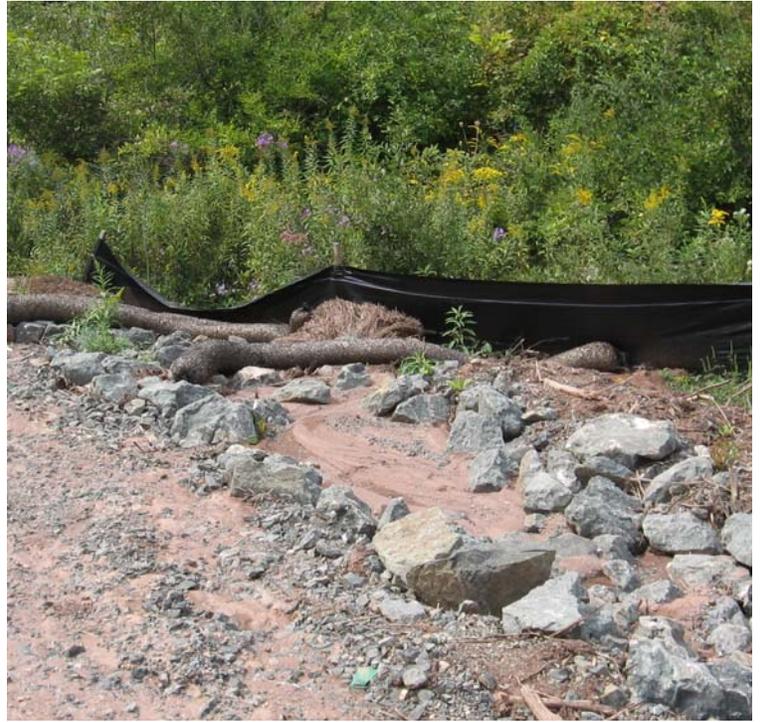
Old Lane Rd: Additional controls may be necessary here to slow stormwater flow and prevent sediment migration into nearby wetlands.

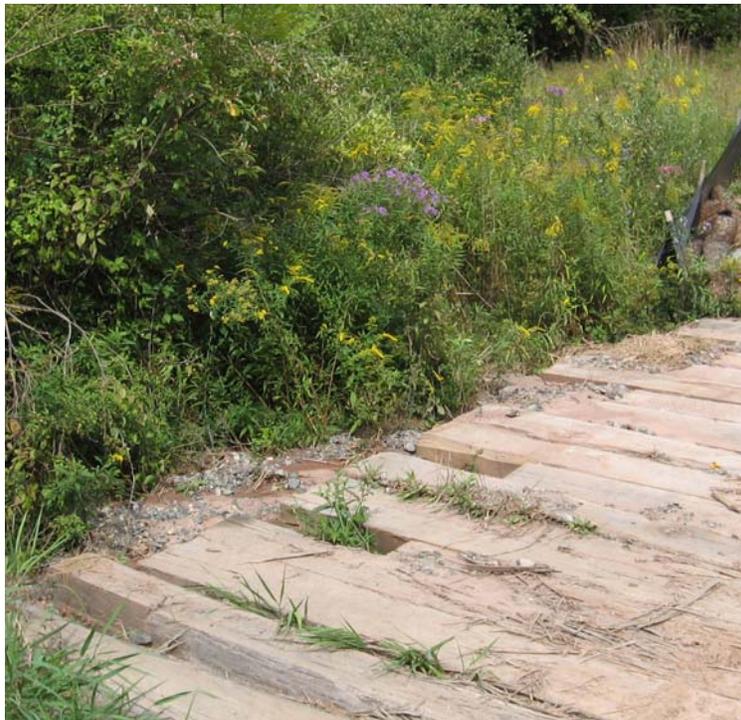
Old Lane Rd: Due to heavy rains, some sediment has migrated into wetland # 94.
