Docket No. 272 – Development and Management Plan Inspection

Segment 3 Underground Line

Date: September 18, 2007

Location: East Devon Substation to the Housatonic River Crossing

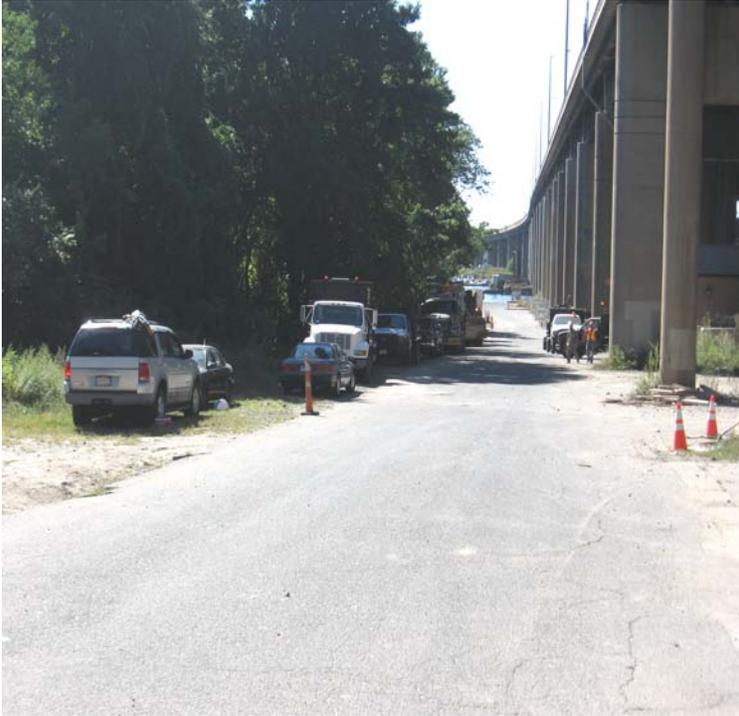
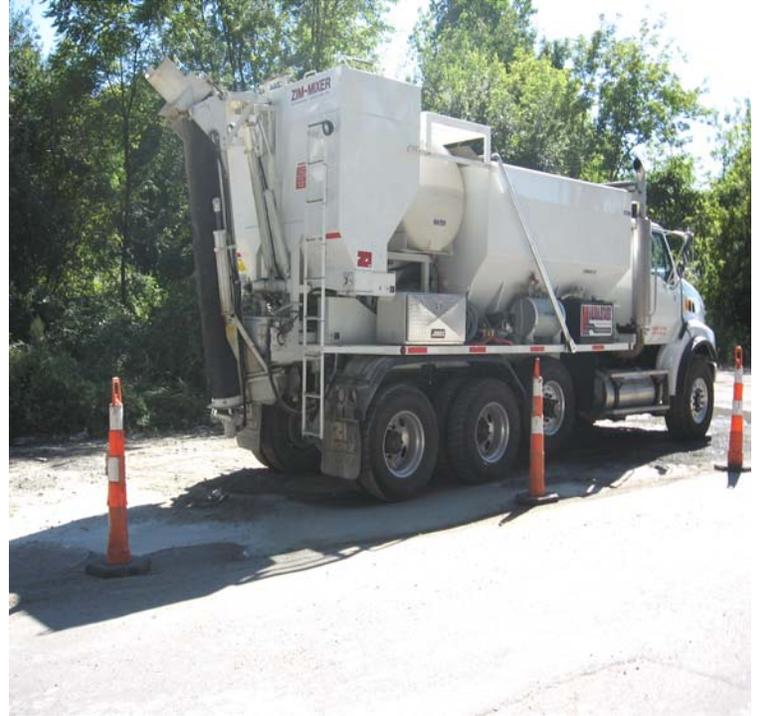
Areas of Inspection	Observation	Recommended Action	Corrected Action
	controls of the yard. (noted since 4/25) 9/18/07		
Additional Observations	Construction activities that are not part of the M/N project have continued near vault #1 for several weeks. This continues to disturb soil in the area and concrete washouts are a regular occurrence. 9/18/07	Further stabilization on the part of M/N contractors would be difficult in this area. 9/18/07	Non-jurisdictional to this D&M plan. Noted for the record.
	The non-project related debris near the Milford lay-down yard was removed this week. 8/27 – 9/11/07	None at this time. 9/18/07	Non-project related debris was removed

Both photographs were taken near sta. #1017. Left: Middlesex Construction vehicles (non-project related) have been routinely parking along the utility trench area, including at vault #1. Right: It appears that the Middlesex Construction concrete truck had recently washed-out at vault #1. Concrete washout has been noted in this location for many weeks.

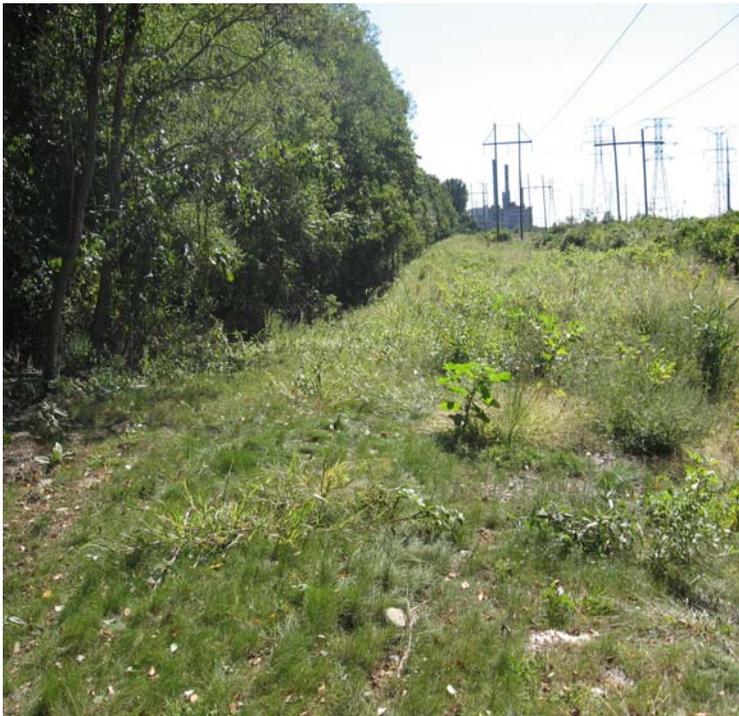
The silt fence has been removed from the eastern side of the cross-country portion of the ROW. does

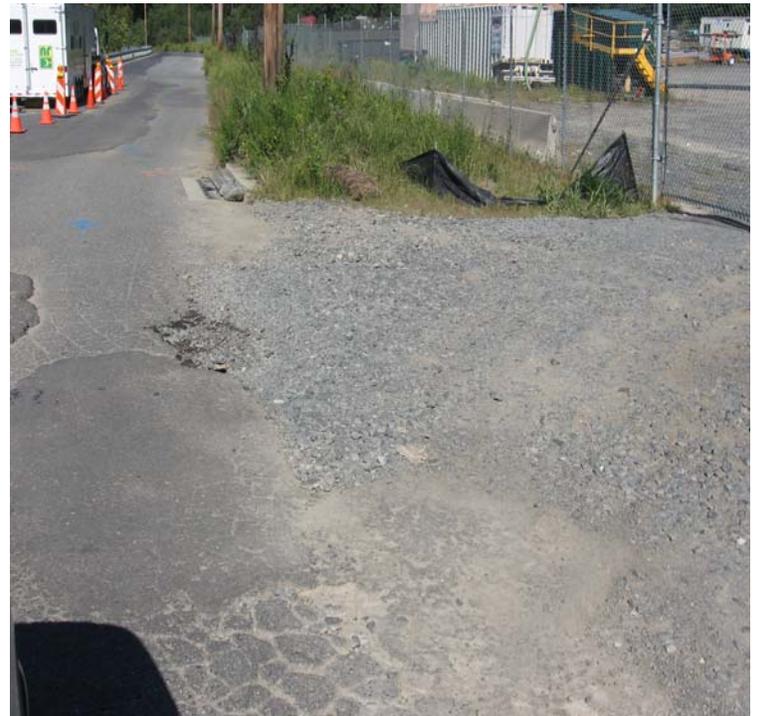
The stone construction entrance at the Milford yard has been pulled back toward the yard where feasible. The remainder of the stone does not have pavement underneath it, and it is recommended that it remain. In addition, the non-project related debris noted outside the yard in previous weeks has been removed.
