**Docket No. 272 – Development and Management Plan Inspection**

**Segment 4a Underground Line**

**Date:** September 5, 2007

**Location:** Singer Substation to Fairfield/Westport Town Line

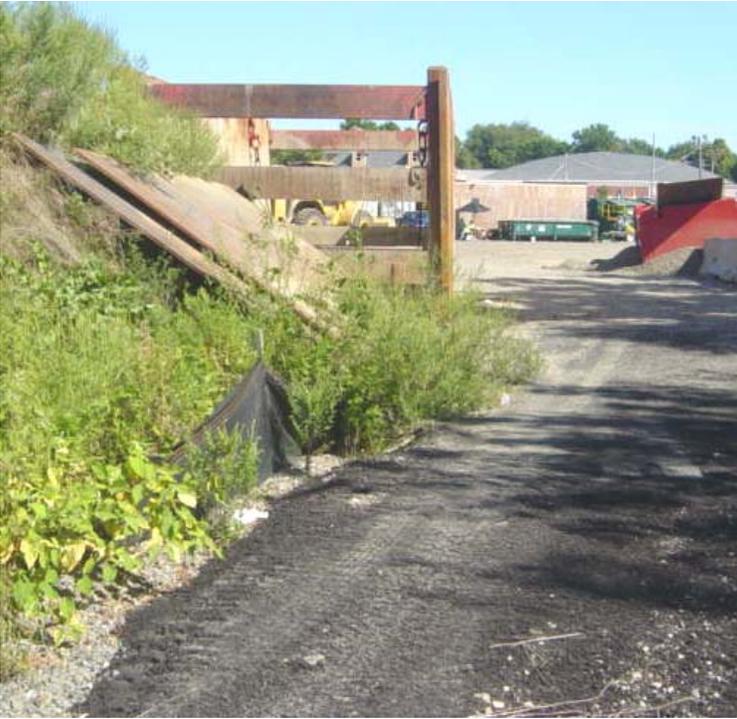
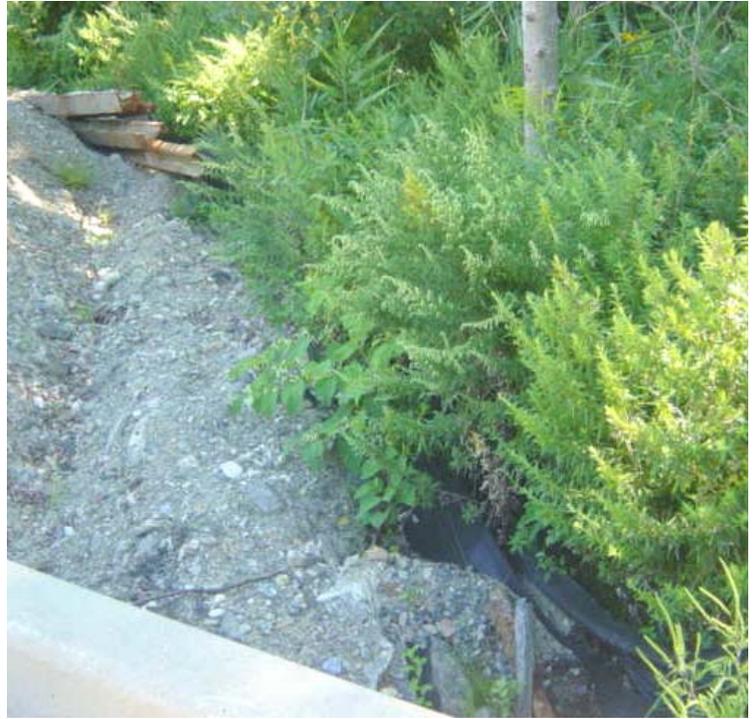
Both photographs were taken within the King's Highway lay-down yard. Erosion controls have been compromised and should be reestablished.

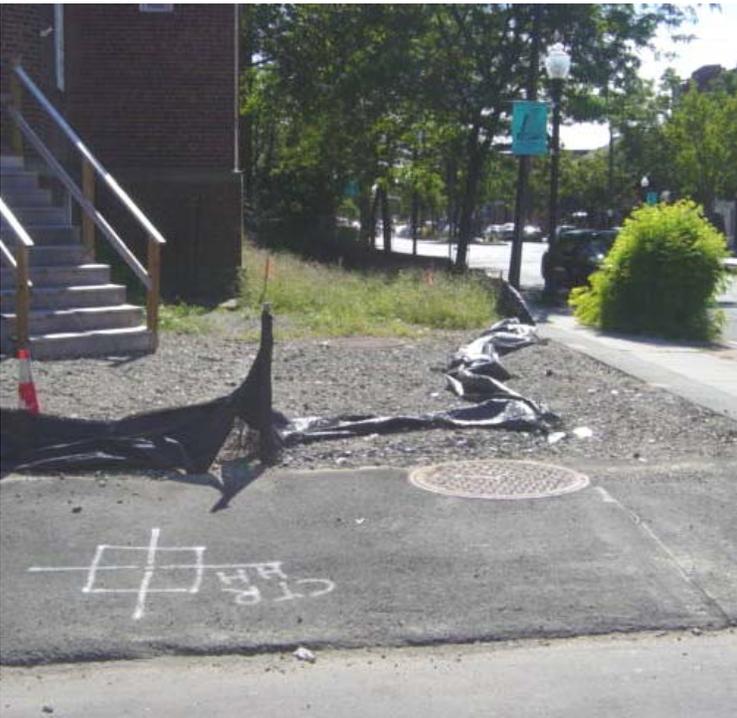
Erosion controls at vault #41 are in need of repair. Sediment does not appear to be migrating from this location. Recommend removing or re-establishing controls.

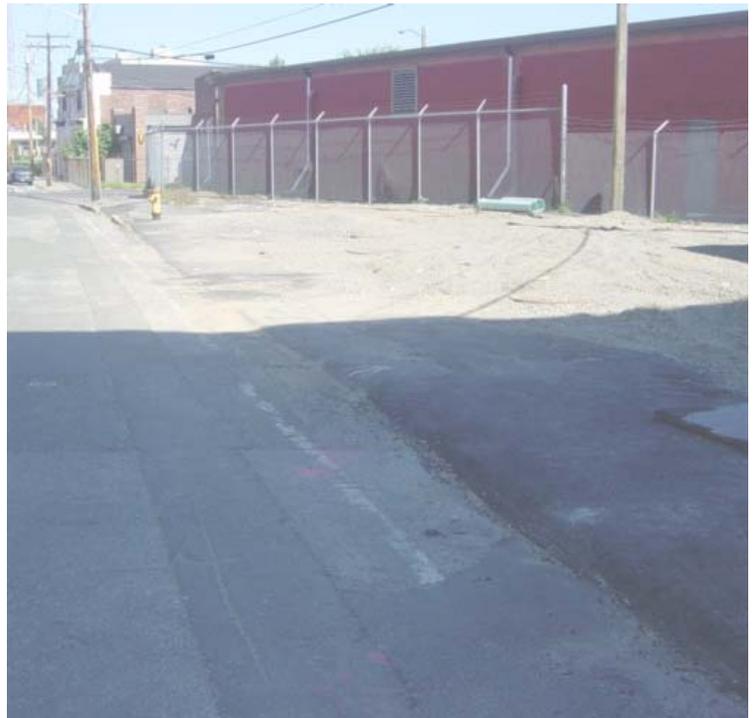
Sediment from construction activities was noted on Railroad Ave., near the shoulder. Recommend sweeping sediment from all paved surfaces.
