Docket No. 272 – Development and Management Plan Inspection

Segment 4b Underground Line

Date: September 11, 2007

Location: Fairfield/Westport Town Line to Westport Avenue in Norwalk

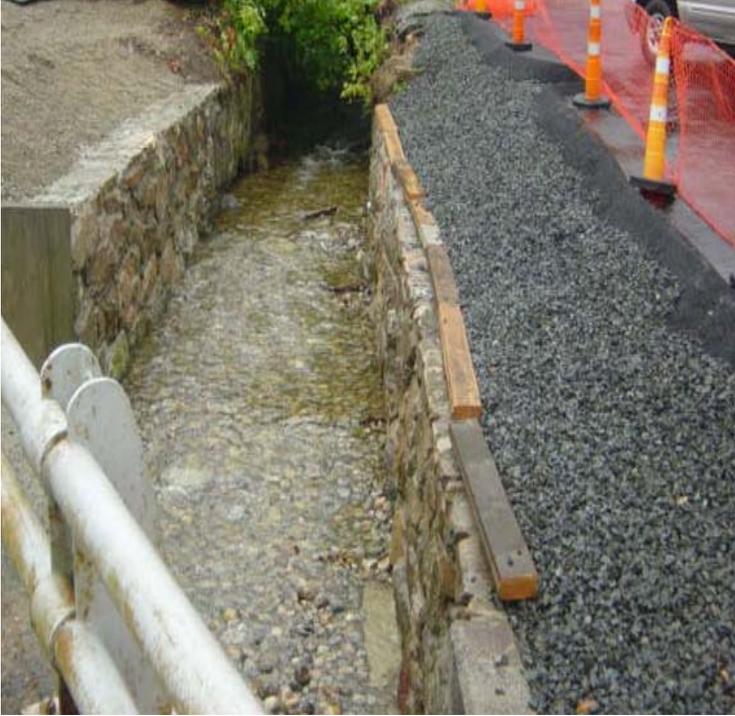
Photograph of the restored Stony Brook. Hard pack material is in place on top of the wall to the left. Install controls between exposed soil and the Brook.

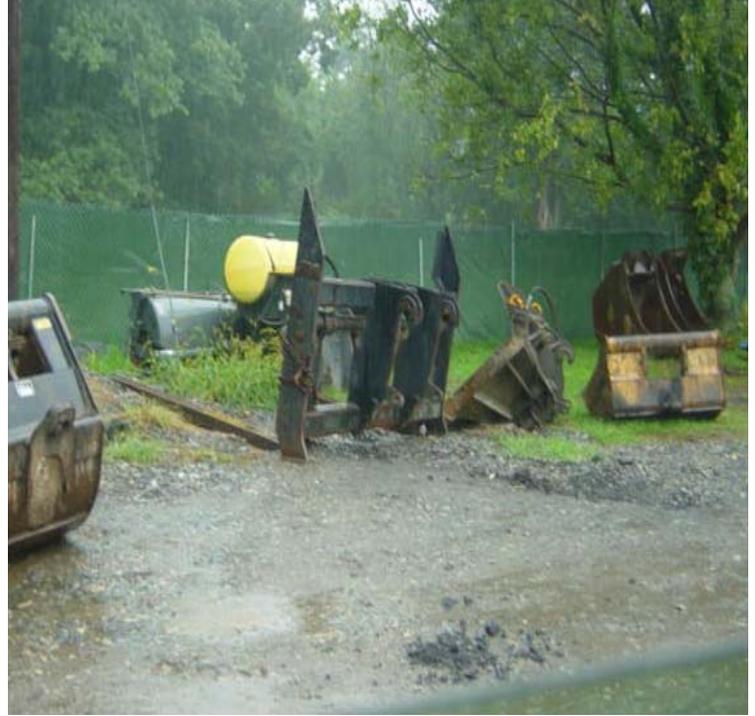
Fluid filled equipment was noted being stored on a grassed area within the Sherwood Island lay-down yard.

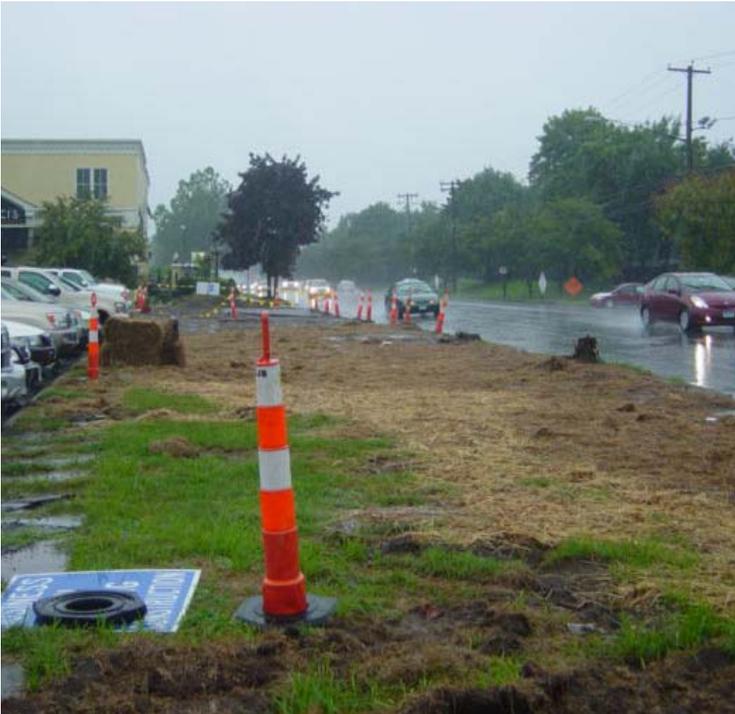
Photograph of the vault #23 location. Hay mulch covers the hard pack material over half of this area. Continue to monitor to ensure material does not migrate from construction area.

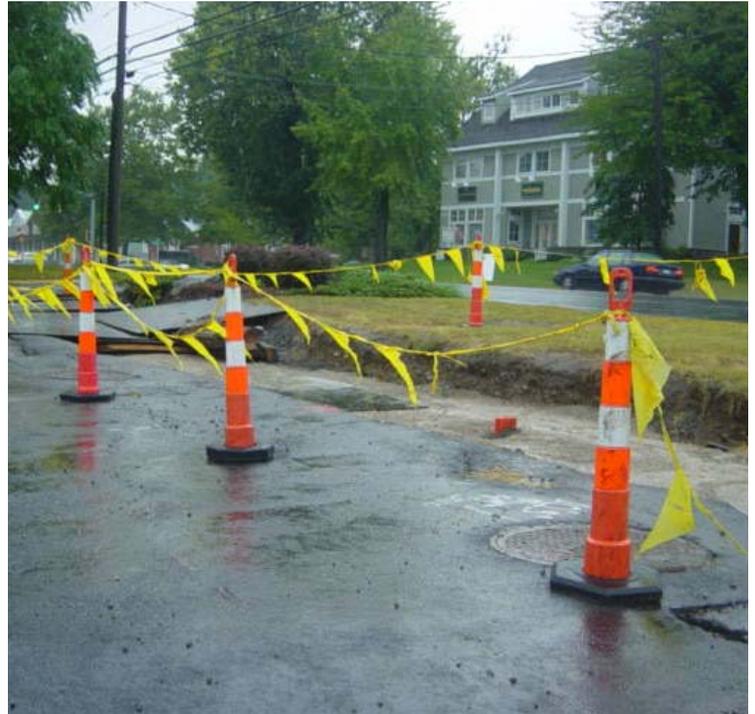
Trenching activities at sta. #432.
