**Docket No. 272 – Development and Management Plan Inspection**

**Segment 4b Underground Line**

**Date:** September 26, 2007

**Location:** Fairfield/Westport Town Line to Westport Avenue in Norwalk

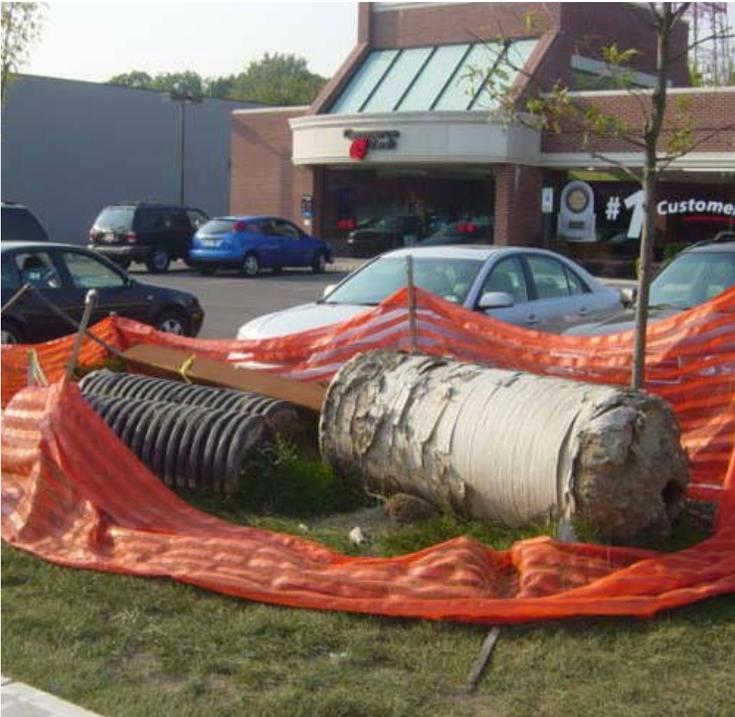
Concrete footings for removed light posts remain at sta. #148.

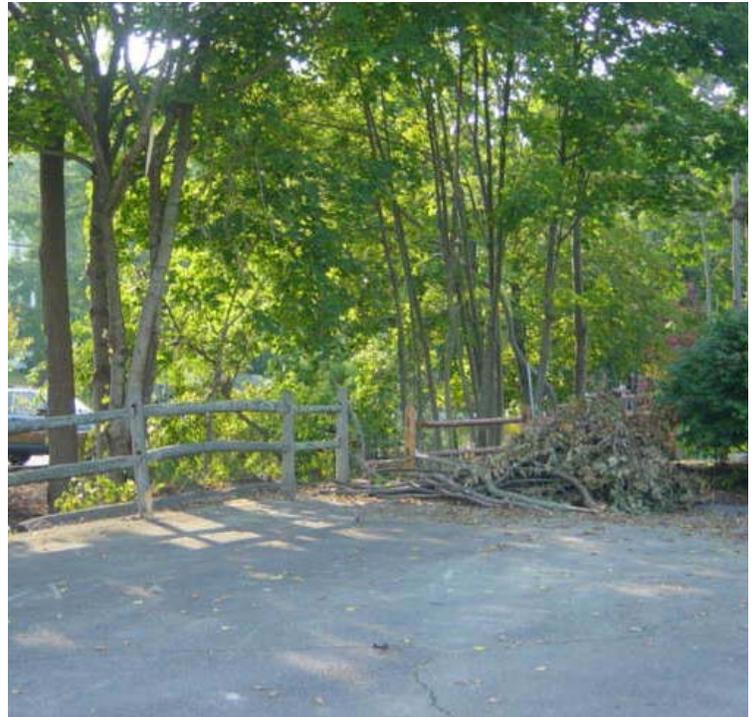
The tree that remained within the parking area adjacent to Stony Brook has been removed. Brush has been deposited in the former location of the tree. Brush does not appear to be project related.

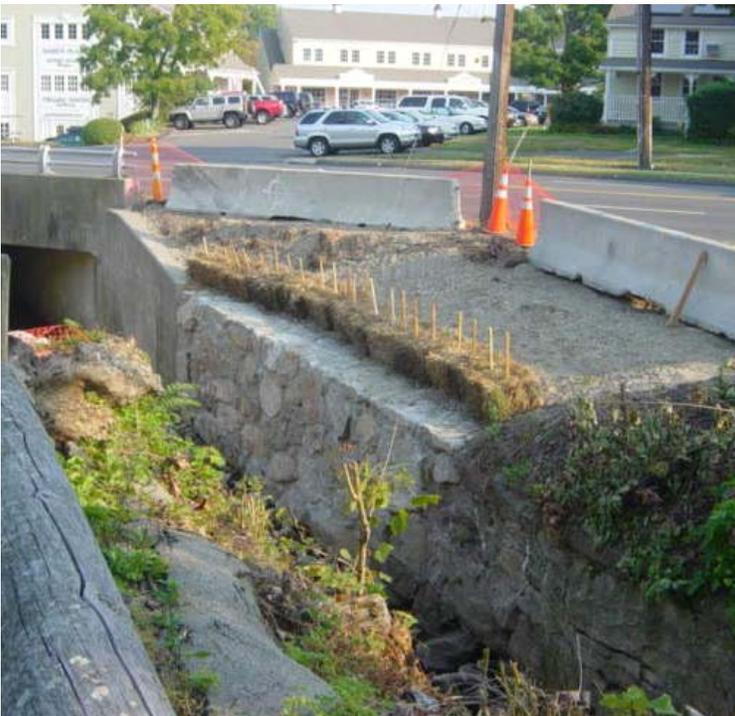
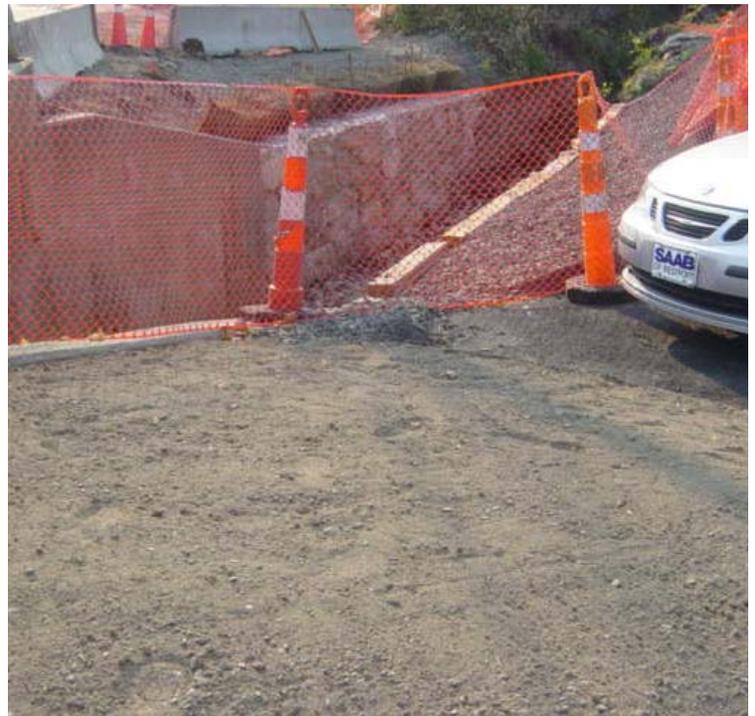
Both photographs were taken at sta. #217 (Stony Brook). Left: Erosion controls have been installed between hard pack and brook. Right: Soils remain exposed immediately adjacent to the brook that require stabilization.

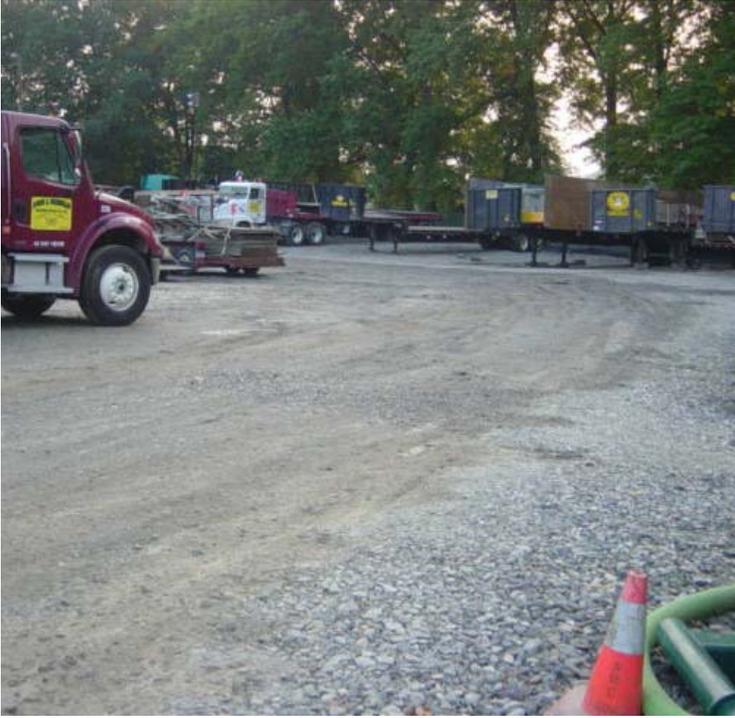
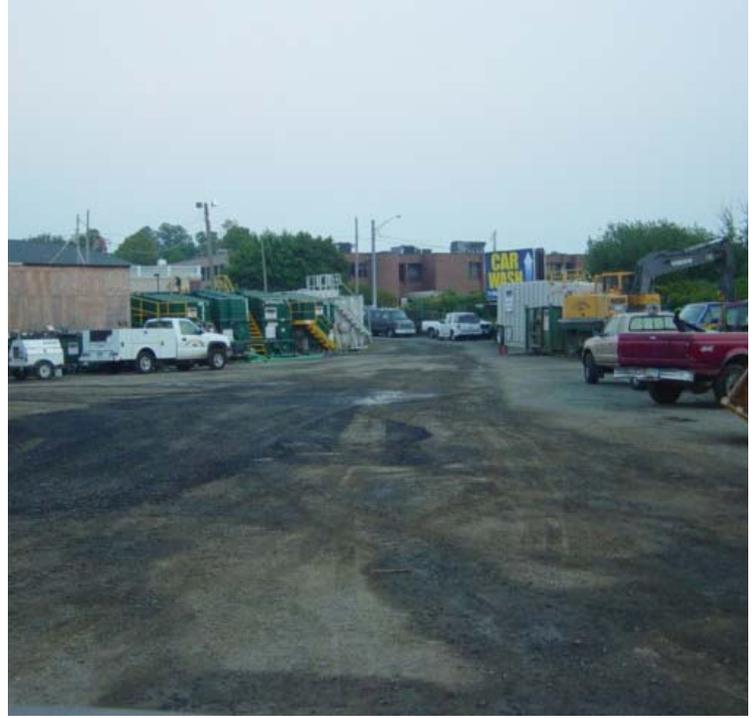
The Sherwood Island lay-down yard (left) and the King's Highway lay-down yard (right) that have been watered down in an effort to control airborne dust migration.

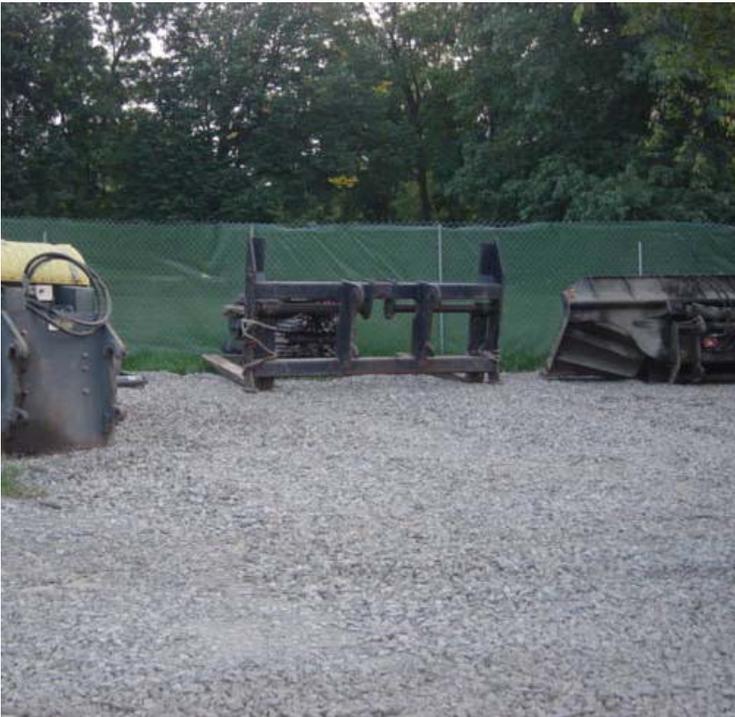
Fluid filled equipment is no longer being stored on grass/soil within the Sherwood Island lay-down yard.

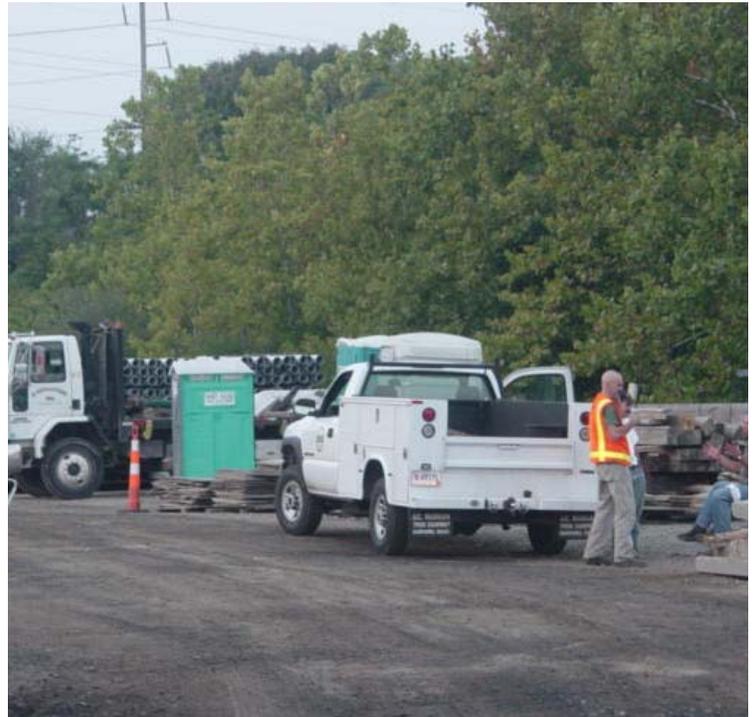
Portable sanitary facilities were being stored within 50-feet of the nearby watercourse.

Areas of Inspection	Observation	Recommended Action	Corrected Action
	feet of the adjacent watercourse. 9/26/07	location that is at least 100-feet from the watercourse, if feasible 9/26/07	
Additional Observations	None 9/26/07	None 9/26/07	NA
