**Docket No. 272 – Development and Management Plan Inspection**

**Segment 3 Underground Line**

**Date:** September 18, 2007

**Location:** Crossings of Watercourses and Railroads in Segments 3, 4a and 4b

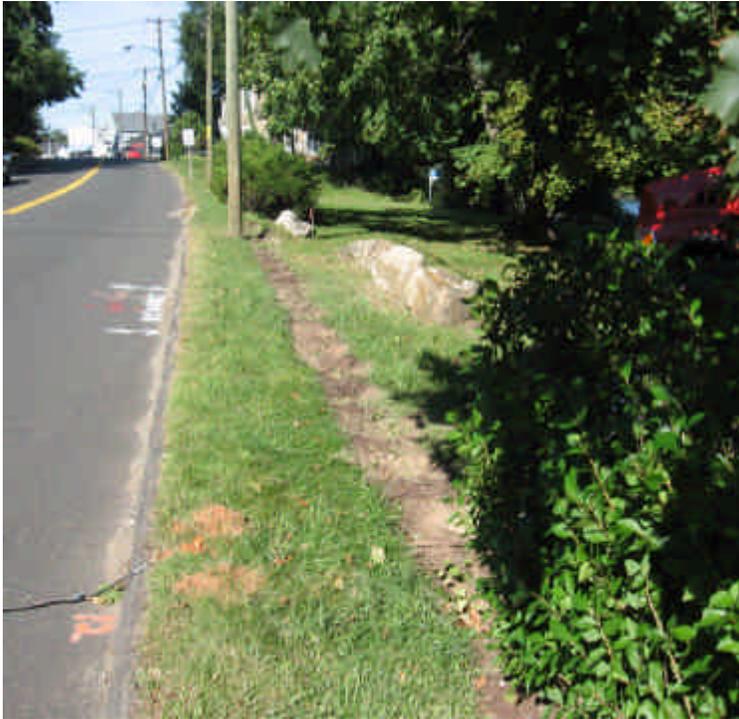
**Shrubs have been removed at sta. #236+25 to accommodate construction activities. A specific note for shrub removal was not provided on the D & M Plan for this location.**

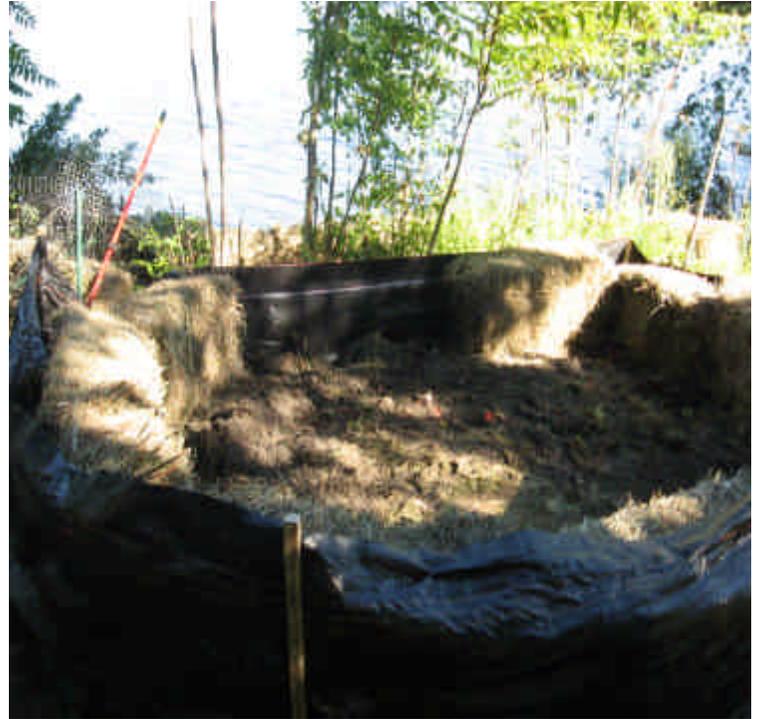
**Frac-out at sta. #236 was contained with a silt fence and haybales enclosure. Sediment was removed by a vac truck.**

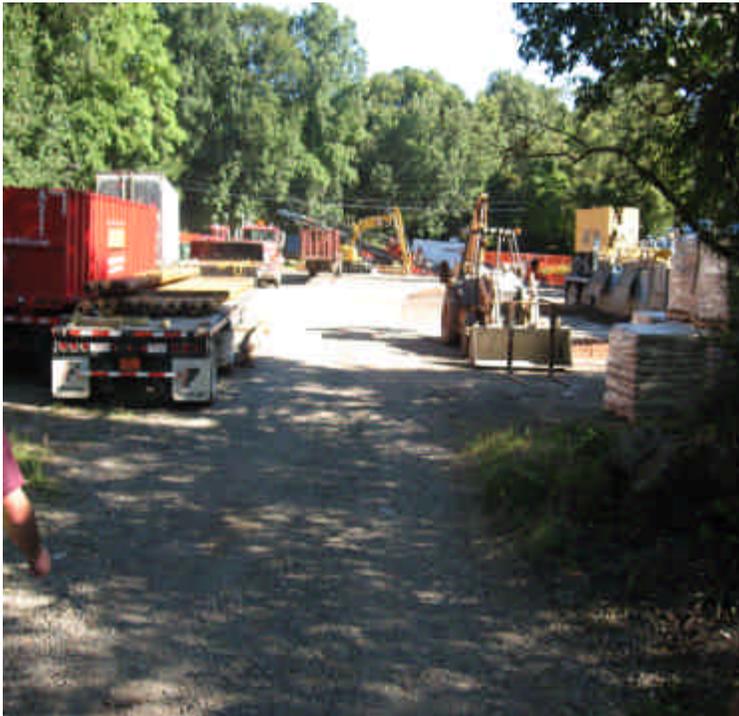
**Photograph of staging area for the HDD located on the east side of the Saugatuck River.**

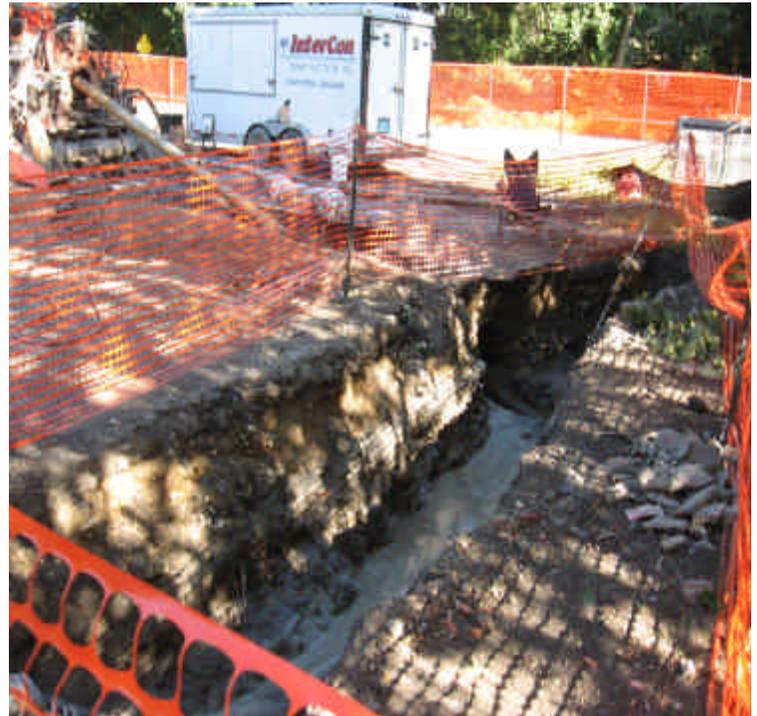
**Photograph of drilling fluid and soil receiving pit and the drill set up on the east side of the Saugatuck River. All materials were adequately contained.**
