Docket No. 272 – Development and Management Plan Inspection

Underground Line Watercourse and Railroad Crossings

Date: September 26, 2007

Location: Crossings of Watercourses and Railroads in Segments 3, 4a and 4b

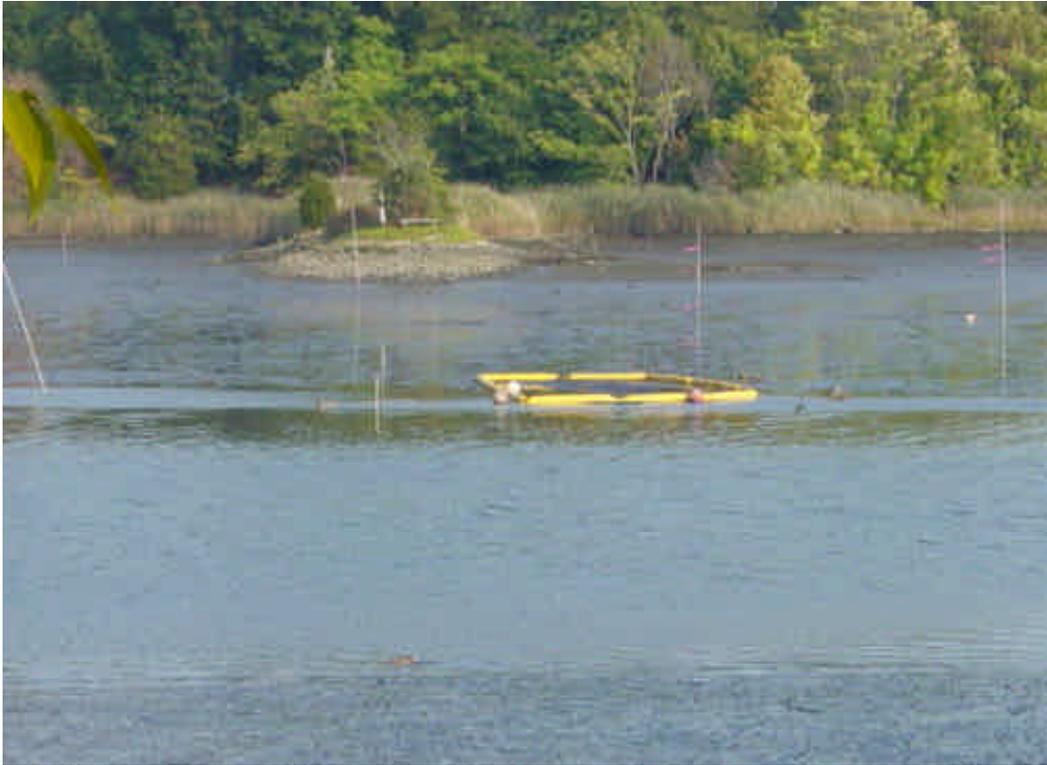
Areas of Inspection	Observation	Recommended Action	Corrected Action
	<p>dust migration. Contractors are aware of the potential. Special attention should be given to the east side staging area as the majority of the area is an exposed dirt surface and residences are nearby. 9/26/07</p>	<p>control specifications within the 2002 CT Guidelines for Soil Erosion and Sediment Control. If exposed soils are not to be worked within 30 days, they should be stabilized. 9/26/07</p>	
<p>Inland Wetland and Watercourse encroachment and mitigation</p>	<p>The currently active portion of the project consists of the watercourse crossing of the Saugatuck River and associated wetlands in Westport 9/26/07</p> <p>A frac-out (accidental release) of drilling fluid was observed in the center of the Saugatuck River. Crews had stopped drilling activities as specified in the D&M Plan to place booms/barriers around the area. Slurry was removed to the extent feasible. DEP and OLISP were contacted as required and it was determined activities could resume. Drilling had reinitiated at the time of inspection. 9/26/07</p>	<p>Continue to implement the approved monitoring plan for the crossing of the Saugatuck River provided in the D&M plan in order to avoid impacts to the resource areas. 9/26/07</p> <p>Continue to monitor carefully for drilling fluid releases and continue to address as specified in the monitoring plan provided in the D&M. Contractors have been monitoring pressure and making regular visual inspections in the river. 9/26/07</p>	<p>NA</p> <p>Regular inspections are occurring, leading to the discovery and appropriate clean-up of a frac-out. DEP was informed.</p>

Photo of a frac-out (release of drilling fluid) which was identified and contained within booms in the center of the Saugatuck River.

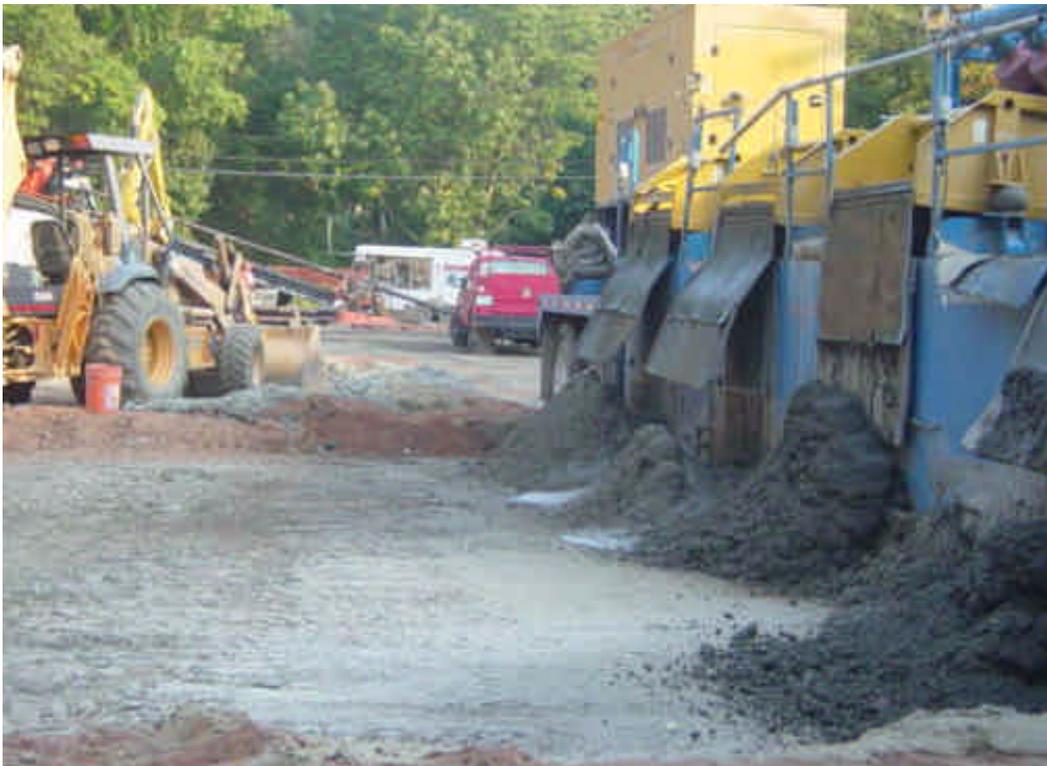
View of the machine set-up used to separate the bentonite clay used for drilling activities from soil so that the bentonite may be reused/recycled.
