CONNECTICUT SITING COUNCIL

Petition 1120: Construction Site Inspection

Date of Inspection: October 8, 2015

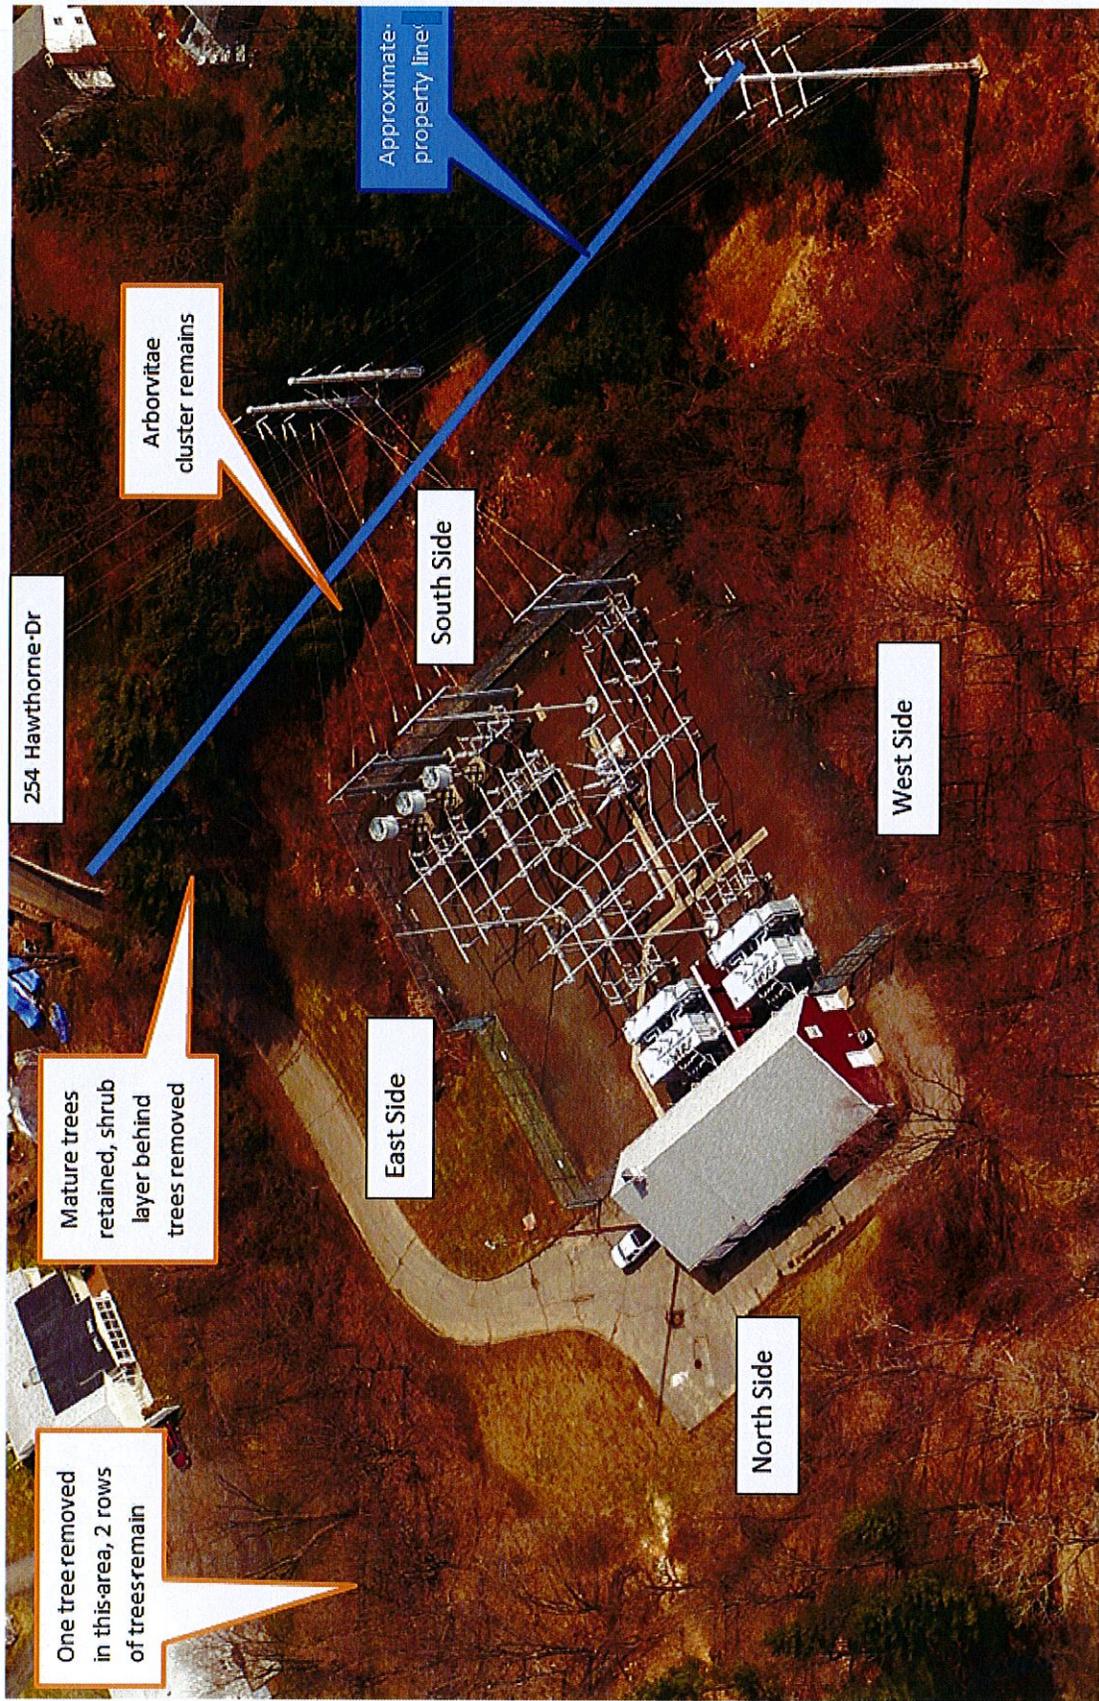
One tree removed in this area, 2 rows of trees remain

Mature trees retained, shrub layer behind trees removed

Arborvitae cluster remains

Substation with site features shown.

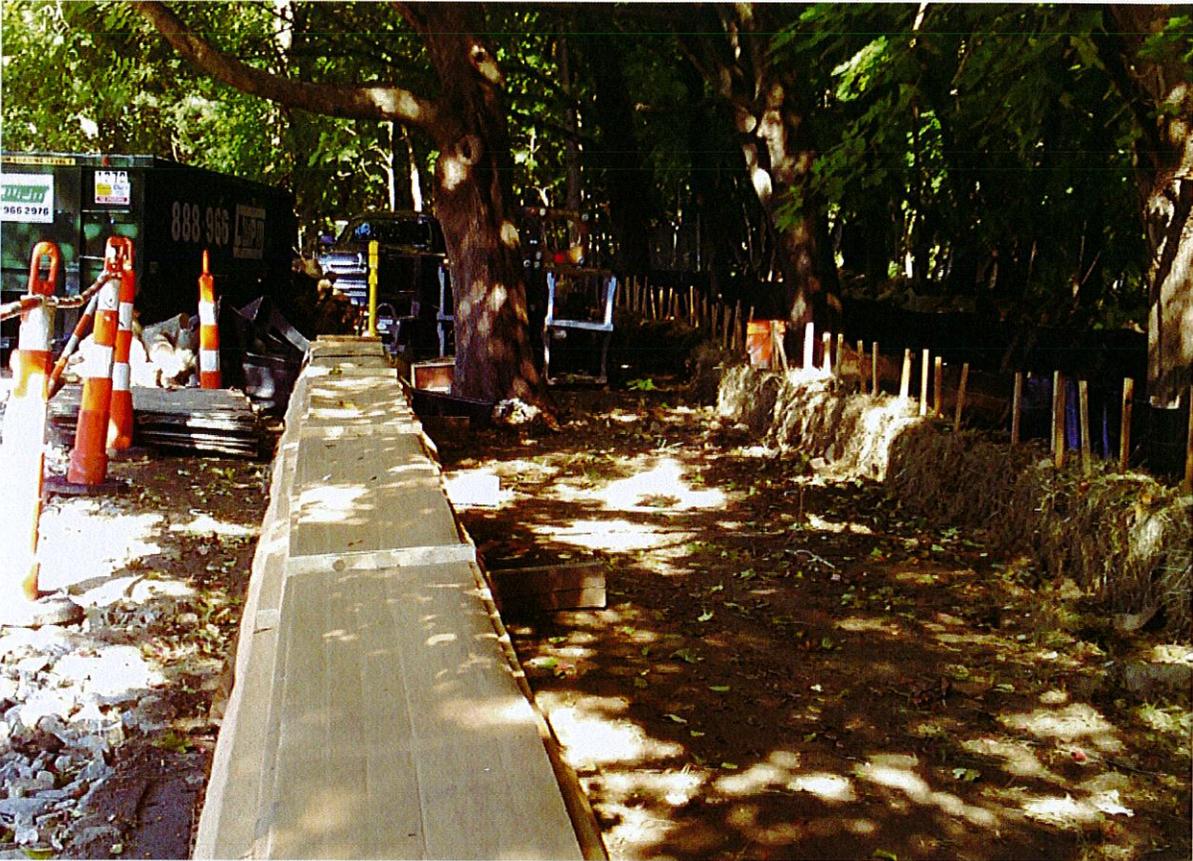
UI removed one Norway maple in the northeast corner of the site and trimmed low branches off other nearby trees to establish the equipment laydown area, as specified in the Development and Management (D&M Plan). No other trees were removed in this area. A double row of erosion control fencing exists in this area to prevent any sedimentation beyond the construction area.

East side of Site, looking north at laydown area showing siltation/turtle barrier and rows of trees to remain. One tree removed in this area per D&M Plan.

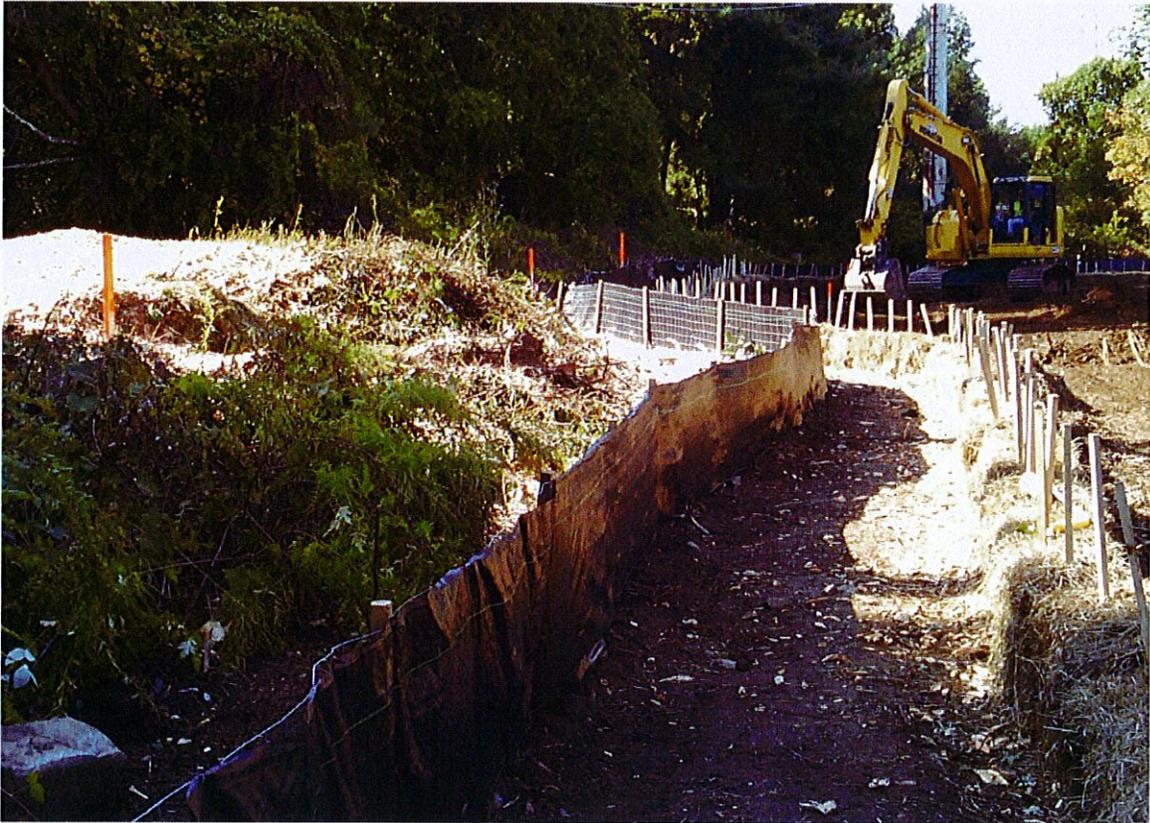
South side of site, looking west from 172 Schiller Road area. Grading is occurring. Orange property markers are visible.

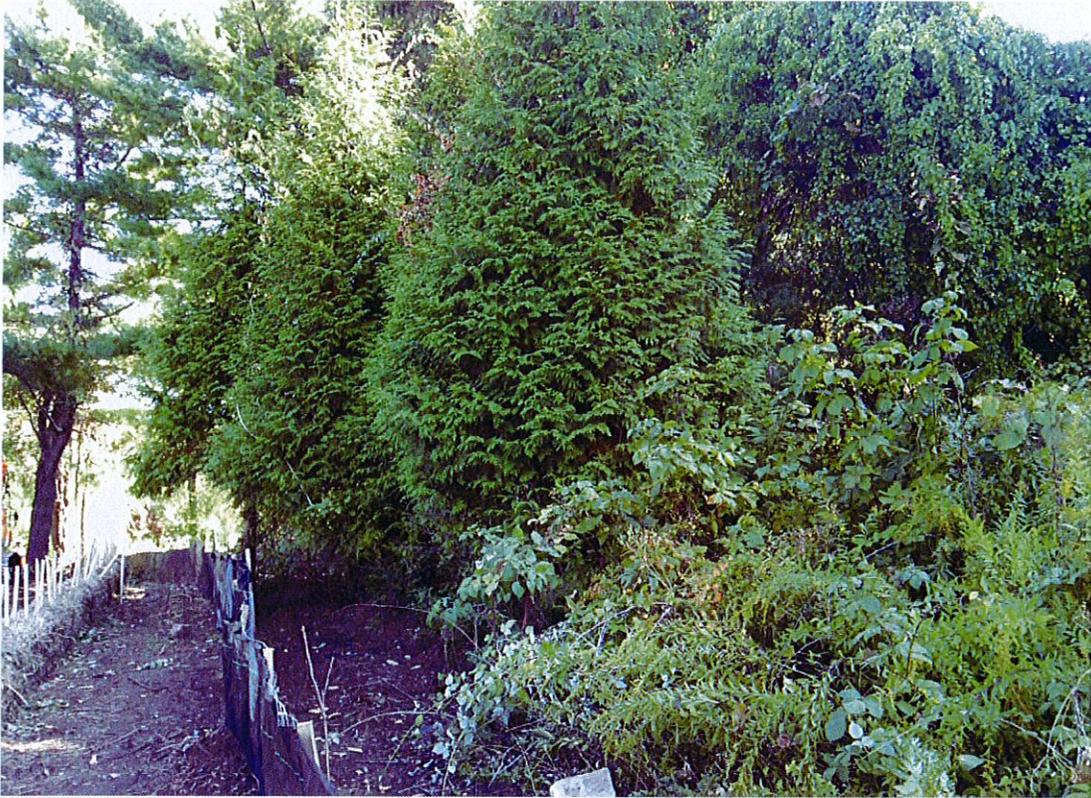
View east along south property line. Arborvitae cluster adjacent to 274 Hawthorne Drive to remain. Double row of siltation barriers. Clearing complete.

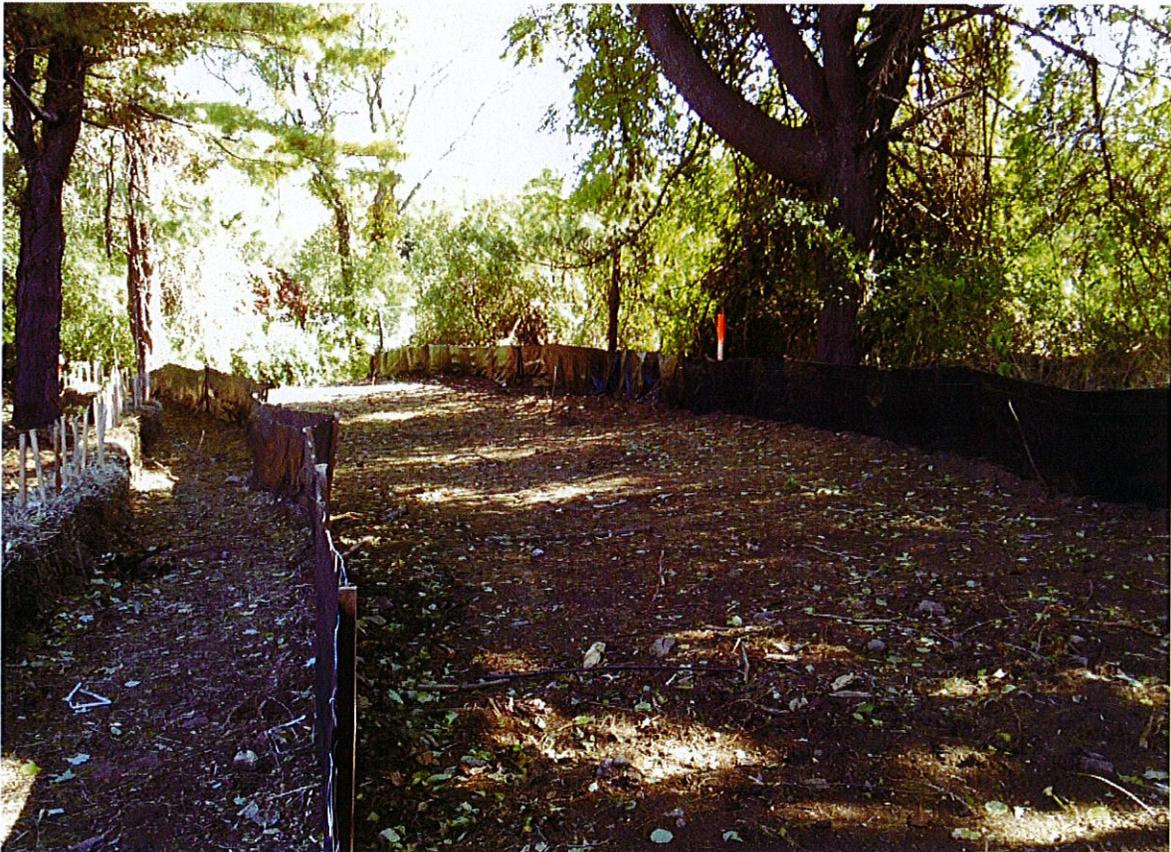
A double row of silt fencing, consisting of a primary barrier of hay bales followed by a secondary rigid silt fence is installed along the southern property line to the access drive. Additionally, a third row of silt fencing is installed along the southeast extent of the property, approximately 10 feet from the primary silt barriers to serve as a tertiary erosion control measure and box turtle barrier. The open ground between the barriers allows for the easier detection of turtles that may attempt to migrate into the construction area. The siltation barriers were installed in accordance with the D&M Plan (E&S Figure 5).

View of southeast corner of substation property, towards 254 Hawthorne Drive. Thick brush/shrubs removed. Mature trees remain. Three rows of siltation barriers as specified in D&M Plan.

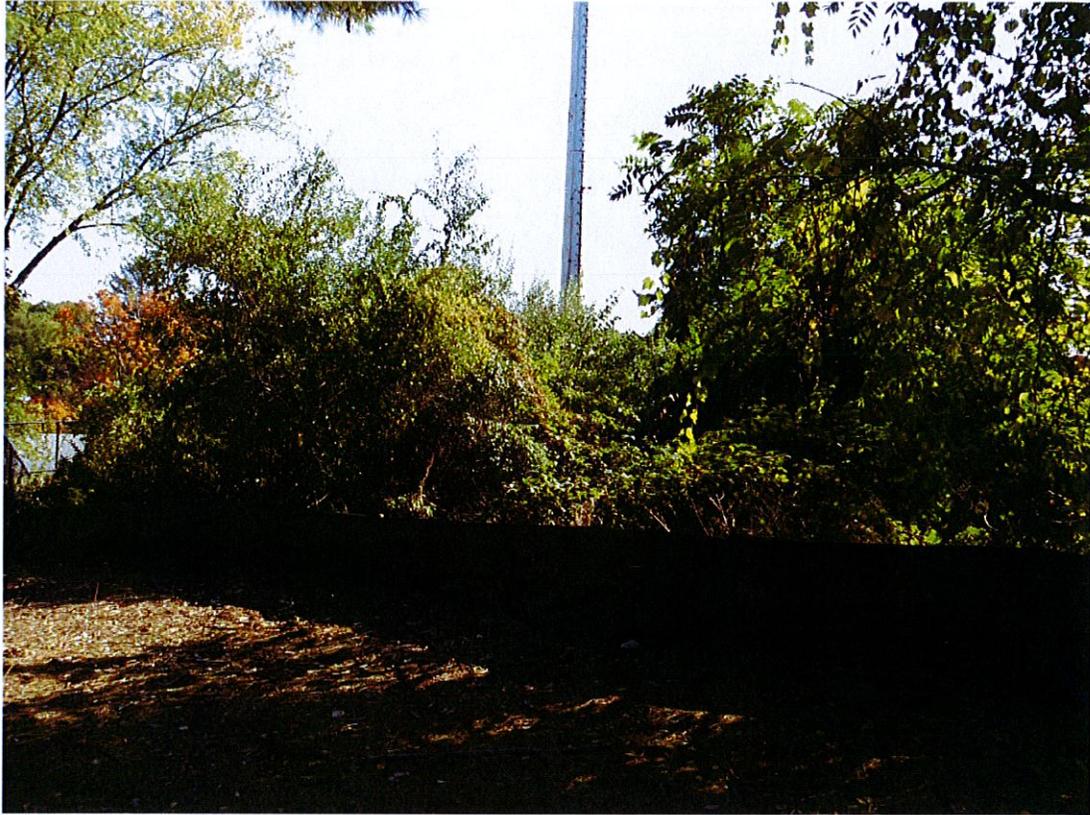
View towards 254 Hawthorne Drive from Southeast corner. Note remaining thick shrub layer. Tower in photo is Eversource transmission structure on 254 Hawthorne Drive property.

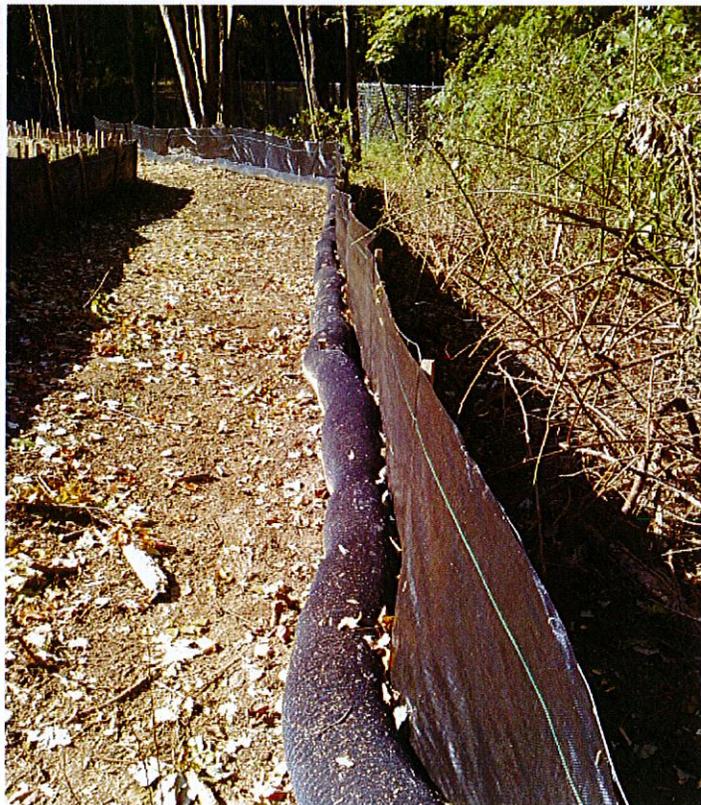
All vegetative clearing activities were completed. A vegetative stockpile was present at the top edge of the slope. Silt fencing near the adjacent wetland consists of a primary barrier of hay bale/silt fence, followed by a rigid silt fence with a silt sock installed on the upgradient side for an additional layer of wetland protection.

Double siltation barrier along north property line. Wetland on abutting property to right.
