Docket No. 424 – Development and Management Plan Inspection

The Connecticut Light and Power Company Certificate of Environmental Compatibility and Public Need for the Connecticut portion of the Interstate Reliability Project.

**Card Street Substation
 Interim Week Inspection:**

**Card Street Substation
 Bi-Week Inspection:**

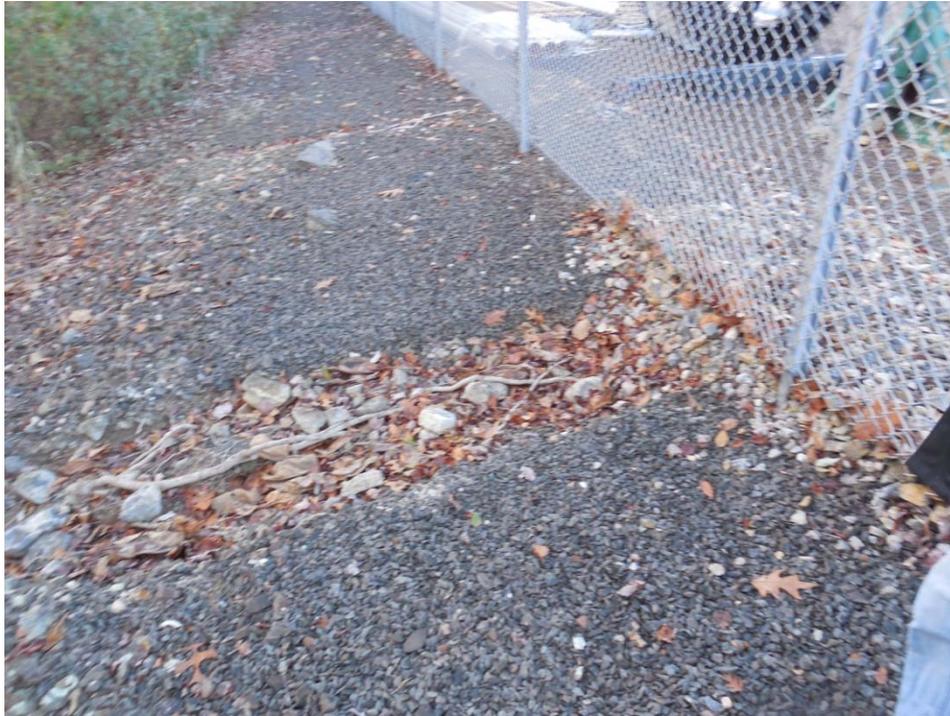
Photo #1: View (facing west) of second runoff outlet at southwestern edge of substation.

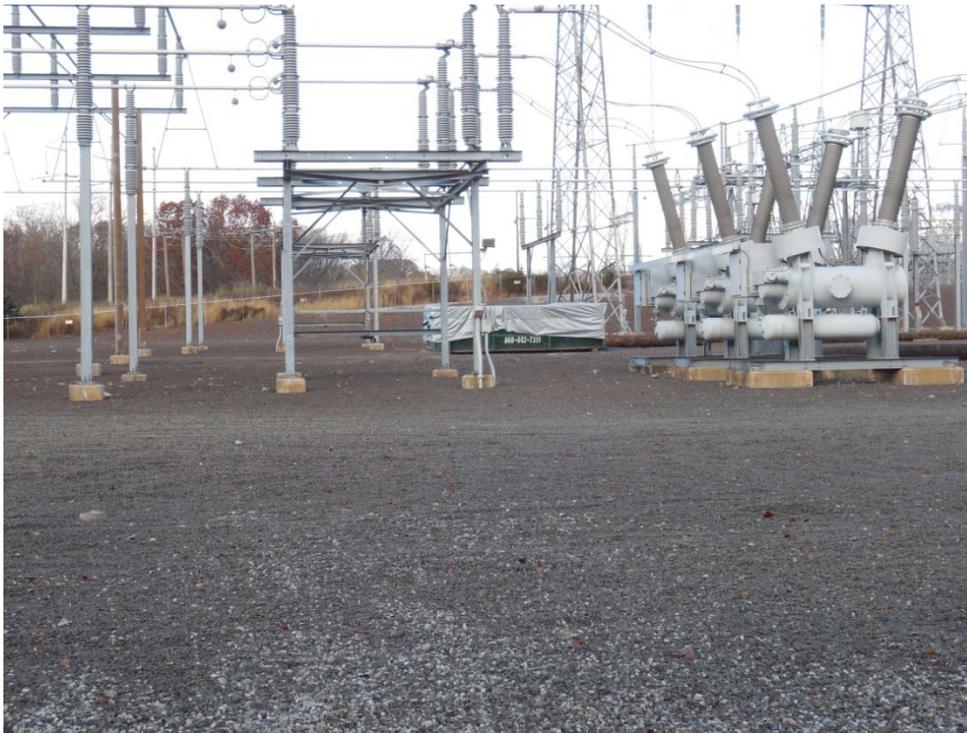
Photo #2: View (facing north) of lined dumpster near excavation.

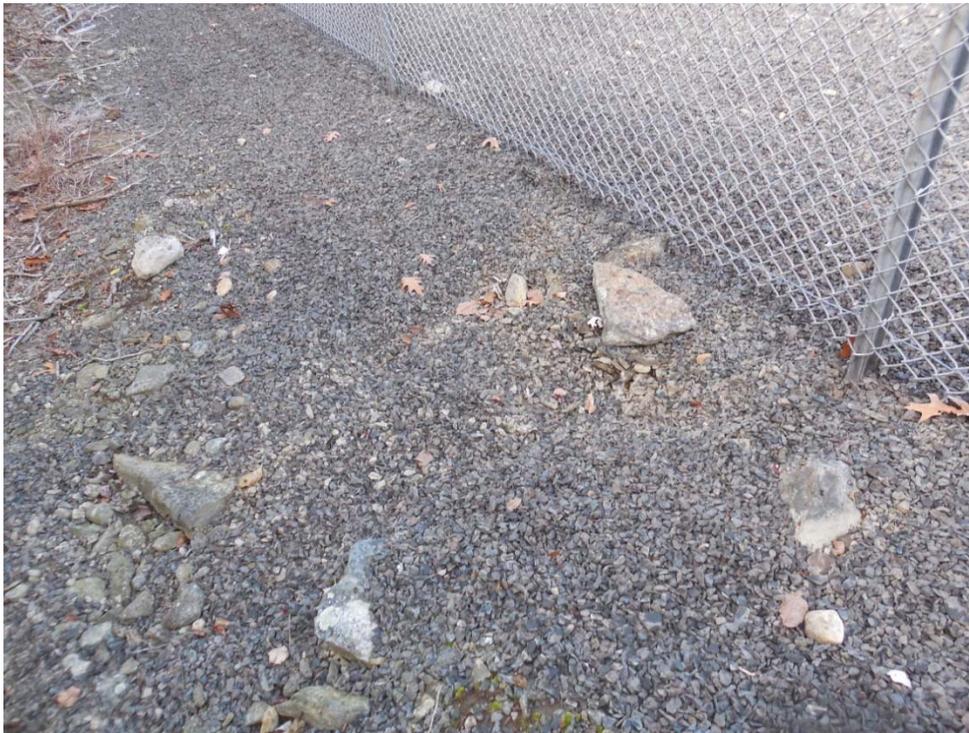
Photo #3: View (facing northwest) of first runoff outlet, 50 feet from access road, at southwestern edge of substation.

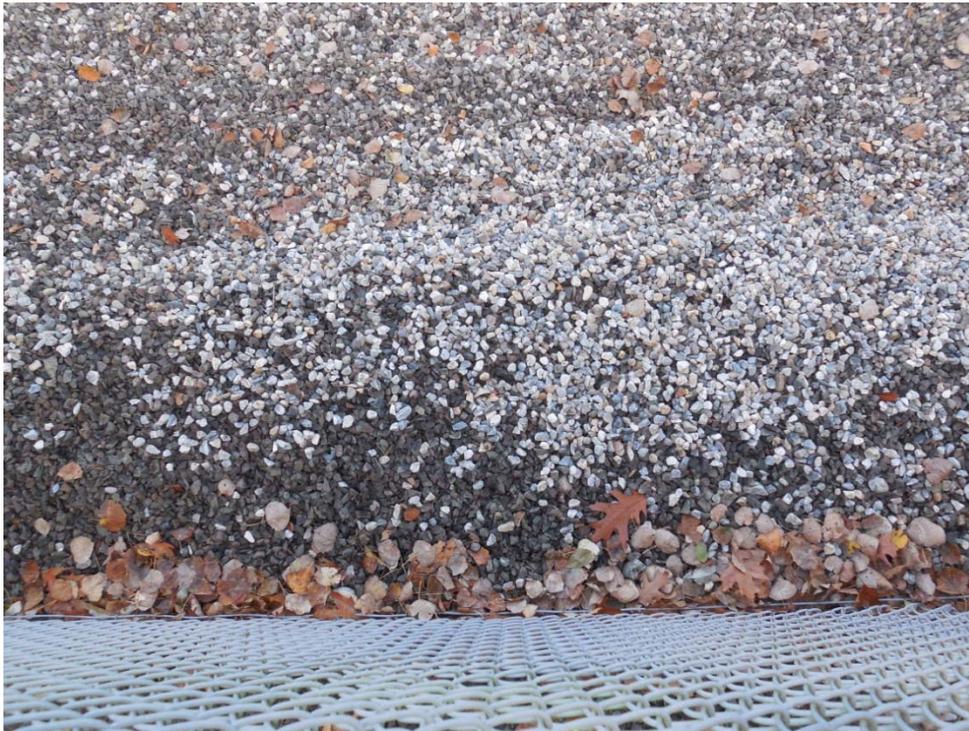
Areas of Inspection	Observation:	Recommended Action:	Corrected Action:
Vegetative Clearing Limits (Including trees to save or danger trees noted.)	NA	NA	NA
Water Crossings	NA	NA	NA
Erosion and Sedimentation Controls	<p>Week 1 (11/8)</p> <p>There is a stone erosion control berm surrounding the perimeter of the substation.</p> <p>Temporary bus excavation is taking place about 70-100 feet from fence line in the southwest section of the substation.</p> <p>The surface of the substation is crushed stone.</p> <p>There appear to be 2 main stormwater runoff outlets from the southwest edge of the substation to the wetland below. The smaller of the 2 outlets discharges flow approximately 100 feet to the west of the access road. The second outlet is approximately 500 feet to the west of the access road. Both outlets were dry at the time of the inspection and visual observation of the area for any sediment staining suggests that both outlets flow free of erosion.</p>	<p>NA</p> <p>NA</p> <p>NA</p> <p>Continue to monitor these outlets during and after significant rain events for erosion off the site into the wetland.</p>	<p>NA</p> <p>NA</p> <p>NA</p>

Photo #4: View (facing north) of stone erosion berm along fence line at edge of substation.

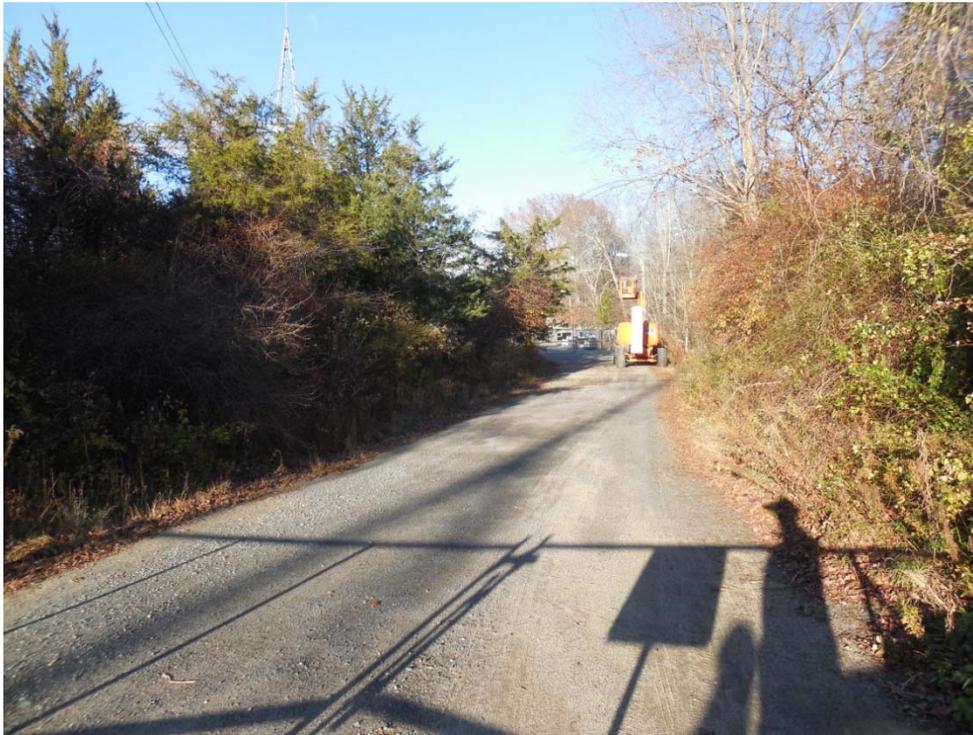
Photo #5: View (facing north) of entrance pad to substation.

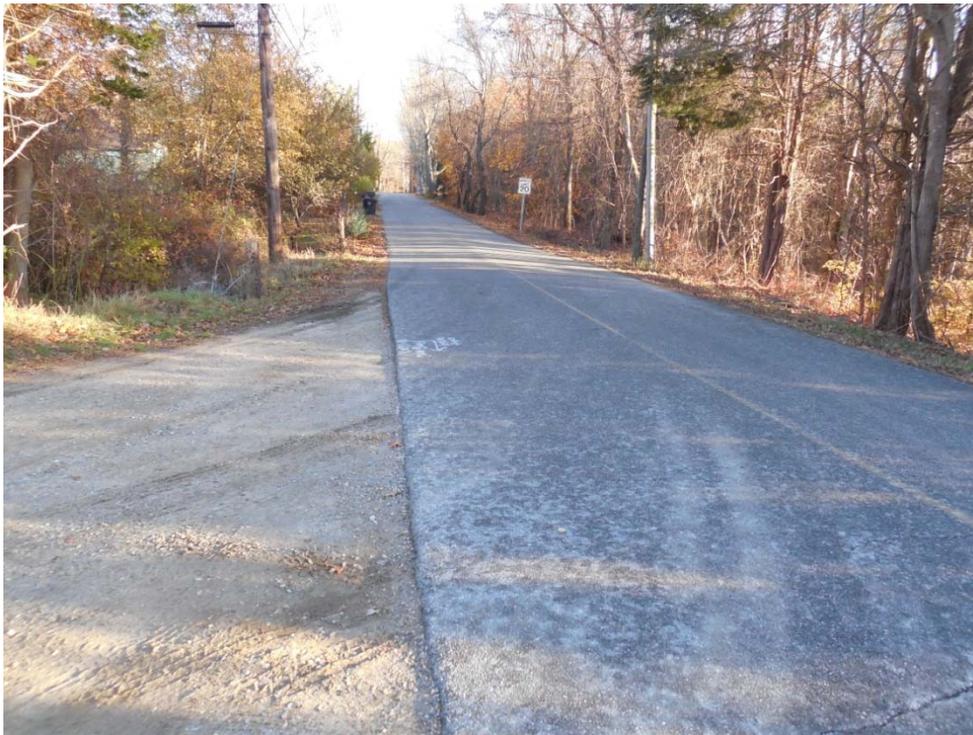
Photo #6: View (facing southeast) of Card Street relatively free of sediment from entrance.

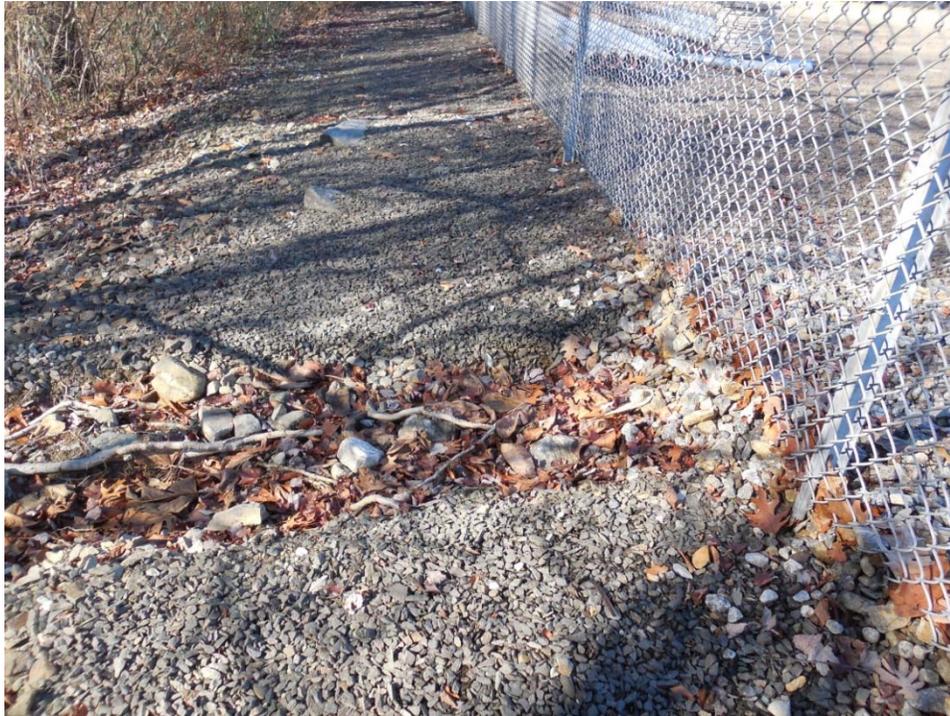
Photo #1: View (facing west) of second runoff outlet at southwestern edge of substation with no apparent sedimentation.

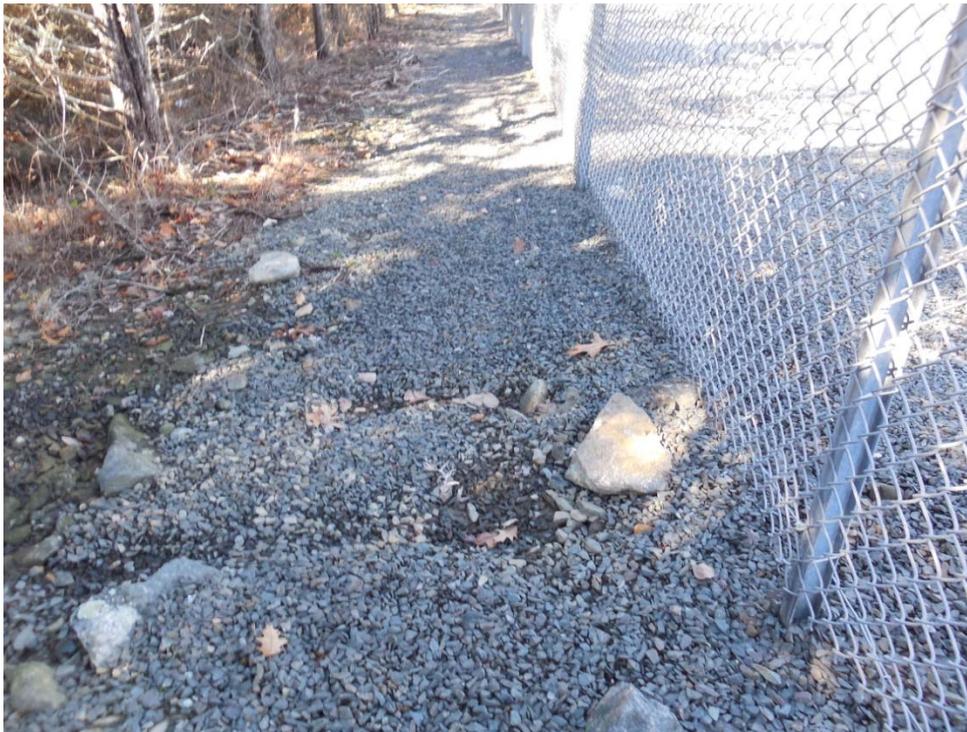
Photo #2: View (facing west) of first runoff outlet at southwestern edge of substation with no apparent sedimentation.

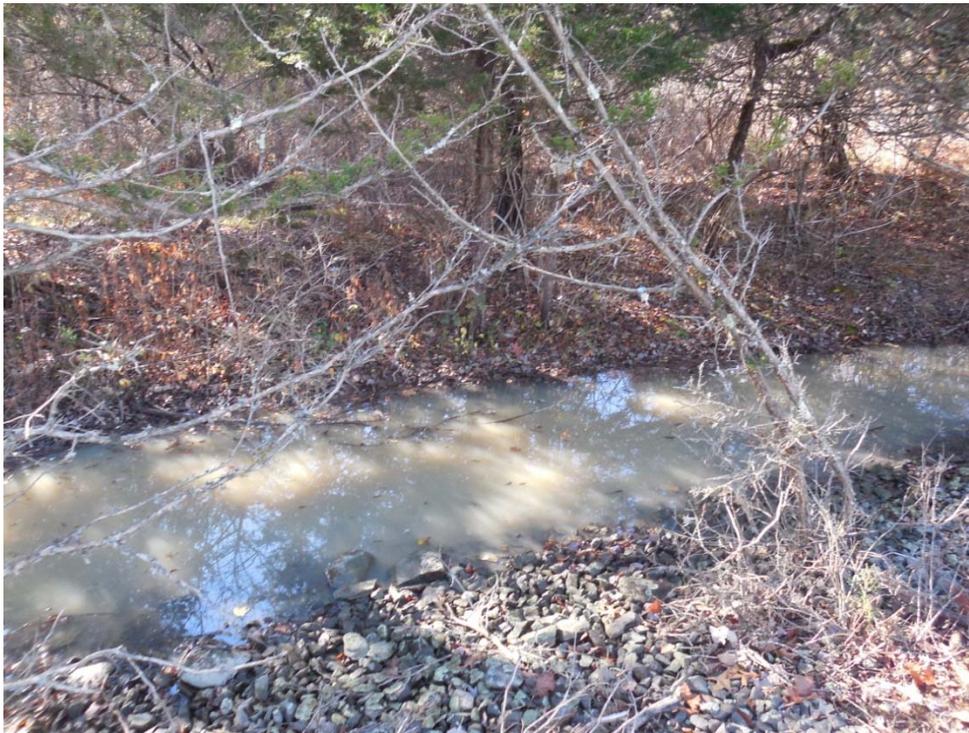
<p>Week 2 (11/18)</p> <p>There is evidence of suspended sediment in the wetland swale southwest of the substation, but the sediment origin is not apparent. (Sedimentation may be the result of heavy rain in the early morning hours unsettling stabilized offsite areas)</p> <p>Both substation outlets are dry at the time of the inspection.</p>	<p>Continue to monitor area for worsening condition following rain events.</p>	<p>Peter Lockwood of Burns and McDonnell provided photo documentation that the wetland swale areas in question showed evidence of sedimentation prior to the start of construction. The area will continue to be monitored following rain events.</p>

Photo #3: View (facing southwest) of wetlands that appears cloudy from sediment of unknown origin along southwestern edge of substation.

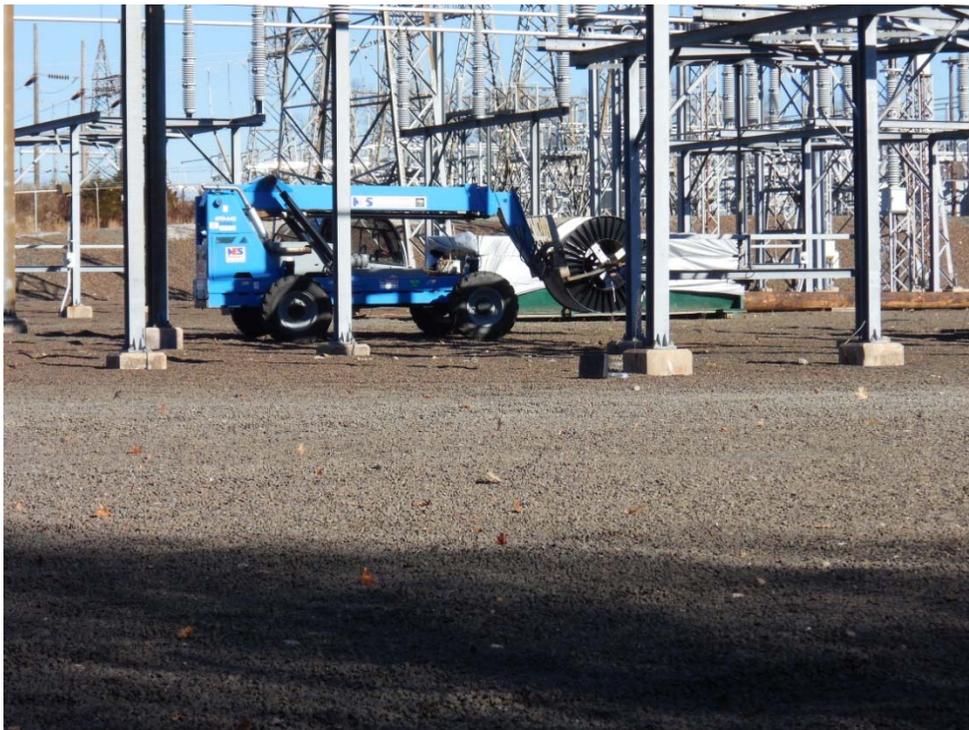
Photo #4: View (facing northeast) of forklift moving equipment from storage area to work area.

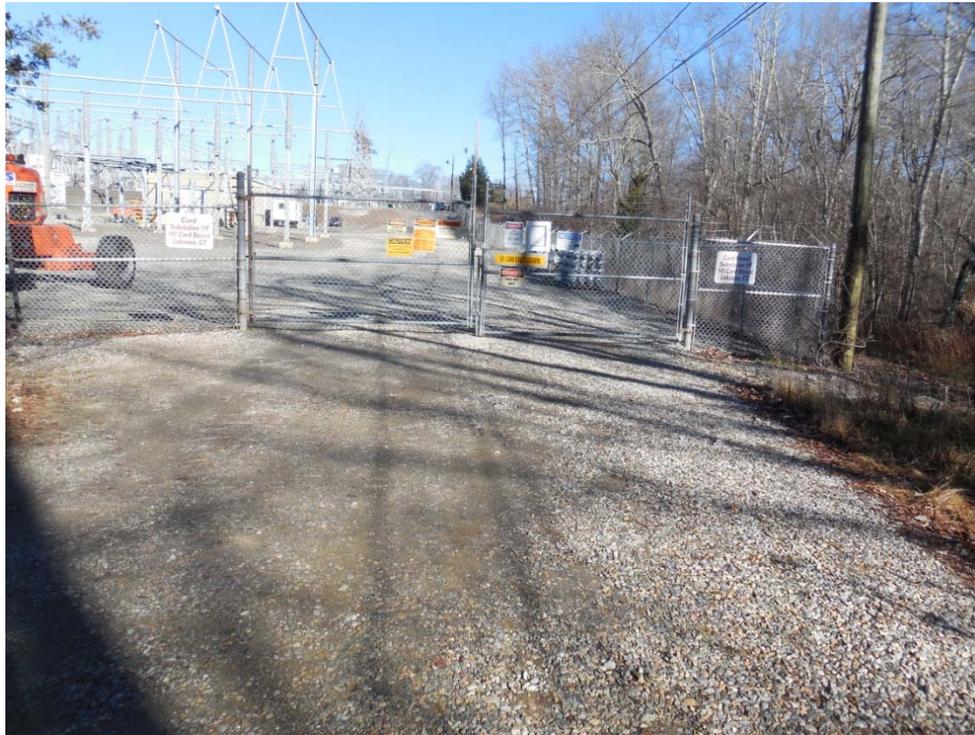
Areas of Inspection		Observation:	Recommended Action:	Corrected Action:
Access Roads and Adjacent Roadways	Week 1 (11/8)	Access to Substation is in compliance with BMP Manual.	Continue to monitor to ensure sediment does not track onto Card Street.	Not Applicable (NA)
	Week 2 (11/18)	Card Street at access to Substation is clean and free of debris and in accordance with the BMP Manual. Access to the substation is heavily tracked and compacted. Portions of the access road nearer to Card Street exhibit some erosion contained within the roadway from the heavy vehicle use.	Continue to monitor access area to ensure vehicle tracking does not cause offsite sedimentation to either the roadway or the adjacent wetlands.	NA NA

Photo #5: View (facing north) of heavily tracked entrance pad to substation.

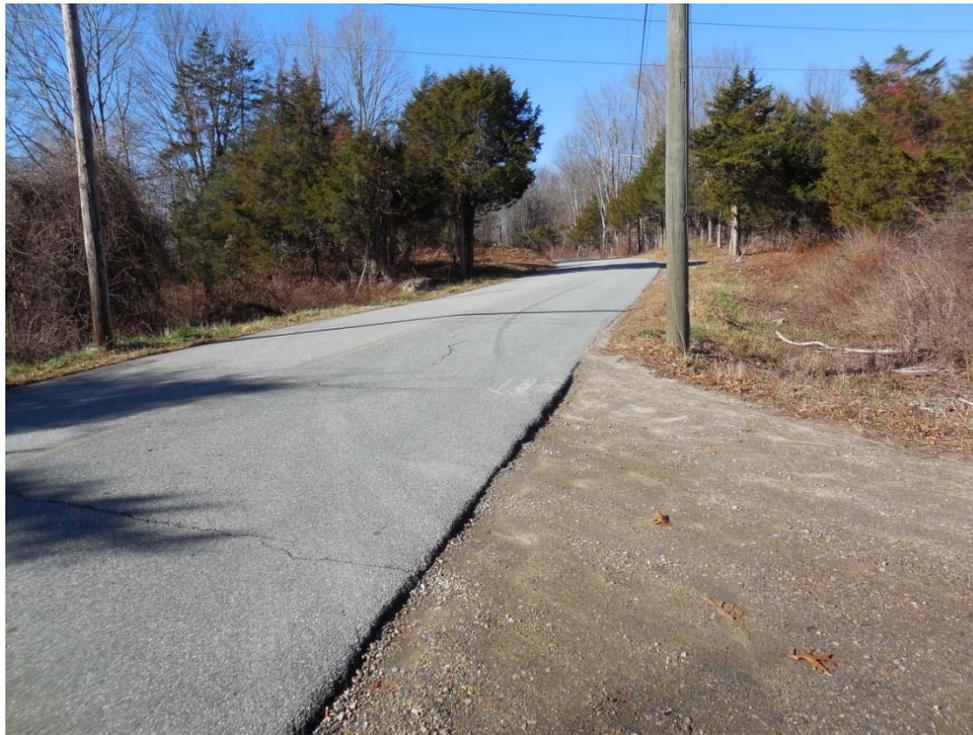
Photo #6: View (facing west) of Card Street, free of sediment from access.
