Docket No. 424 – Development and Management Plan Inspection

The Connecticut Light and Power Company Certificate of Environmental Compatibility and Public Need for the Connecticut portion of the Interstate Reliability Project.

**Card Street Substation
 Interim Week Inspection:**

**Card Street Substation
 Bi-Week Submission Inspection:**

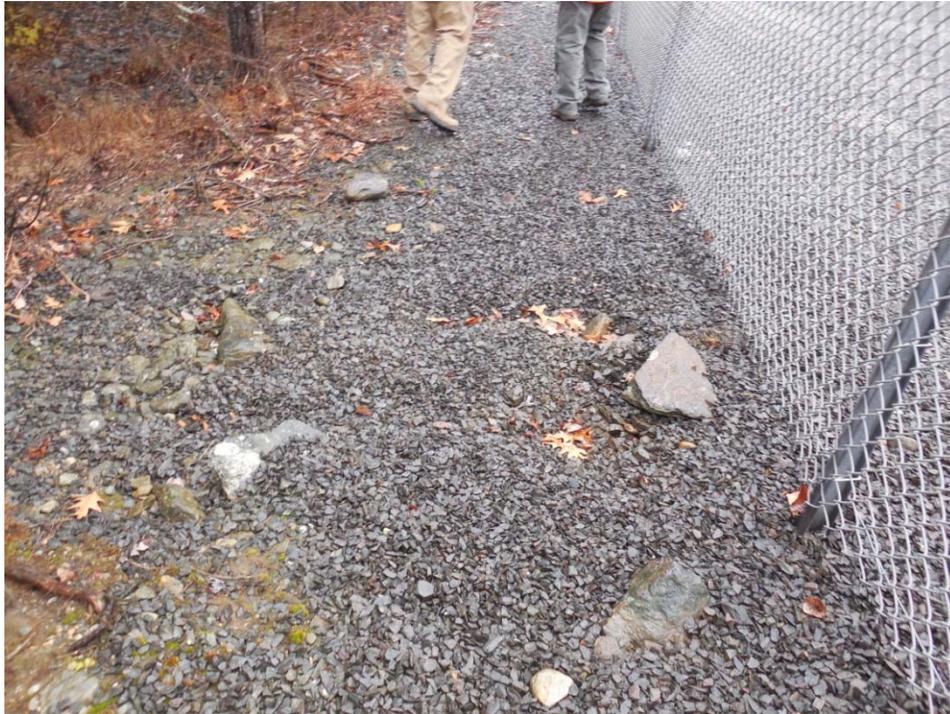
Photo #1: View (facing west) of runoff outlet at southwestern edge of substation with no apparent sedimentation.

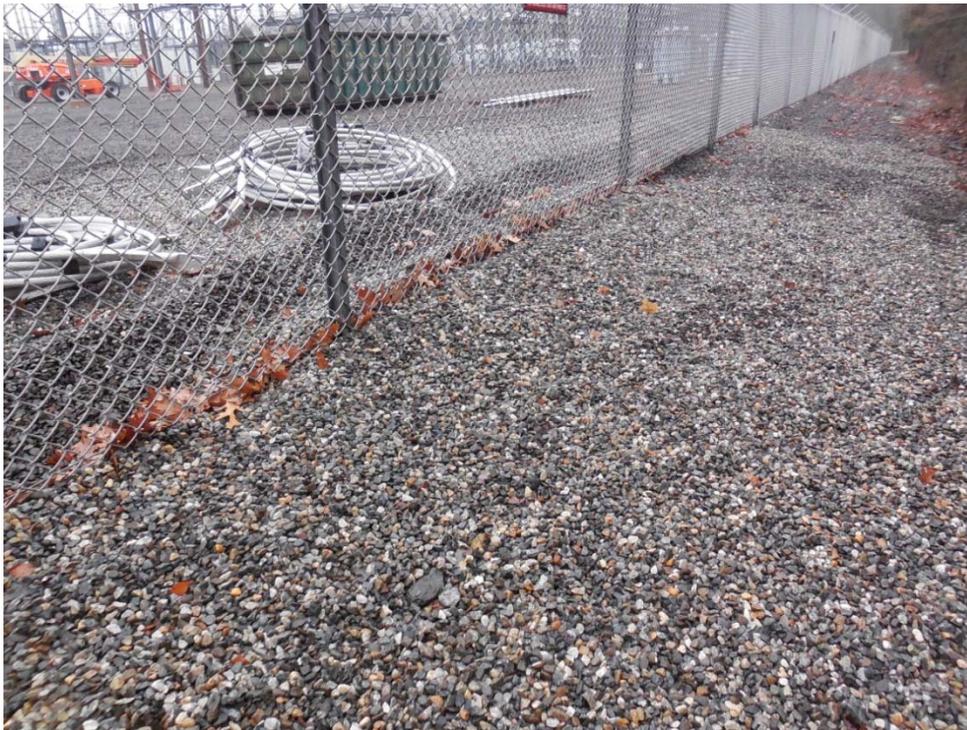
Photo #2: View (facing east) of Third (main) runoff outlet at southwestern edge of substation with no apparent sedimentation.

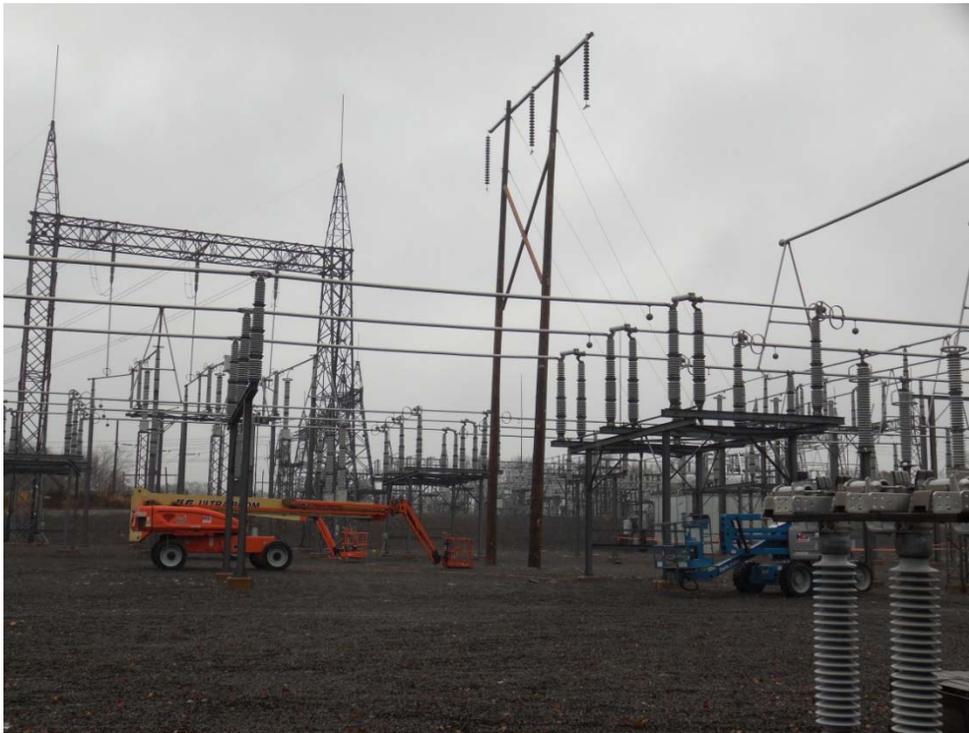
Photo #3: View (facing northeast) of first of two new Wood Pole H-frame Structures.

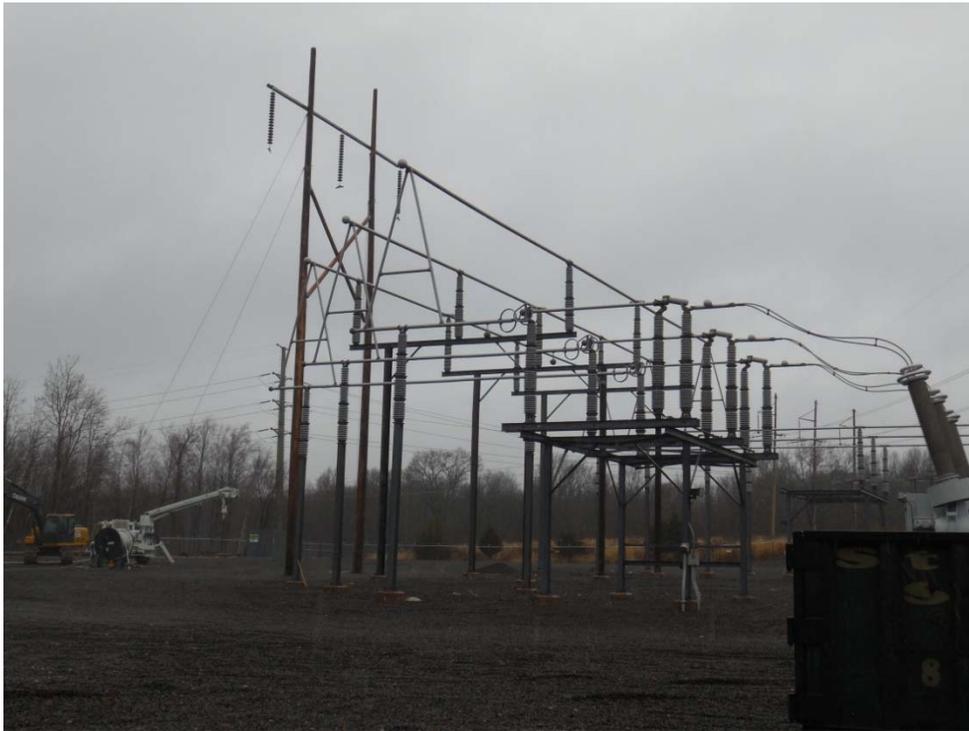
Photo #4: View (facing northwest) of second of two new Wood Pole H-frame Structures.

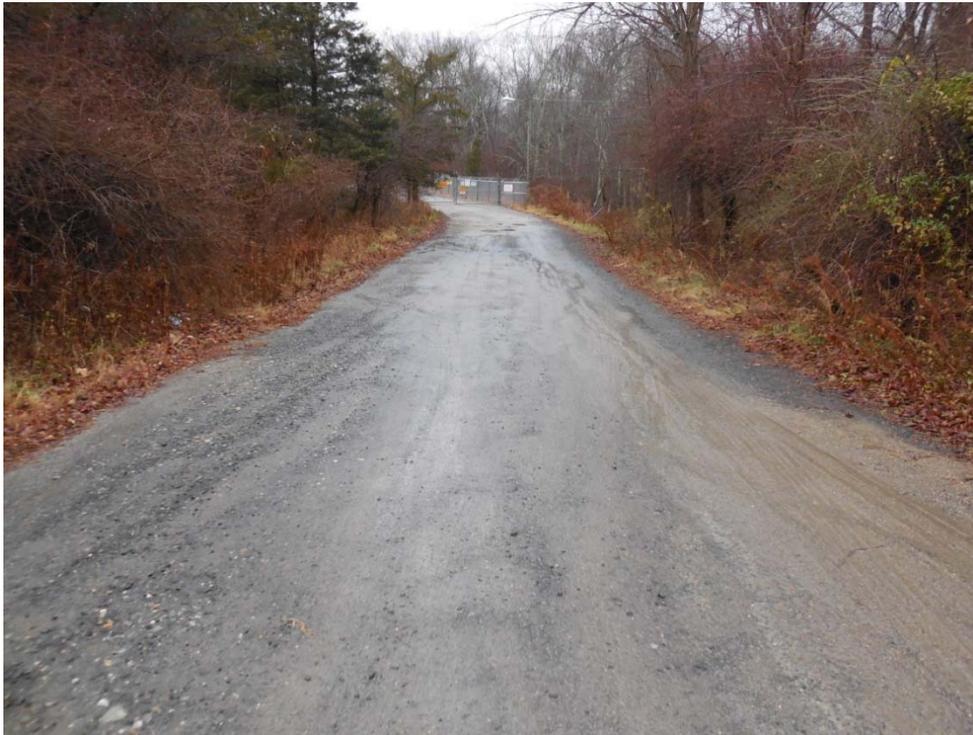
Areas of Inspection	Observation:	Recommended Action:	Corrected Action:
Access Roads and Adjacent Roadways	<p>Card Street at access to Substation is clean and free of debris in accordance with the BMP Manual.</p> <p>Access to Substation is heavily tracked and compacted. Stormwater runoff channelization is beginning to occur along the access road, although it is contained to the roadway.</p>	<p>Continue to monitor access area to ensure vehicle tracking does not cause offsite sedimentation onto Card Street or adjacent sensitive area.</p>	<p>Not Applicable (NA)</p> <p>(11/29): Temporary substation work complete. No IRP work planned in SS until early 2014. There should be limited (if any) IRP traffic entering the substation through the winter months.</p>
Vegetative Clearing Limits (Including trees to save or danger trees noted.)	NA	NA	NA

Photo #5: View (facing north) of heavily tracked and compacted entrance pad to substation with water channelization.

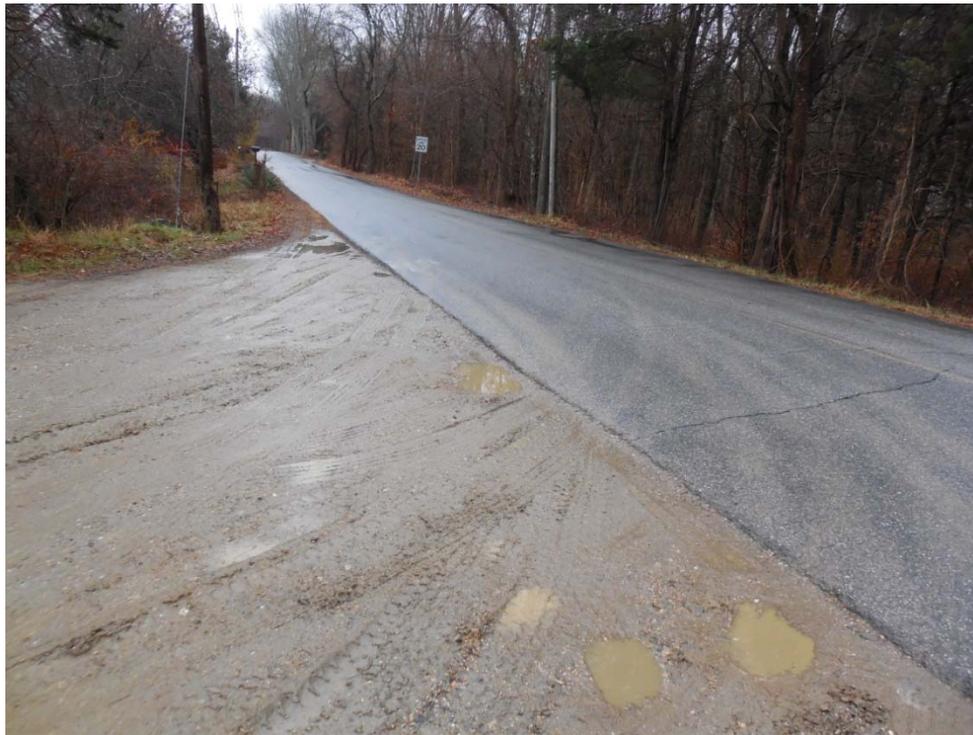
Photo #6: View (facing east) of Card Street, free of significant sediment from access.

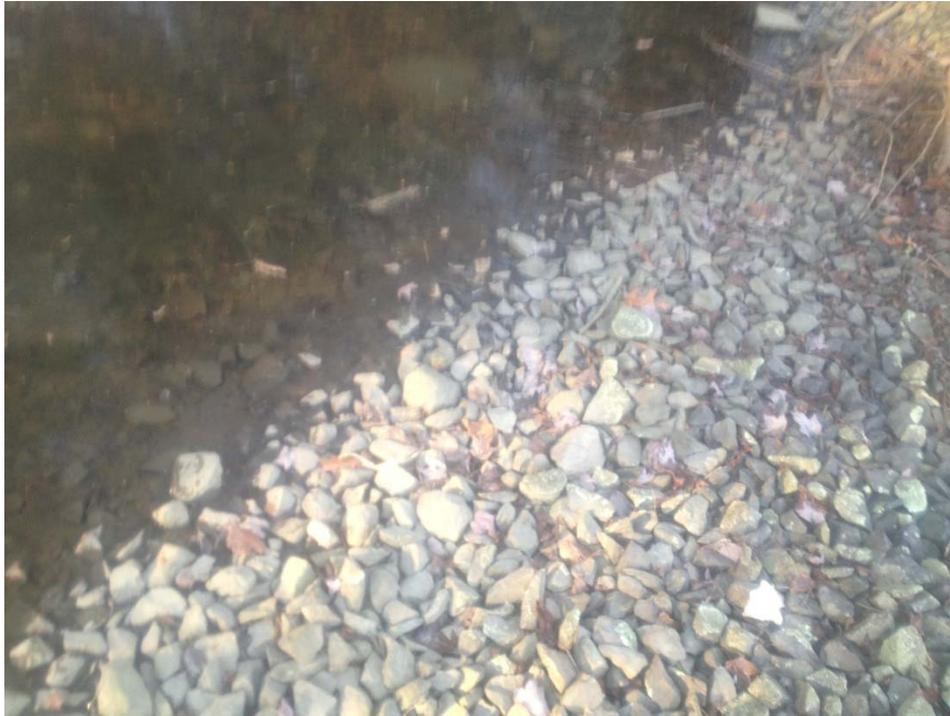
<p>Week 2 (11/29)</p> <p>Rock staining from what appeared to be rock flour was observed in the swale on the southern edge of the substation.</p>	<p>Peter Lockwood of Burns and McDonnell indicated he would suggest a row of silt fence be installed along the southern substation fence in this area.</p>	<p>NA</p>
Inland Wetland and Watercourse encroachment and mitigation	<p>There is no work taking place in wetlands.</p>	<p>NA</p>	<p>NA</p>
Spills and Material Storage.	<p>All excavation stockpile being contained to lined dumpster and covered after work hours.</p> <p>Materials for project stored on site away from excavation, along southern and western substation fence.</p>	<p>Continue to follow this procedure.</p> <p>NA</p>	<p>NA</p> <p>NA</p>

Photo #1: View (facing west) of rock staining from rock flour on southwestern edge of substation.

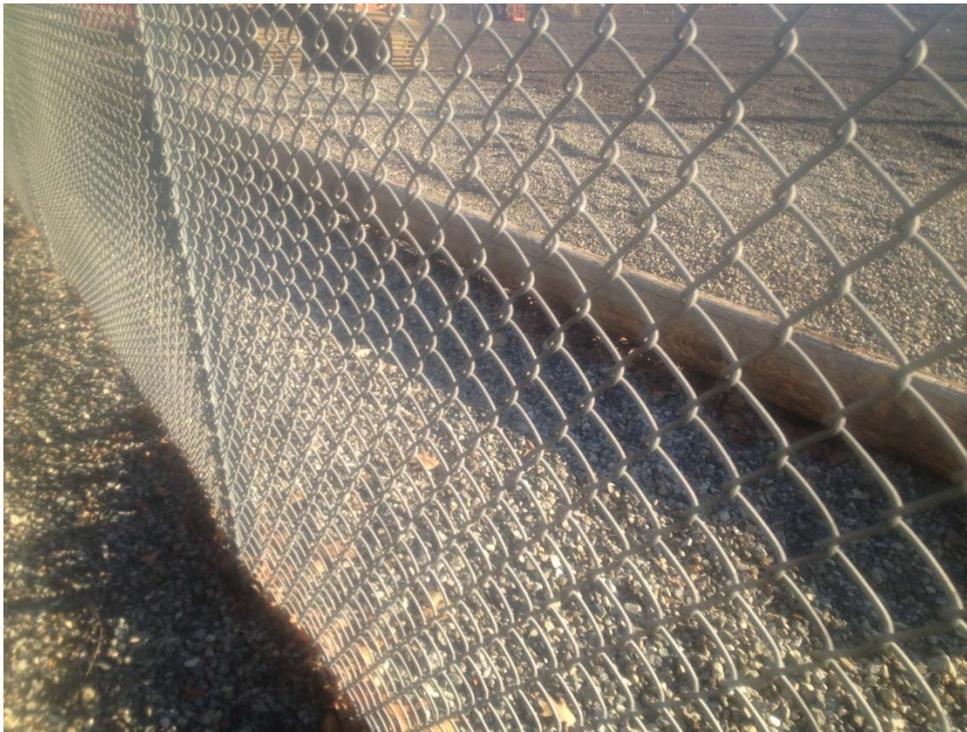
Photo #2: View (facing northeast) of new, clean stone along western fence.

Areas of Inspection	Observation:	Recommended Action:	Corrected Action:
Water Crossings	NA	NA	NA
Erosion and Sedimentation Controls	<p>Week 1 (11/22)</p> <p>The stone berm surrounding the perimeter of the substation remains in-place.</p> <p>There appears to be 3 main stormwater runoff outlets from the southwest edge of the substation to the wetland below. All three outlets were dry at the time of the inspection and visual observation of the area for any sediment staining suggests that both outlets flow free of erosion.</p> <p>There is an area of substation stone along the western fence of the substation that contains what appears to be a high percentage of fines.</p>	<p>NA</p> <p>Continue to monitor these outlets during and after significant rain events for erosion off the site into the wetland.</p> <p>Peter Lockwood of Burns and McDonnell indicated he would suggest a row of silt fence be installed along the fence in this area.</p>	<p>NA</p> <p>NA</p> <p>NA</p> <p>(11/29) Silted stone along western fence was replaced with clean stone.</p>

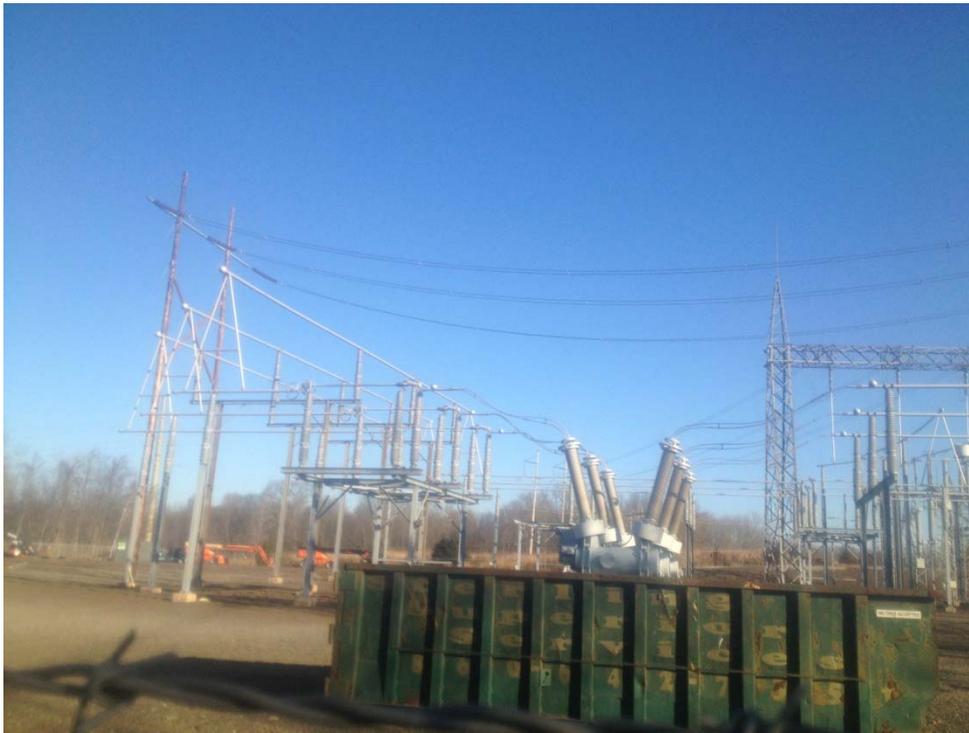
Photo #3: View (facing northwest) of Wood Pole H-frame Structures with aerial work complete.

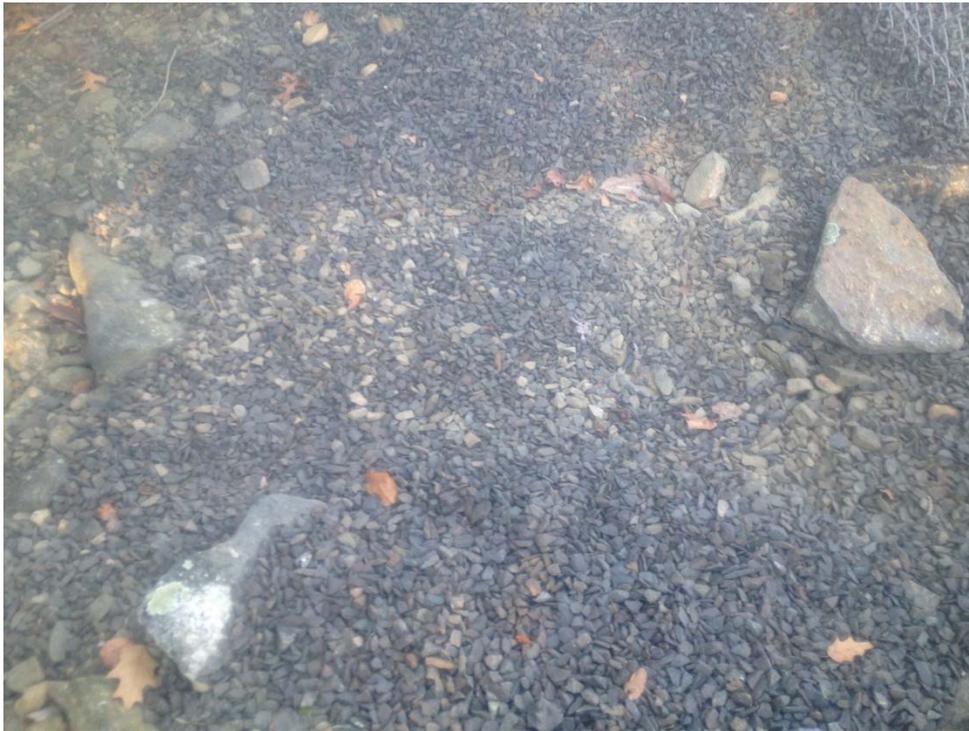
Photo #4: View (facing west) of runoff outlet at southwestern edge of substation with slight rock staining from rock flour.

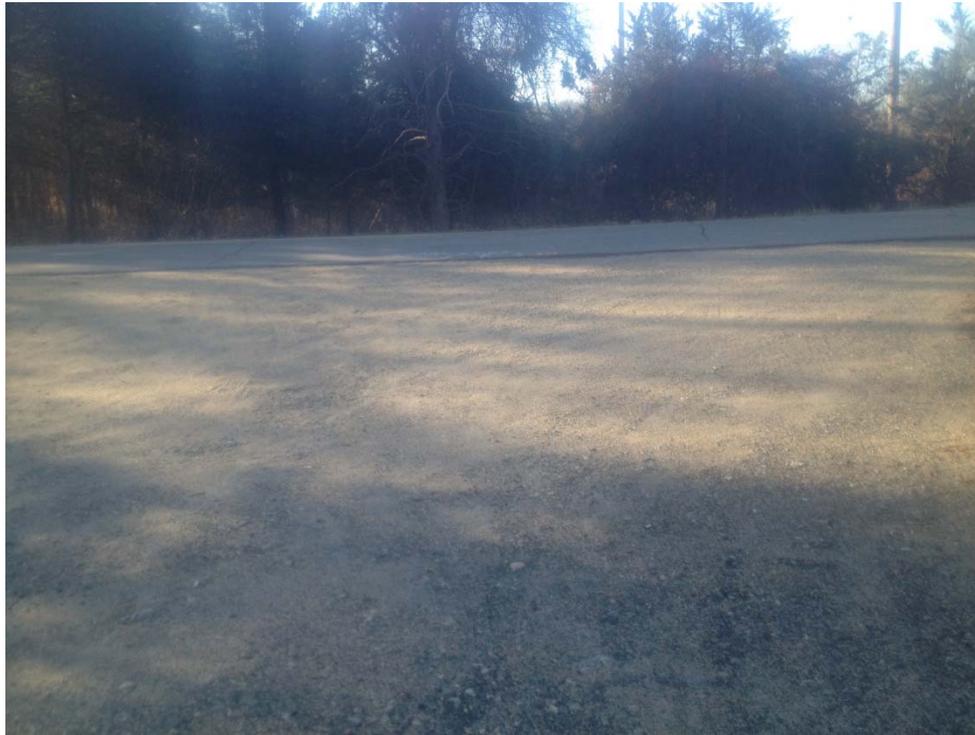
Photo #5: View (facing south) of entrance pad to substation.
