Docket No. 424 – Development and Management Plan Inspection

The Connecticut Light and Power Company Certificate of Environmental Compatibility and Public Need for the Connecticut portion of the Interstate Reliability Project.

IRP Overhead ROW

Bi-Weekly Week Inspection:

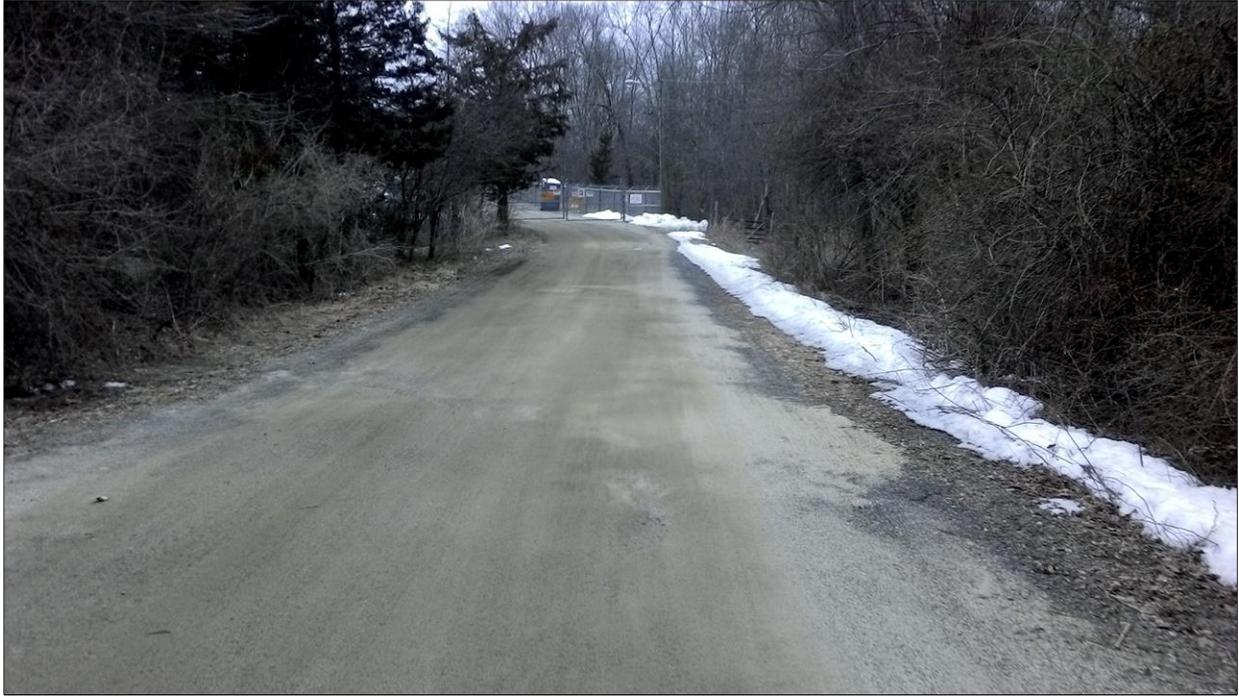
Areas of Inspection	Observation:	Recommended Action:	Corrected Action:
Access Roads and Adjacent Roadways	Interim Week (4/2) CSSS: Tracking pad is not installed. Str 263-268: Entrance road muddy and unstable. Str 30: Entrance road muddy Adjacent roadways clear and free of sediment at all other visited sites	Install tracking pad as soon as possible. NA Recommend additional stabilization measures. Continue to follow this procedure.	NA 3/26: Tracking pad is installed. NA NA
	Bi-Week (4/9) CSSS: Tracking pad is not installed. Adjacent roadways clear and free of sediment at all other visited sites	Install tracking pad as soon as possible. Continue to follow this procedure.	NA NA
Vegetative Clearing Limits (Including trees to save or danger trees noted.)	Interim Week (4/2) Str 82: Clearing appears to be in accordance with D&M requirements	Continue to follow this procedure.	NA

Photo #1: Entrance at Card Street Substation. Tracking Pad should be installed as soon as possible.

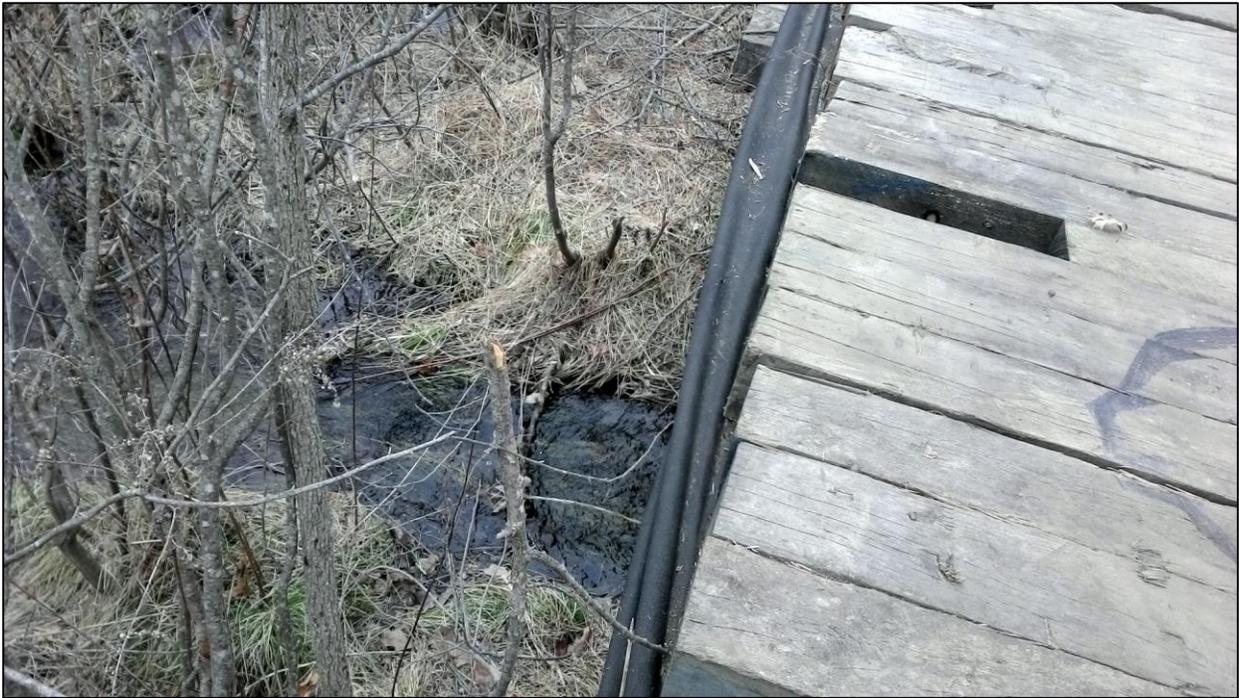
Photo #2: View of filter fabric beneath wetlands mats.

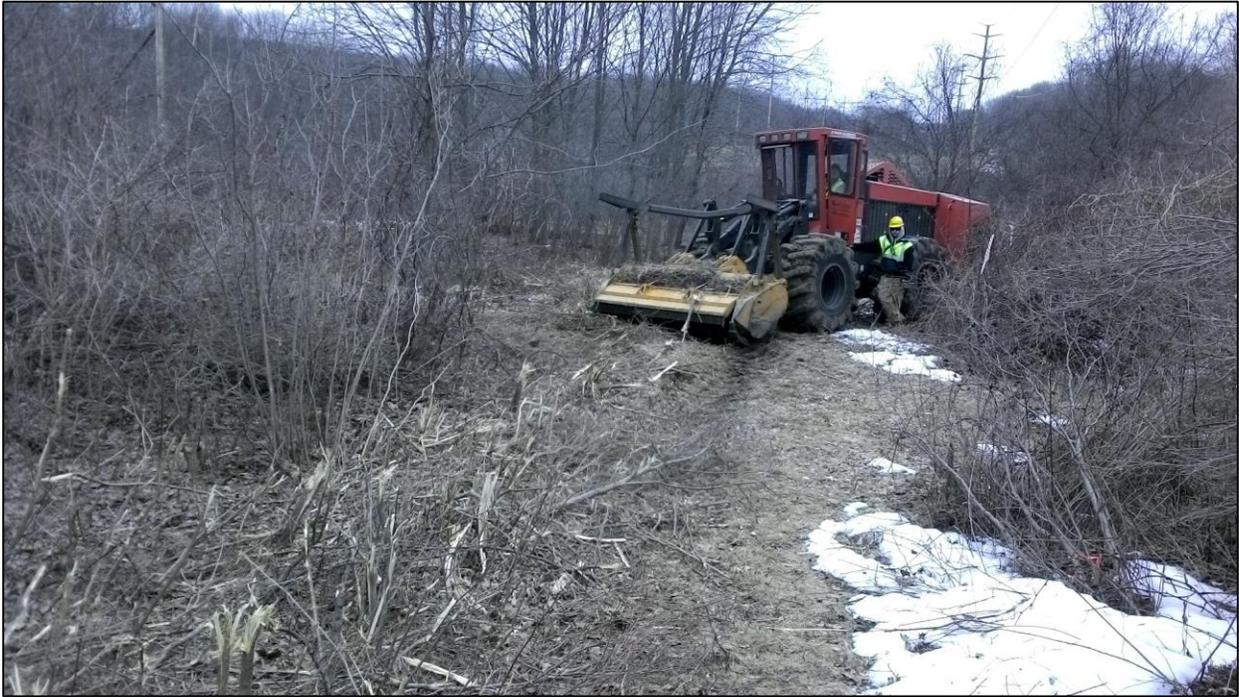
Photo #3: View facing up-line of mowing. (photo located up-line of Structure 7)

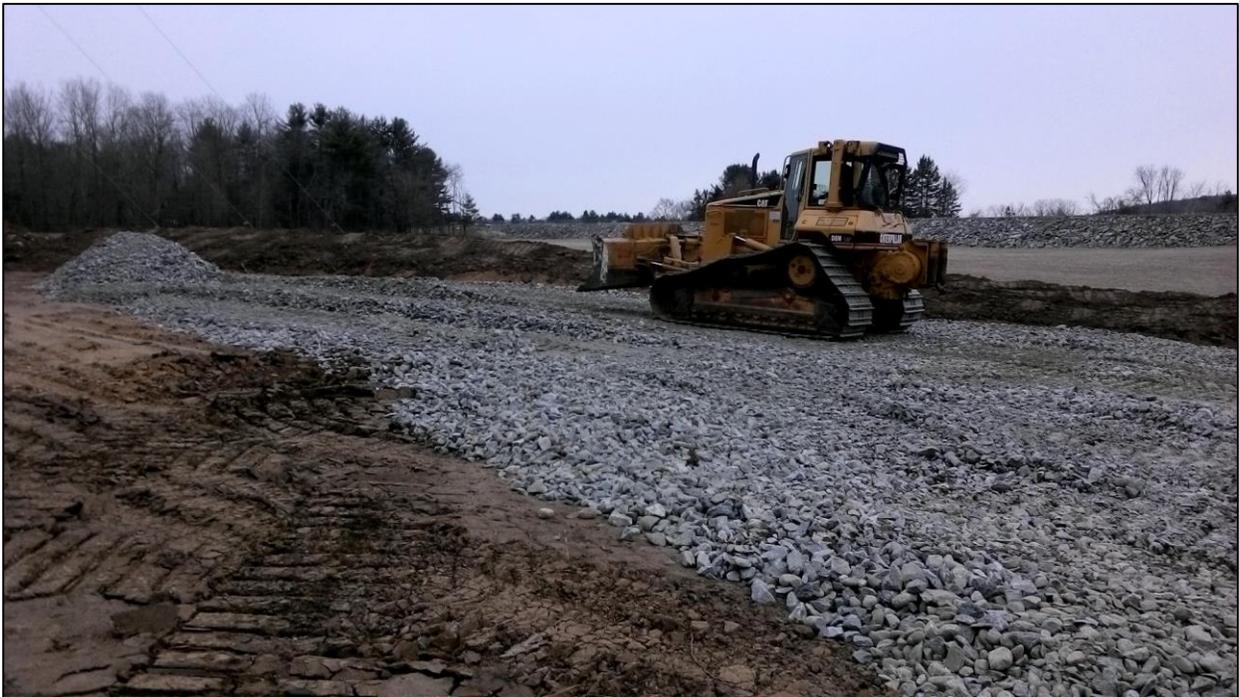
Photo #4: View of grading access road down-line of structure 83.

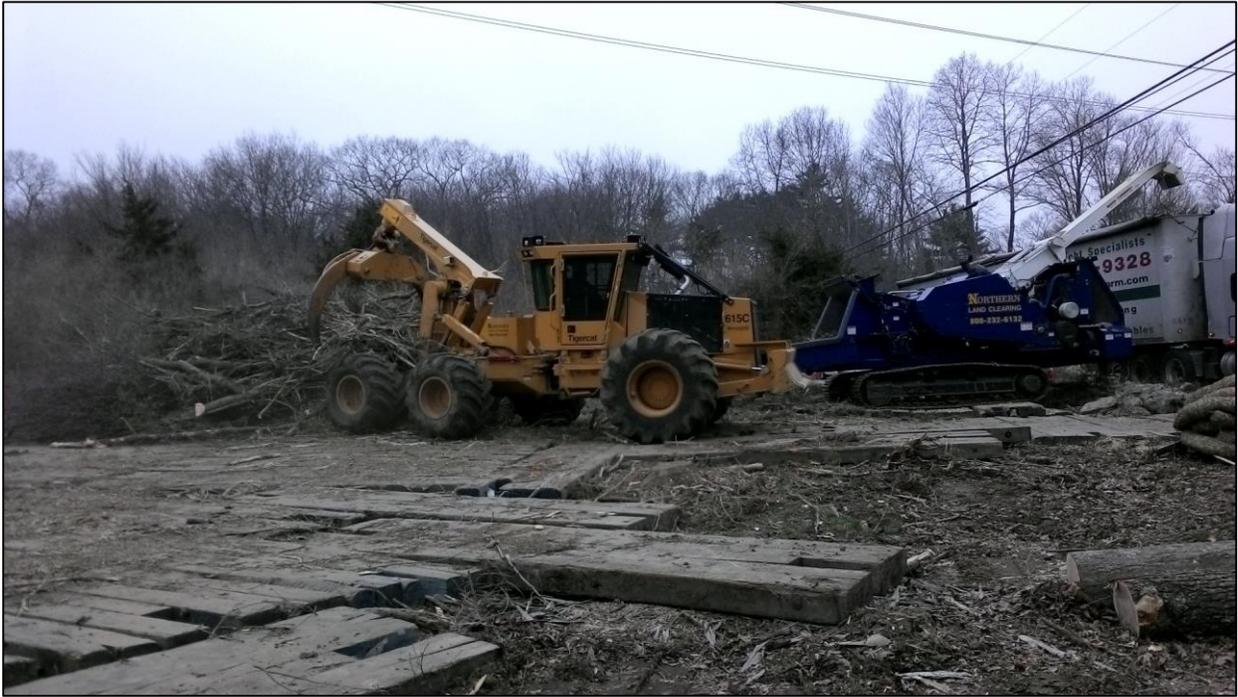
Photo #5: View of loading brush into chipper down-line of structure 91.

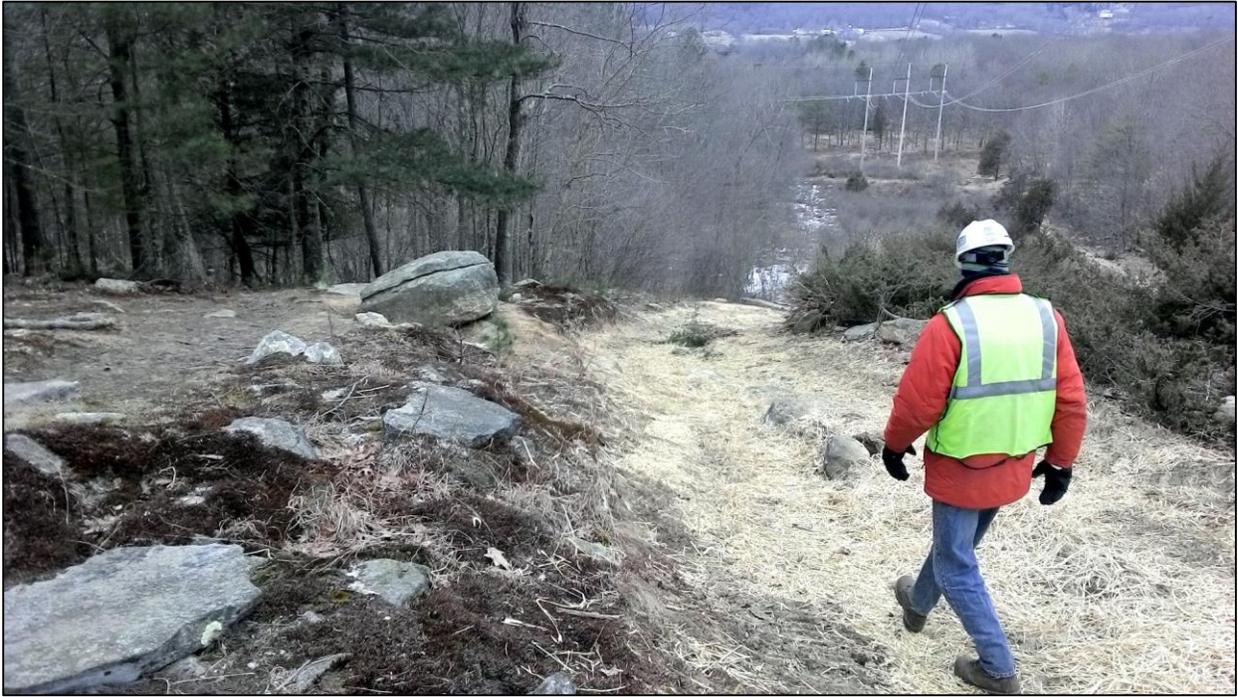
Photo #6: View of erosion control measures up-line of Structure 42.

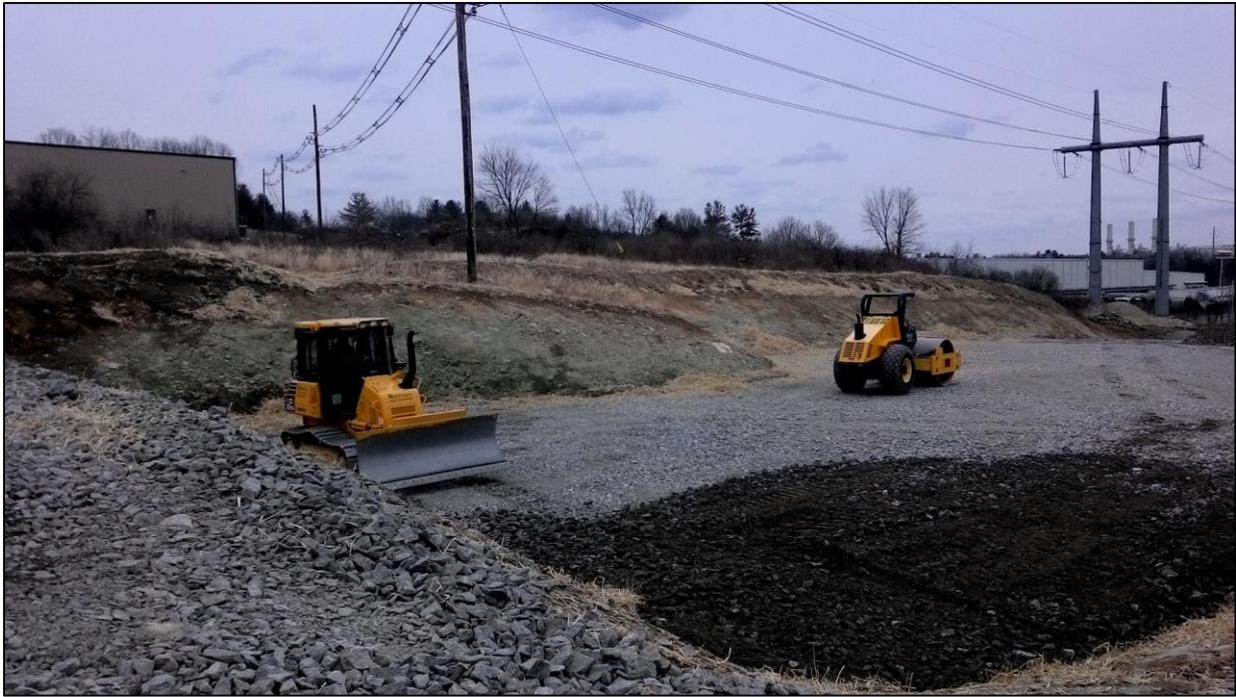
Photo #7: View of grading and compacting pulling pads at Structures 272 and 273.

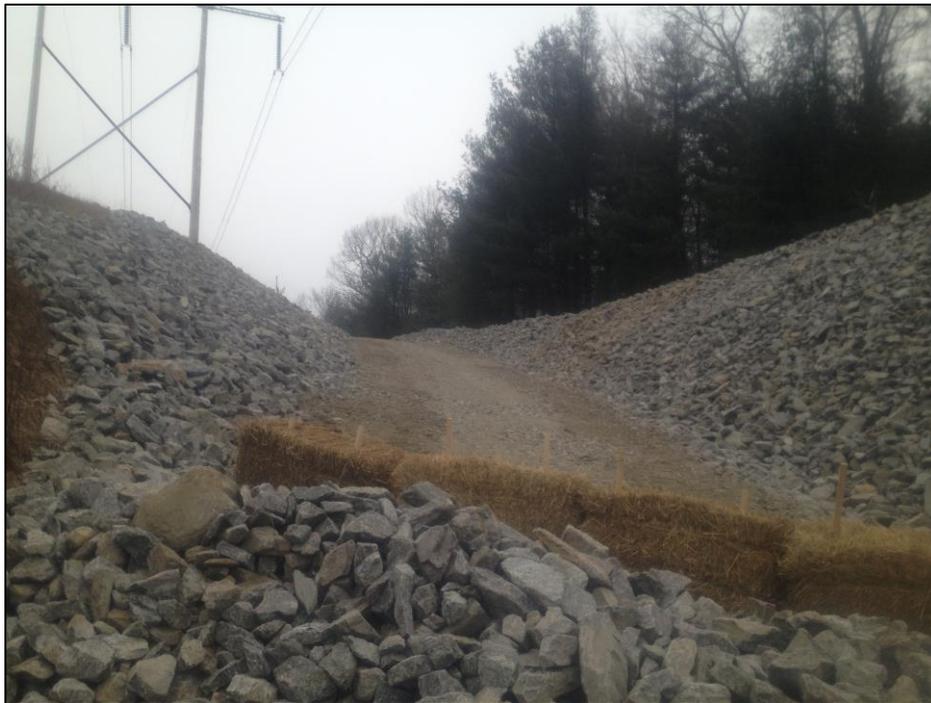
Photo #8: View of erosion control measures down-line of Structure 263.

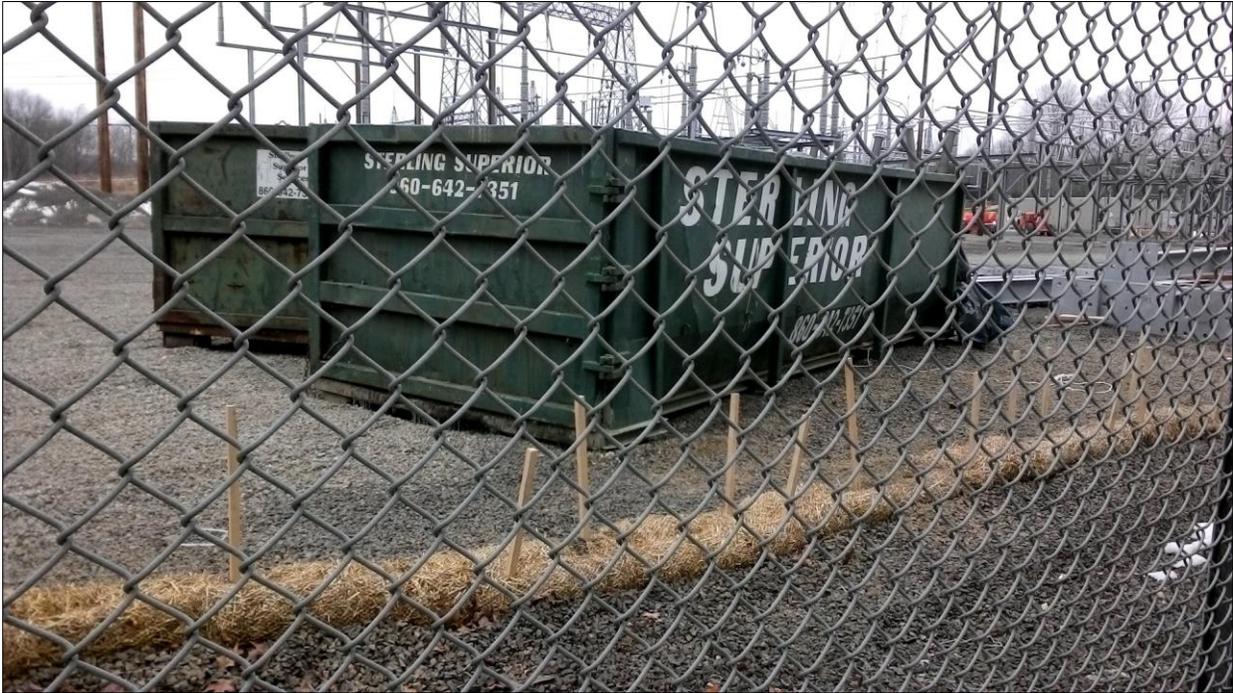
Photo #9: View of wattles installed near edge of fence at CSSS.

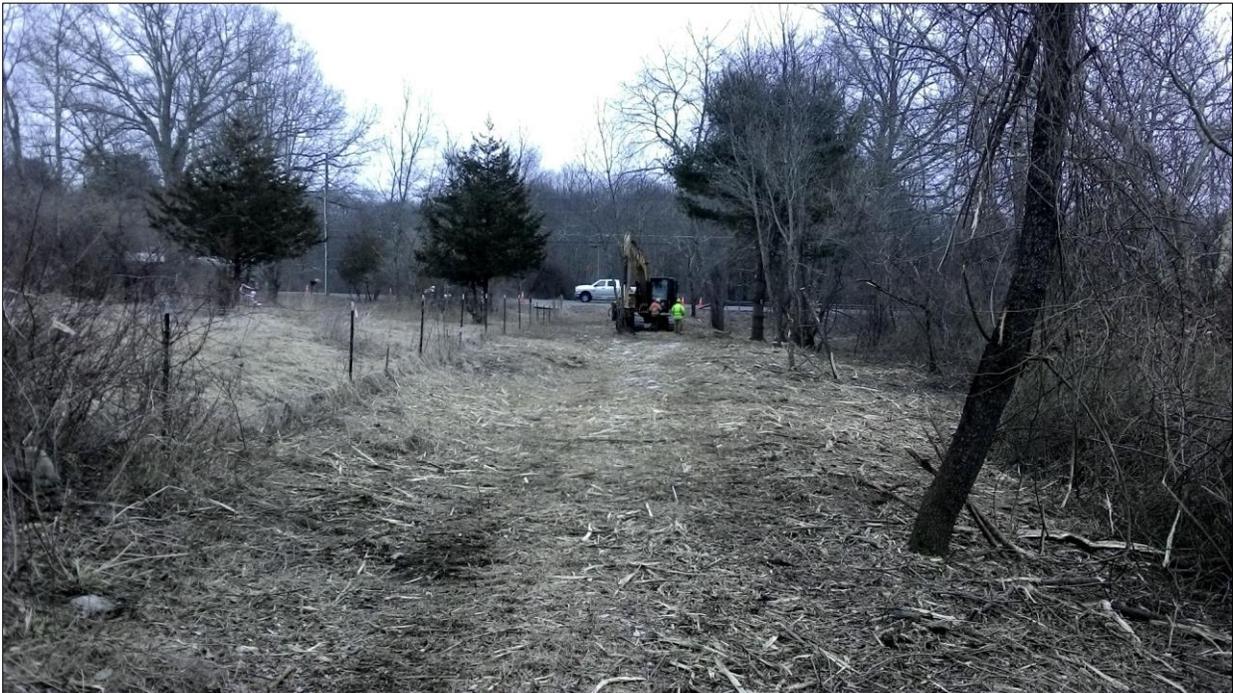
Photo #10: View of mowing up-line of Structure 101.
