Docket No. 424 – Development and Management Plan Inspection

The Connecticut Light and Power Company Certificate of Environmental Compatibility and Public Need for the Connecticut portion of the Interstate Reliability Project.

Interim Week Inspection:

Date: April 18, 2014

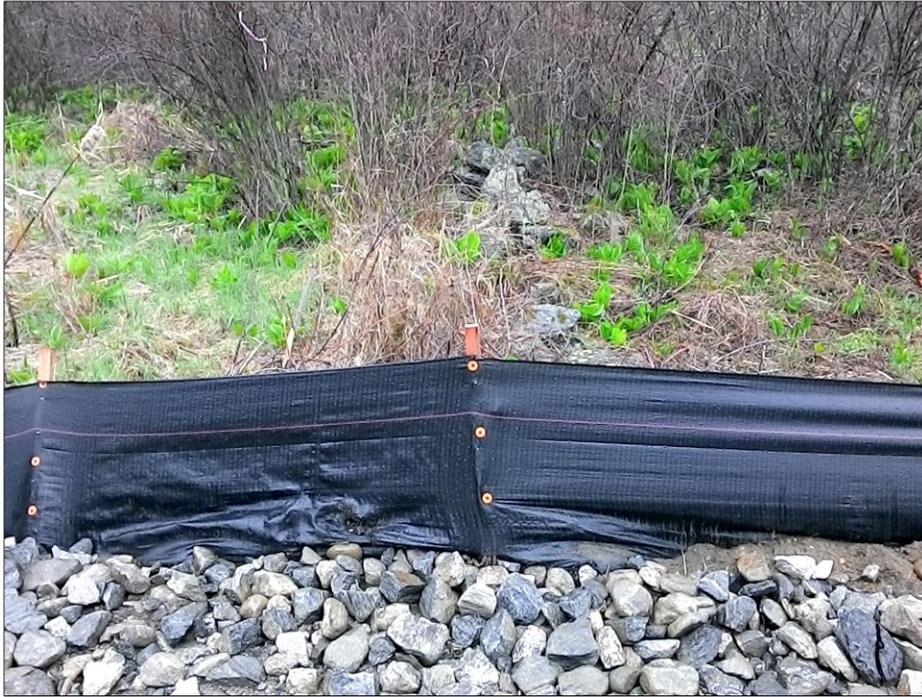
Bi-Week (4/23)	<p>Str 5-6: Observed three (3) holes in silt fence between Str 4 and 5 on right side of access road. (See Photo #1)</p> <p>Str 5: Silt fence adjacent to Str 5 appears too short in relation to the wetland associated with it. (See Photo #2)</p> <p>Blown hay stabilization being utilized along the ROW</p>	<p>Repair silt fence</p> <p>Recommend increasing length of silt fence around Str 5 due to proximity of wetlands</p> <p>Continue to follow this procedure.</p>	<p>P. Lockwood noted observation.</p> <p>P. Lockwood noted observation.</p> <p>NA</p>
Inland Wetland and Watercourse encroachment and mitigation	Interim Week (4/18)	Wetland mat installations appear to be in accordance with the BMP Manual.	Continue to follow this procedure.	NA

Photo #1: Photo of hole in silt fence up-line of Str 4.

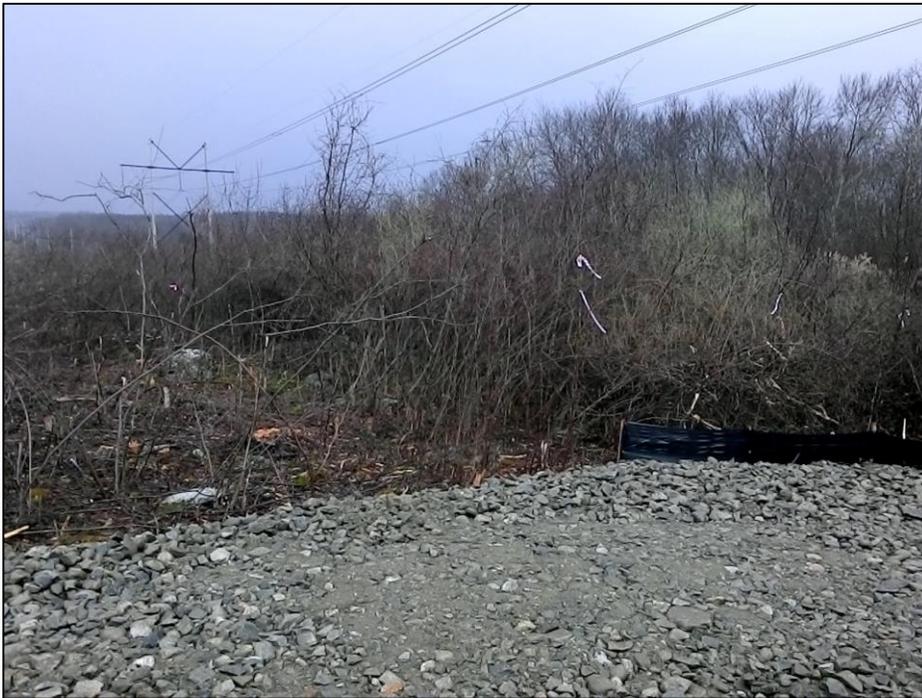
Photo #2: Photo of observed perimeter silt fence being too short at Str 5.

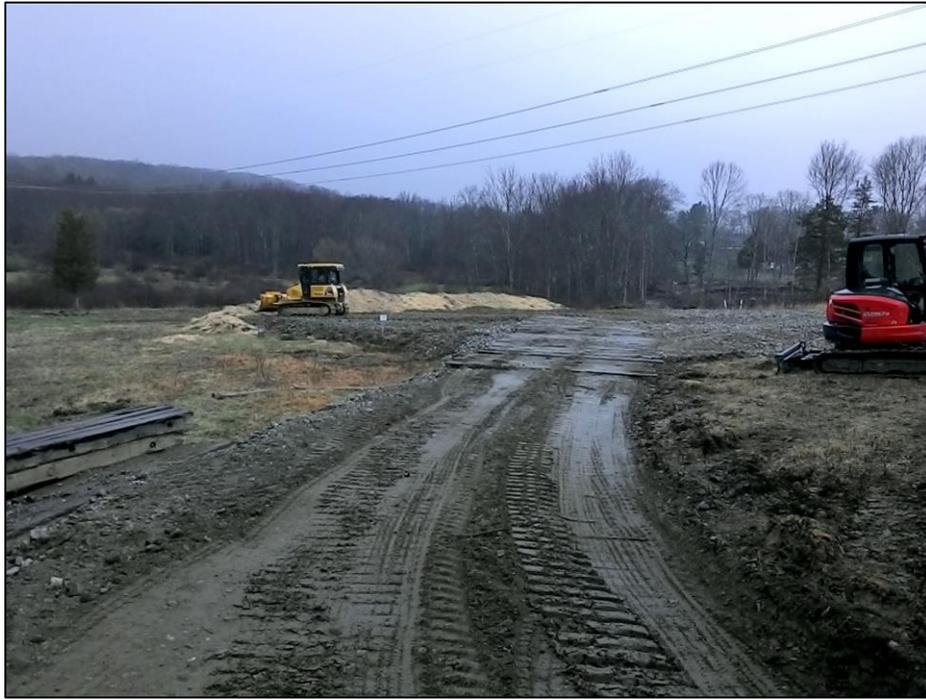
Photo #3: Photo of grading Str 6 pad.

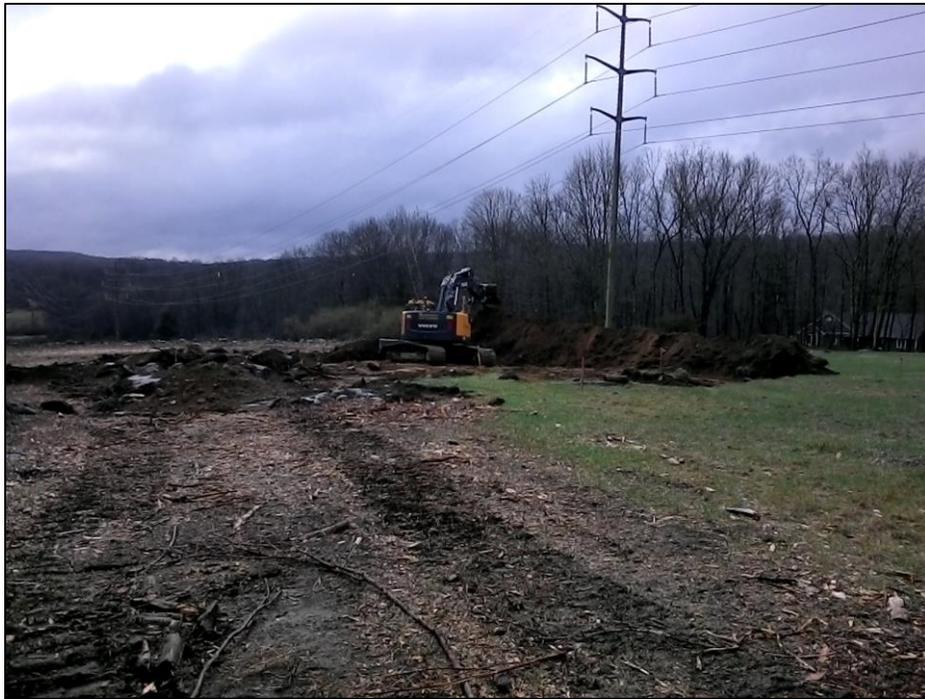
Photo #4: Photo of rough grading Str 9 pad.

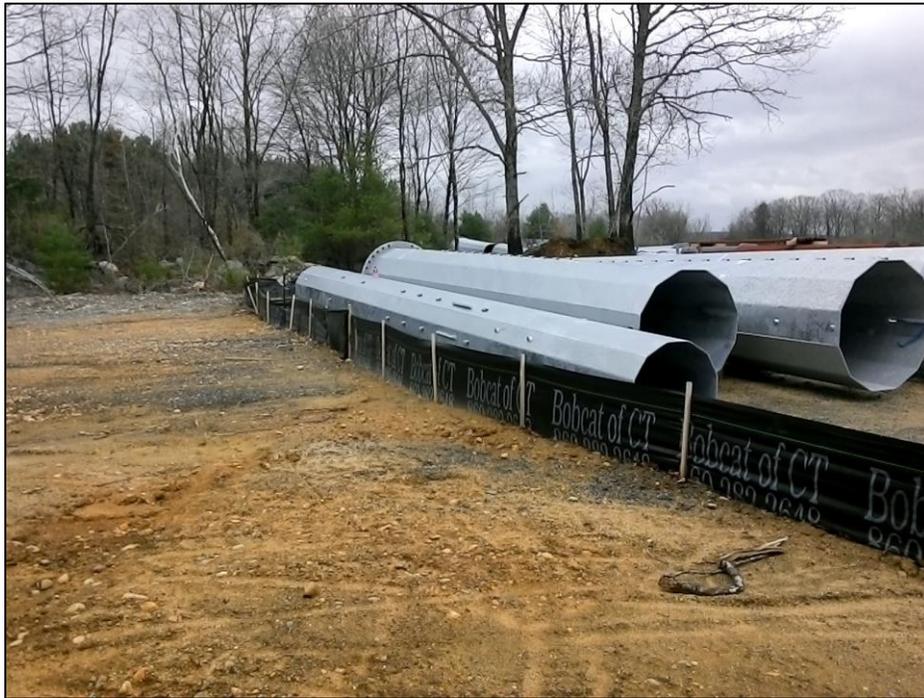
Rare, Threatened, and Endangered Species	Interim Week (4/18)	NA	NA	NA
	Bi-Week (4/23)	NA	NA	Laydown Area, 87 Boston Post Road, Windham: Separations in the snake exclusion fence have been fixed. (See Photo #5) NA
Additional Documentation Comments: Notes for 4/18/2014: <ul style="list-style-type: none"> Warning signage and gates have been installed across the Airline Trail crossing between structures 5 and 6. Roadway in the vicinity of Str 93 and 94 in agricultural farmland area being installed with filter fabric barrier in accordance with D and M detail sheets. Drilling operations ongoing for Str 271 and 272. Notes for 4/23/2014: <ul style="list-style-type: none"> Drilling operations ongoing for Str 272 and 267. 				
Open Items: Closed Items: <ol style="list-style-type: none"> Card Street sub station anti tracking pad

Photo #5: Photo of fixed silt fence at Boston Post Road laydown area.

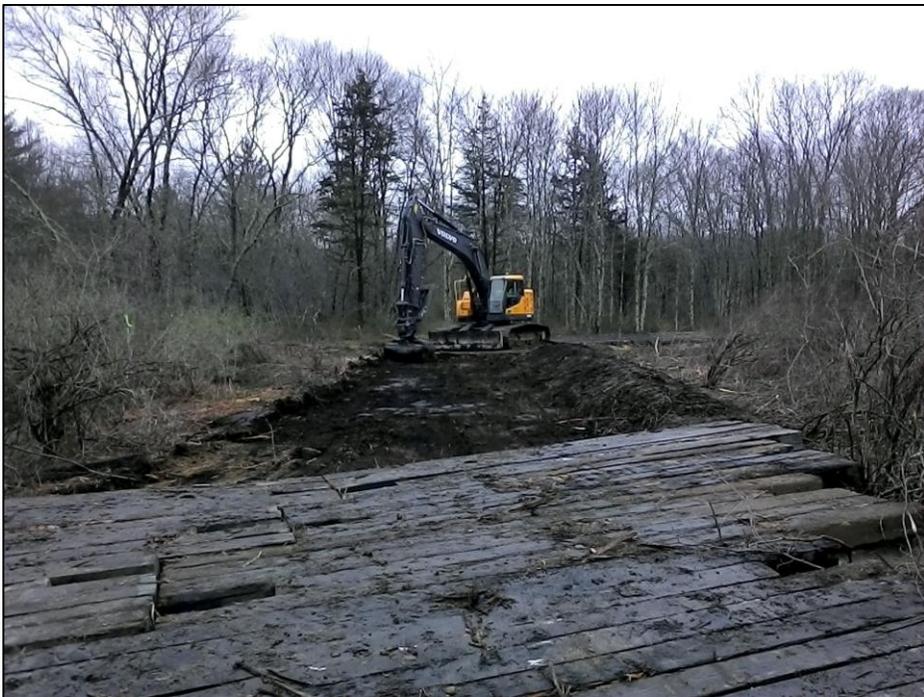
Photo #6: Photo of excavating of topsoil down-line of Str 96.

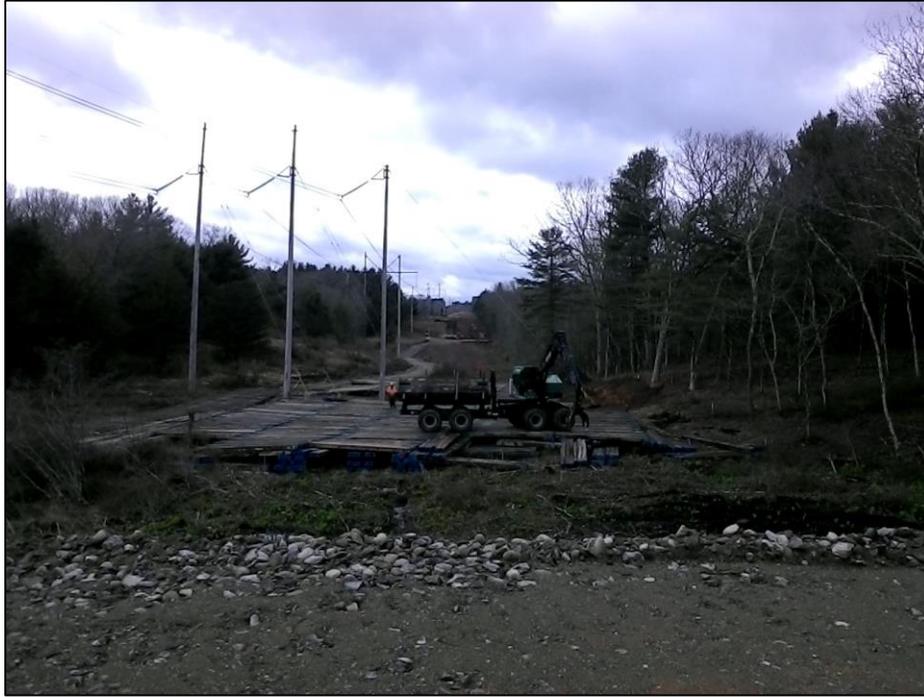
Photo #7: Photo of wetland mats installation at Str 99.

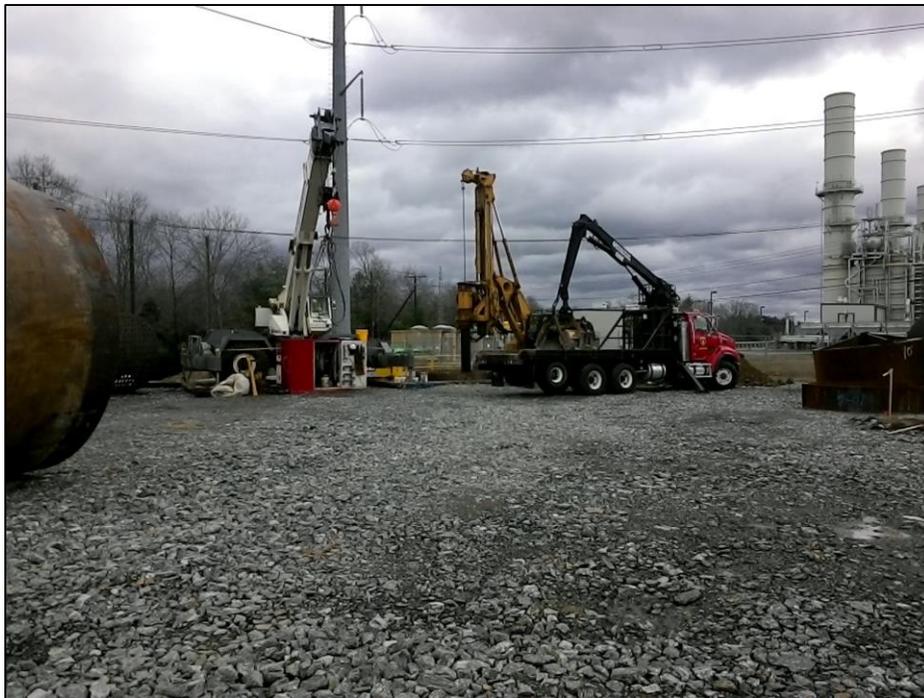
Photo #8: Photo of drilling operations at Str 267.
