Docket No. 424 – Development and Management Plan Inspection

The Connecticut Light and Power Company Certificate of Environmental Compatibility and Public Need for the Connecticut portion of the Interstate Reliability Project.

IRP Overhead ROW

Interim Week Inspection:

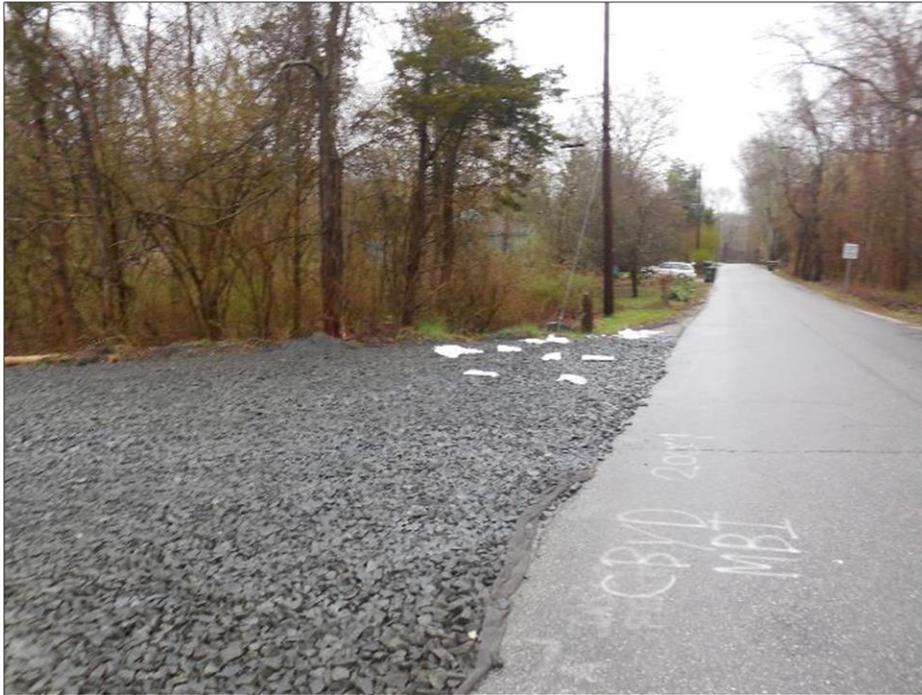
Spills and Material Storage.	Interim Week (5/1)	<p>CSSS: Observed non-project related diesel spill on the entrance tracking pad to Card Street Substation. (See Additional Documentation Comments) (photo 1).</p> <p>Spill kits noted on all visited sites.</p>	<p>NA</p> <p>Continue to follow this procedure.</p>	<p>Burns and McDonnell Representatives indicated that all contaminated stone and underlying geotextile will be removed and replaced.</p> <p>NA</p>
	Bi-Week (5/9)	<p>CSSS: P. Lockwood indicated that contaminated stone and Geotextile have been replaced at the substation entrance.</p> <p>Spill kits noted on all visited sites.</p>	<p>NA</p> <p>Continue to follow this procedure.</p>	<p>NA</p> <p>NA</p>
Cultural Resources	Interim Week (5/1)	<p>NA</p>	<p>NA</p>	<p>NA</p>

- **CSSS:** Observed diesel fuel spill on Card Street entrance pad. (Follow-up communications with Burns and McDonnell representatives indicated the truck causing the spill was associated with work within the substation not part of the IRP Station Modifications. B & M Representatives indicated the Interstate station contractors responded to the spill using the spill kits they has onsite and the emergency response contractor (McVac) was dispatched later that morning to clean up the area. The contamination was contained in uplands and additional oil booms were deployed around the area for additional safety measures.) (see photo 1)

Photo #1: (5/1) (southeast) Diesel spill at CSSS entrance road (not project related)

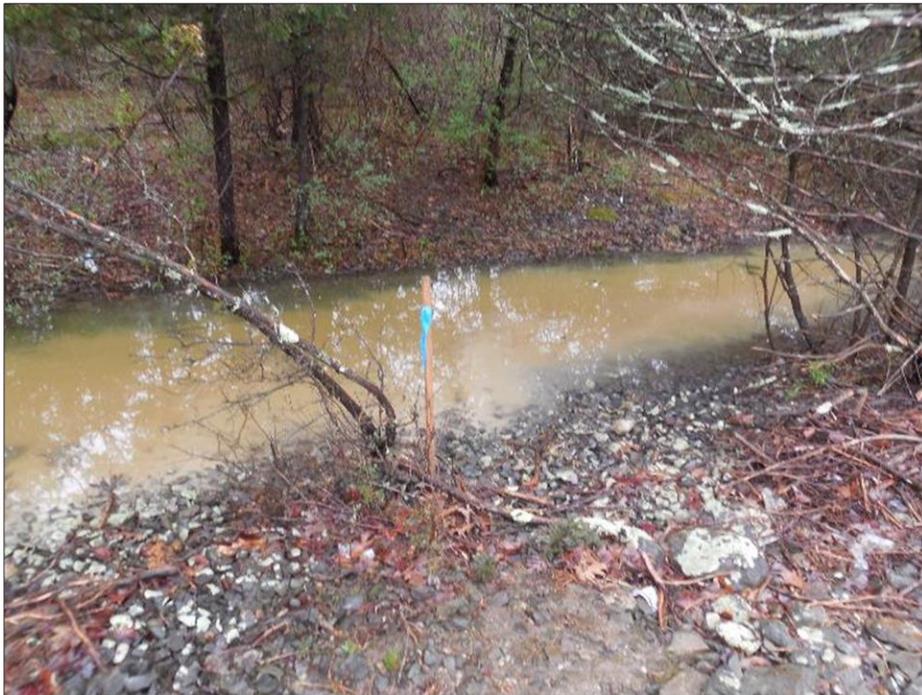
Bi-Week (5/9)	<p>NA</p> <p>CSSS: Sedimentation of the wetland swale south of the substation during heavy rain events has not yet been rectified.</p> <p>Silt fence installations along ROW observed during inspection appear to be in accordance with BMP Manual.</p>	<p>NA</p> <p>CL&P and Burns and McDonnell continue to investigate a solution to what appears to be a pre-existing condition.</p> <p>Continue to follow this procedure.</p>	<p>Str 4: P. Lockwood indicated that the damaged silt fence up-line of Str 4 has been fixed.</p>

- **CSSS:** The sediment discharged to the wetland swale, observed approximately 50 feet to the northwest of the entrance, appears to be originating from within the substation and is associated with the original substation design. An additional row of straw wattles were installed for further protection, however, the sediment appears to be filtering through the stone, under the perimeter controls and discharging into the wetland. CL&P and Burns and McDonnell Project Management is aware of the situation and is actively searching for a solution to prevent further discharge. (See photo 2)

Photo #2: (5/1) (southwest) View of discharge into wetland swale at CSSS.

1. Continue to investigate and resolve sediment discharge into wetland swale at Card Street Substation during heavy rain events.
2. Recommend additional silt fence installation adjacent to Str 5 to further protect wetland area.

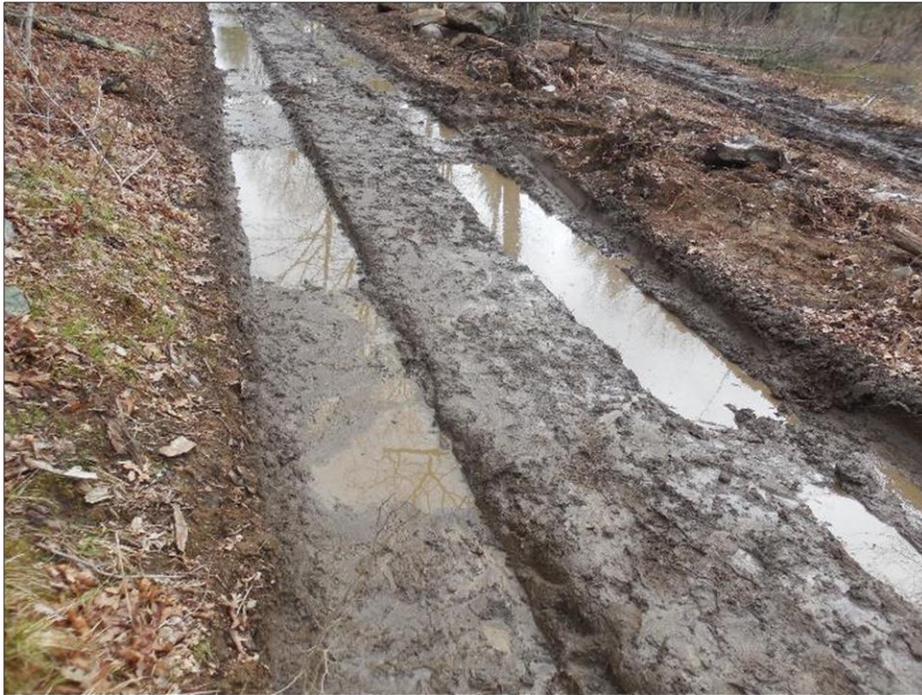
- **MS21:** The land owner east of Chewink Road, in the vicinity of Str 113 and 114, hired a private (not project related) contractor to remove the existing stone walls on his property. In the process of removing the stone walls, the existing unimproved access road used by the private contractor became very muddy and deeply rutted. Also, it appears the private contractor excavated a drainage trench near vernal pool CH-13-VP to divert and lower the water level to enable the private contractor's equipment to gain access to the stone walls opposite the pool. Northern Contractors decided to temporarily stand down work in this area due to the instability of the site and undefined actions of the land owner. (See photos 3 and 4)

Photo #3: (5/1) View of existing unimproved access road ruts by land owner on MS21.

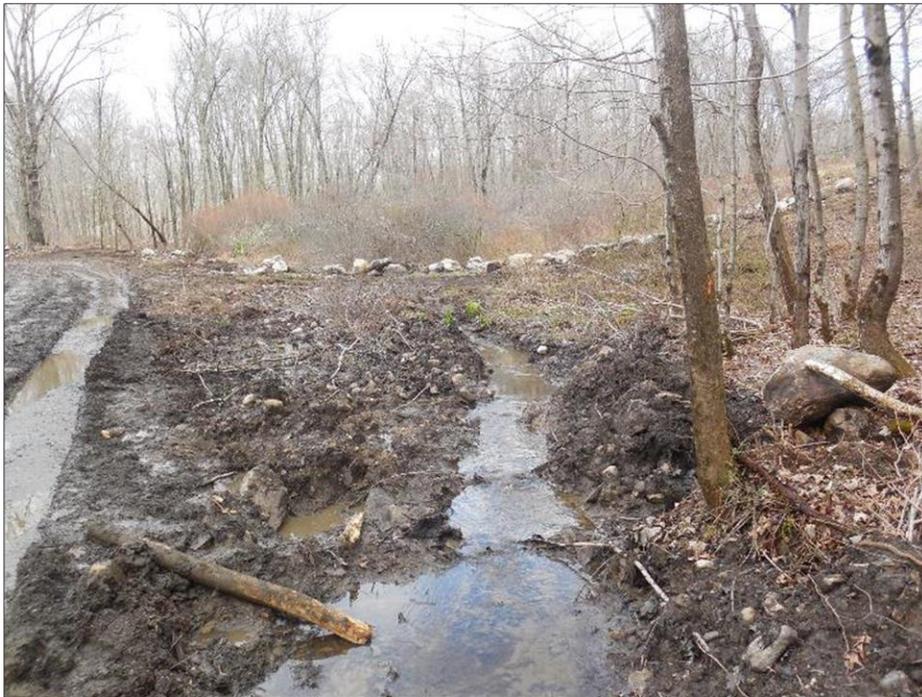
Photo #4: (5/1) View facing vernal pool CH-13-VP showing excavation trench installed by land owner at center of photo.

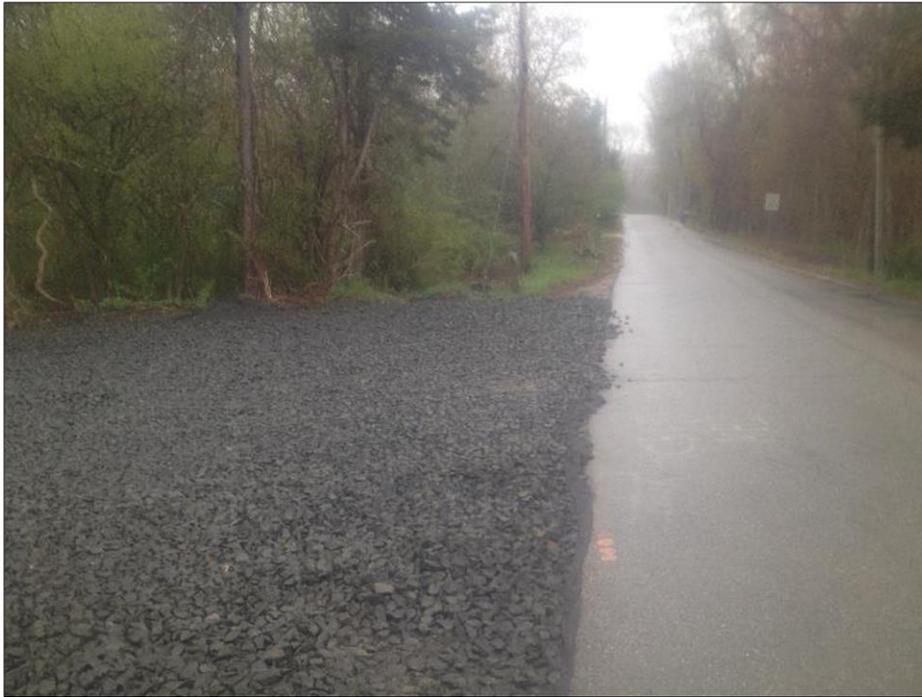
- **CSSS:** Geotextile fabric and construction entrance pad changed due to a diesel fuel spill that was associated with work within the substation not part of the IRP station modifications. (See photo 5)

Photo #5: New geotextile fabric and entrance pad at CSSS.

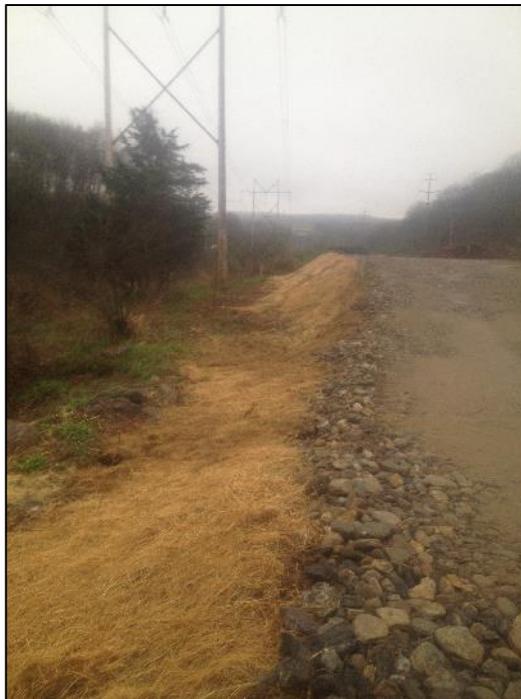
Photo #6: Erosion & sedimentation control measures up-line of Str 11.

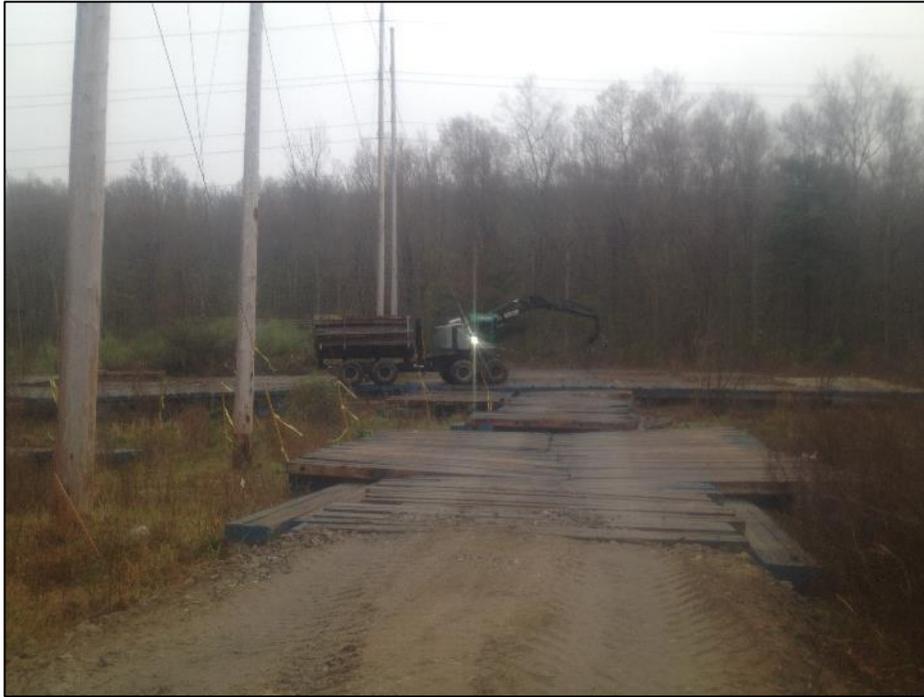
Photo #7: Installation of wetland mats at Str 15.

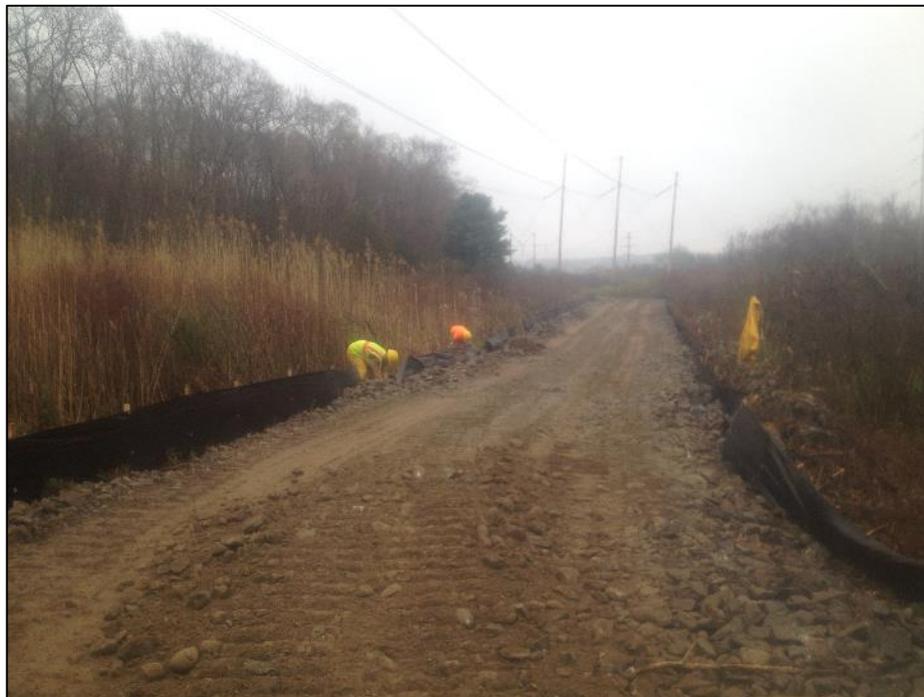
Photo #8: Silt fence installation up-line of Str 15 in accordance with BMP Manual.

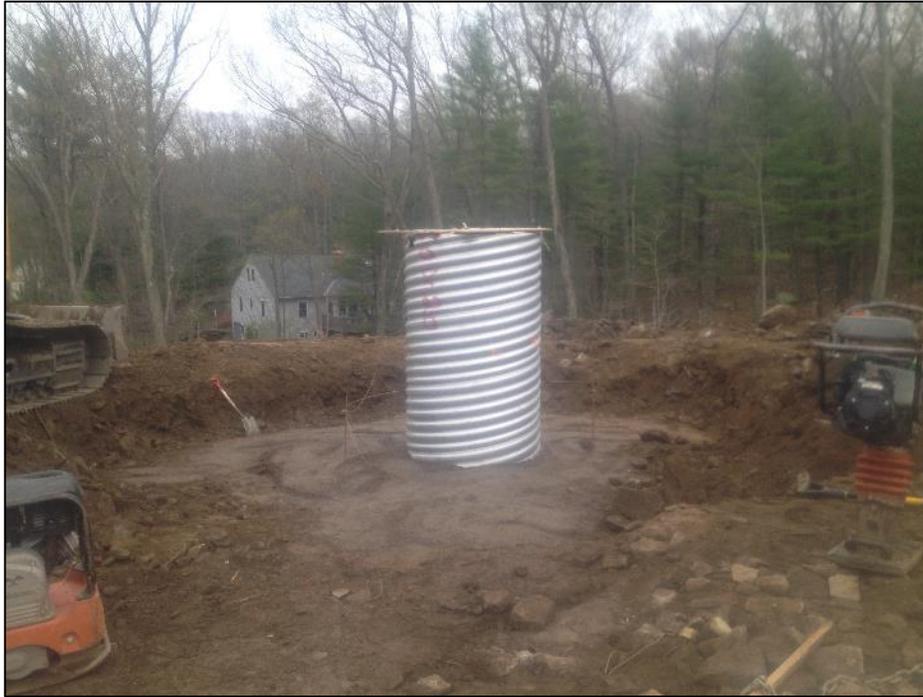
Photo #9: View of backfill and compaction of direct embed caisson for Str 89.

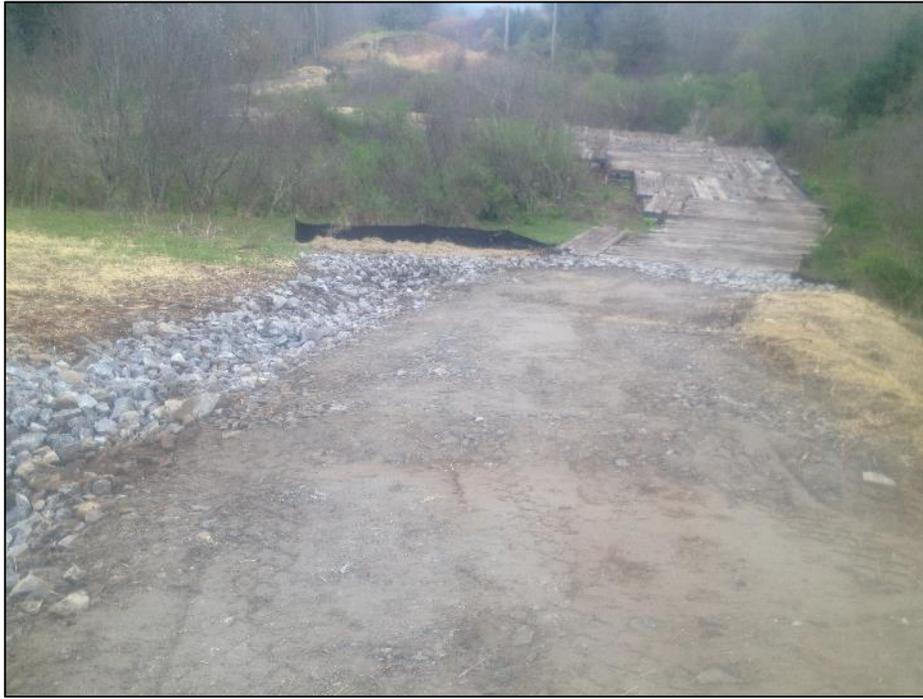
Photo #11: View of new diversion swales up-line of Str 95.

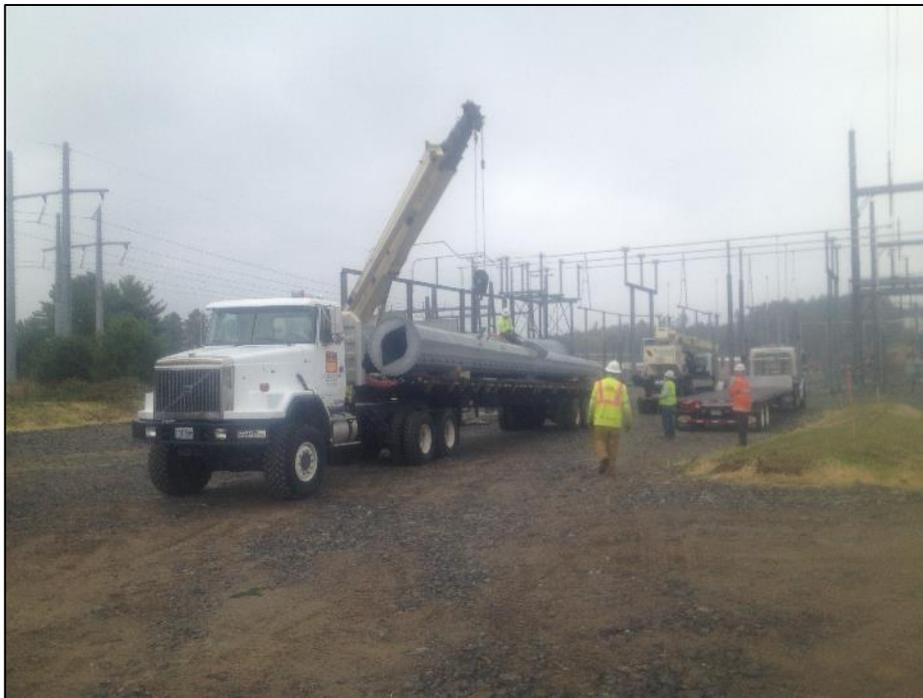
Photo #12: Delivery of Steel H-Frame Structure # 271.
