Docket No. 424 – Development and Management Plan Inspection

The Connecticut Light and Power Company Certificate of Environmental Compatibility and Public Need for the Connecticut portion of the Interstate Reliability Project.

Interim Week Inspection:

Bi-Weekly Week Inspection:

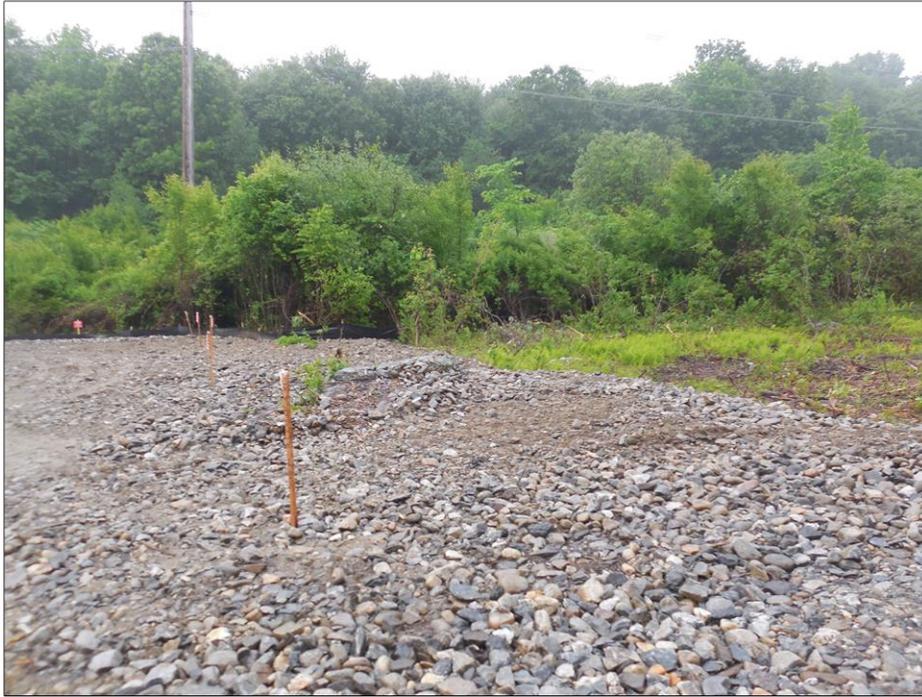
MS1, Str 1: Drilling operations at Str 1. Contractors extended construction pad for Str 5.

Photo #1: Extension of Str pad 5. Recommend installing addition fence along edge of stone.

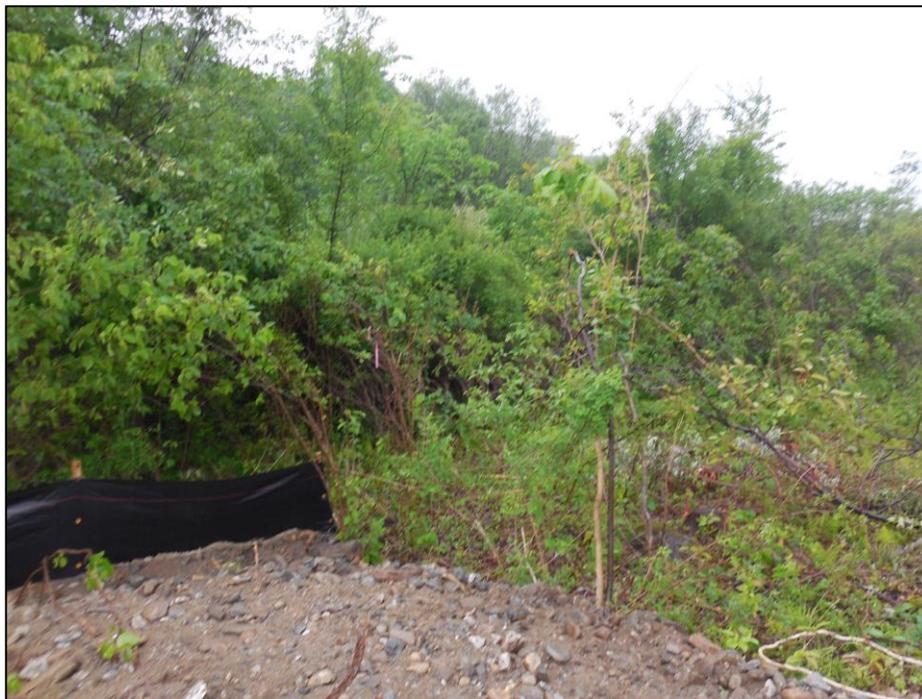
Photo #2: Portion of silt fence at Str pad 5 at edge of wetlands. (Note pink wetland flag at center of photo)

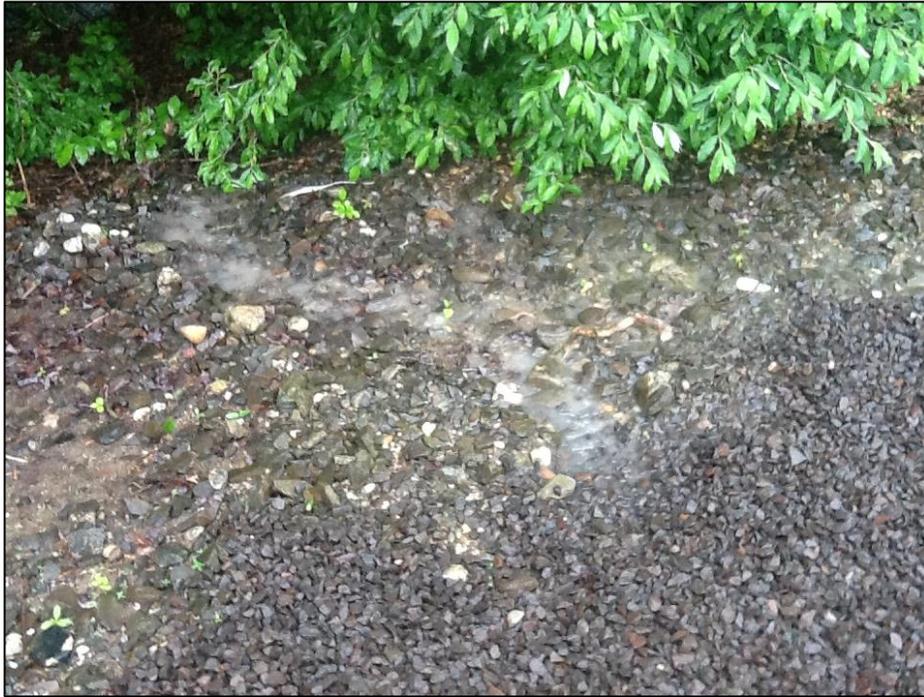
Bi-Week (6/5)	CSSS: Observed turbidity in the wetland swale south of the substation. (Photo 3-4)	See Additional Documentation Comments for further information.	NA
Spills and Material Storage.	Interim Week (5/29)	Spill kits noted on all visited sites. Contractor implementing concrete wash out areas down-line from Killingly Substation and adjacent to the Lake Road Switching Station for foundation concrete pours.	Continue to follow this procedure. Continue to follow this procedure.	NA
	Bi-Week (6/5)	Spill kits noted on all visited sites. Str 43: Observed one (1) diesel drip up-line of Str 43.	Continue to follow this procedure. NA	NA Northern crew immediately contained and removed affected stone during inspection.
Cultural Resources	Interim Week (5/29)	Pads in cultural areas are being installed with a geotextile separation fabric and sand buffer layer prior to the installation of the pad material.	NA	NA

Open Items from previous inspections:				
<ol style="list-style-type: none"> 1. CL&P is in the process of evaluating long-term solutions to resolve the discharge of sediment into the wetland swale south of Card Street Substation following significant rain events. CL&P is in direct coordination with DEEP and USACE to determine the most suitable course of action. 				
Closed Items from previous inspections:

Photo #3: Turbid discharge exiting perimeter stone of CSSS along southern fence line.

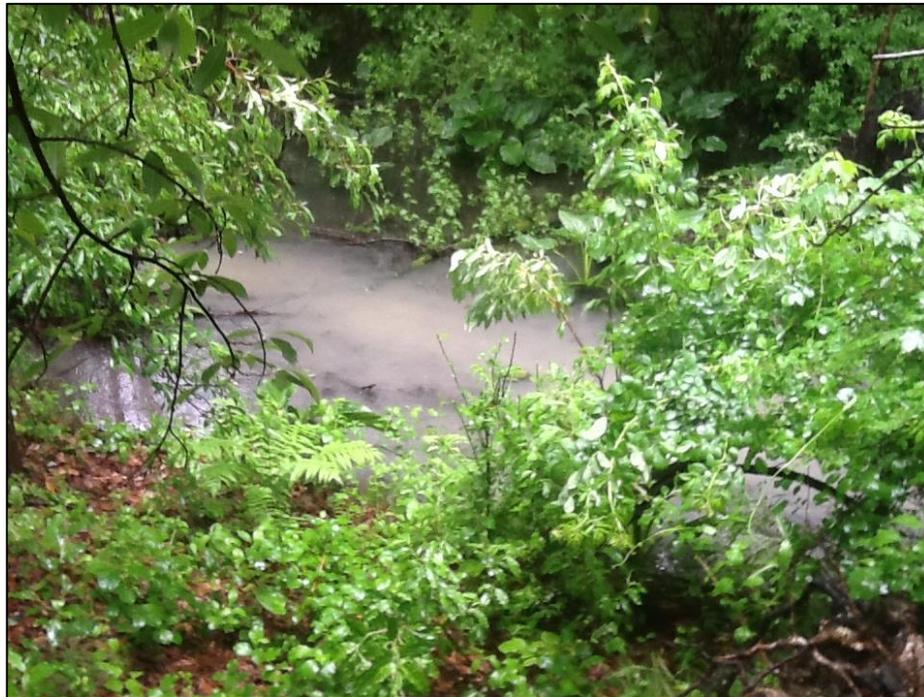
Photo #4: Turbidity in swale at CSSS.

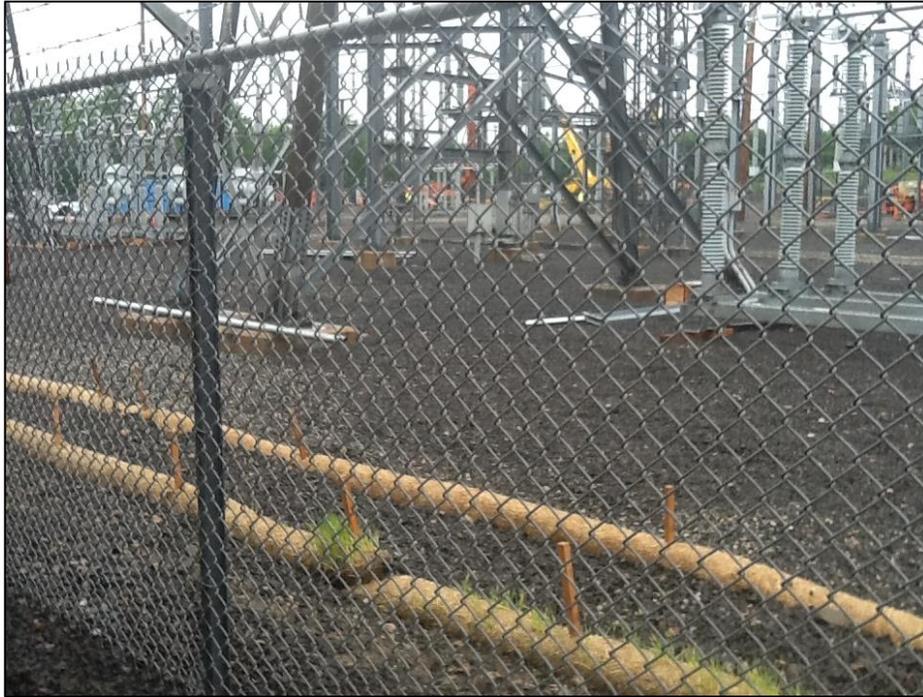
Photo #5: Second row of wattles were installed at southern fence line at CSSS.

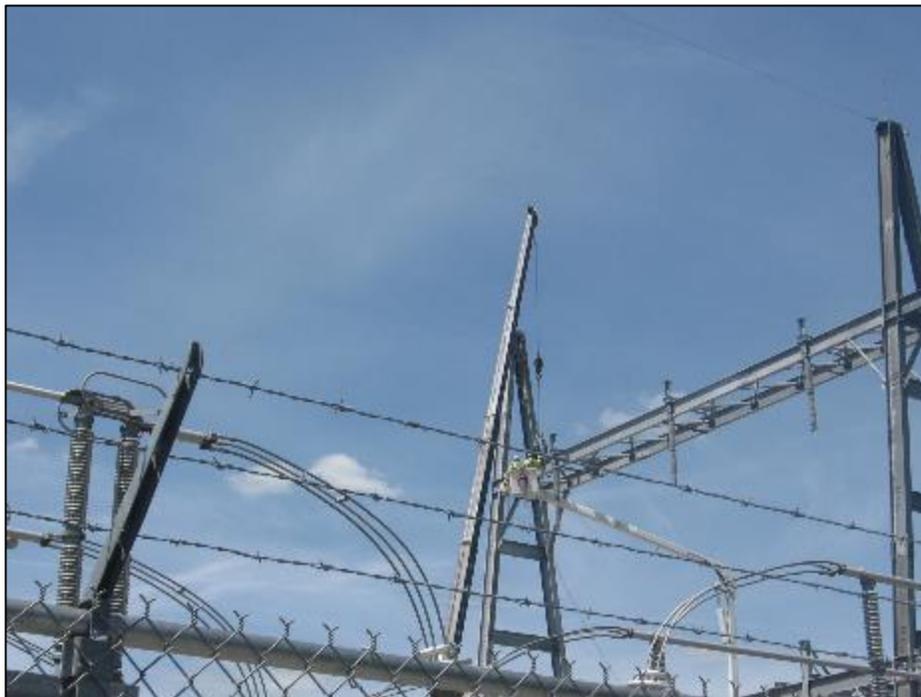
Photo #6: (5/29) Aerial work preparing for a conductor pull at Killingly Substation.

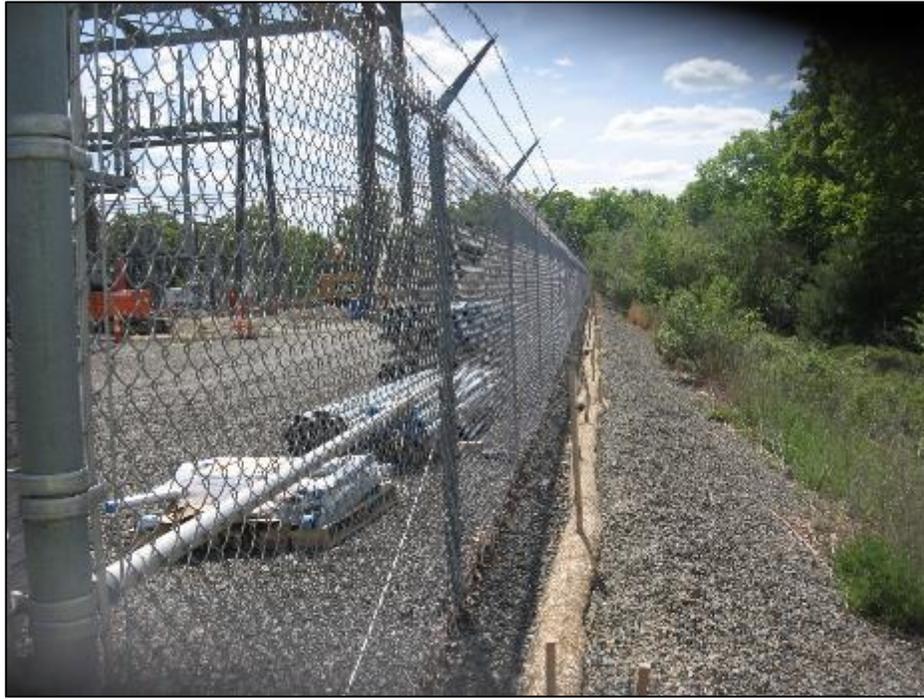
Photo #7: (5/29) Erosion control measures surrounding Lake Road Switching Station.

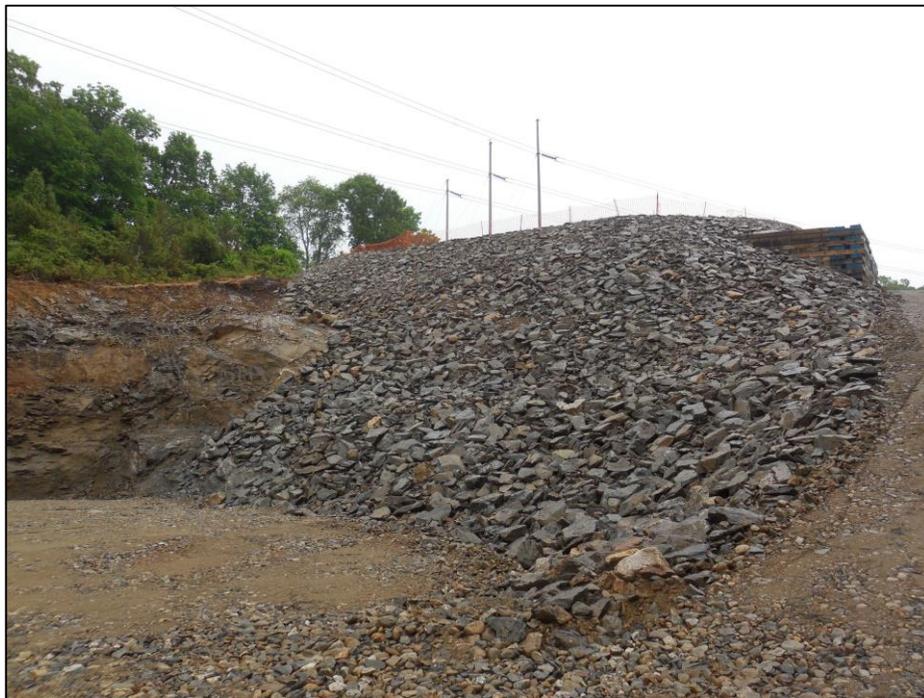
Photo #8: Rip rap slope stabilization measures at Str 34.

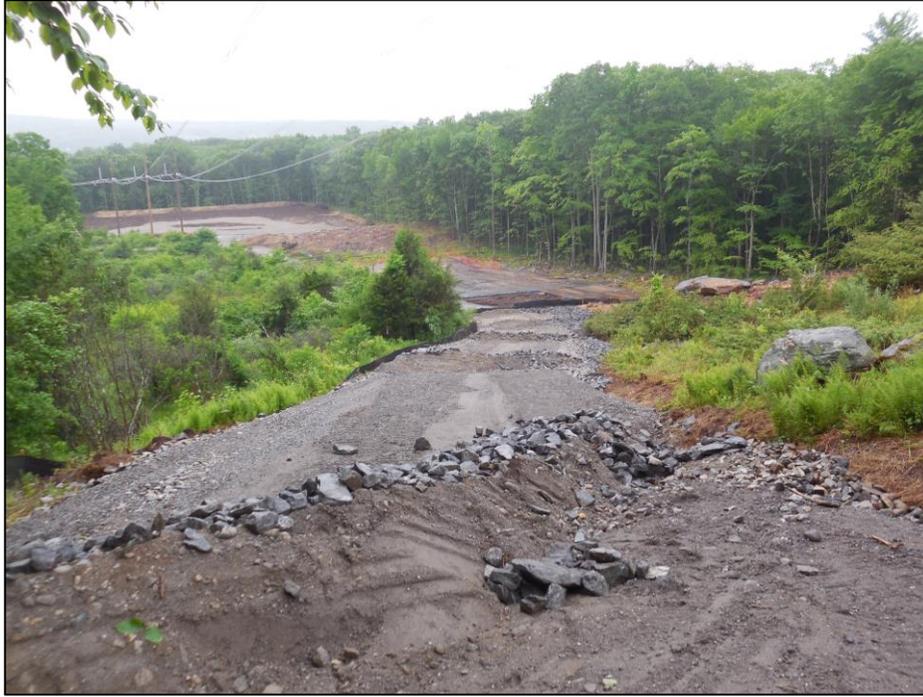
Photo #9: Substantial erosion control measures on access road to prepare for forecast rain event down-line of Str 43.

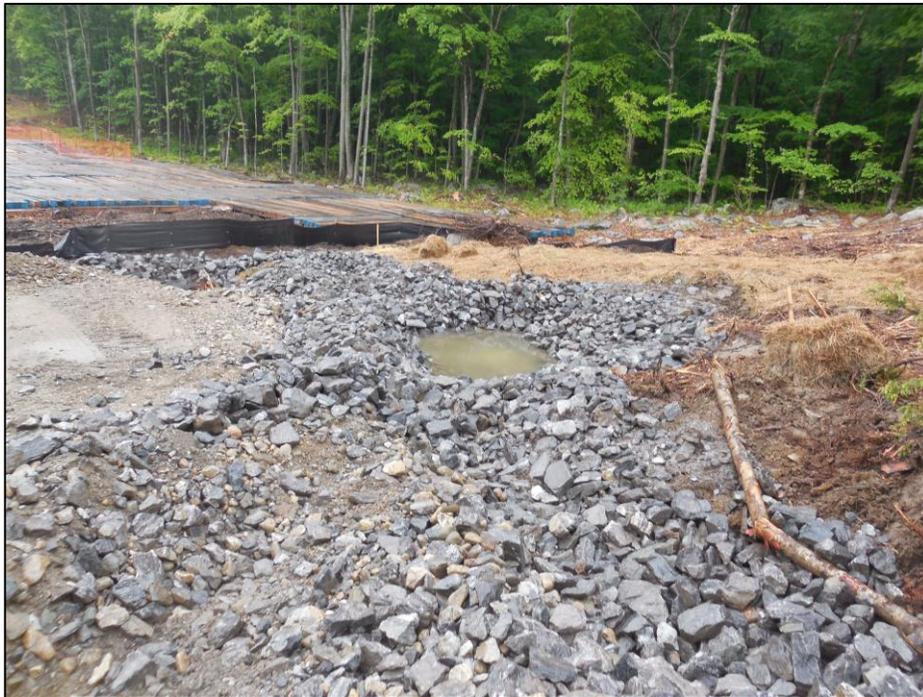
Photo #10: Plunge pool at base of slope down-line of Str 43.
