Docket No. 424 – Development and Management Plan Inspection

The Connecticut Light and Power Company Certificate of Environmental Compatibility and Public Need for the Connecticut portion of the Interstate Reliability Project.

Interim Week Inspection:

Bi-Weekly Week Inspection:

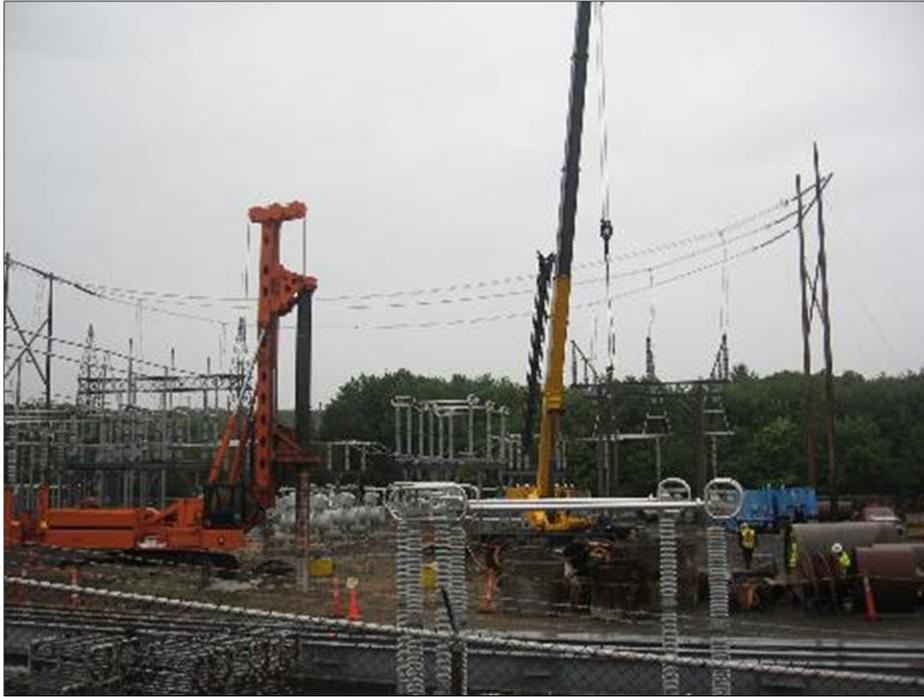
CSSS: Drilling operations (Photo 1)

Photo #1: Drilling operations inside CSSS.

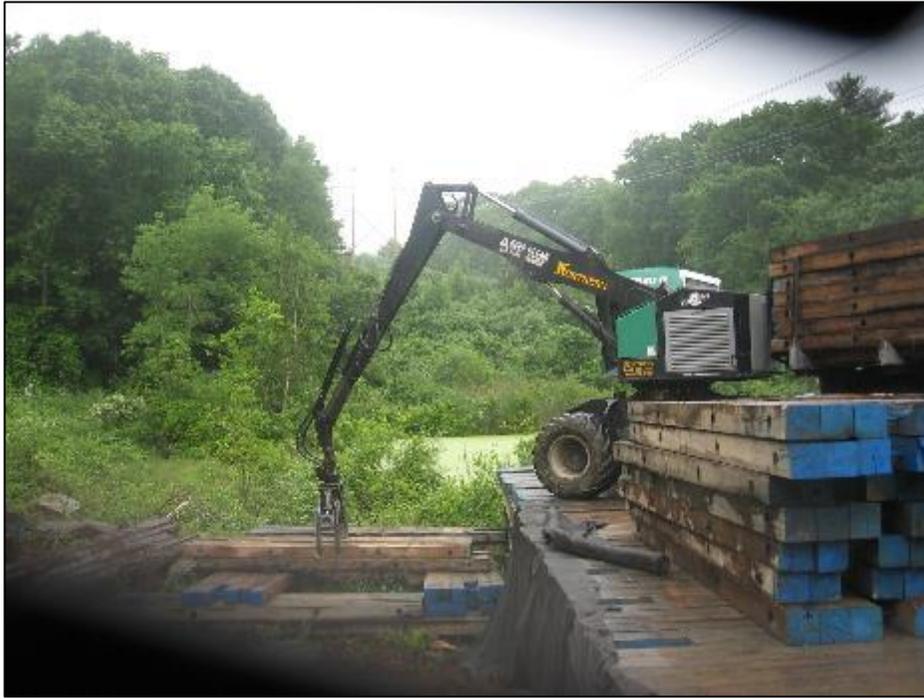
| | Bi-Week (6/19) | Mat installations in wetland areas are in accordance with the BMP Manual. (Photo 3) | Continue to follow this procedure. | NA |

Photo #3: Pad installation with wetland mats.

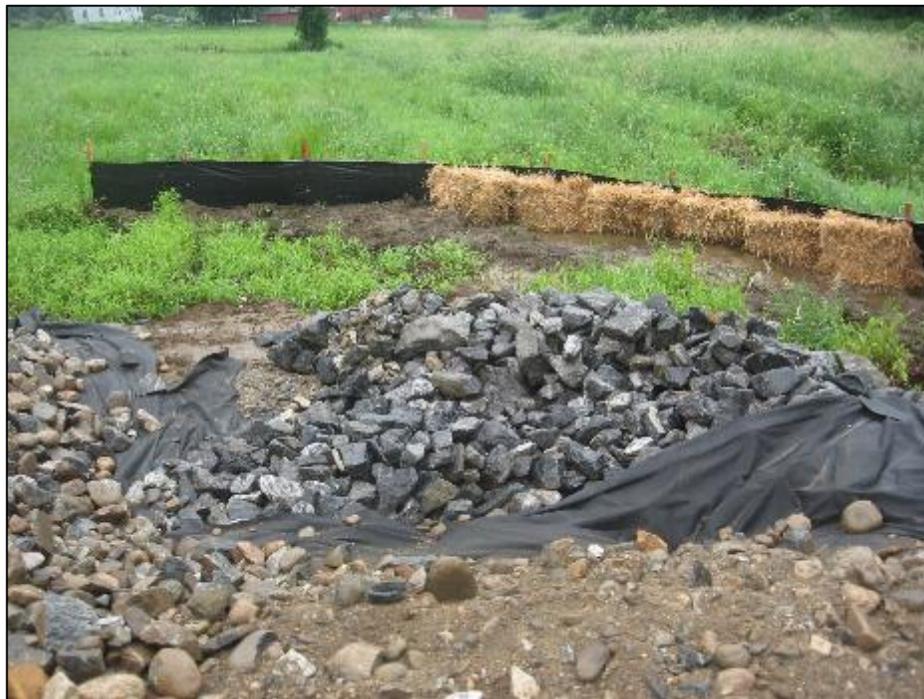
- **CSSS:** Drilling operations ongoing inside Card Street Substation.
- Drilling operations ongoing at Replacement Str 9080 and Str 84.
- **Str 56:** Area of channelization appears to be flowing beneath construction pad and discharging clean. Area is contained with straw bale reinforced silt fence.
- **Str 269 and 270:** Construction pad have been removed, re-graded, restored, and stabilized with blown straw mulch back to their pre-construction grades and slopes. (Photo 9)

Photo #4: Plunge pool leading into row of haybales and silt fence at Str 56.

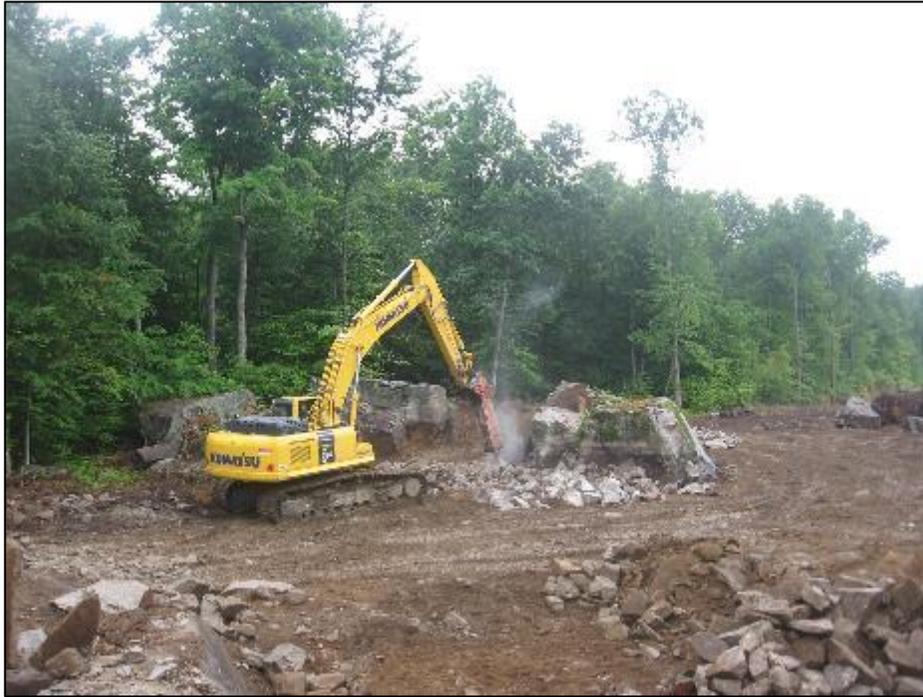
MS 11, Str 61-62: Hammering of oversize boulders up-line of Str 61, installing silt fence up-line of Str 62. (Photo 5 & 6)

Photo #5: Hammering of boulders up-line of Str 61.

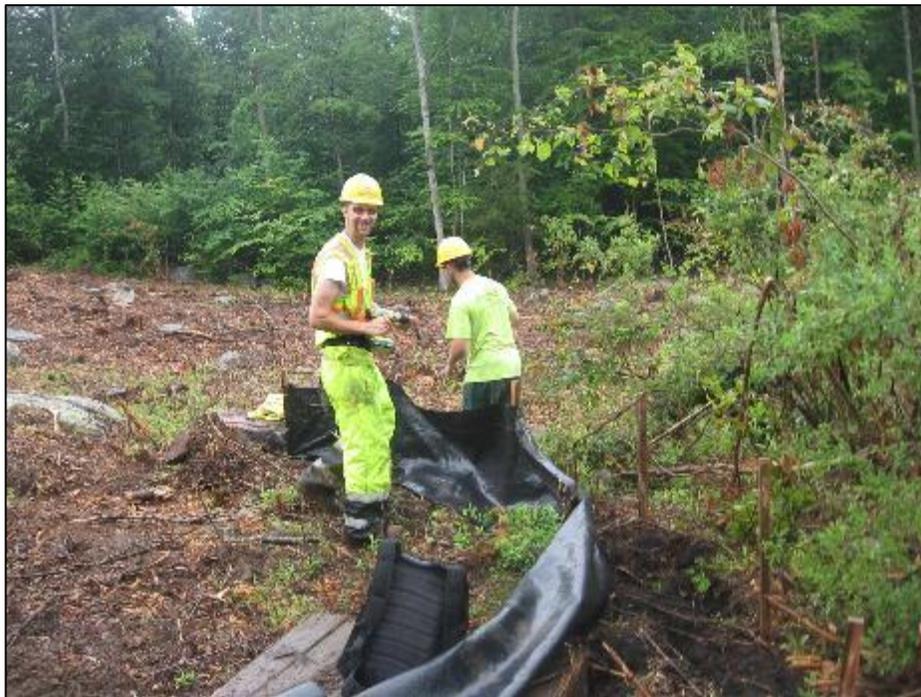
| Bi-Week (6/19) | Str 62: Observed installation of silt fence. (Photo 6) | NA | NA | |

Photo #6: Installation of silt fence up-line of Str 62.

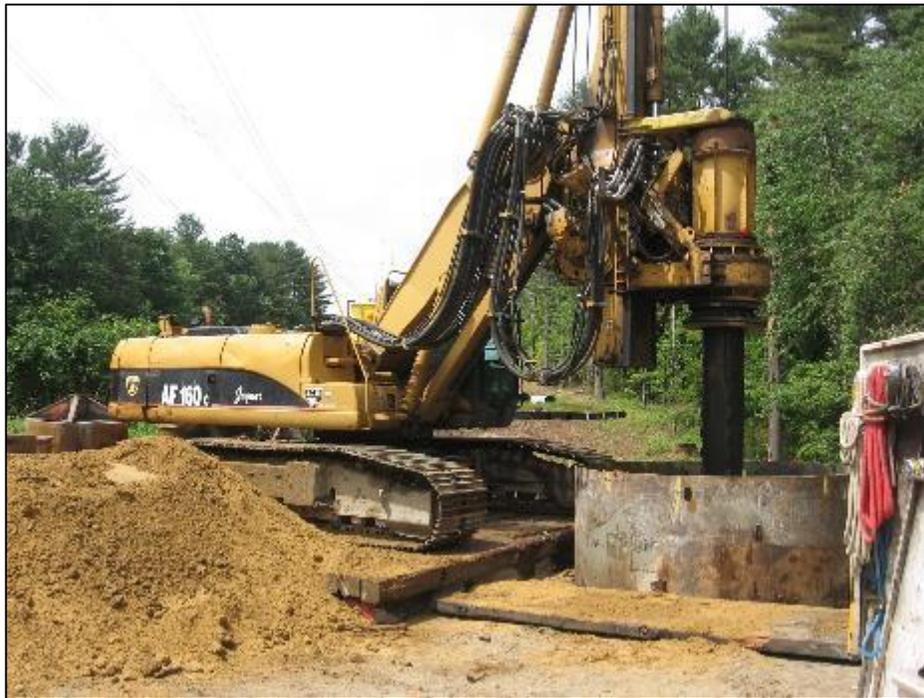
MS16, Str 84: Drilling operation at Str 84. (Photo 7)

Photo #7: Drilling operations at Str 84.

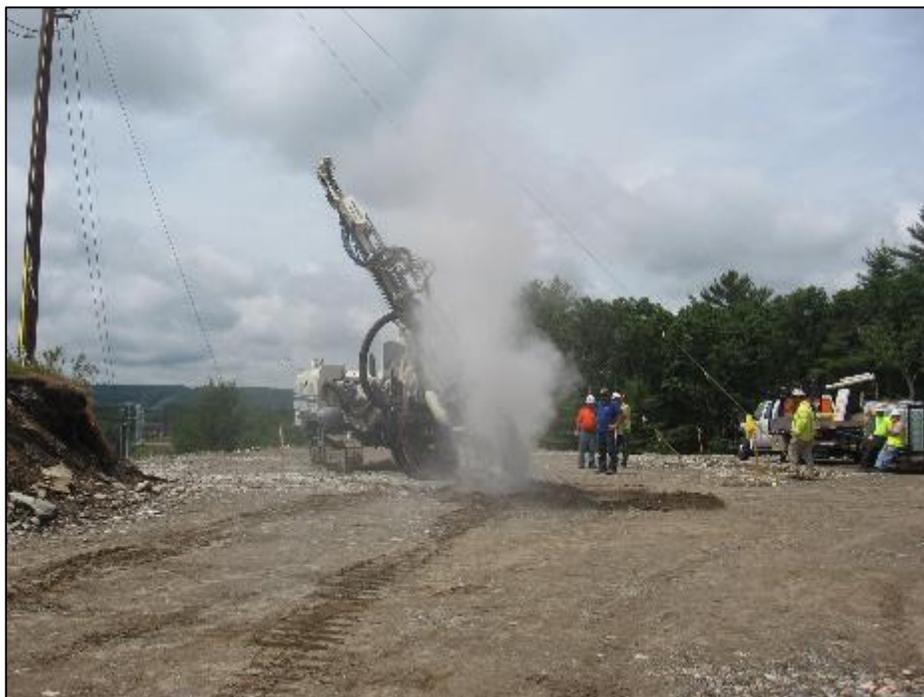
MS17, Str 89, 92: Drilling for rock anchors at Str 89, preparing site for pole installation at Str 92. (Photo 8)

Photo #8: Installing drill rock anchors at Str 89.

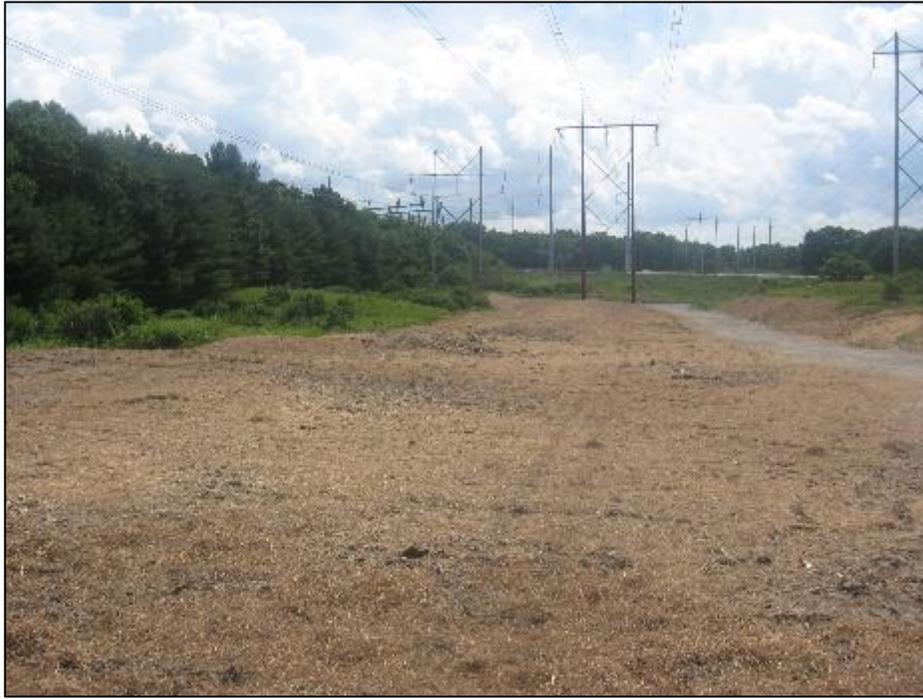
Photo #9: Restoration at Str 269 and Str 270.

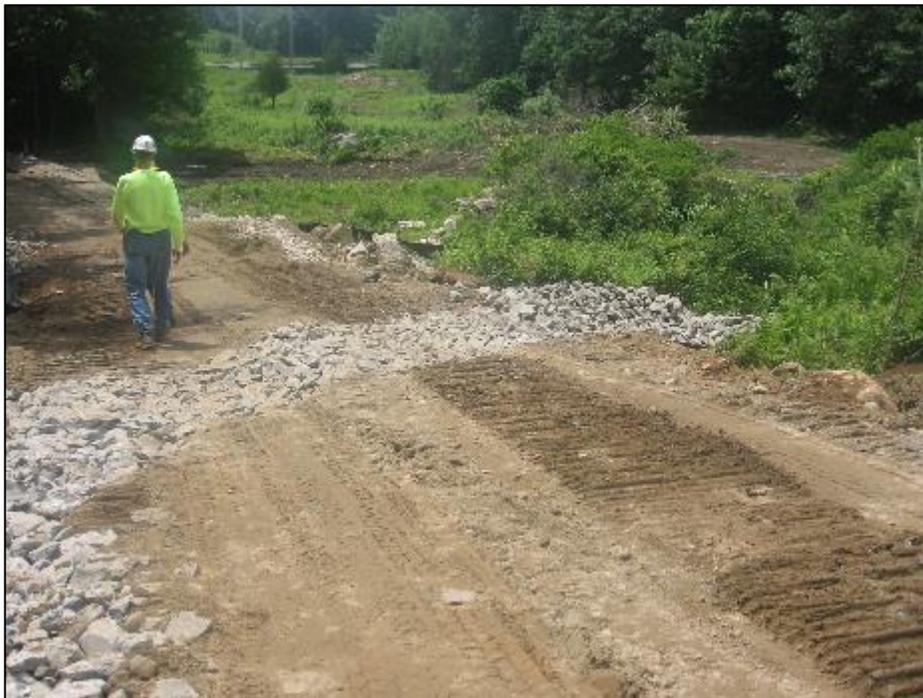
| | Str 144: Observed stone filled water bars installed across access road leading into plunge pool. (Photo 10) | Continue to follow this procedure. | NA | |

Photo #10: Stone water bars leading into plunge pool on access road down-line of Str 114.
