Docket No. 424 – Development and Management Plan Inspection

The Connecticut Light and Power Company Certificate of Environmental Compatibility and Public Need for the Connecticut portion of the Interstate Reliability Project.

IRP Overhead ROW

Interim Week Inspection:

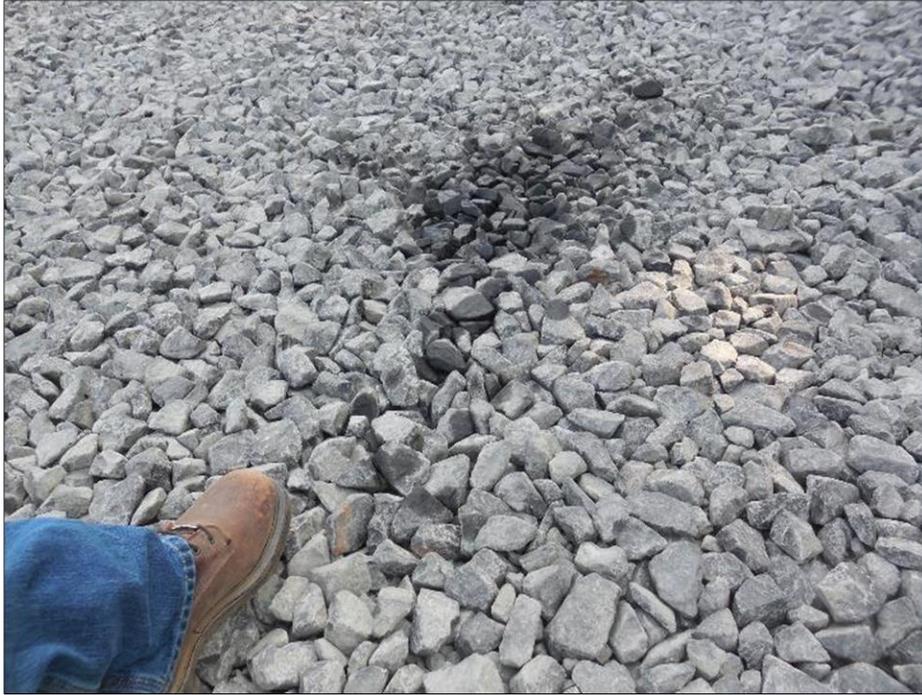
Photo #1: Hydraulic Fluid Spill on CSSS Entrance Pad.

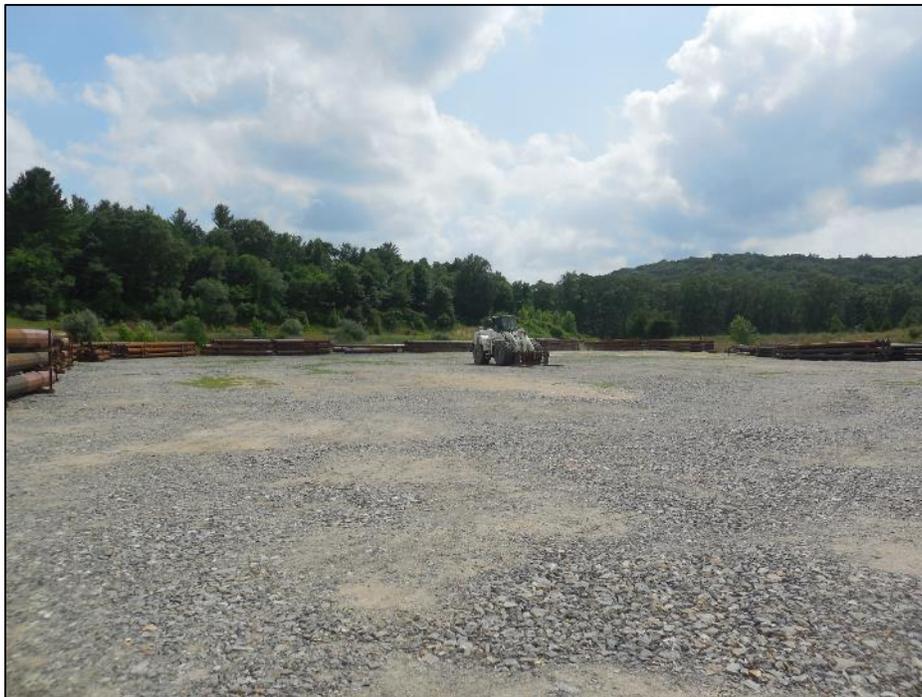
- **CSSS:** Drilling operations and conduit installation ongoing inside Card Street Substation.
- According to Burns and McDonnell representatives, USACE indicated (via email) that the swale along the south edge of the substation is considered non-jurisdictional (meaning it is not a water of the U.S.).
- Drilling operations ongoing at Str 2 and Str 90.
- Observed Nora Lane Lay-Down Area. The area is stabilized. (Photo 2)
- Concrete vehicles for foundation pour are utilizing a washout container.

Photo #2: Nora Lane Laydown Area in Pomfret.

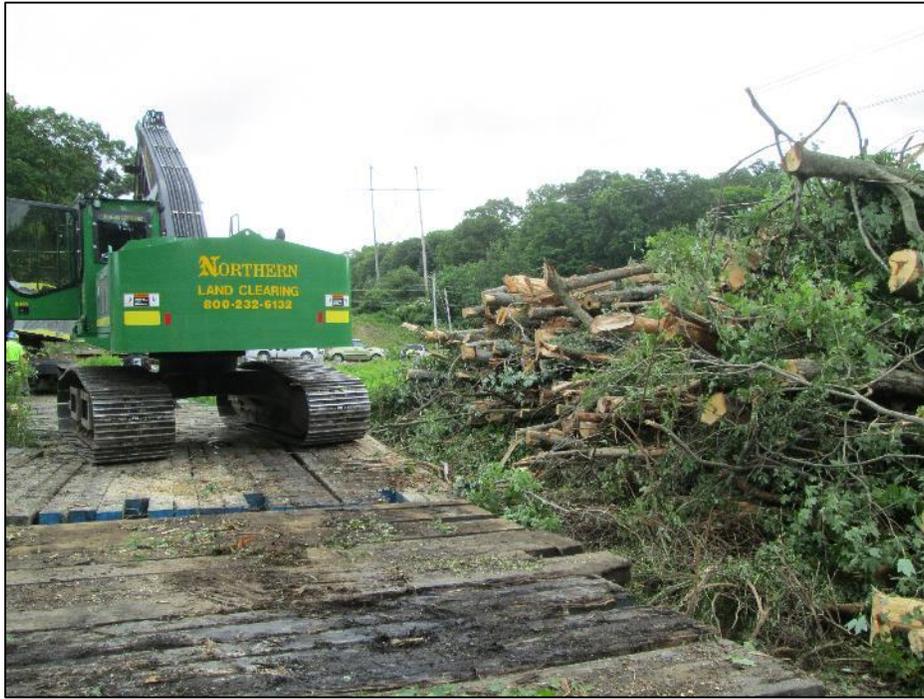
MS10, Str 56: clearing down-line of Str 56, cleaning of equipment after being in invasive species area.

Photo #3: Cleaning of equipment at Str 56. (6/26)

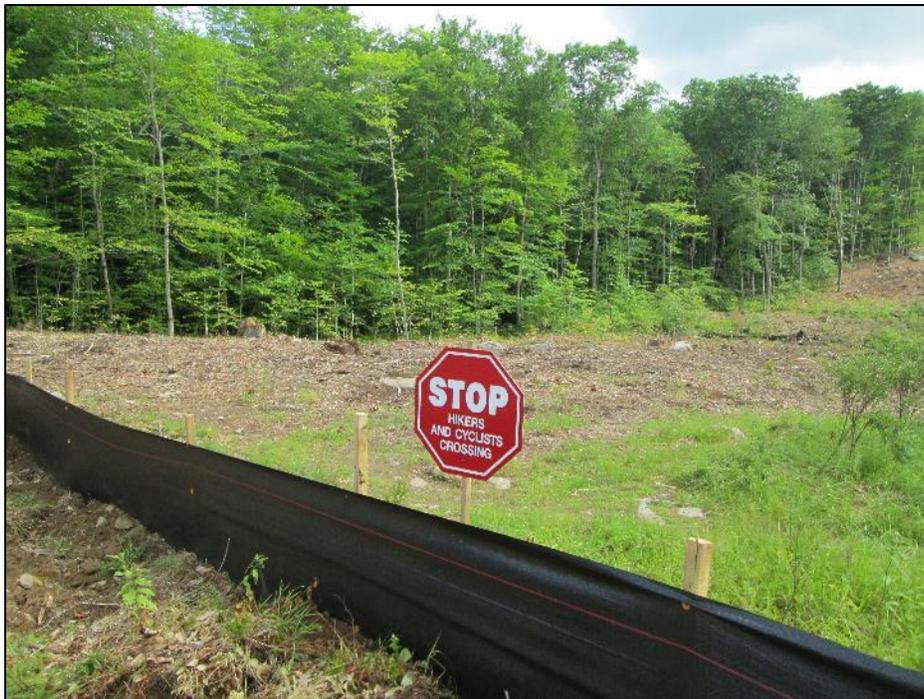
- Warning signage and silt fence have been installed across the Nipmuck Trail crossing – west branch, between structures 65 and 66. (Photo 4 & 5)

Photo #4: Warning signage and silt fence at the Nipmuck Trail – West Branch, between Str 65 & 66. (6/26)

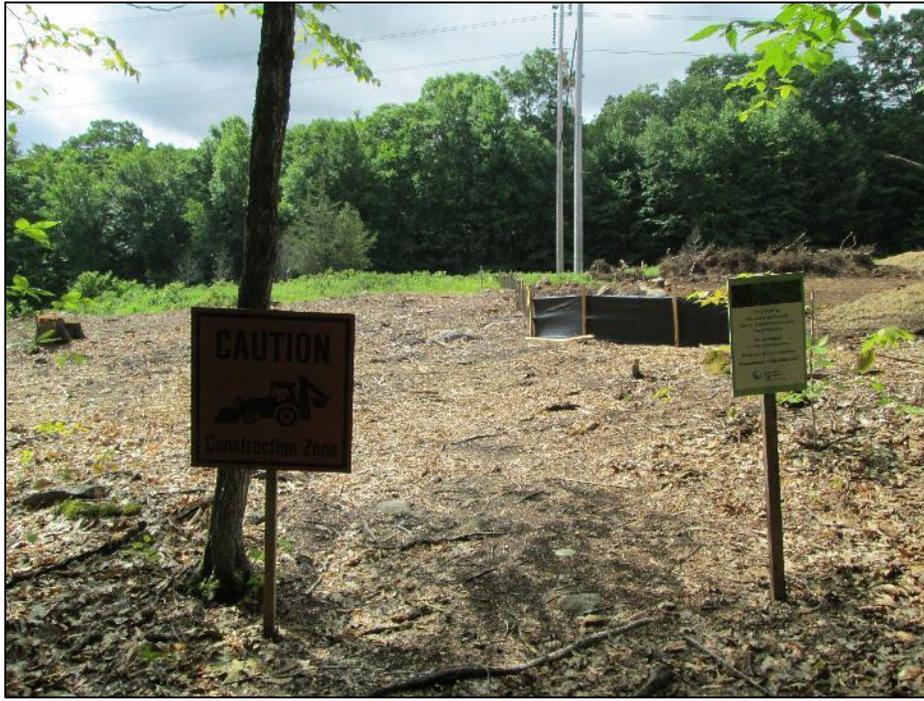
Photo #5: Warning signage on Nipmuk Trail – West Branch. (6/26)

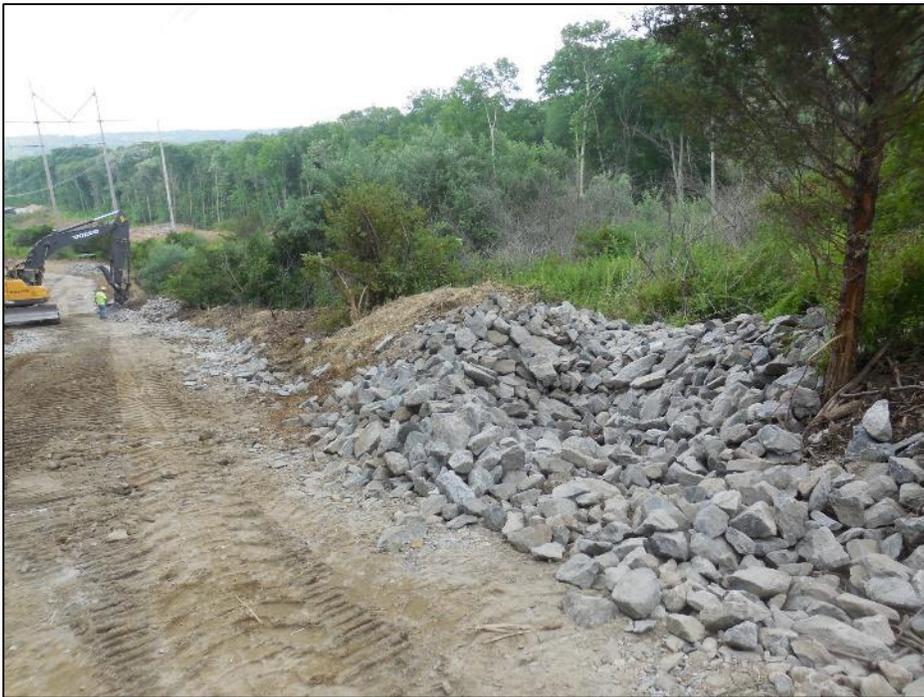
Bi-Week (7/2)	All crossings appear to be functioning in accordance with the BMP Manual. No sediment appears to be entering the streams or wetlands.	Continue to follow this procedure.	
Erosion and Sedimentation Controls	Interim Week (6/26)	Noted that stockpile areas along ROW are being surrounded with straw wattles and stabilized with blown straw.	Continue to follow this procedure.	NA
		Str 50: Noted chipping of brush for stabilization down slope towards Str 49.	Continue to follow this procedure.	NA
		Str 71: Noted stone swale on edge of access road up-line of Str 71.	NA	NA
Erosion and Sedimentation Controls	Bi-Week (7/2)	Str 102: Sweeping dirt off wetland mats. (Photo 7)	Continue to follow this procedure.	NA
		Str 103-105: Noted spreading of hay on bare topsoil. (Photo 9)	Continue to follow this procedure.	NA
		Str 114-115: Noted stone swale and plunge pool installation on side of access road. (Photo 6)

Photo #6: Installation of stone swale and plunge pools Up-line of Str 114.

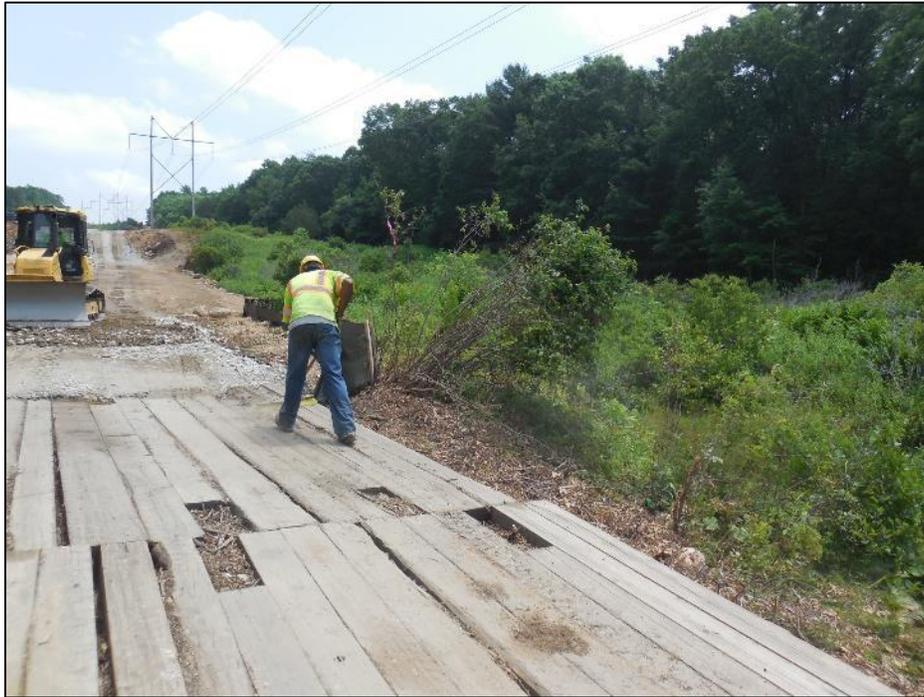
MS19, Str 102-103: Grading of access roads up-line of Str 102, sweeping sediment off wetland mats.

Photo #7: Sweeping up sediment from wetland mats up-line of Str 102.

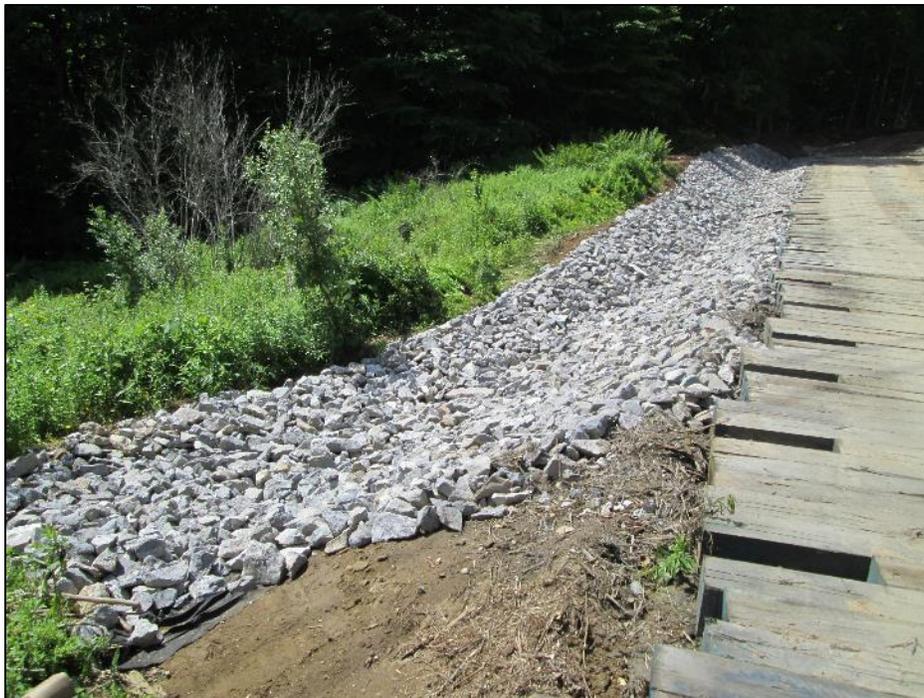
Photo #8: Stone swale up-line of Str 71.

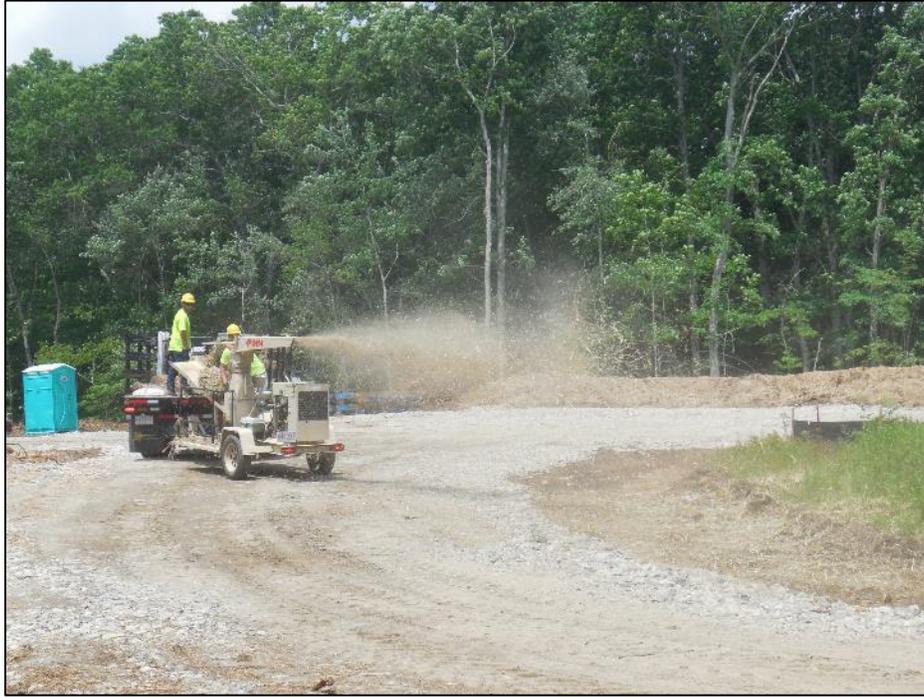
MS20, Str 103-106: Spreading of hay on exposed topsoil. Compacting of Str pad 105. Building access road with wetland mats up-line of Str 105.

Photo #9: Spreading of hay on bare topsoil up-line of Str 103.

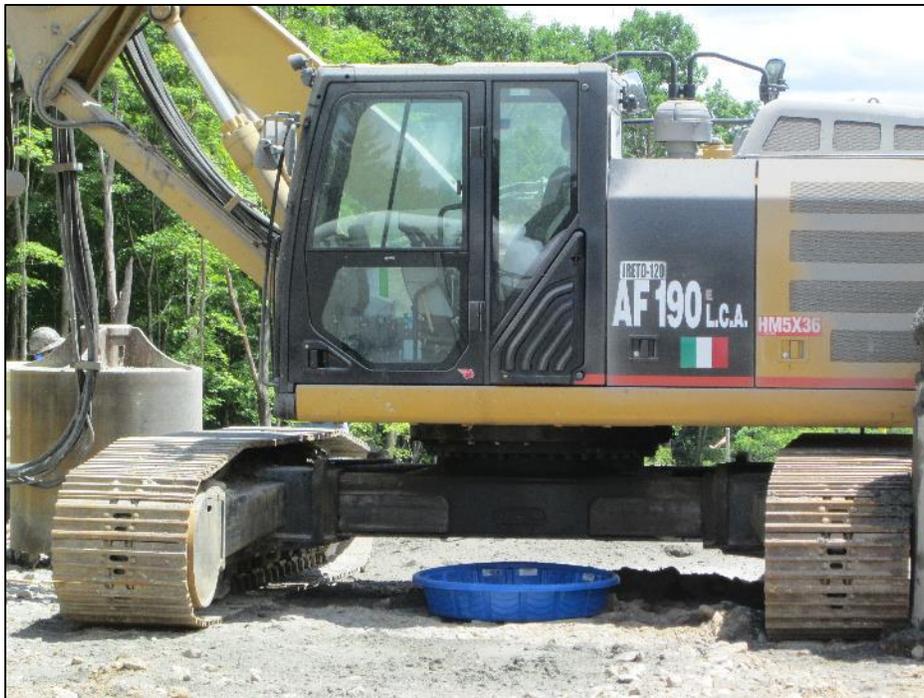
Spills and Material Storage.	Interim Week (6/26)	Spill kits noted on all visited sites. Str 90: Noted kiddie pool under drilling machinery for precautionary measures. (Photo 10)	Continue to follow this procedure. Continue to follow this procedure.	NA NA
	Bi-Week (7/2)	Spill kits noted on all visited sites. CSSS: Observed hydraulic fluid spill on CSSS entrance pad. (Photo 1)	Continue to follow this procedure.	NA ES Boulos crew immediately contained and removed affected areas during inspection.
Cultural Resources	Interim Week (6/26)	Pads in cultural areas are being installed with a geotextile separation fabric and sand buffer layer prior to the installation of the pad material.	NA	NA
	Bi-Week (7/2)	Pads in cultural areas are being installed with a geotextile separation fabric and sand buffer layer prior to the installation of the pad material.	NA	NA
Rare, Threatened, and Endangered Species	Interim Week (6/26)	NA	NA	NA

Photo #10: Child pool under machinery for precautionary measures at Str 90.
