Docket No. 424 – Development and Management Plan Inspection

The Connecticut Light and Power Company Certificate of Environmental Compatibility and Public Need for the Connecticut portion of the Interstate Reliability Project.

IRP Overhead ROW

Interim Week Inspection:

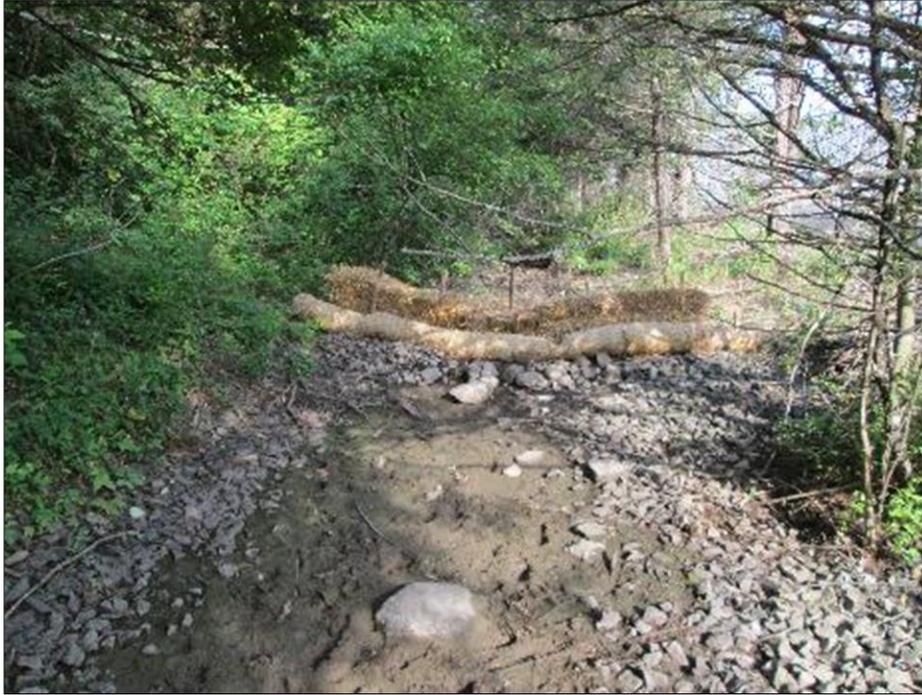
Photo #1: Check Dam in CSSS southern swale. (7/10)

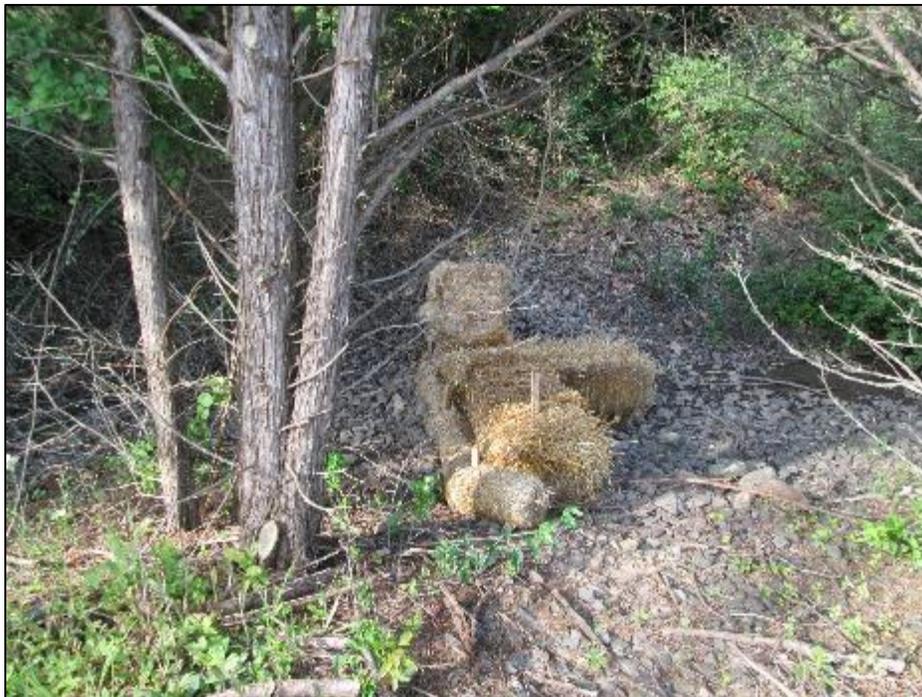
Photo #2: Check Dam in CSSS southern swale. (7/10)

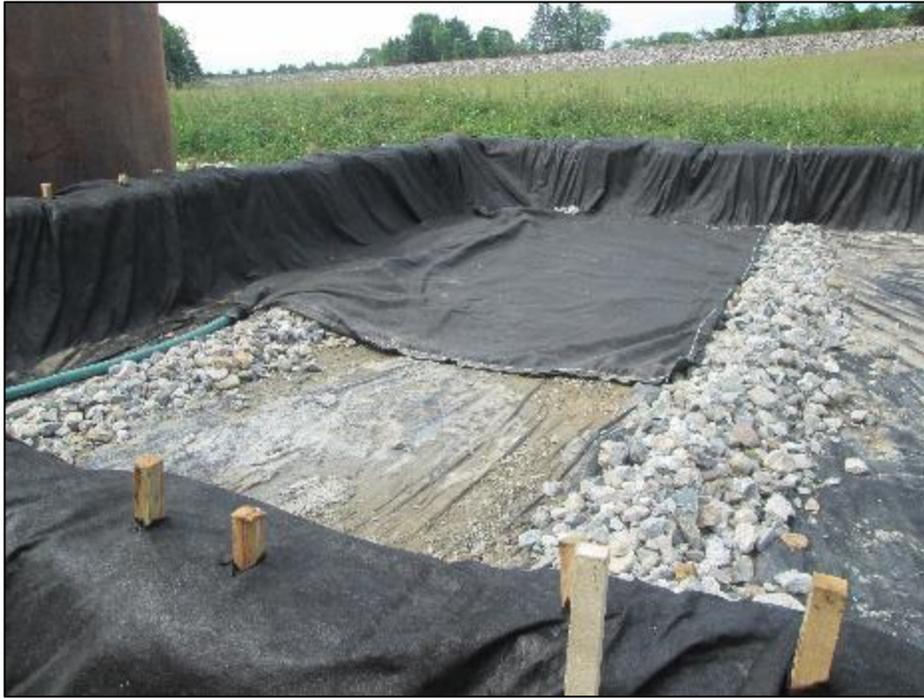
Photo #3: Check dams and “dirt bag” installed in dewatering basin down-line of Str 83.

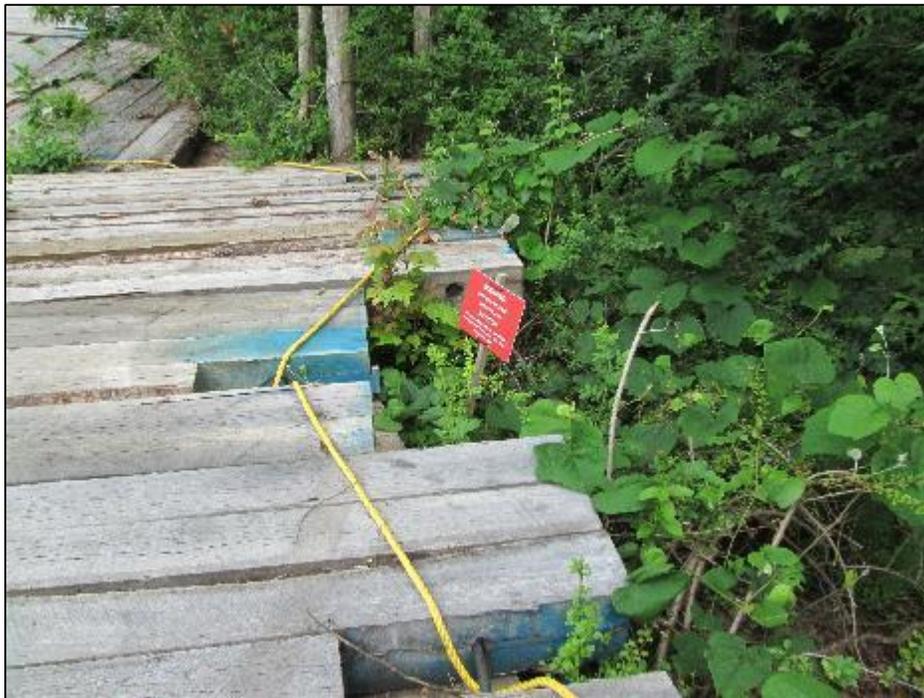
Inland Wetland and Watercourse encroachment and mitigation	Interim Week (7/10)	<p>Mat installations in wetland areas are in accordance with the BMP Manual.</p> <p>Str 23: Wetland mats in 100-year Floodplain are tied to each other to prevent migration during a flood condition. (Photo 4)</p>	<p>Continue to follow this procedure.</p> <p>Continue to follow this procedure.</p>	<p>NA</p> <p>NA</p>
	Bi-Week (7/17)	<p>Mat installations in wetland areas are in accordance with the BMP Manual.</p>	<p>Continue to follow this procedure.</p>	<p>NA</p>
Spills and Material Storage.	Interim Week (7/10)	<p>Spill kits noted on all visited sites.</p> <p>Str 96: Concrete spill on wetland mats up-line of Str 95. (Photo 8)</p> <p>Str 23: Noted child pools under drilling machinery for precautionary measures. (Photo 6)</p>	<p>Continue to follow this procedure.</p> <p>Continue to follow this procedure.</p>	<p>NA</p> <p>Burns & McDonnell Representative noted that the concrete will be cleaned up by tri-state before the end of the work day. (it is easier to remove the spill in its entirety after it sets.)</p> <p>NA</p>

Photo #4: Wetland mats tied to each other in 100-year Floodplain at Str 23. (7/10)

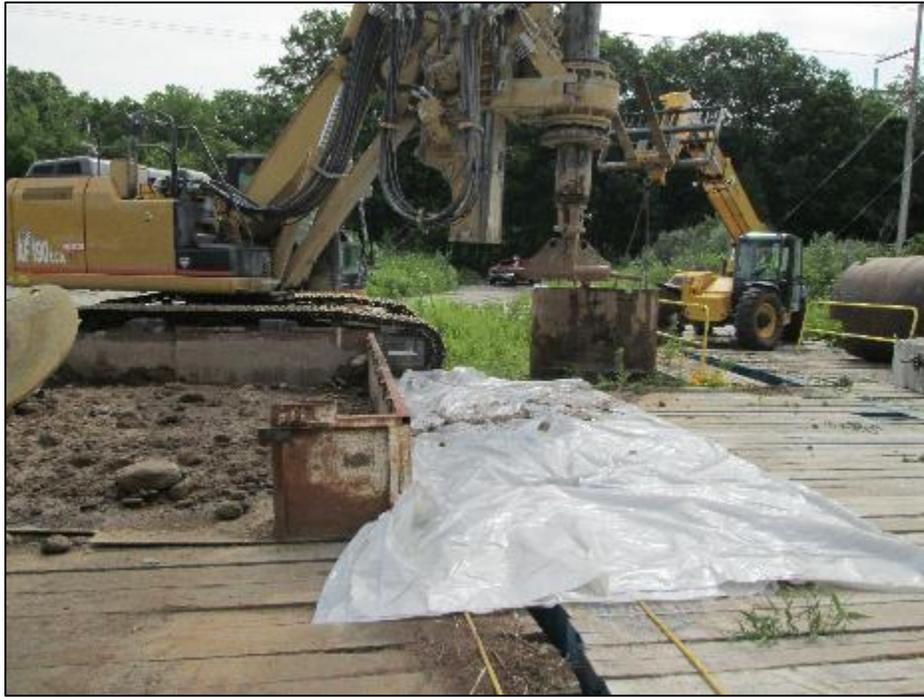
Photo #5: Spin off tarp over wetland mats at Str 23. (7/10)

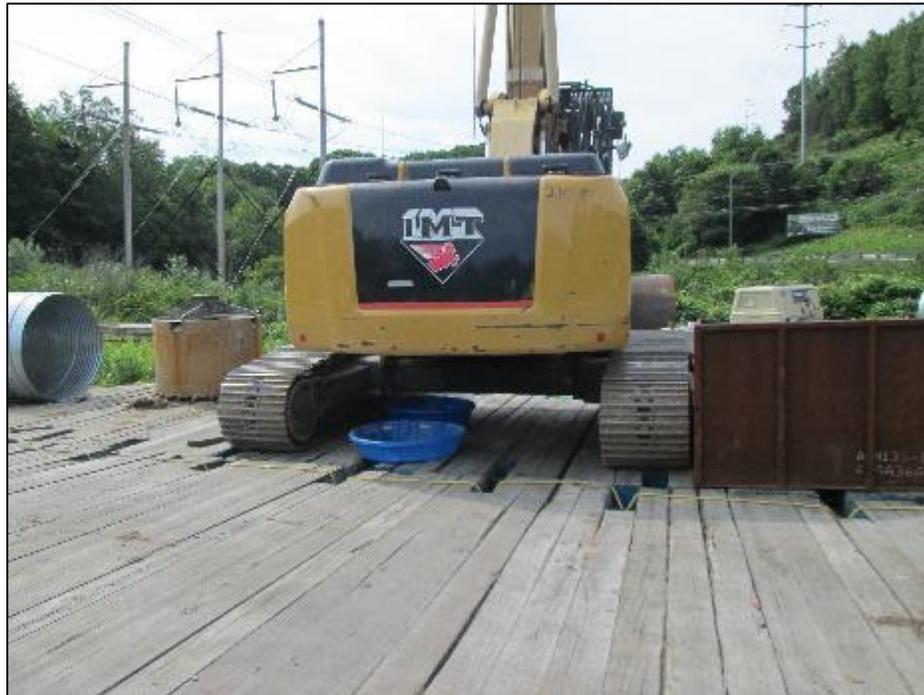
Photo #6: Child pool under machinery for precautionary measures at Str 23. (7/10)

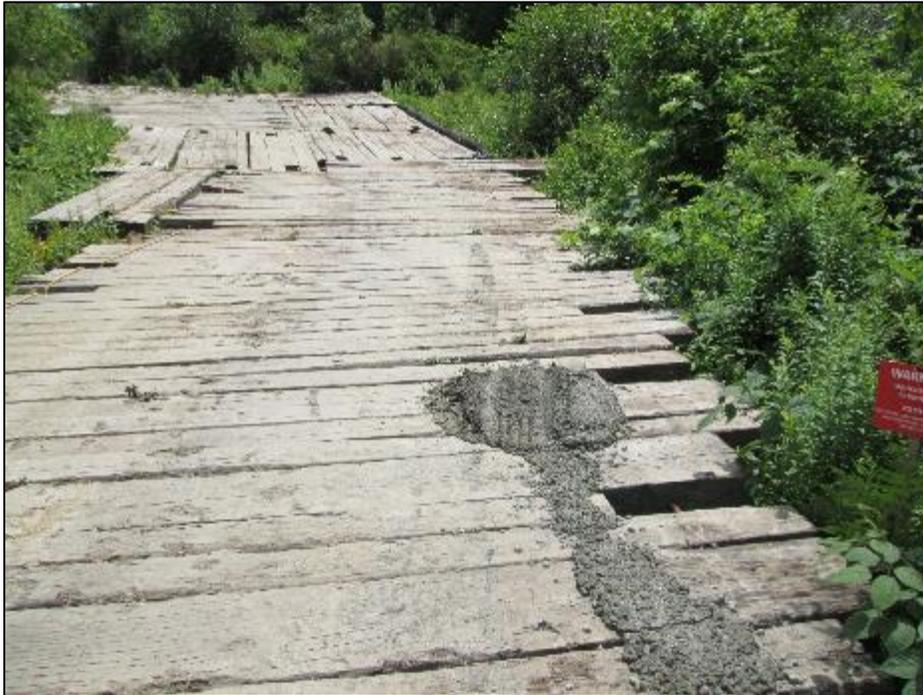
Photo #8: Concrete spill on wetland mats up-line of Str 95. (7/10)

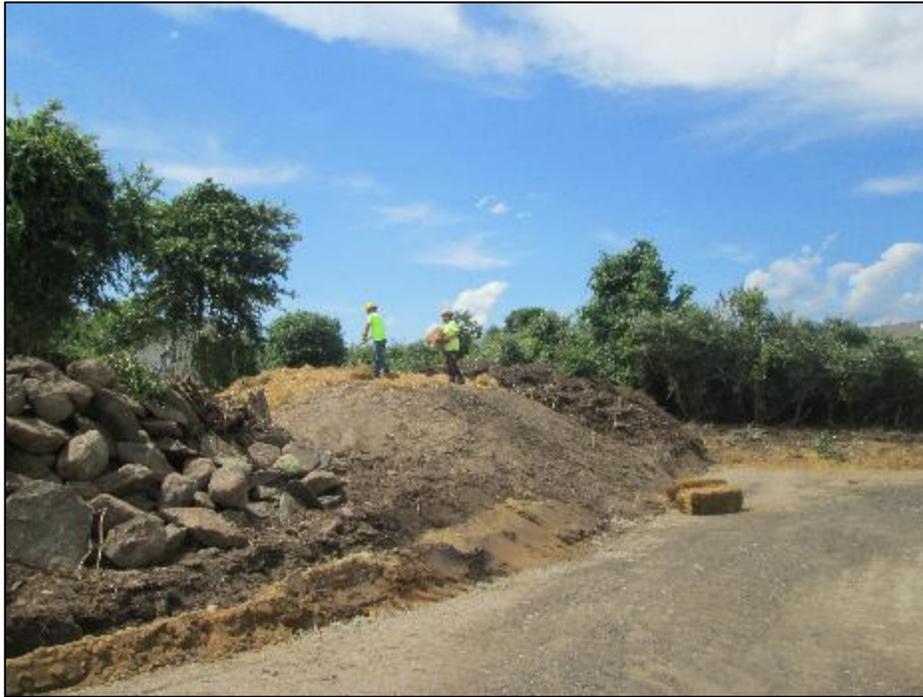
Photo #9: Topsoil stabilization with spread hay at Str 219.
