Docket No. 424 – Development and Management Plan Inspection

The Connecticut Light and Power Company Certificate of Environmental Compatibility and Public Need for the Connecticut portion of the Interstate Reliability Project.

IRP Overhead ROW

Bi-Weekly Week Inspection:

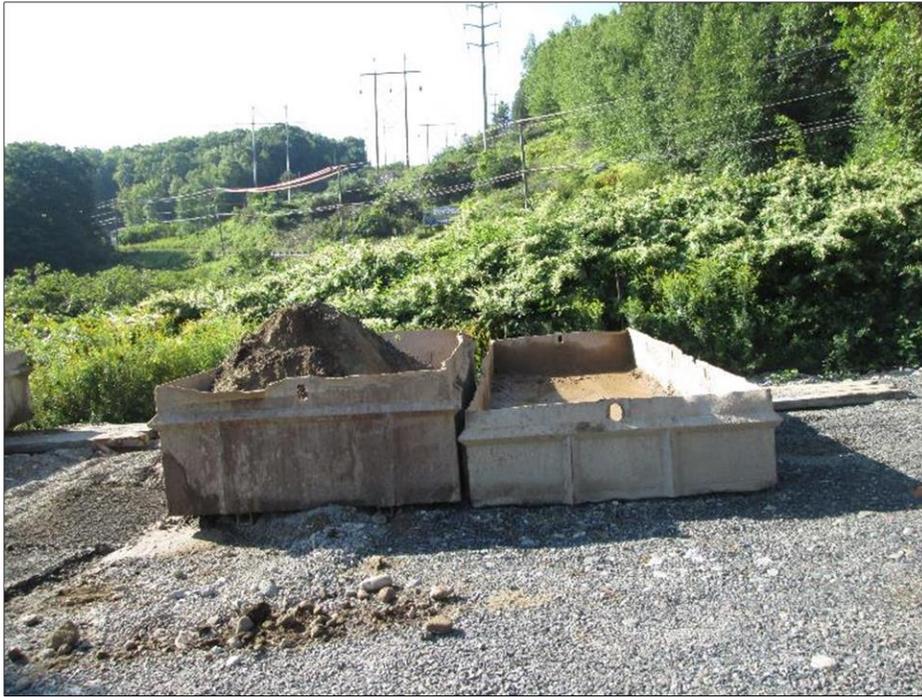
Photo #1: Spoils being contained in “spin off” containers at Str 23.

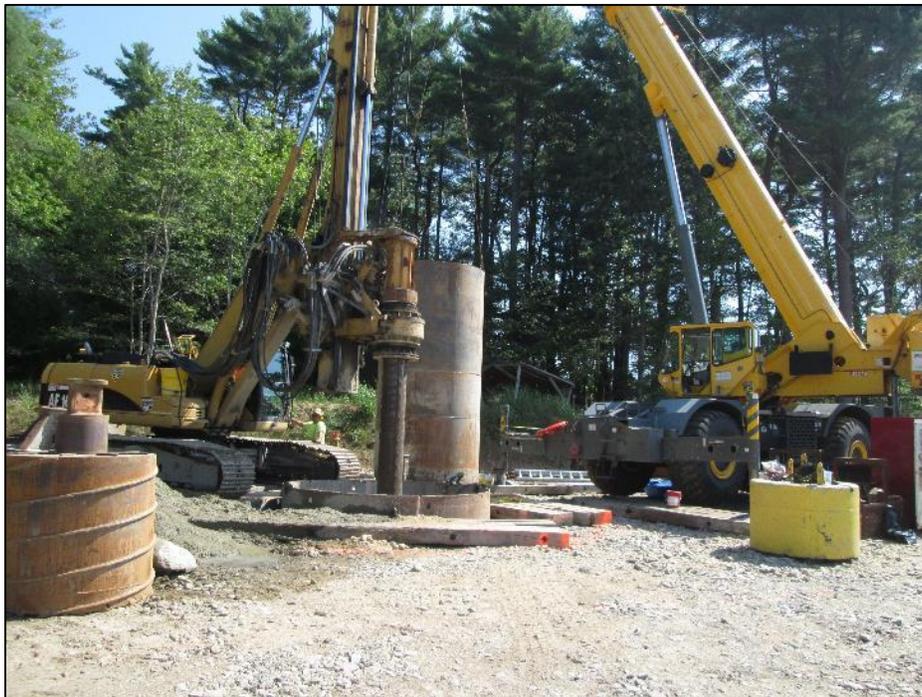
MS15, Str 81: Drilling operations. (Photo 2)

Photo #2: Drilling operations at Str 81.

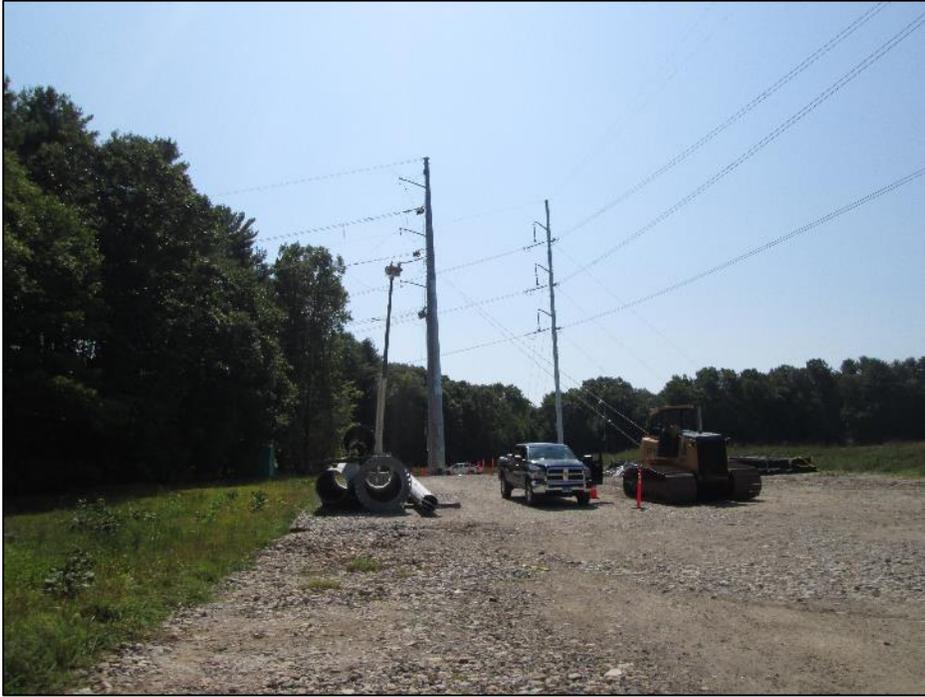
MS15-21, Str 83-111: Tensioning and clipping dead end wire. (Photo 3)

Photo #3: Tensioning and clipping dead end wire at Str 83.

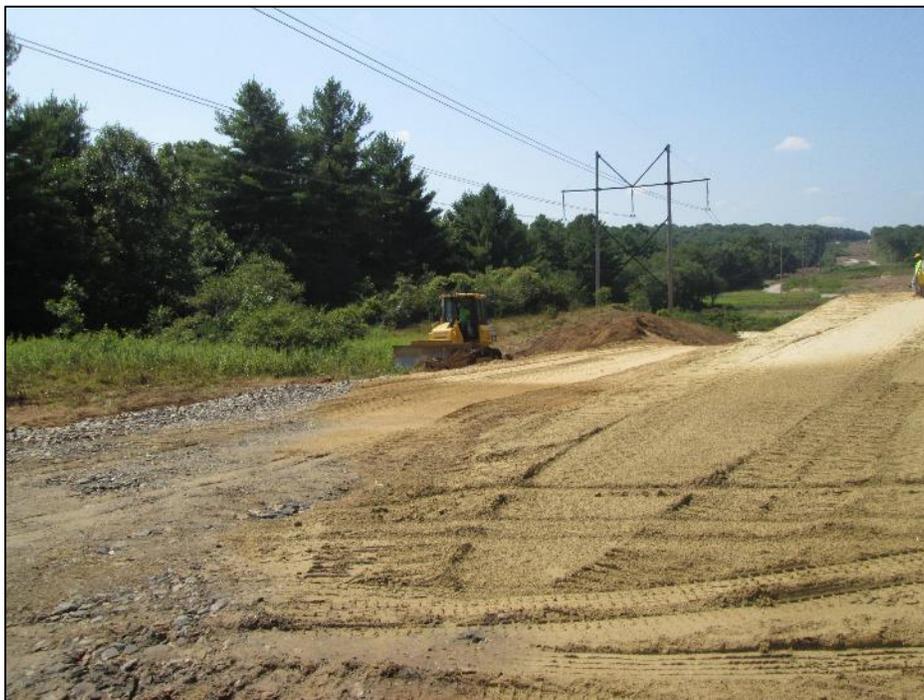
MS28, Str 147-148: Building of Str pad and access road up-line of Str 147, delivery of materials. (Photo 4)

Photo #4: Grading of access road up-line of Str 147.

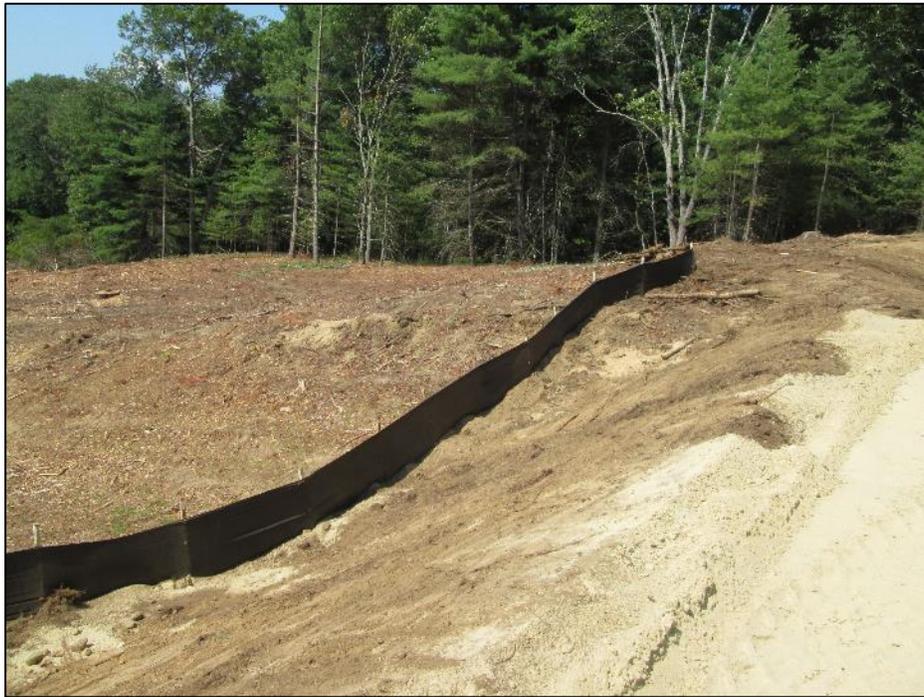
Photo #5: Recommend additional structural controls to reinforce silt fence facing down-line of Str 147.

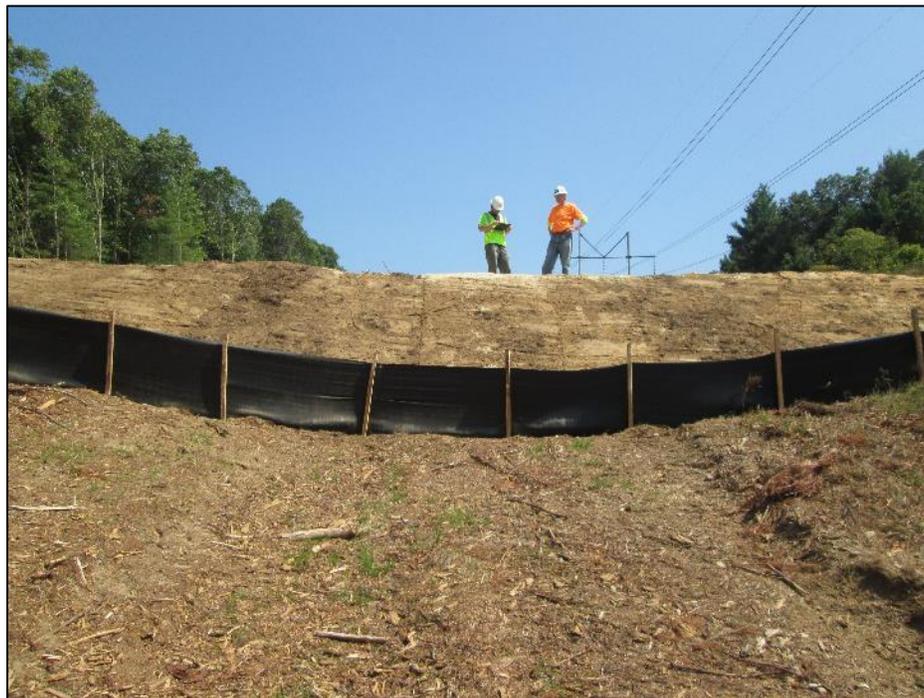
Photo #6: Recommend additional erosion controls facing up-line of Str 147.

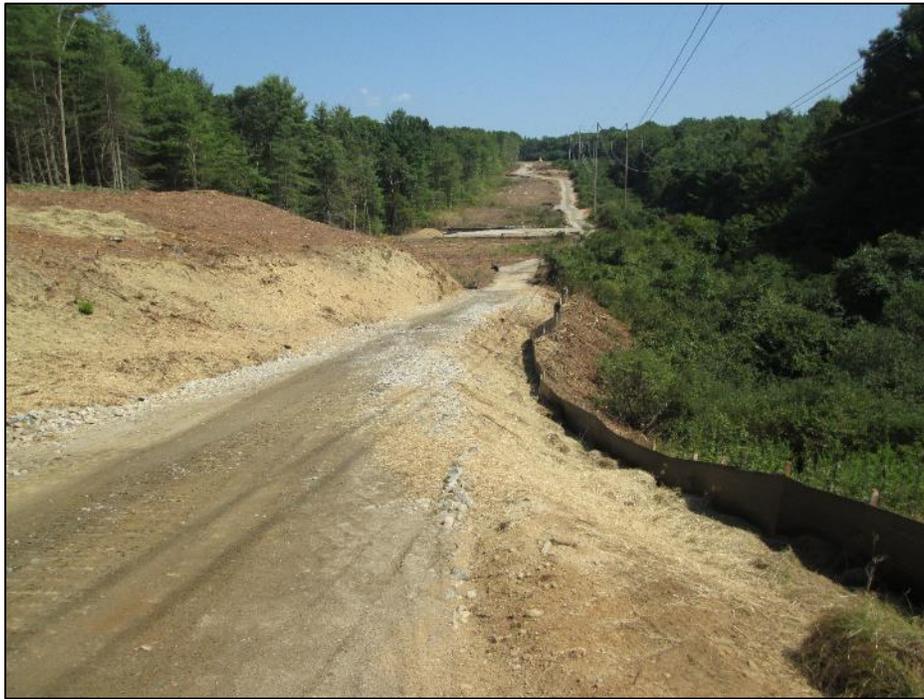
Photo #7: Erosion control measures up-line of Str 148.

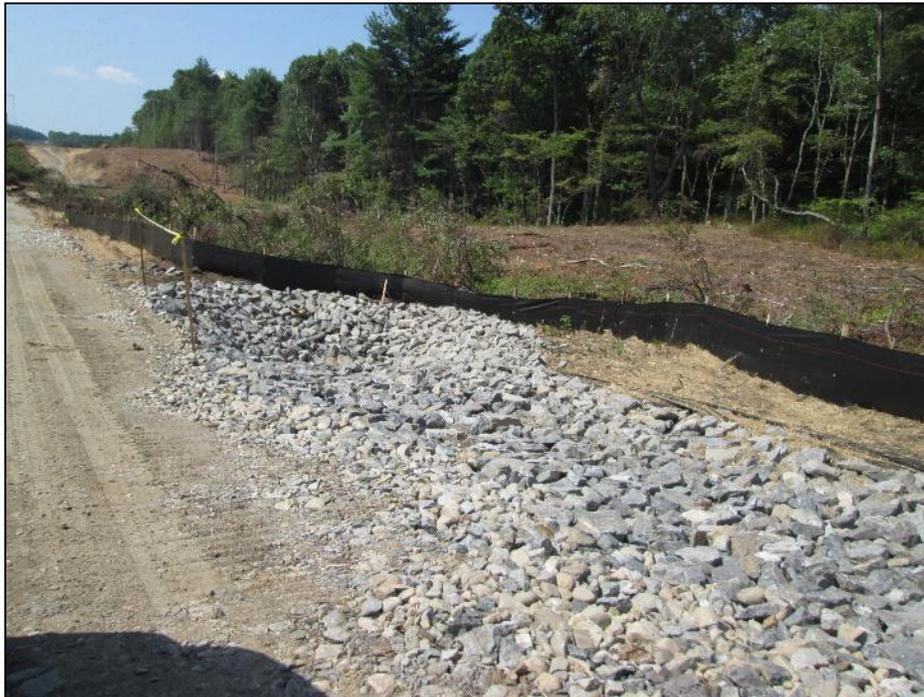
Photo #8: Plunge pool and erosion control measures up-line of Str 149.

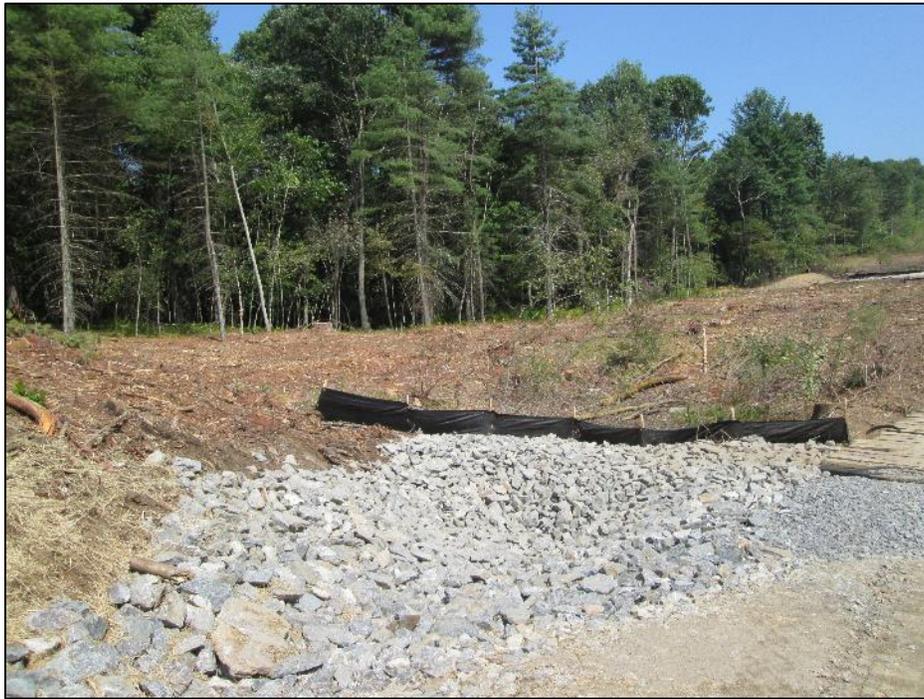
Photo #9: Plunge pool down-line of Str 149.

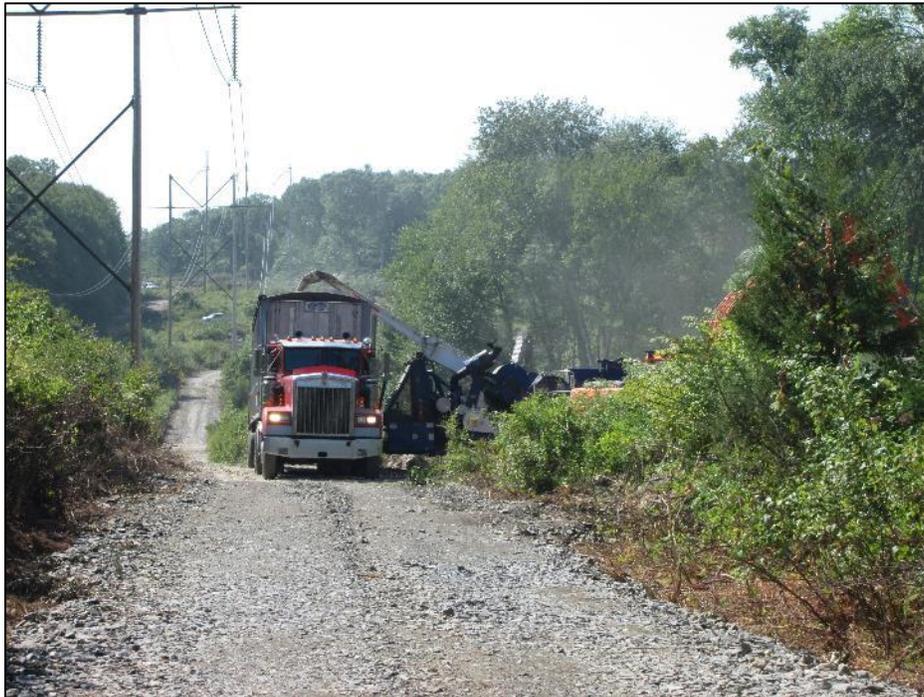
MS34, Str 176-178: Clearing operations, chipping brush into truck down-line of Str 177.

Photo #10: Chipping brush into truck down-line of Str 177.
