Docket No. 424 – Development and Management Plan Inspection

The Connecticut Light and Power Company Certificate of Environmental Compatibility and Public Need for the Connecticut portion of the Interstate Reliability Project.

IRP Overhead ROW

Interim Week Inspection:

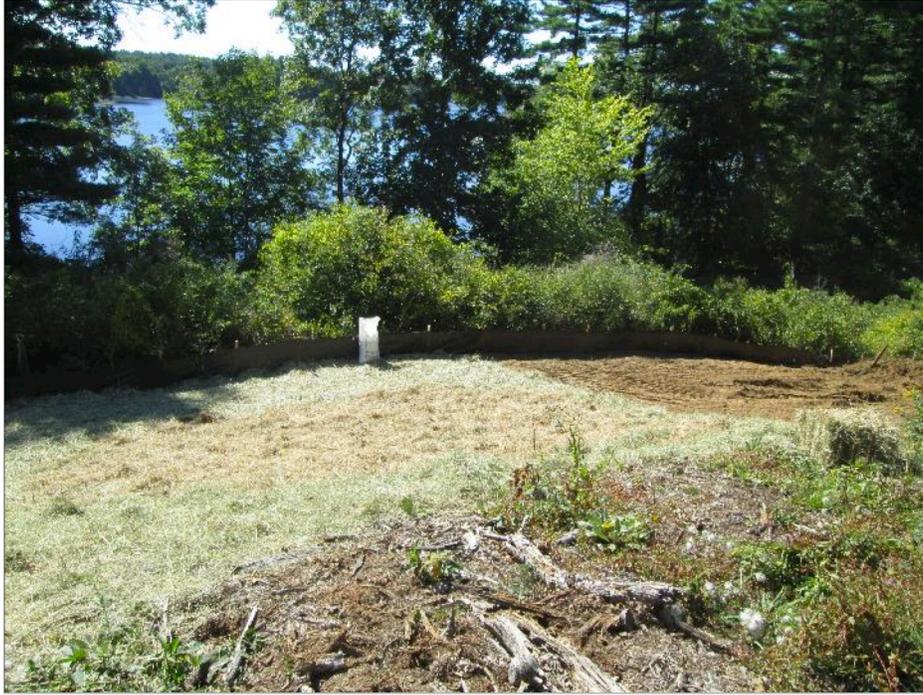
MS16, Str 84-85: Restoration and reclamation of Str pad 84 & 85 and access road, seeding and spreading of hay on exposed soil. (Photo 1 & 2)

Photo #1: Additional silt fence installed on edge of access road up-line of Str 84. (9/17)

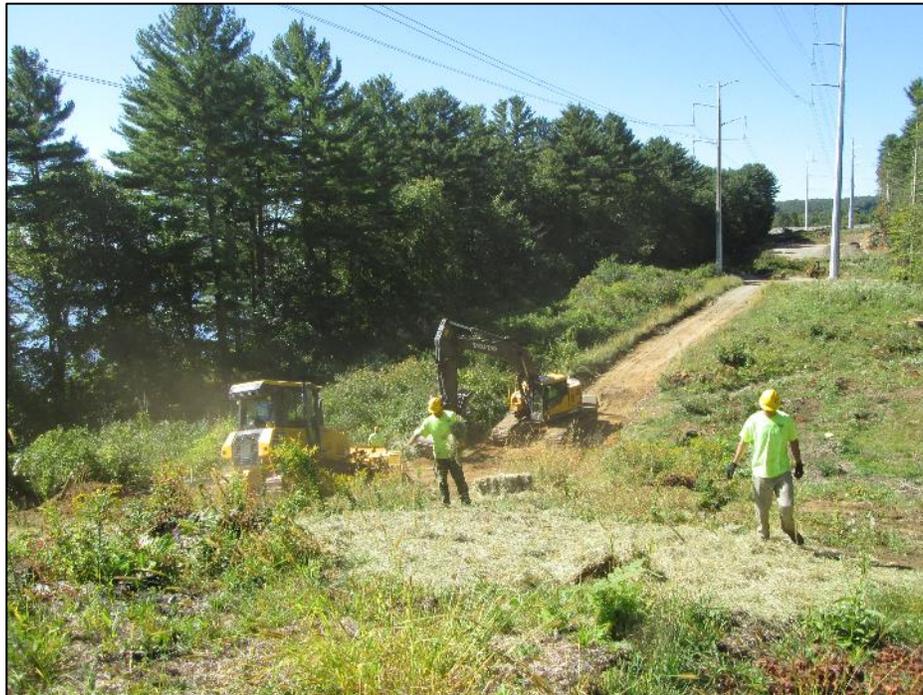
Photo #2: Spreading of hay and seed on exposed topsoil up-line of Str 84. (9/17)

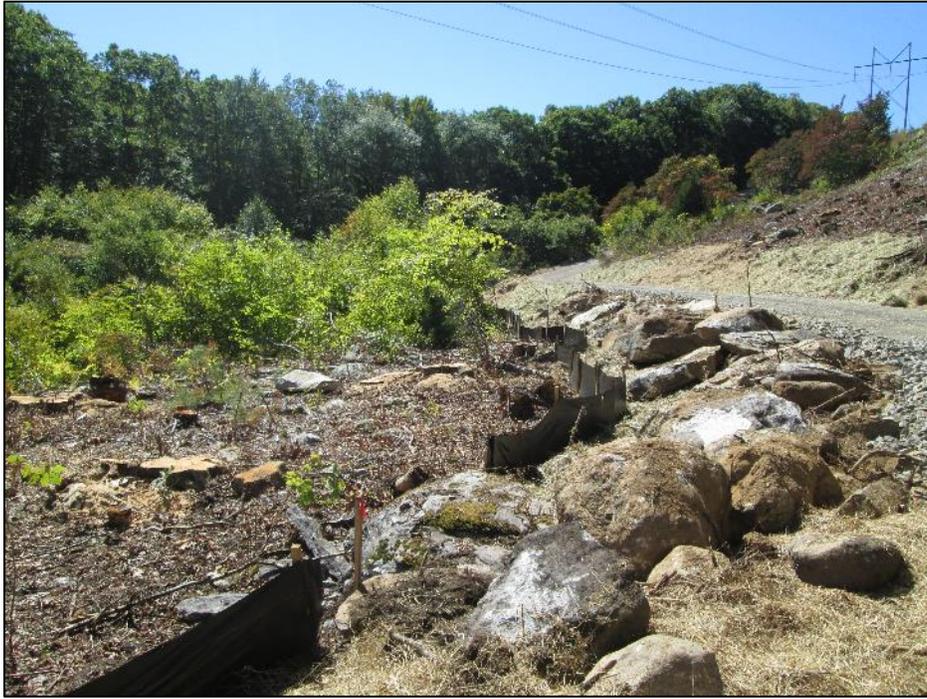
Photo #3: Gap in silt fence on edge of access road between Str 171 & 172. (9/17)

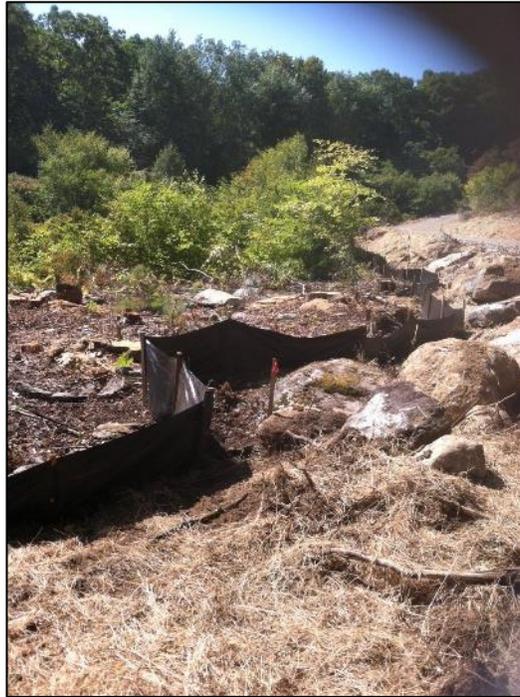
Photo #4: Repaired gap in silt fence on edge of access road between Str 171 & 172. (9/17)

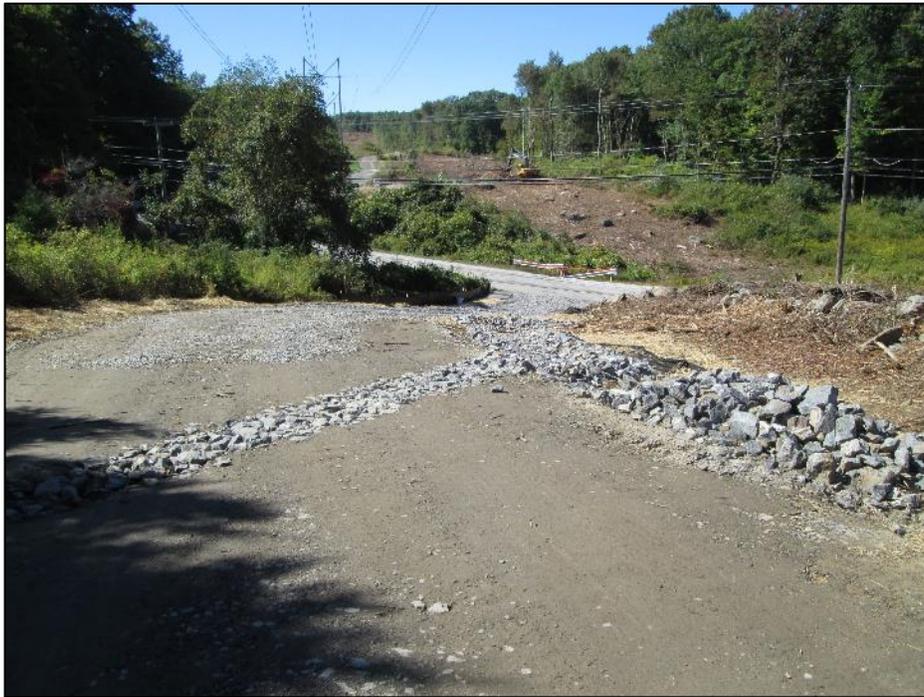
Photo #5: Armored waterbar leading to plunge pool at entrance of Str 179. (9/17)

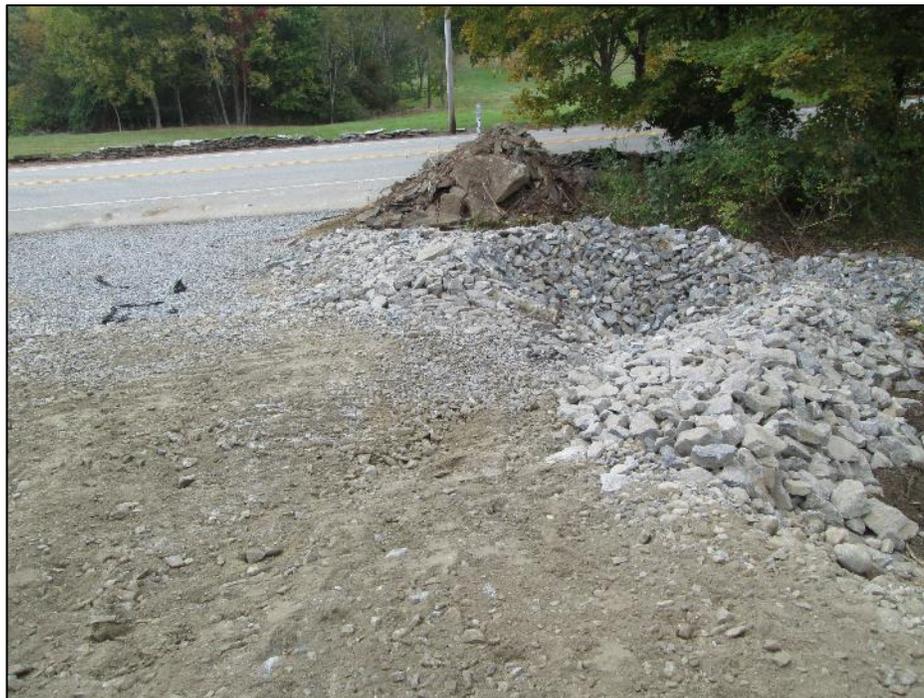
Photo #6: Observed plunge pool at entrance to Str 199.

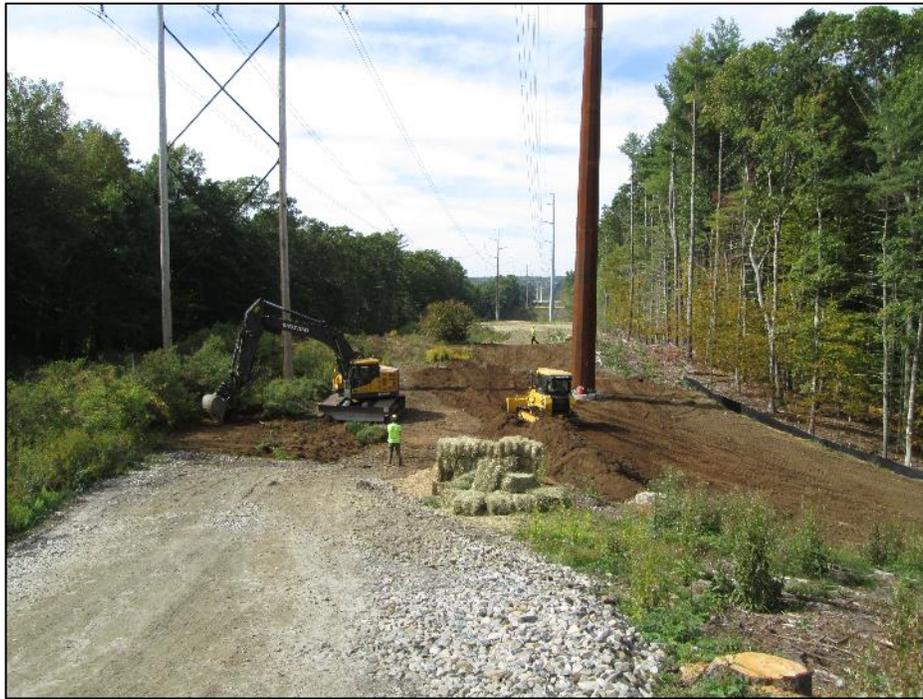
MS17, Str 88: Reclamation and restoration of Str pad 88, seeding and spreading of hay on exposed soil. (Photo 7 & 8)

Photo #7: Striping gravel and fill from Str pad 88.

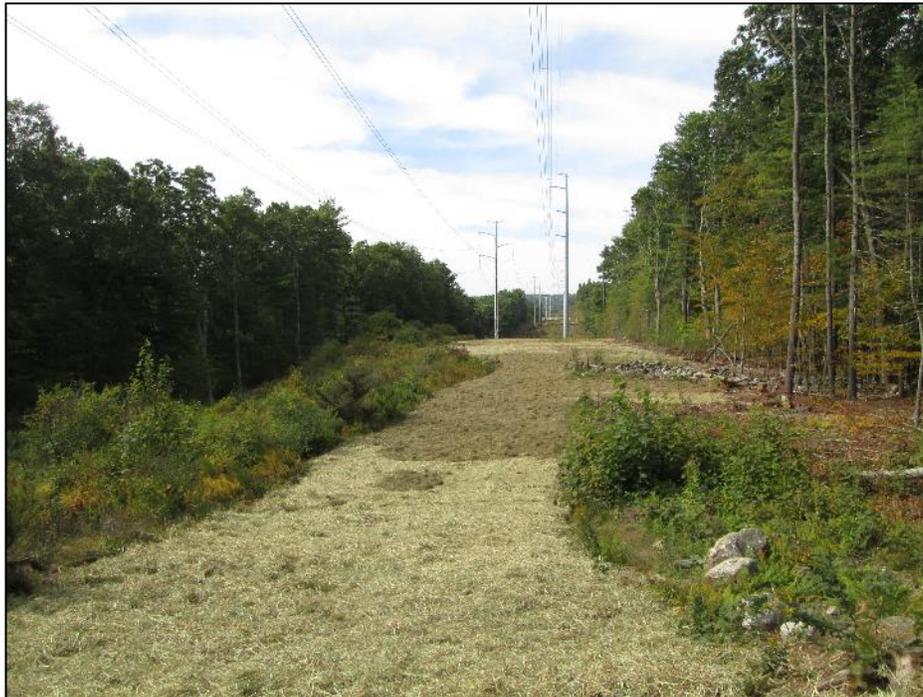
Photo #8: Spreading of hay and seed on exposed topsoil up-line of Str 87.

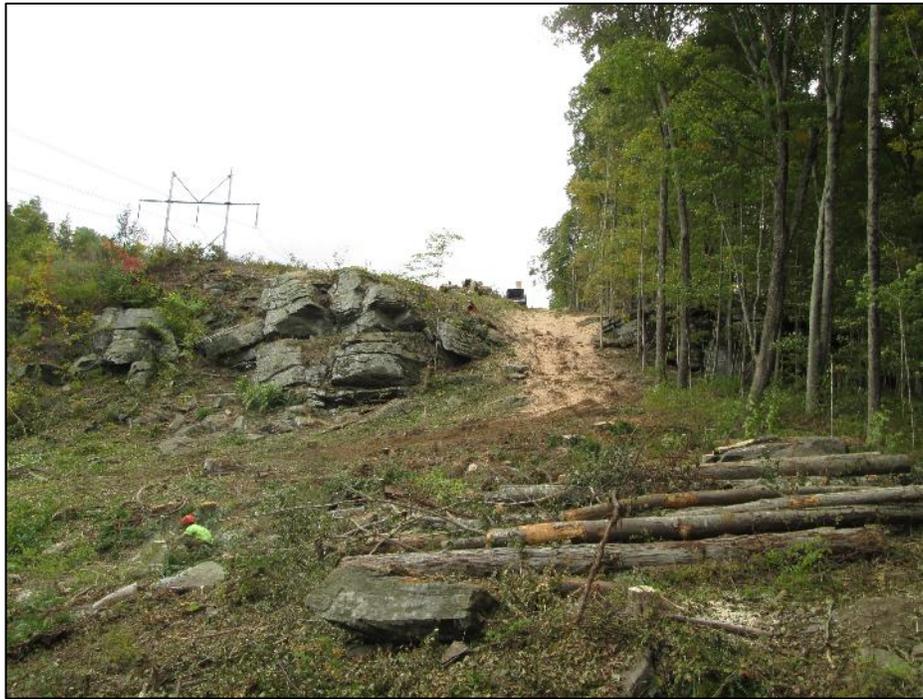
Photo #9: Chipping brush down-slope for stabilization measures up-line of Str 201.

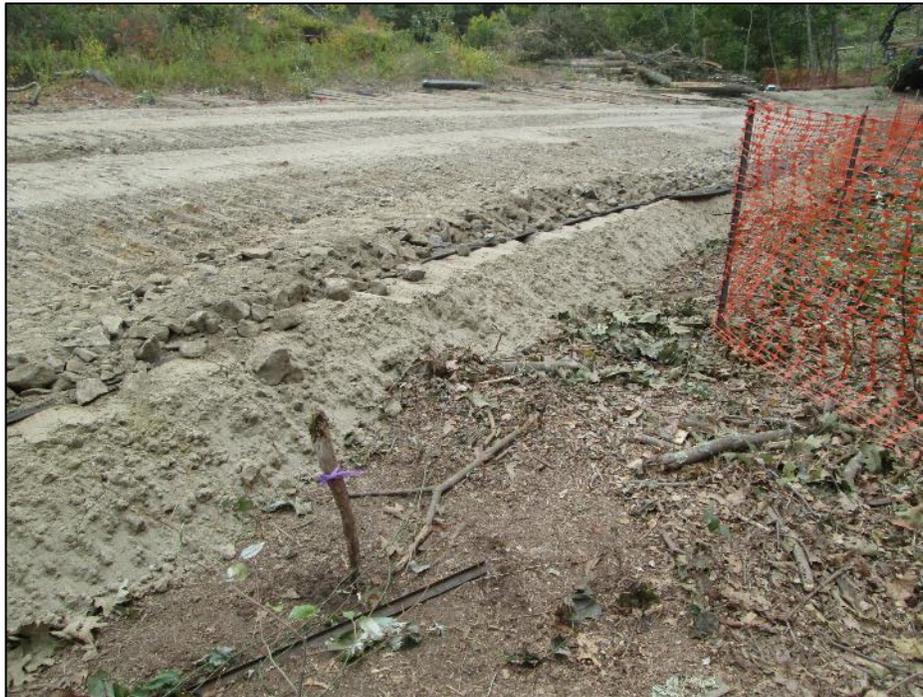
Photo #10: Pad in cultural area installed with a geotextile separation fabric and sand buffer layer prior to the installation of the pad material up-line of Str 202.

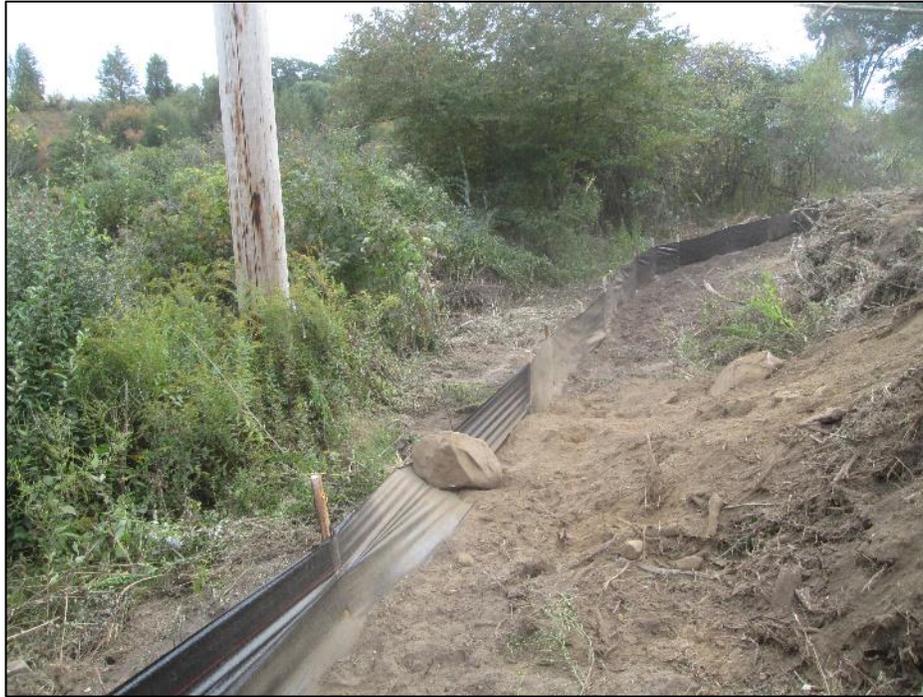
Photo #11: Observed damaged silt fence at Str 222.

Bi-Week (9/24)	All crossings appear to be functioning in accordance with the BMP Manual. No sediment appears to be entering the streams or wetlands.	Continue to follow this procedure.	NA
Erosion and Sedimentation Controls	Interim Week (9/17)	<p>Noted that stockpile areas along ROW are being surrounded with straw wattles and stabilized with blown straw.</p> <p>Str 84-85: Additional silt fence installed, spreading of hay and seeding on exposed topsoil. (Photo 1 & 2)</p> <p>Str 171-172: Gap in silt fence on edge of access road between Structures 171 and 172. (Photo 3 & 4)</p> <p>Str 179: Observed armored waterbar and plunge pool at entrance to Str 179. (Photo 5)</p>	<p>Continue to follow this procedure.</p> <p>Continue to follow this procedure.</p> <p>NA</p> <p>Continue to follow this procedure.</p>	<p>NA</p> <p>NA</p> <p>Northern crew immediately repaired gap in silt fence.</p> <p>NA</p>
	Bi-Week (9/24)	<p>Noted that stockpile areas along ROW are being surrounded with straw wattles and stabilized with blown straw.</p> <p>Str 87-88: Spreading of hay and seeding on exposed topsoil. (Photo 7 & 8)</p> <p>Str 199: Observed plunge pool at entrance to Str 199. (Photo 6)</p> <p>Str 201: Chipping brush down slope as a stabilization measure. (Photo 9)</p> <p>Str 222: Observed silt fence damaged by falling boulder. (Photo 11 & 12)</p>	<p>Continue to follow this procedure.</p> <p>NA</p>	<p>NA</p> <p>NA</p> <p>NA</p> <p>NA</p> <p>Northern crew immediately repaired damaged silt fence.</p>

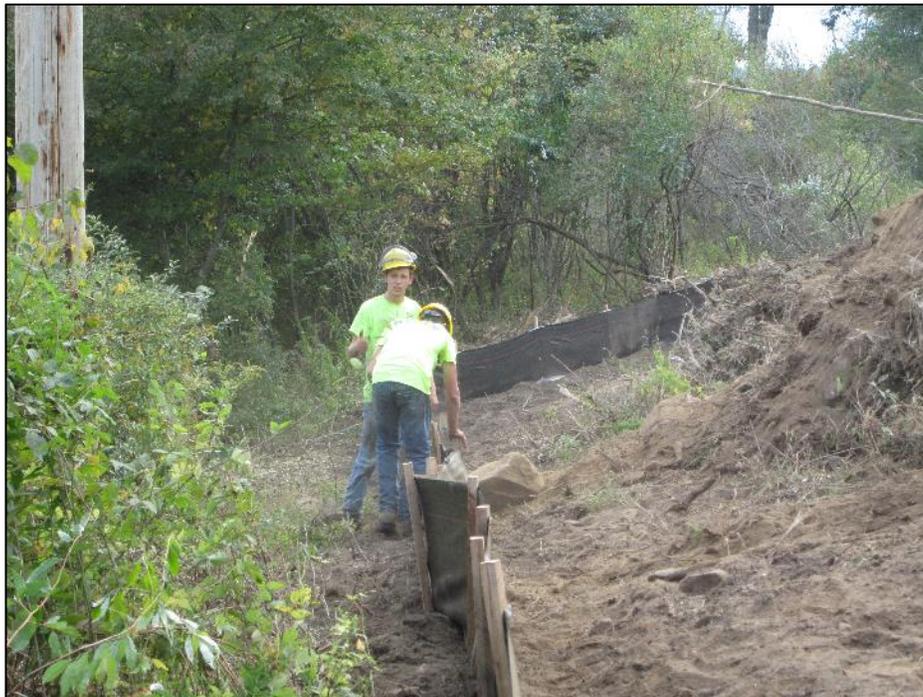
Photo #12: Northern crew repaired and stabilized damaged silt fence at Str 222 immediately.
