Docket No. 424 – Development and Management Plan Inspection

The Connecticut Light and Power Company Certificate of Environmental Compatibility and Public Need for the Connecticut portion of the Interstate Reliability Project.

Interim Week Inspection:

Date: October 17, 2014

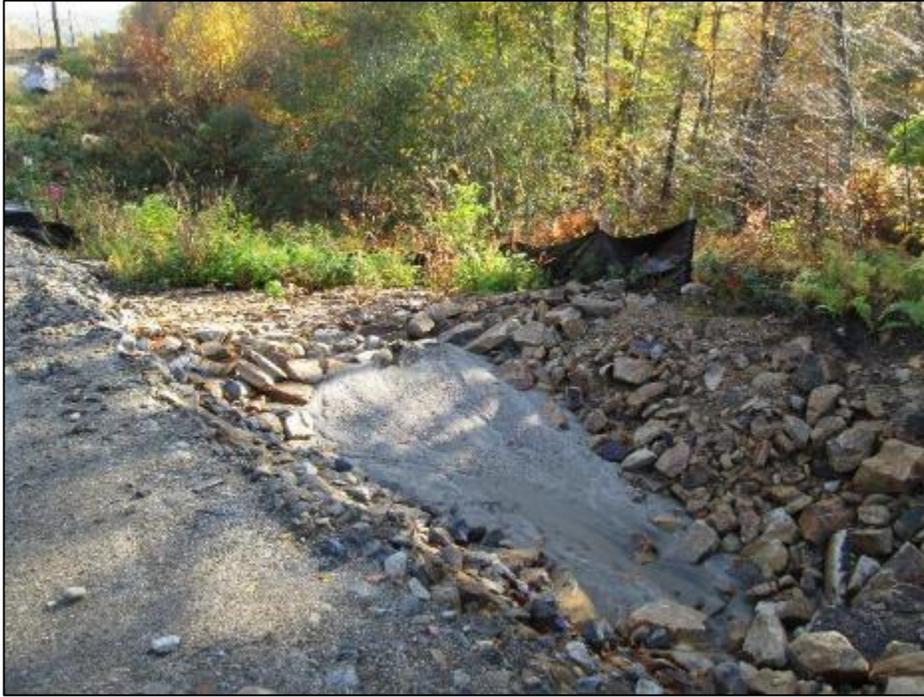
Photo #1: Plunge pool on edge of access road up-line of Str 59 with 9-10 inches deep of sediment. (10/17)

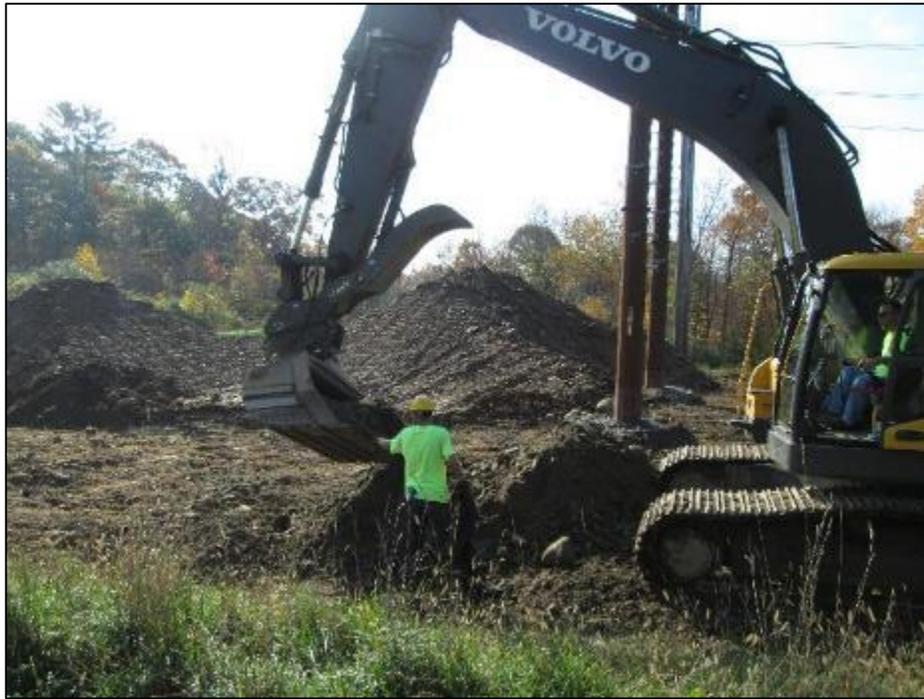
MS18, Str 93: Striping gravel and fill from pad, restoration and reclamation of Str pad 93. (Photo 3)

- **CSSS:** Non-project related work inside station.
- Drilling operations ongoing at Str 115, and Str 121.
- Str 93: Construction pad 93 has been removed, restored and stabilized with straw mulch to their original, pre-construction grades and slopes. (Photo 3)
- Construction pads for structure assembly and erection that were removed, with their areas restored to original grades and slopes: Str 84-87, 93-100, and 269-270.

Photo #3: Removal of stone, fill, and filter fabric from Str pad 93. (10/17)

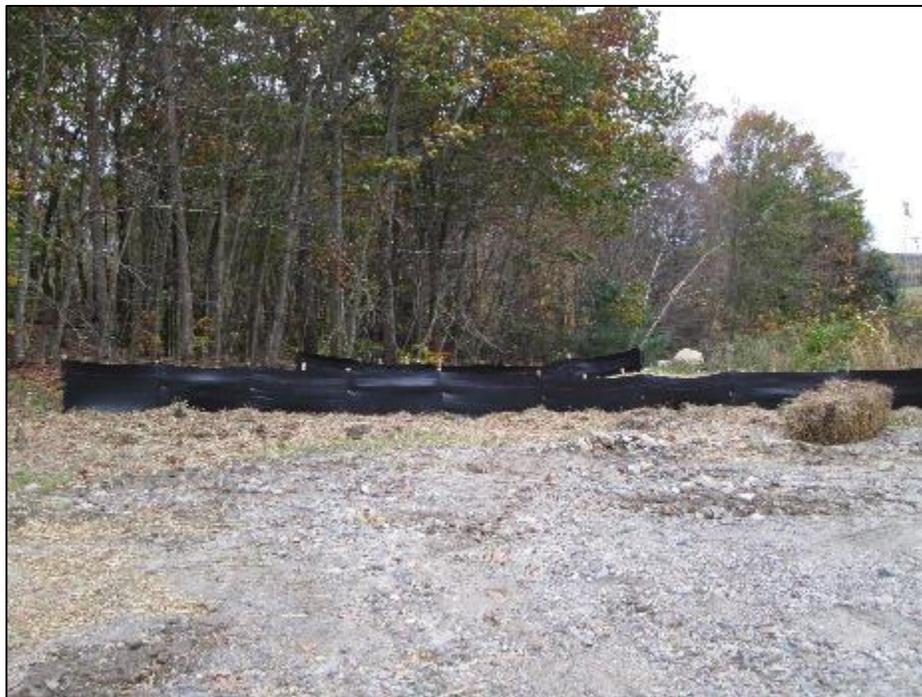
Photo #4: Erosion control measures down-line of Str 57.

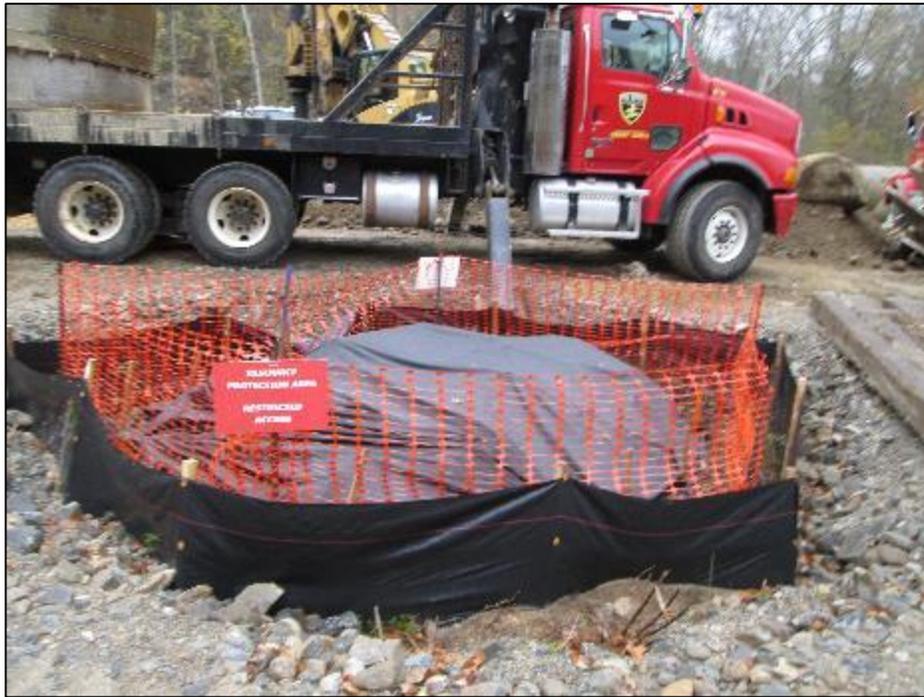
Photo #5: Cultural resource protection measures over rock feature at Str 186.

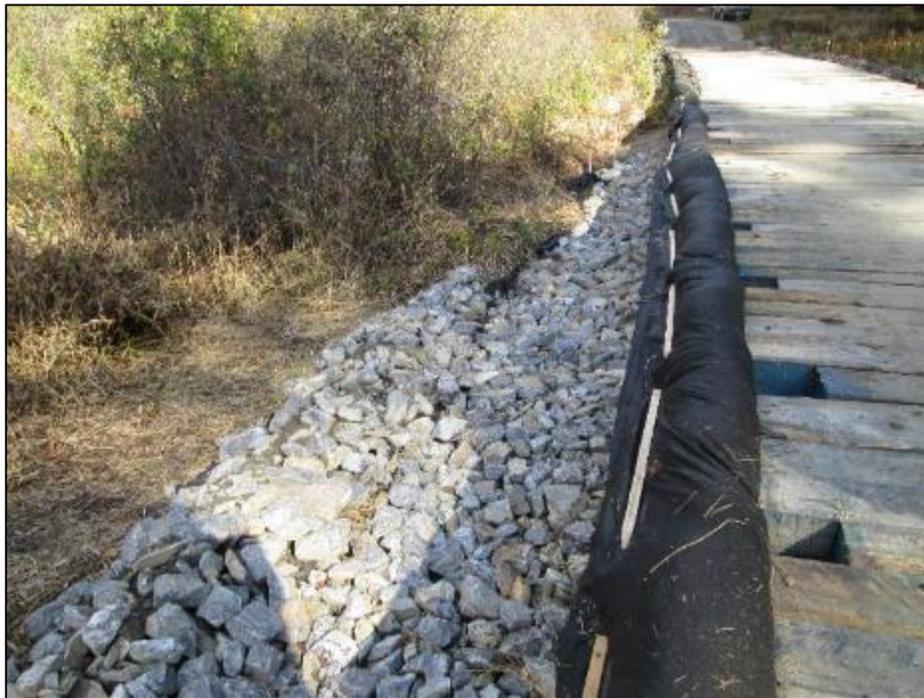
Photo #6: Water conveyance structure up-line of Str 328. (10/17)

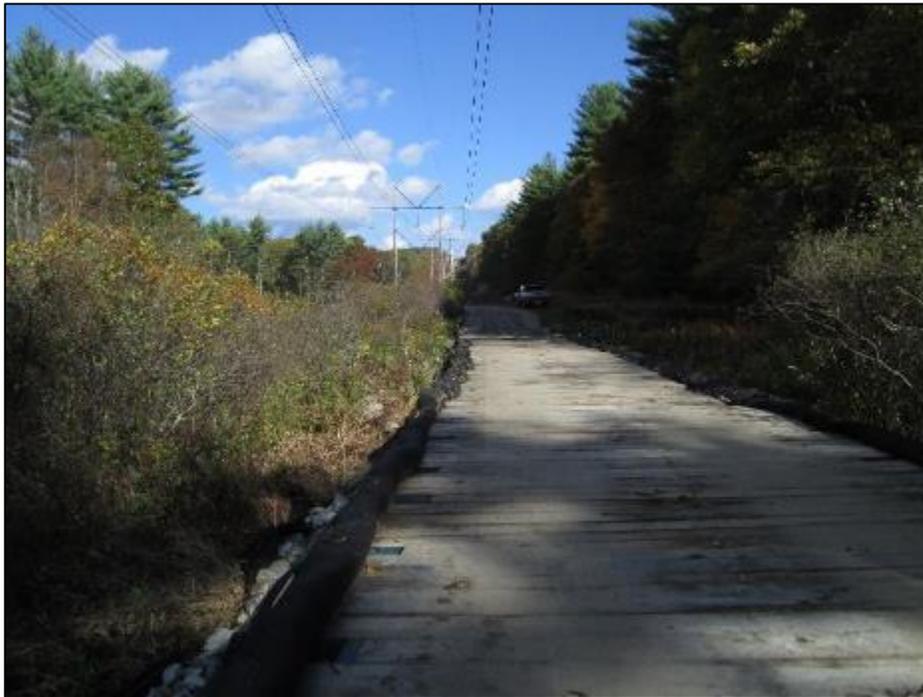
Photo #7: Wetland bridge crossing with wetland mats and geotextile fabric. (10/17)

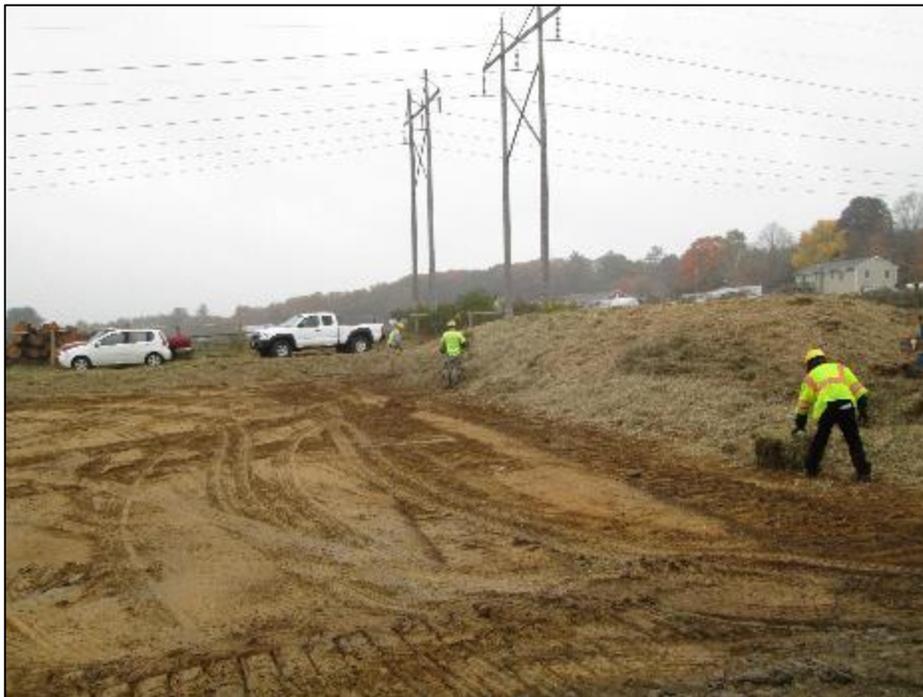
MS48, Str 243: Installation of access road, stabilization of exposed topsoil with spread hay (Photo 8)

Photo #8: Hay stabilization over exposed topsoil at Str 243.
