Docket No. 424 – Development and Management Plan Inspection

The Connecticut Light and Power Company Certificate of Environmental Compatibility and Public Need for the Connecticut portion of the Interstate Reliability Project.

Interim Week Inspection:

Date: January 22, 2015

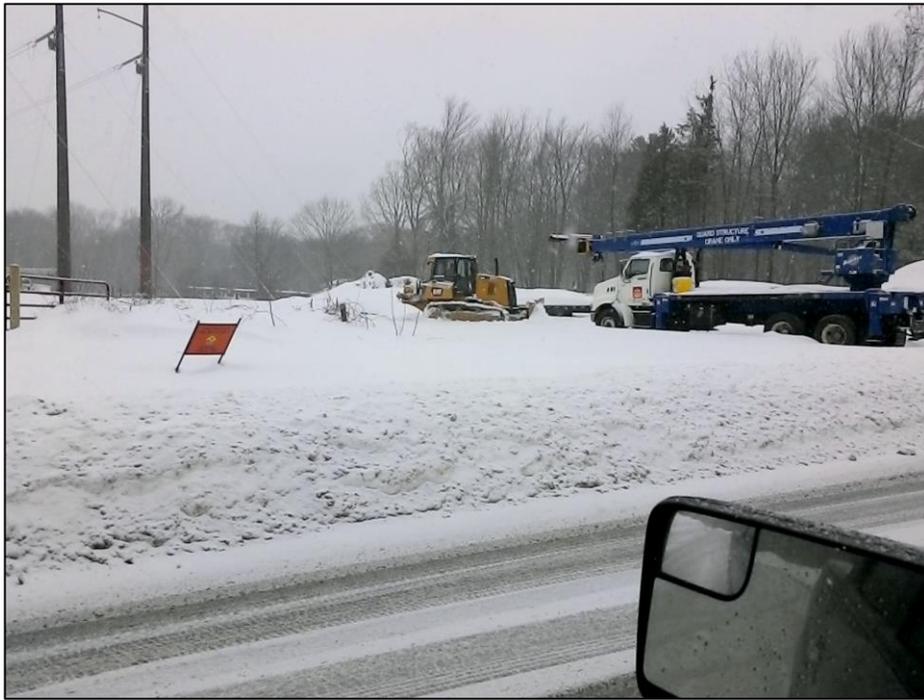
MS24, Str 124: Snow Removal. (Photo 1)

Photo #1: Snow Removal at Str 124. (1/30)

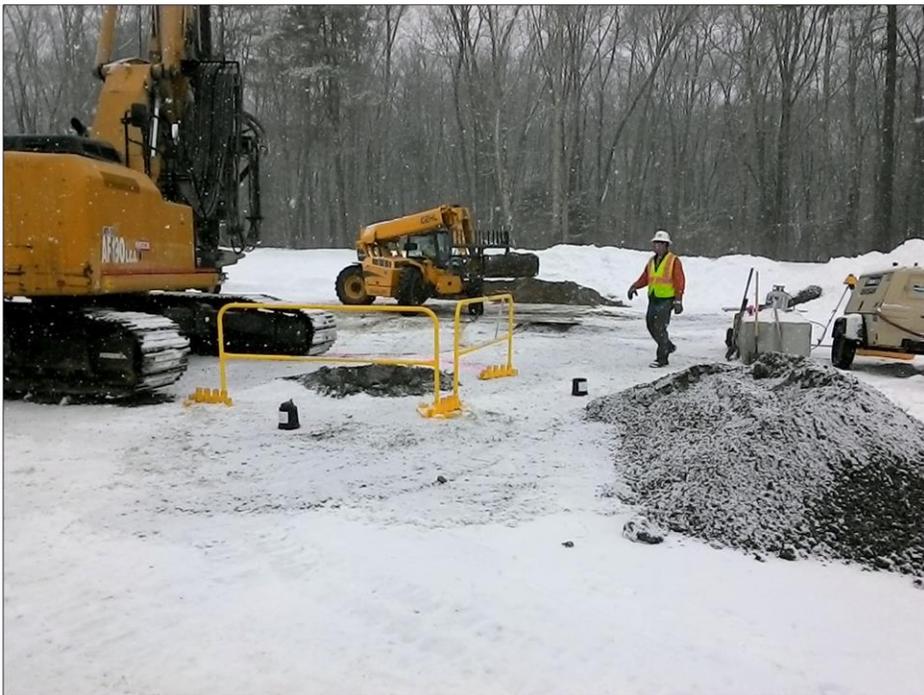
MS38, Str 198: Drilling Operation (Photo 2)

Photo #2: Drilling Operation at Str 198. (1/30)

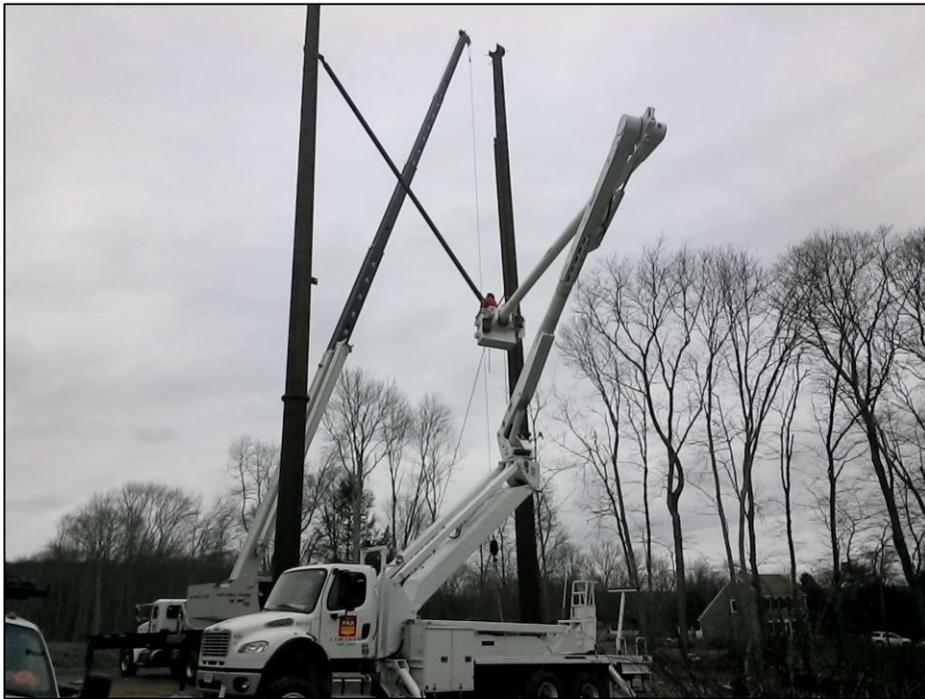
MS34, Str 177: Structure erection. (Photo 3)

Photo #3: Structure 177 erection. (1/22)

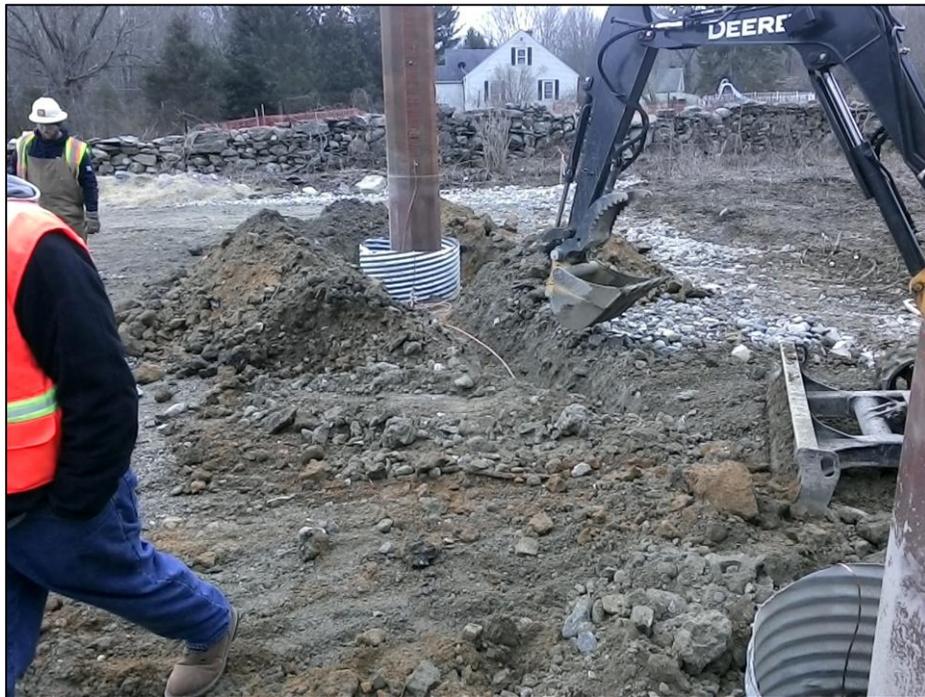
MS34, Str 178: Structure Grounding (Photo 4)

Photo #4: Structure 178 Grounding. (1/22)

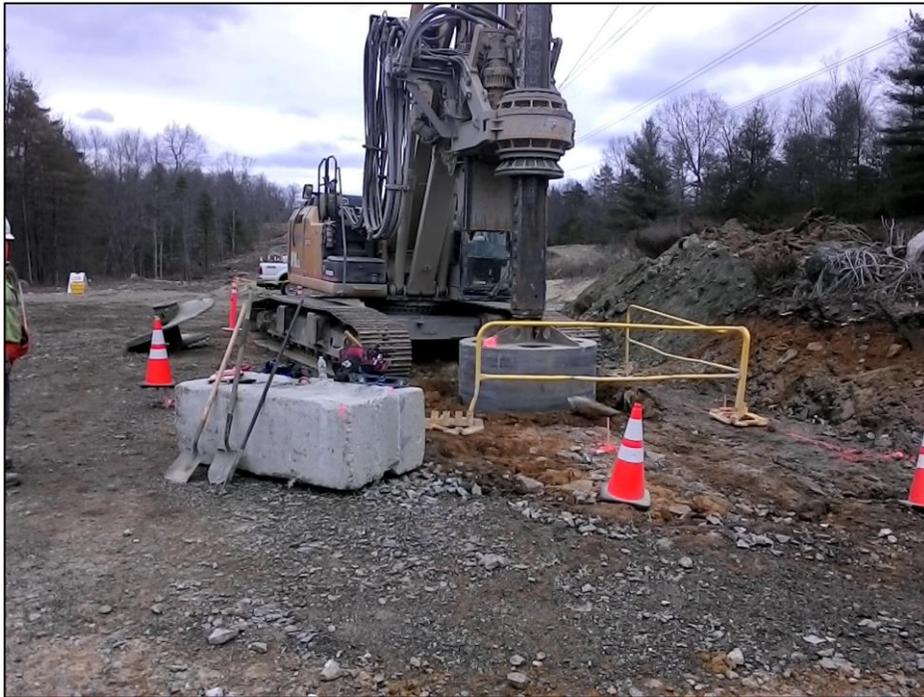
MS38, Str 196: Drilling Operation (Photo 5)

Photo #5: Drilling Operation at Str 196. (1/22)

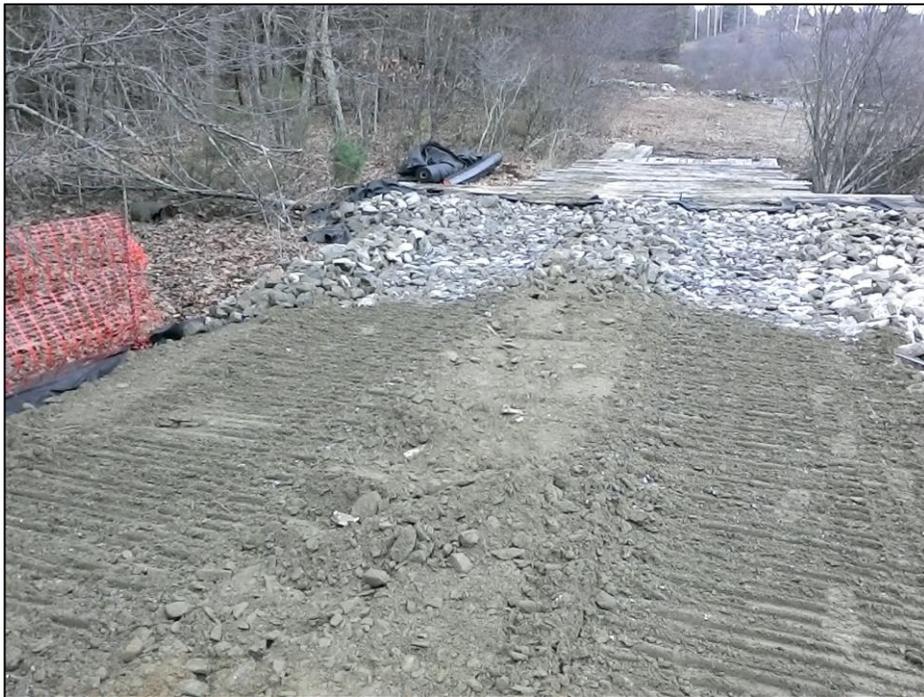
MS49, Str 253: Road Construction (Photo 6)

Cultural Resources	Interim Week (1/22)	<p>Potential Cultural Resource Areas protected in accordance with D&M Plans.</p> <p>Str 253: Road construction throughout the relocated roadway area utilizing the approved access method through cultural resource area (Geotextile base layer with roadway stone above).</p>	<p>NA</p> <p>NA</p>	<p>NA</p> <p>NA</p>
	Bi-Week (1/28)	<p>NA</p>

Photo #6: Road Construction in the vicinity of Str 253. (1/22)

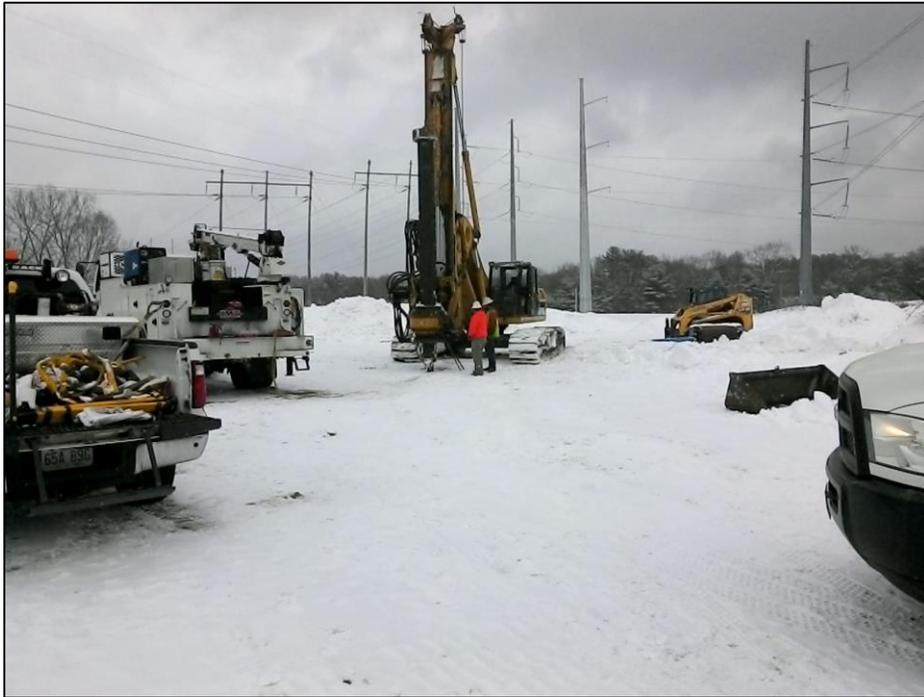
MS53, Str 264: Preparation for Drilling Operation (Photo 7)

Photo #7: Preparation for drilling for Str 264. (1/30)

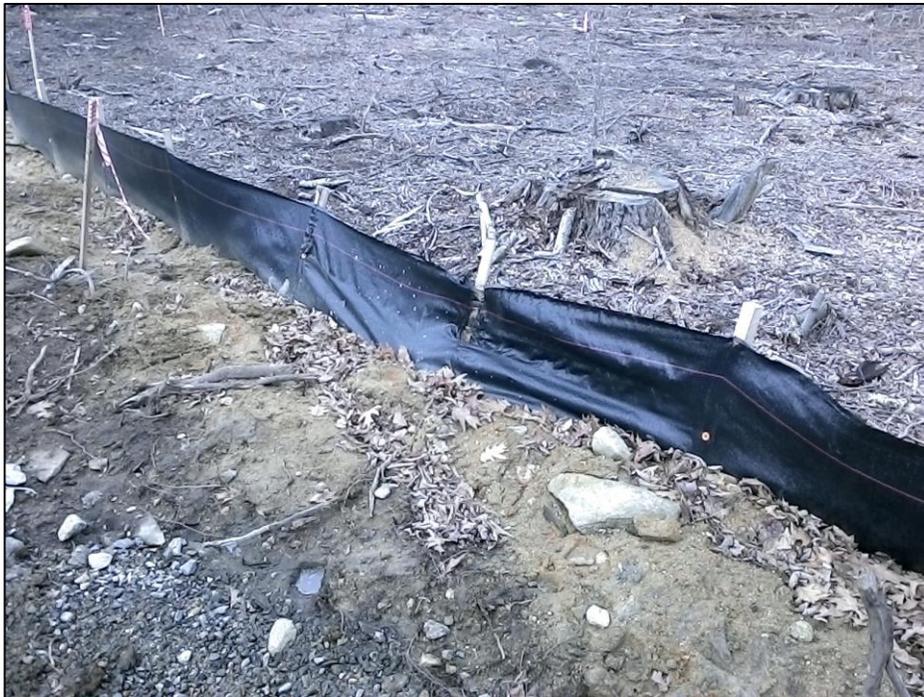
Photo #8: Perforation in silt fence down-line of Str 178. (1/22)

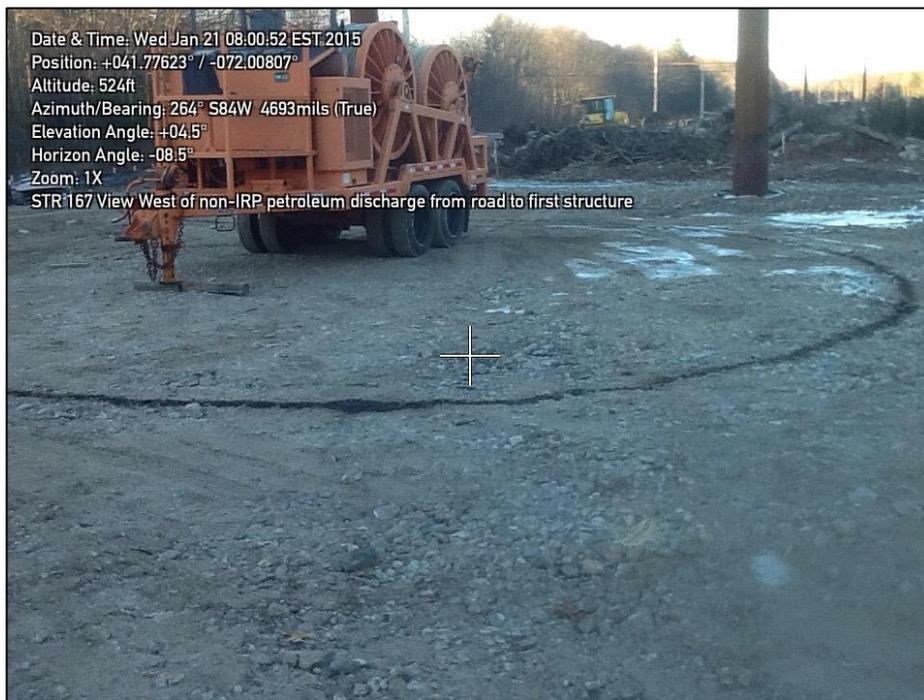
Spills and Material Storage.	Interim Week (1/22)	<p>Str 167: T. Ramborger indicated a non-project related Petroleum based spill on pad 167. (Photo 10)</p> <p>Spill kits noted on all visited sites.</p> <p>Str 201: Observed child pool beneath Drill.</p>	<p>Continue to follow this procedure.</p> <p>Continue to follow this procedure.</p>	<p>NU dispatched Clean Harbors immediately to clean up the area. (Photo 11)</p> <p>NA</p> <p>NA</p>
	Bi-Week (1/28)	<p>Str 197: At 11:45 am Contractors observed a leak coming from one of the air-compressors associated with rock drilling. After further inspection, Contractors determined a diesel fuel hose broke and discharged fuel oil to the surrounding area. It is estimated approximately 15 Gallons may have leaked onto the construction pad up-line of the drilling area.(Photos 13-16)</p>		<p>J. Roberge (PAR Environmental Manager) was onsite and indicated that the Crew immediately began containing fuel oil with spill kits. J.R. also indicated that a McVac Emergency Response Unit was immediately notified and was on its way and that D.E.E.P. would be notified. T. Ramborger indicated that all necessary parties (NU, Burns and McDonnell) had been notified.</p> <p>[Follow-up: T. Ramborger indicated that DEEP representative arrived and inspected site and was satisfied that all parties addressed containment and mitigation of the spill appropriately]</p>

Photo #10: Evidence of petroleum based leakage on pad 167 taken on 1/21/2015. Spill was not the result of any project work or personnel. (Photo courtesy R. Gibson of AECOM) (1/22)

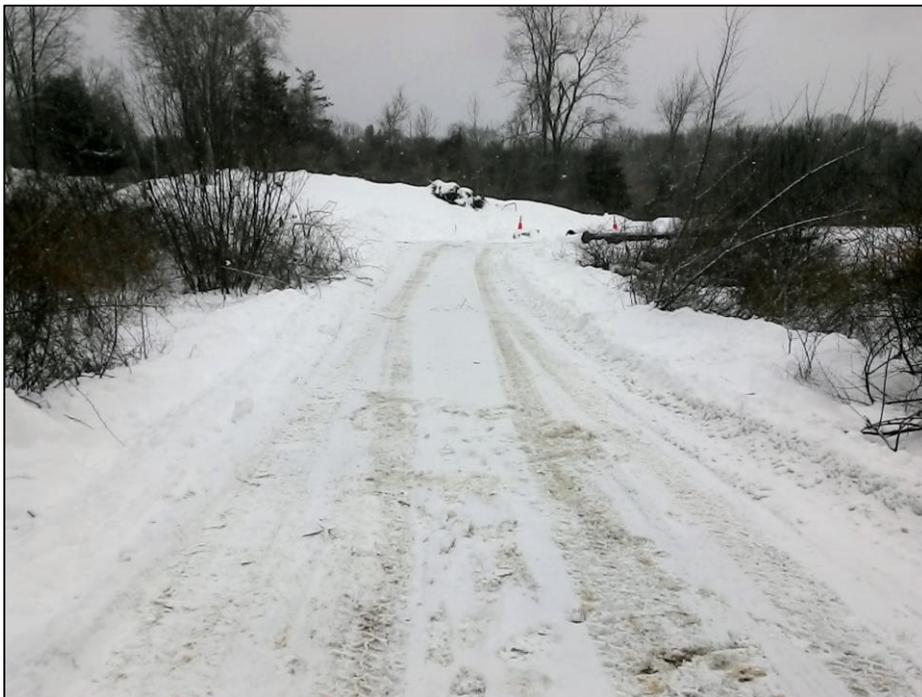
Bi-Week (1/15)	Observed snow removal in accordance with recently amended snow removal protocol. (Photo 12)	Continue to follow this procedure.	NA

Photo #12: Example of snow removal from a wetland area in accordance with recently amended snow removal protocol. (1/30)

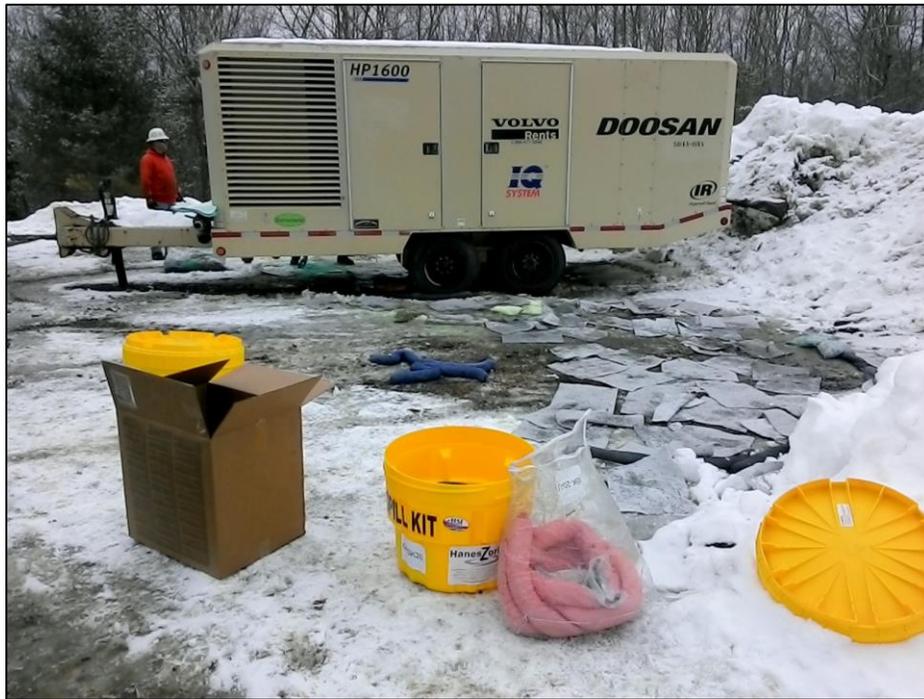
Photo #13: Area of 15 gallon diesel spill on pad 197 (1/30)

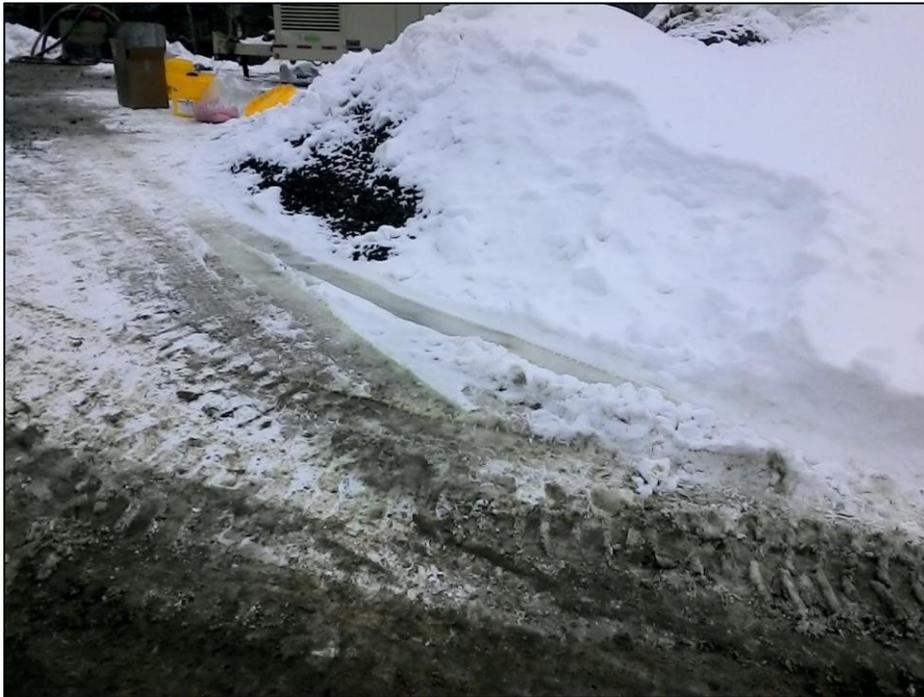
Photo #15: Area of potential seepage of diesel fuel through direct imbed stone pile on pad 197. According to J. Roberge, area will be thoroughly examined and cleaned by McVac emergency response (1/30)

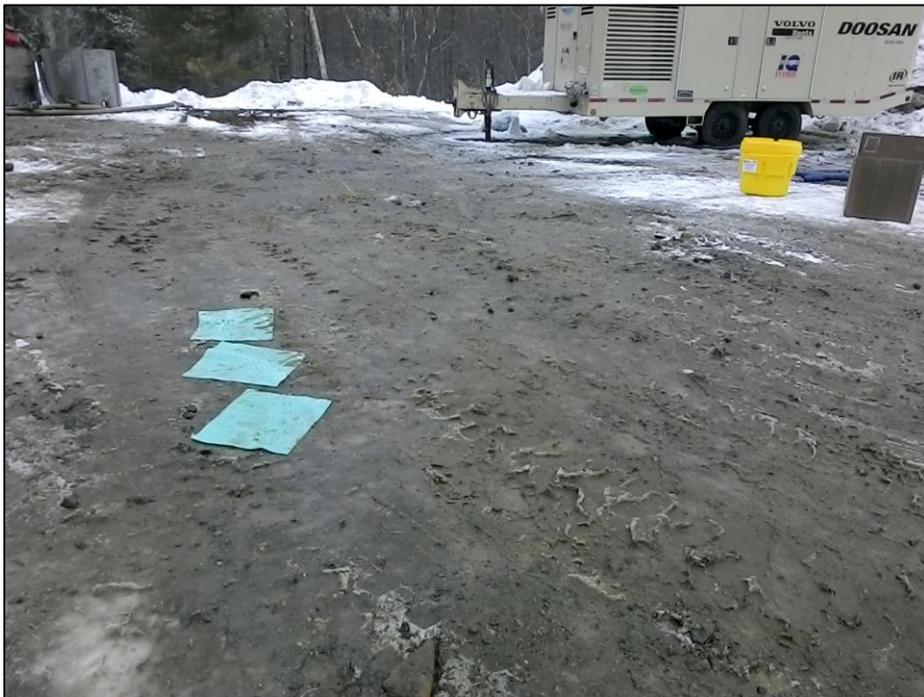
Photo #16: Small amount of diesel fuel tracked away from main spill area on pad 197. (1/30)
