Docket No. 424 – Development and Management Plan Inspection

The Connecticut Light and Power Company Certificate of Environmental Compatibility and Public Need for the Connecticut portion of the Interstate Reliability Project.

IRP Overhead ROW

Interim Week Inspection:

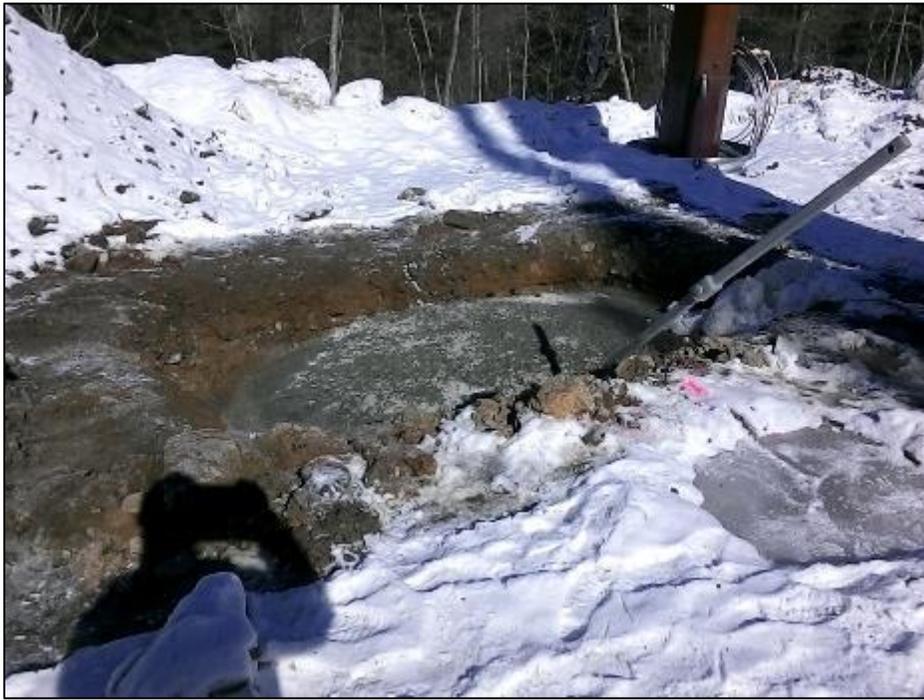
Photo #1: Anchor installation at Str 196. (3/6)

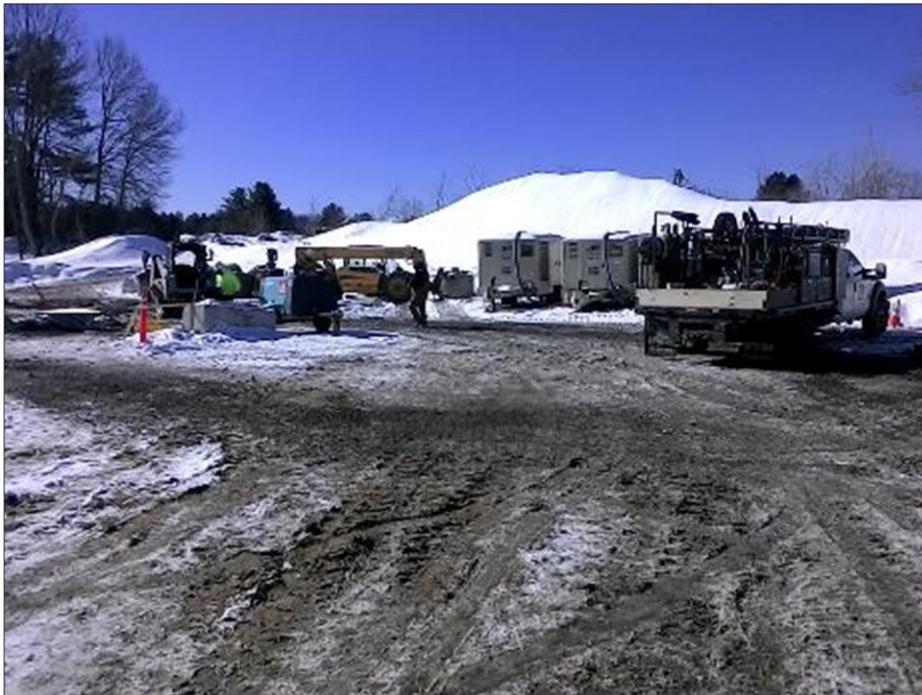
Photo #2: Driller Demobilizing from Str 238. (3/6)

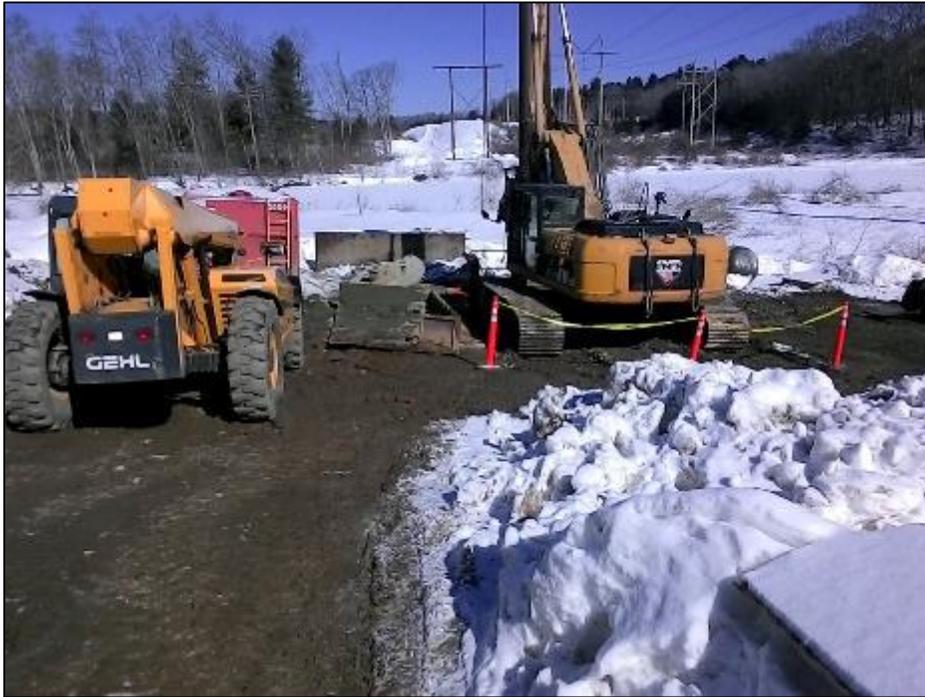
Photo #3: Drilling operations at Str 239.(3/6)

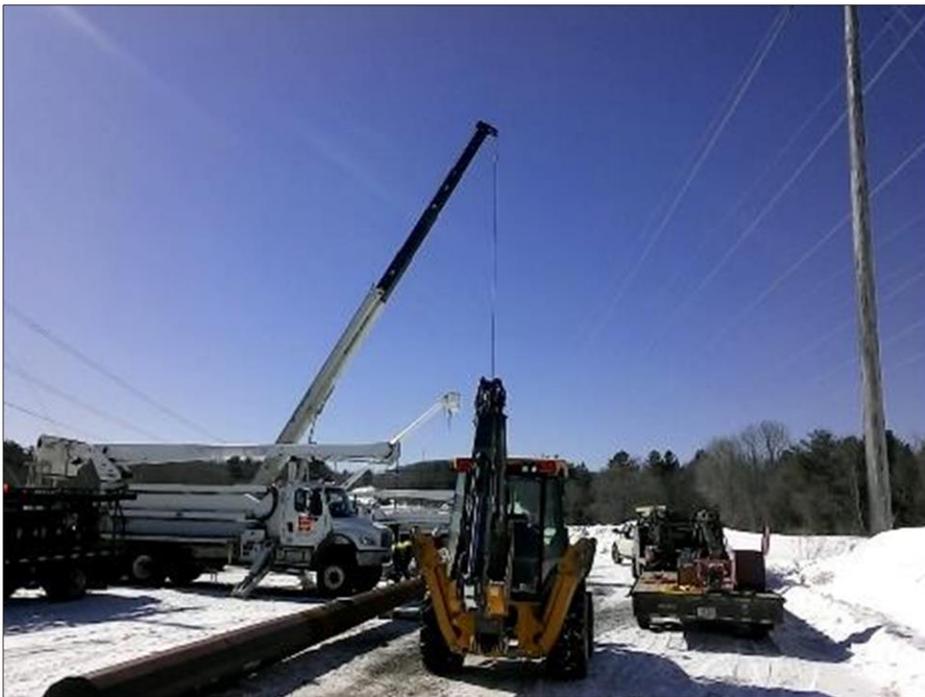
Photo #4: Str 257 erection. (3/6)

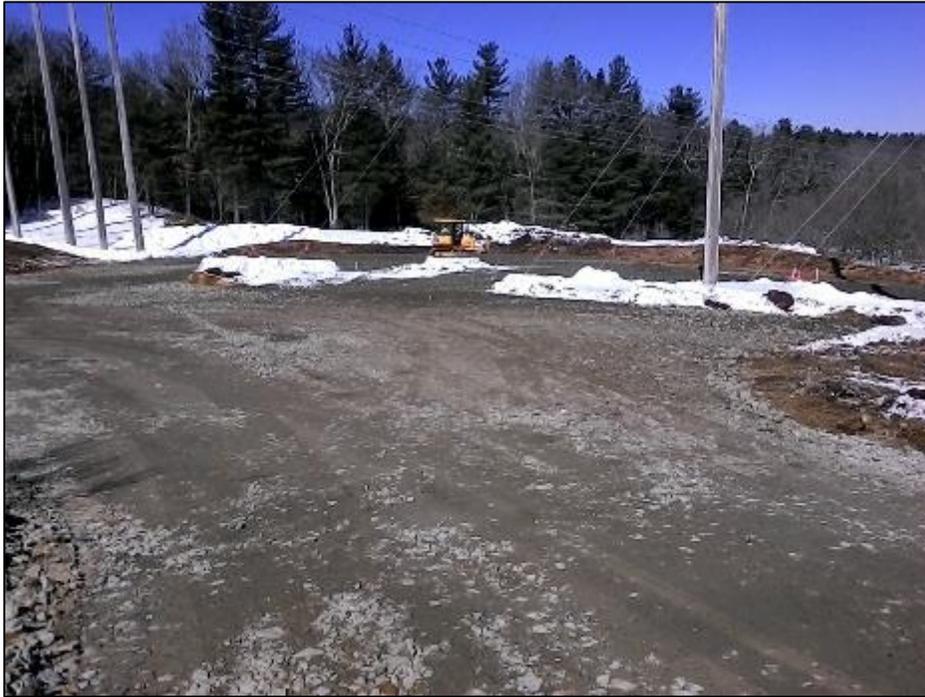
Photo #5: Str 255 pad construction. (3/6)

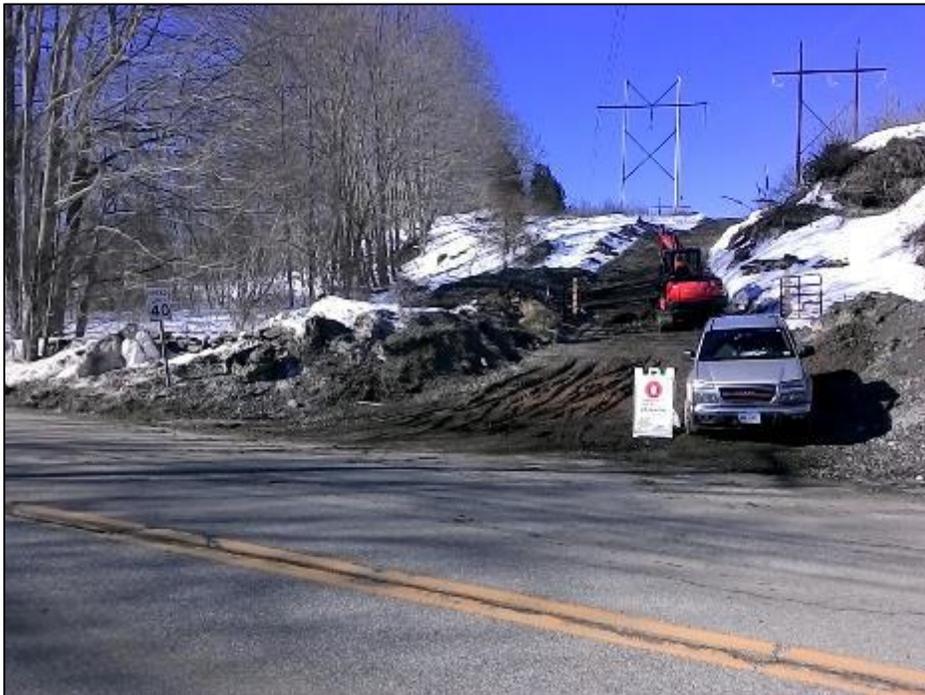
Photo #6: Repairing and re-grading Str 199 access road in accordance with BMP manual. (3/12)

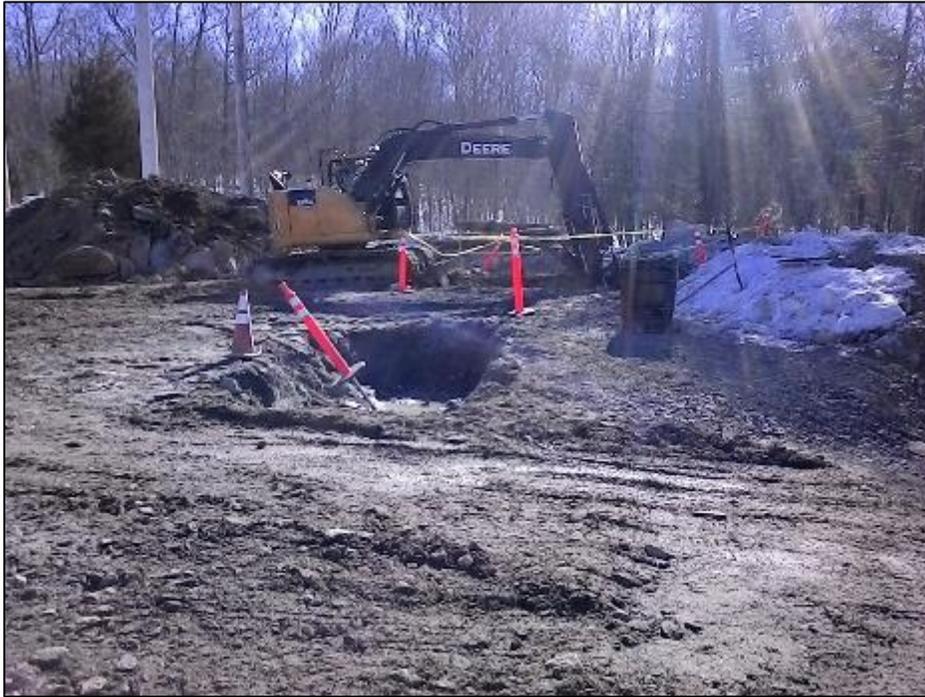
Photo #7: Str 204 anchor installation. (3/12)

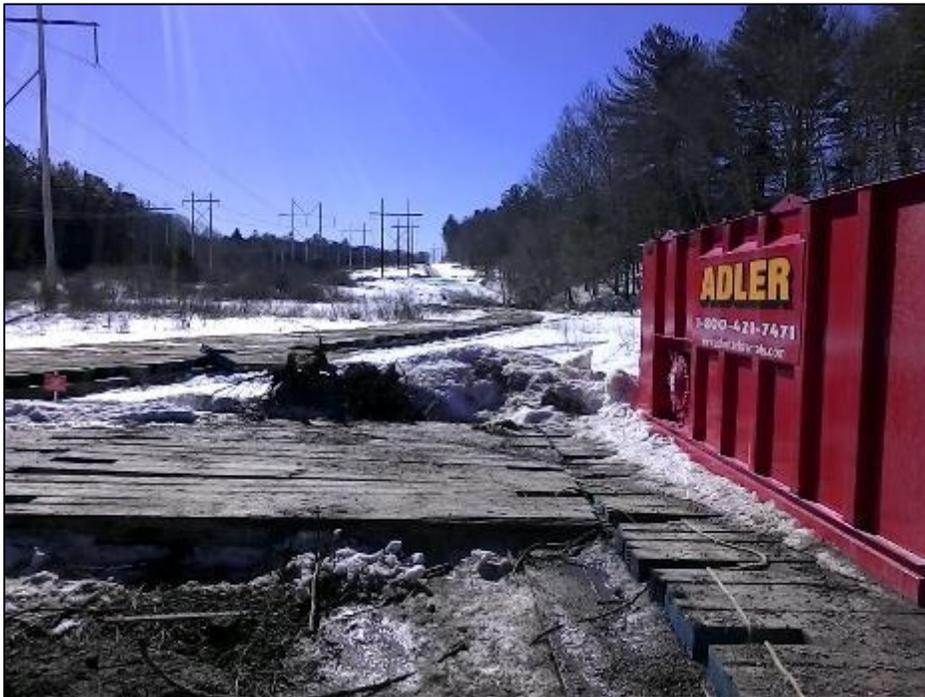
Photo #8: Temporary wetland timber mat installation at Str 237. (3/12)

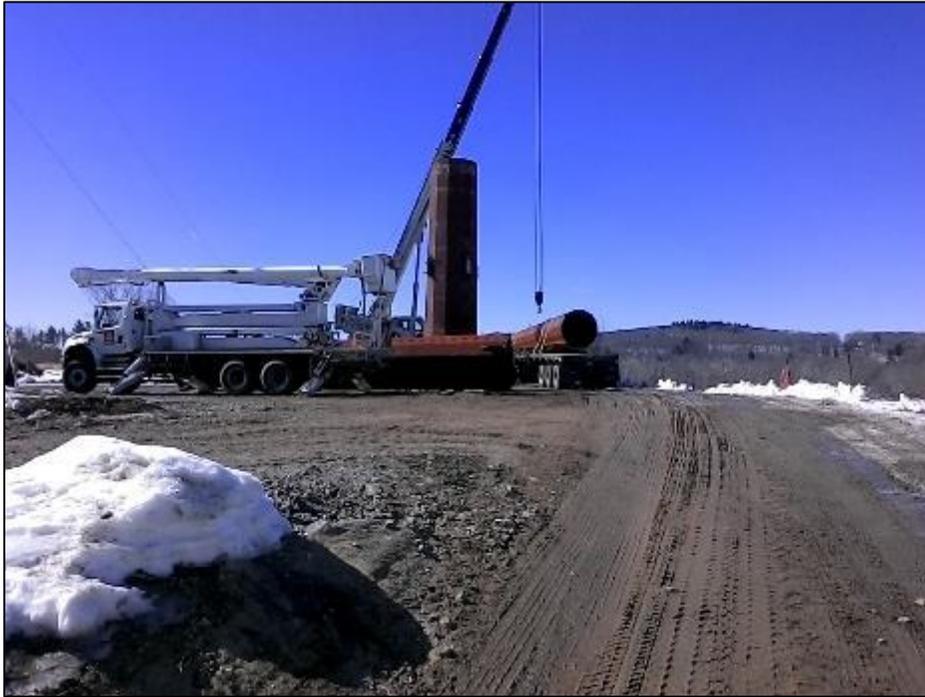
Photo #9: Str 241 erection. (3/12)

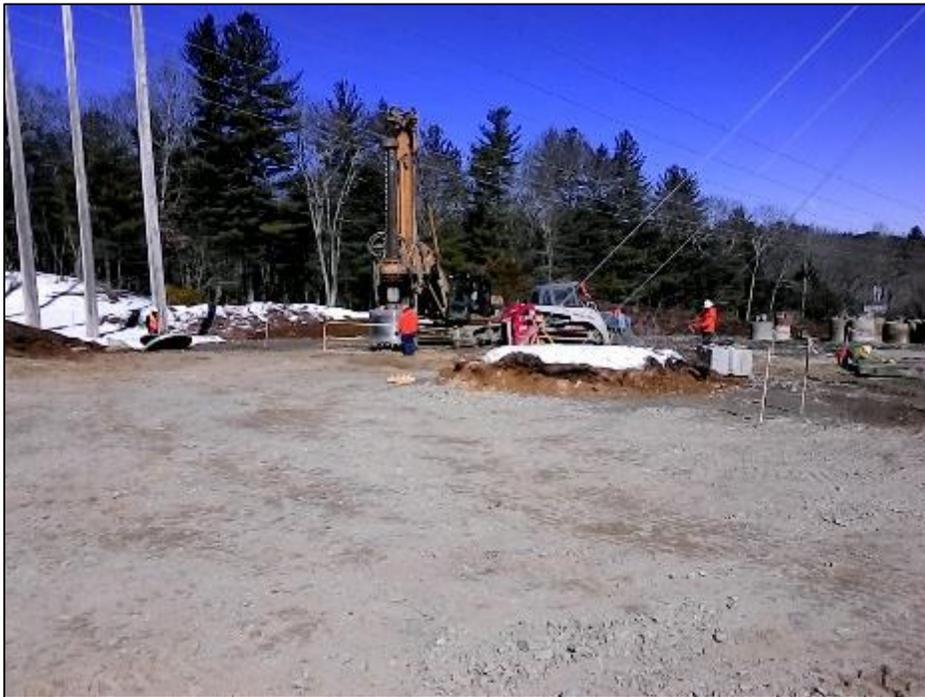
Photo #10: Drilling Operations at Str 255. (3/12)

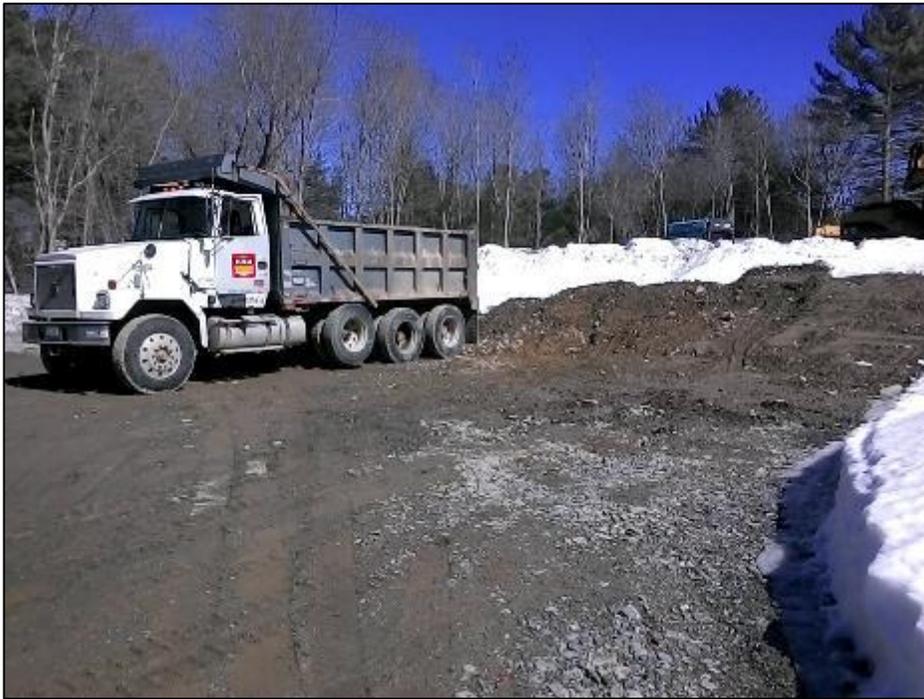
Photo #11: Mobilizing for Drilling Operation at Str 323. (3/12)

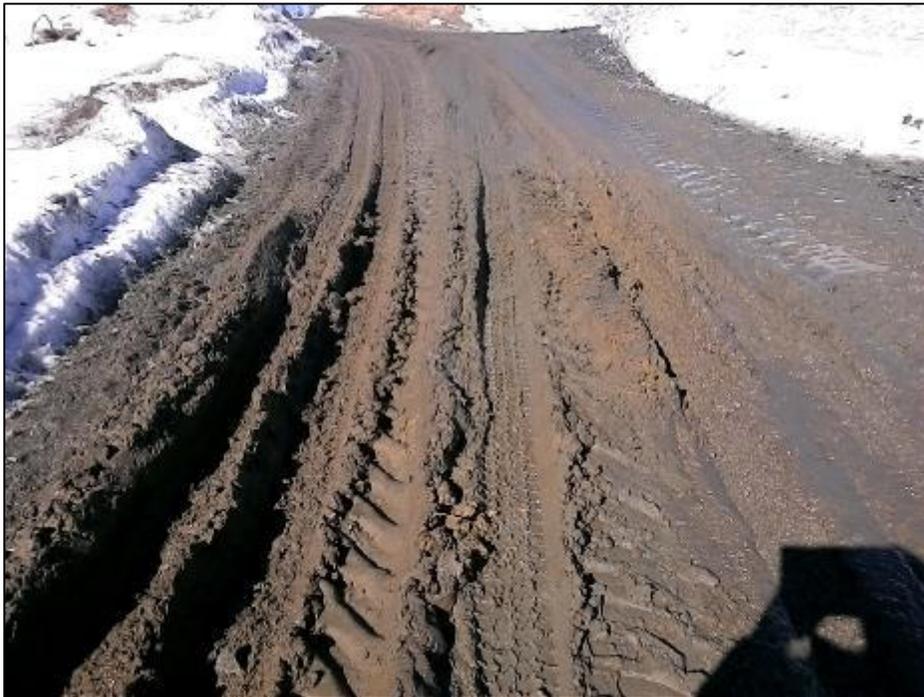
Areas of Inspection		Observation:	Recommended Action:	Corrected Action:
Access Roads and Adjacent Roadways	Interim Week (3/6)	All observed pads and ROW's free of snow.	NA	NA
	Bi-Week (3/12)	ROW's and access roads in poor condition due to rain and snow melt. Roads contain many ruts, as well as large areas of mud and/or standing water. However, there was no observed instance of sediment entering a resource area. (Photo 12)	Re-grade access roads and repair all ruts as necessary.	Northern is aware of these issues and is in the process of fixing and re-grading these areas as quickly as possible.
Vegetative Clearing Limits (Including trees to save or danger trees noted.)	Interim Week (3/6)	Mechanized Clearing along IRP ROW complete.	NA	NA
	Bi-Week (3/12)	Mechanized Clearing along IRP ROW complete.	NA	NA
Water Crossings	Interim Week (3/6)	All crossings appear to be functioning in accordance with the BMP Manual. No sediment appears to be entering the streams or wetlands.	Continue to follow this procedure.	NA

Photo #12: Rutting and muddy conditions along ROW up-line of Str 237. (Typical of most of the visited sites. However, there was no visible evidence of sedimentation entering resource areas from rutted access roads at any visited sites.) (3/12)

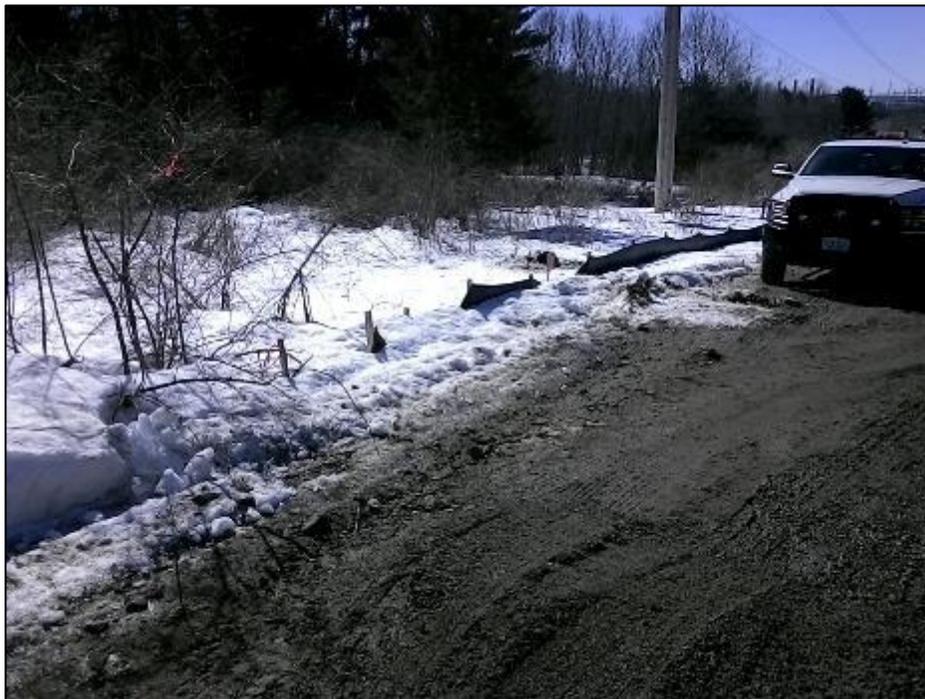
Photo #13: Majority of visited sites with buried silt fence. Recommend fixing any damaged areas of fence in locations of excessive snow melt. (3/12)

T. Ramborger indicated that a list has been compiled by the Environmental Inspectors that lists potential erosion “hot spot” areas. These areas include any project-related sites that could generate excess runoff or sediment in the event of rain and/or snow melt. (See Notes)	Recommend installation of additional silt fence and hay bales, as needed, in all potentially problematic areas. Continue to monitor sites as weather gets warmer and during any rain event.	NA
Erosion and Sedimentation Controls	Bi-Week (3/12)	Noted that numerous areas of silt fence are in need of repair due to the excessive snows received at most sites. (Photo 13)	Recommend repairing these disturbed areas of fence when conditions allow, especially where the fence is disturbed down to ground level. Continue to monitor and repair silt fence as snow melt continues and more areas of damage may be revealed.	Northern is aware of damaged site controls and will attempt to monitor and maintain them as required.
