Docket No. 424 – Development and Management Plan Inspection

The Connecticut Light and Power Company Certificate of Environmental Compatibility and Public Need for the Connecticut portion of the Interstate Reliability Project.

IRP Overhead ROW

Interim Week Inspection:

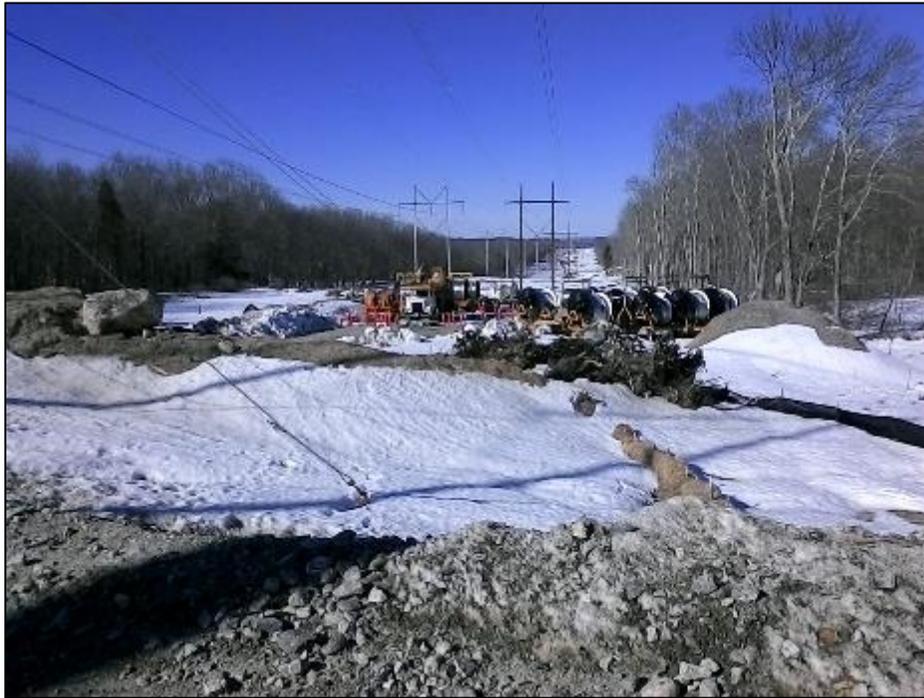
MS24, Str 124: Conductor stringing operations. (Photo 1)

Photo #1: Pulling cable at Str 124. (3/19)

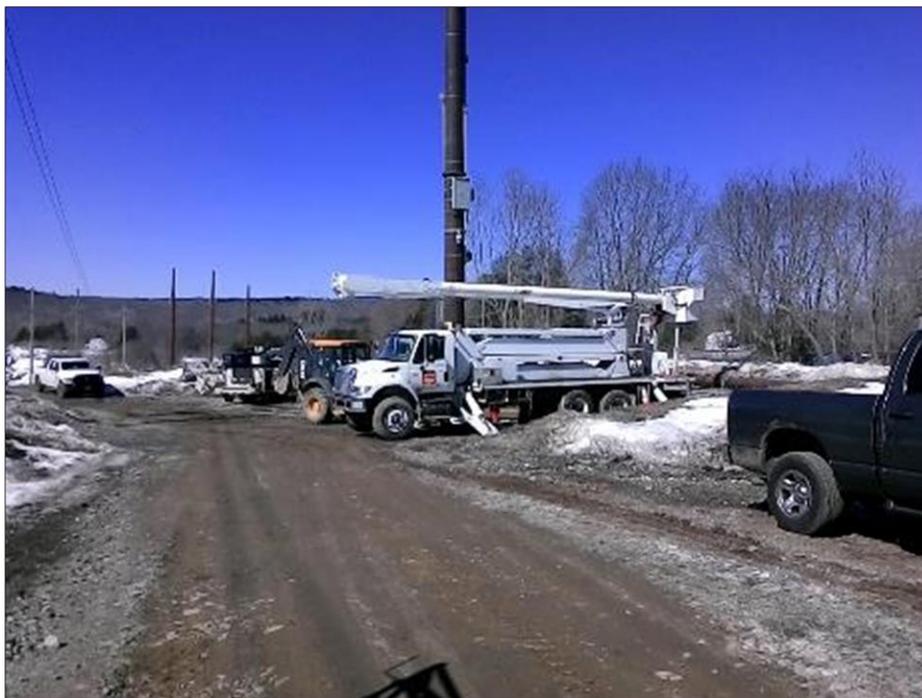
MS42, Str 215: Structure Erection. (Photo 2)

Photo #2: Structure 215 erection. (3/19)

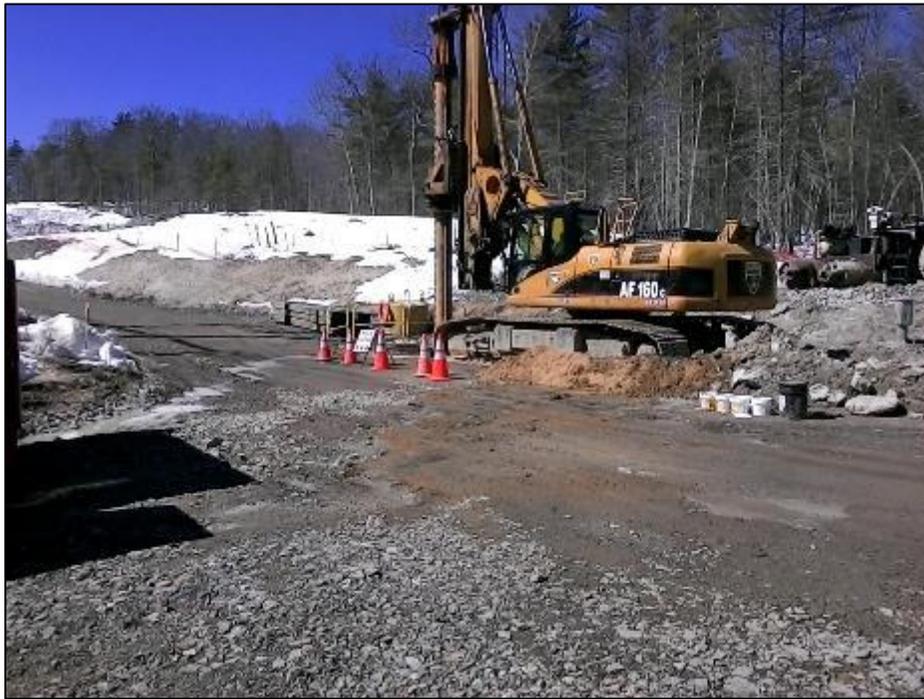
MS66, Str 337: Drilling Operations. (Photo 3)

Photo #3: Drilling operations at Str 337. (3/19)

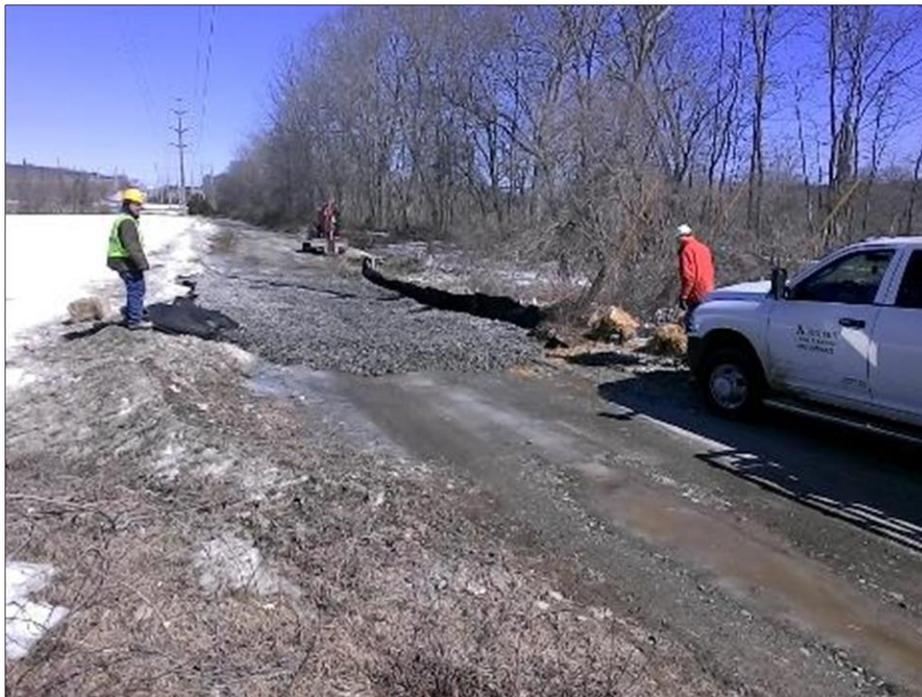
| Areas of Inspection | | Observation: | Recommended Action: | Corrected Action: |
|--|---|---|---|---|
| Access Roads and Adjacent Roadways | Interim Week (3/19) | Noted all visited ROW's and access roads to be in good condition. T. Ramborger indicated that Northern has worked as fast as possible to repair all access roads damaged by snow plowing or during snow melt. (Photo 4) | Continue to follow this procedure. | NA |

Photo #4: Str 222 access road. Northern is preparing road to add timber mats to eliminate rutting. (3/19)

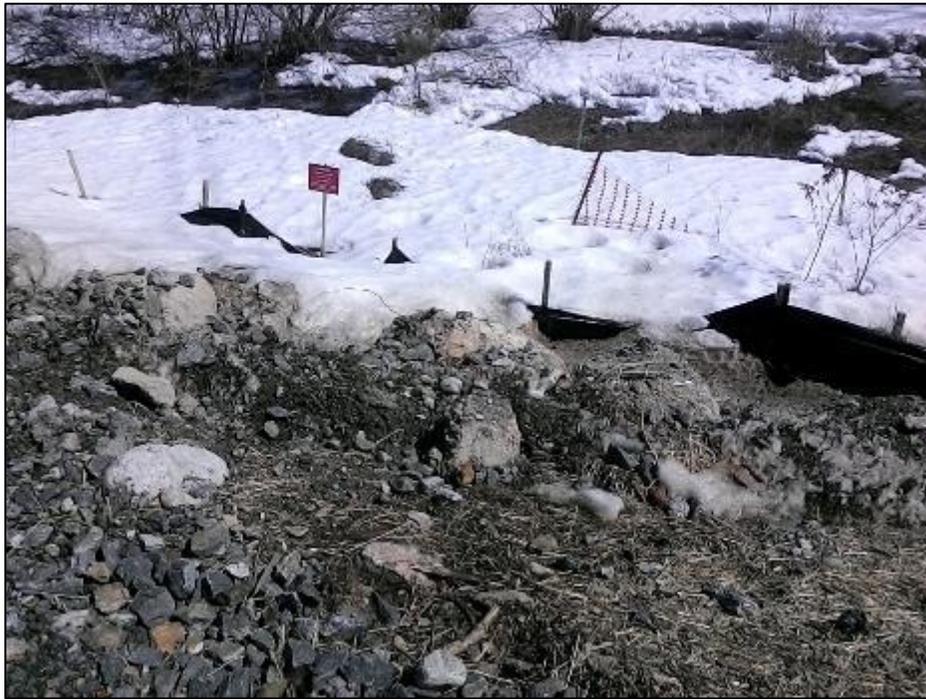
| Erosion and Sedimentation Controls | Interim Week (3/19) | Noted areas of damaged silt fence. No resources appeared to be significantly impacted. (Photo 5) Noted recent installation of silt fence and hay bales. (Photo 6) | Recommend re-stapling of damaged sit fence as soon as possible. Continue to follow this procedure as needed. | T. Ramborger indicated that Northern is trying to repair all site controls as quickly as possible. NA |

Photo #5: Damaged silt fence at Str 337 pad. (3/19)

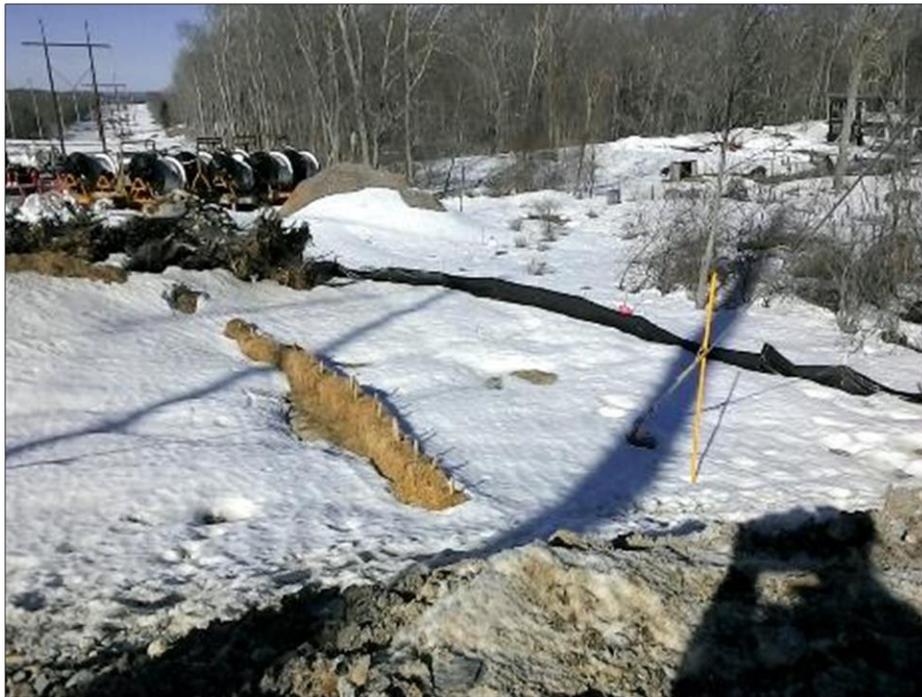
Photo #6: Installation of new hay bales and silt fence at Str 124. (3/19)

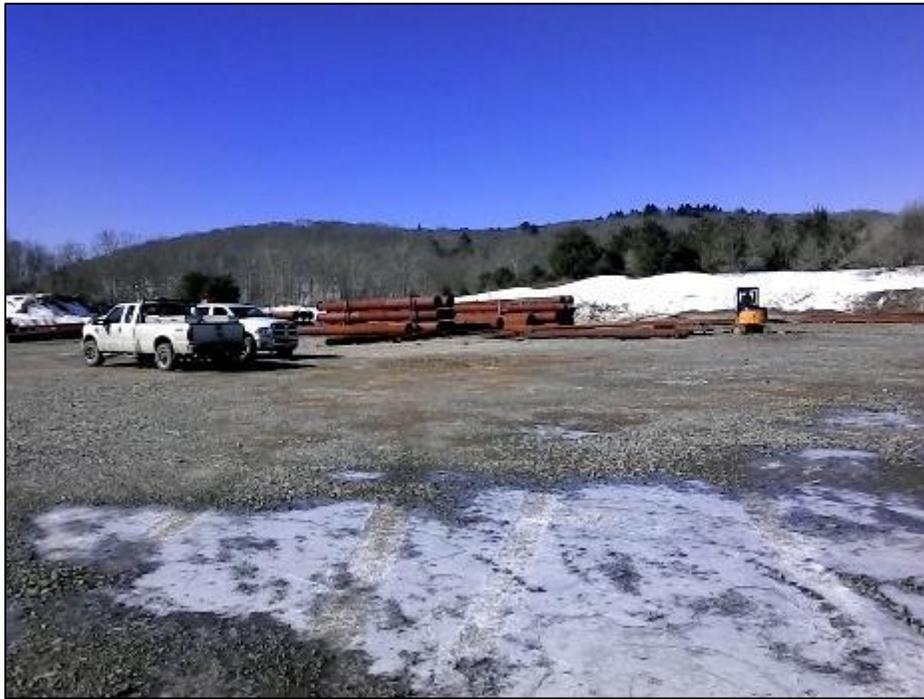
Photo #7: Dayville Laydown Yard off State Route 101. (3/19)

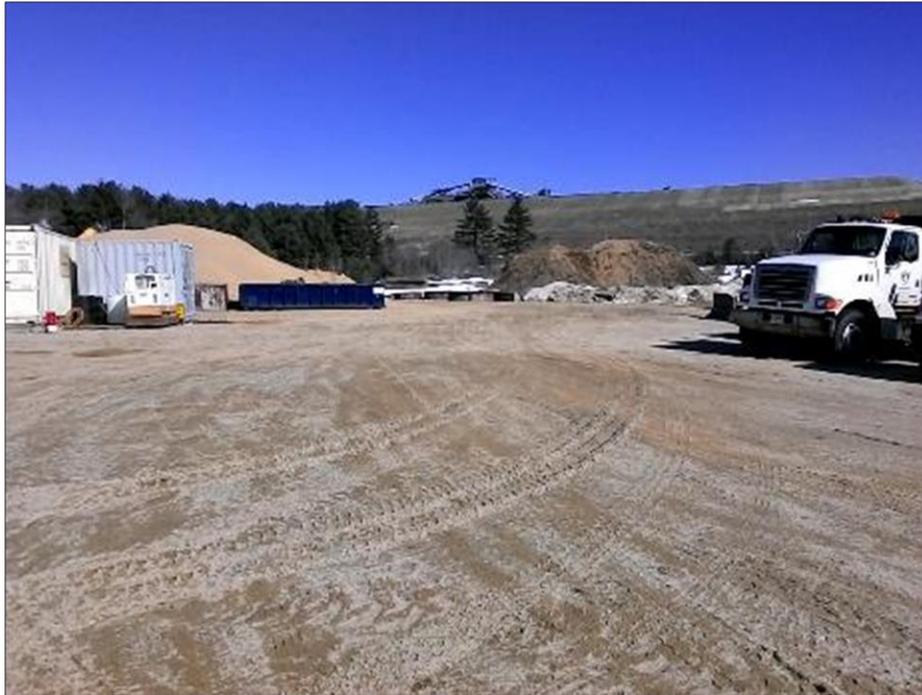
Photo #8: Putnam Laydown Yard off River Road. (3/19)

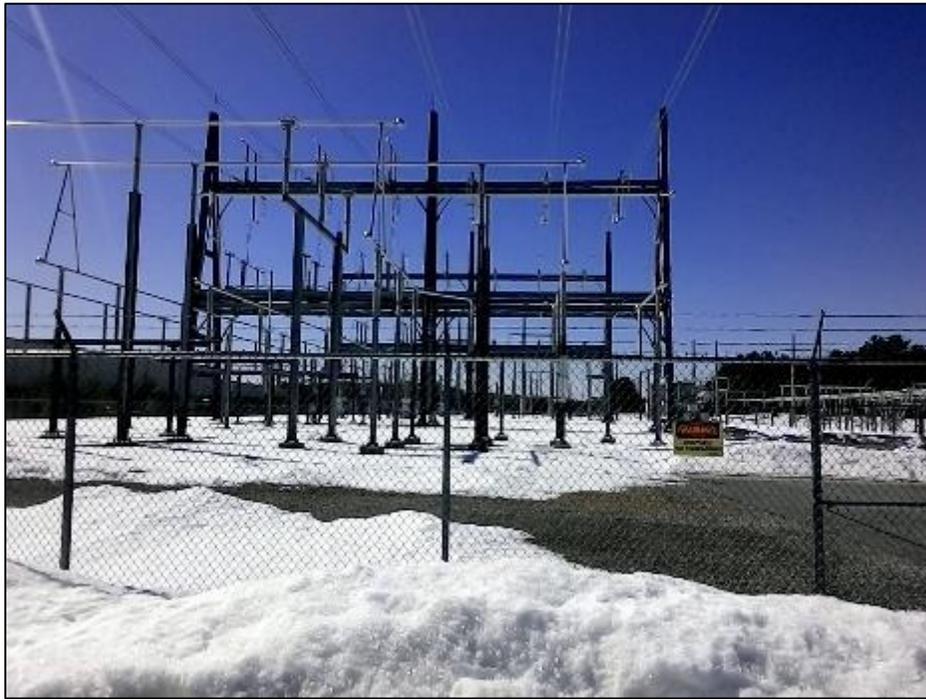
Photo #9: Killingly Sub Station now considered complete and permanently stabilized. (3/19)

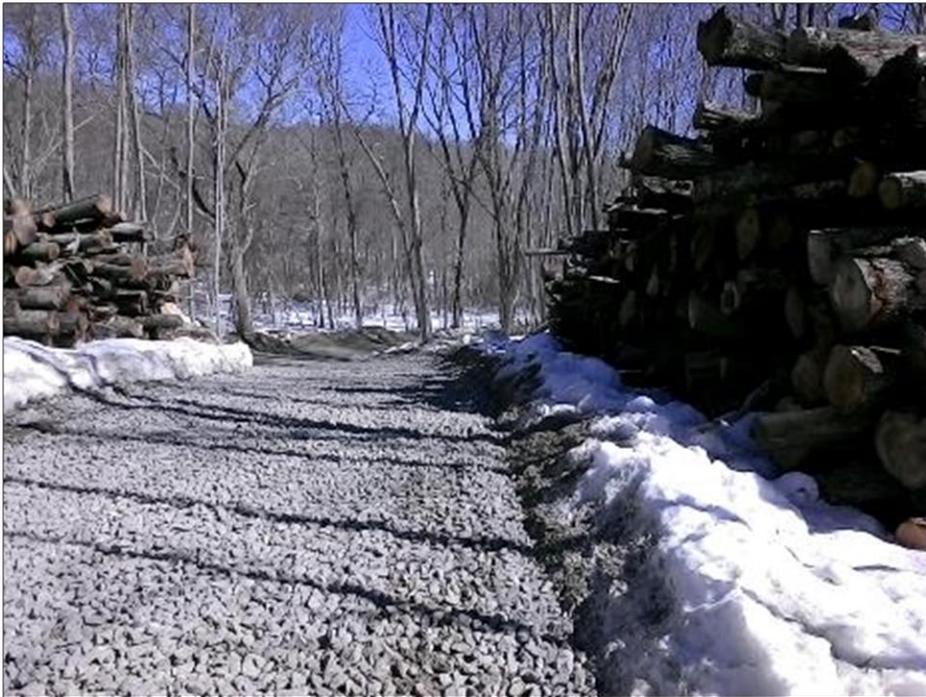
Photo #10: Str 201 access road. Road completely re-graded and re-surfaced with stone. (3/19)

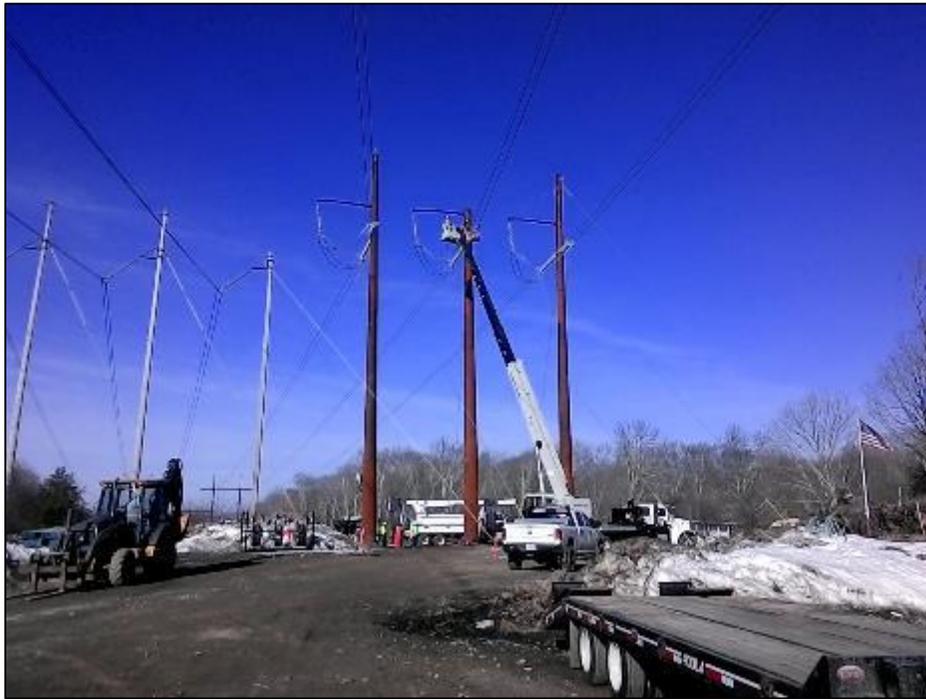
MS24, Str 124: Conductor line work. (Photo 11)

Photo #11: Linework at Str 124. (3/25)

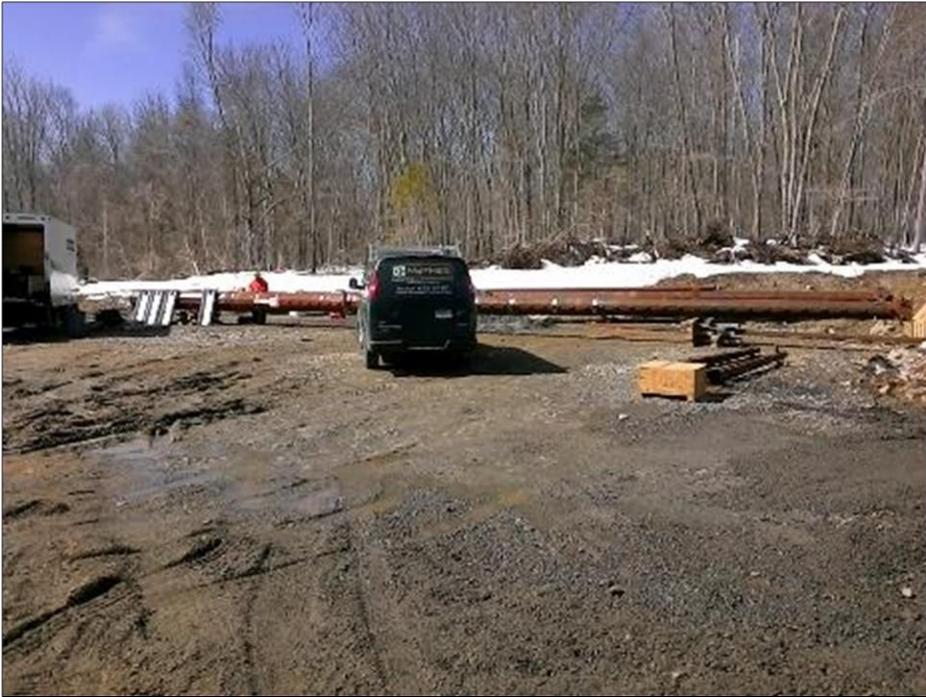
MS44, Str 224: Fiber Optic Installation Work. (Photo 12)

Photo #12: Fiber Optic work at Str 224. (3/25)

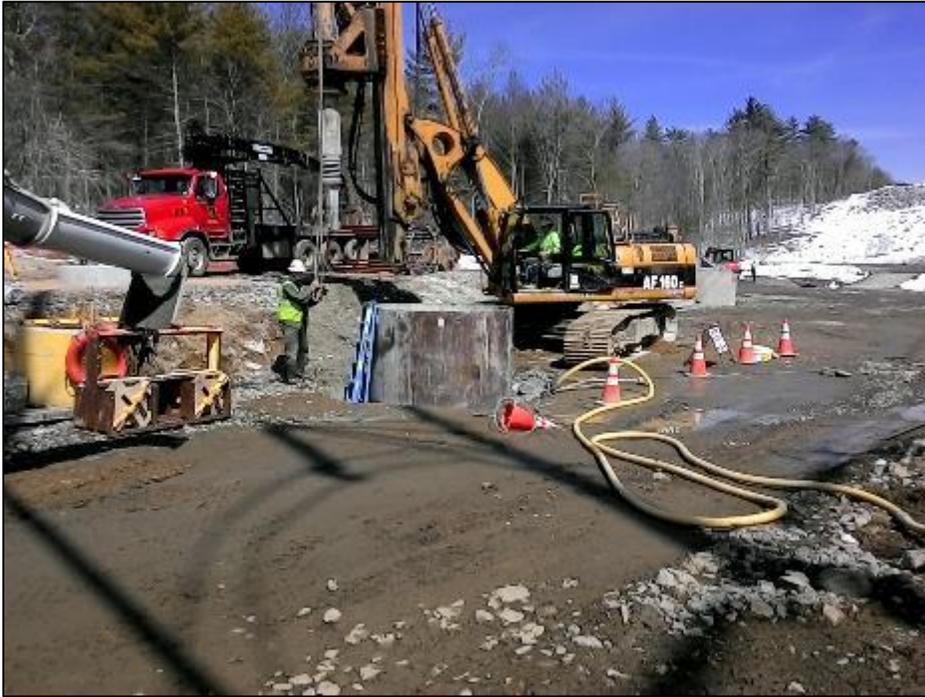
MS66, Str 337: Foundation concrete placement. (Photo 13)

Photo #13: Placement of concrete for foundation of Str 337. (3/25)

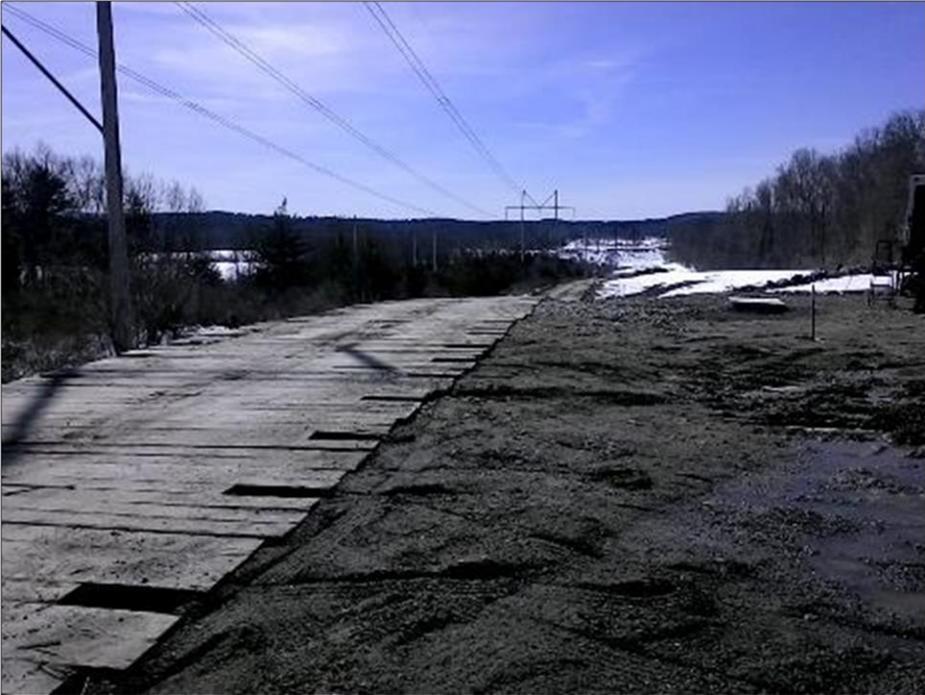
| Areas of Inspection | | Observation: | Recommended Action: | Corrected Action: |
|--|---|---|---|---|
| | Bi-Week (3/25) | All observed access roads and ROW's have been recently re-graded and/or stabilized with gravel. Roads appear to be in excellent condition. Str 224-225: Mats used on ROW to prevent rutting. (Photo 14) | NA Continue to follow this procedure. | NA NA |

Photo #14: Str 224-225 ROW stabilized with timber mats. (3/25)

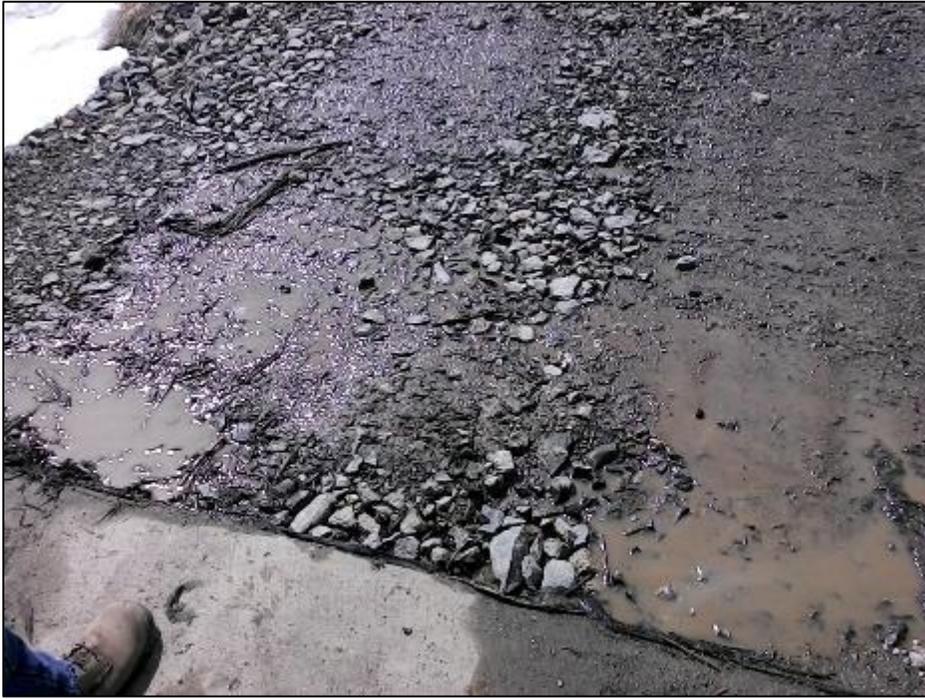
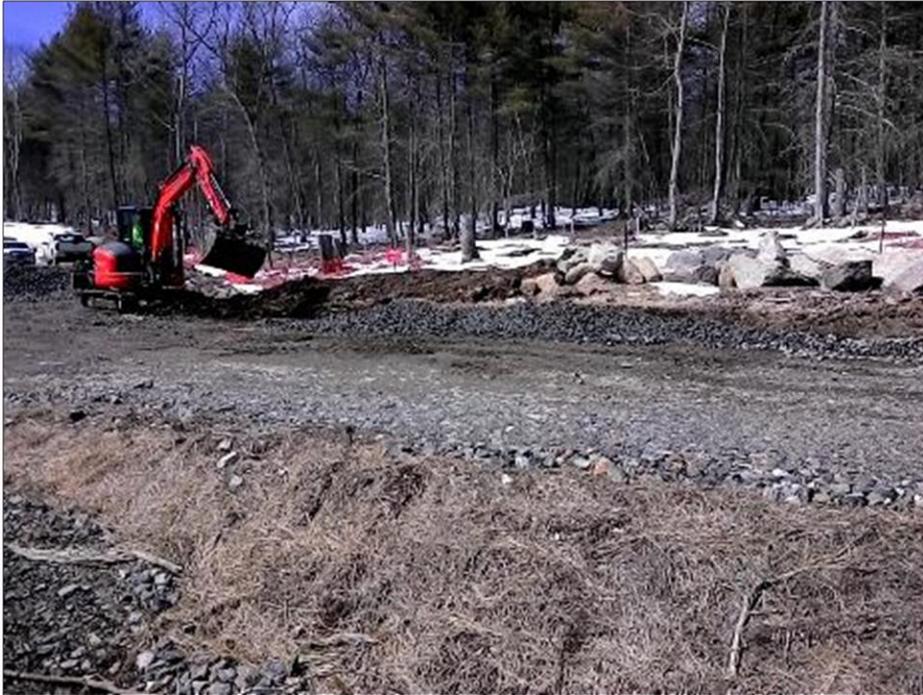
| | Bi-Week (3/25) | Noted many areas of damaged silt fence. No resources appeared to be significantly impacted. Str 337: Noted area up-line of pad where water was running off of site. Northern was in the process of constructing a drainage channel. (Photos 15 & 16) | Recommend re-stapling of damaged sit fence as soon as possible. NA | Contractor and EI's are actively and conscientiously monitoring and repairing these areas. NA |

Photo #15: Runoff from Str 337. (3/25)

Photo #16: Construction of drainage channel at Str 337 to control runoff (pictured above). (3/25)
