Docket No. 424 – Development and Management Plan Inspection

The Connecticut Light and Power Company Certificate of Environmental Compatibility and Public Need for the Connecticut portion of the Interstate Reliability Project.

Interim Week Inspection:

Date: April 2, 2015

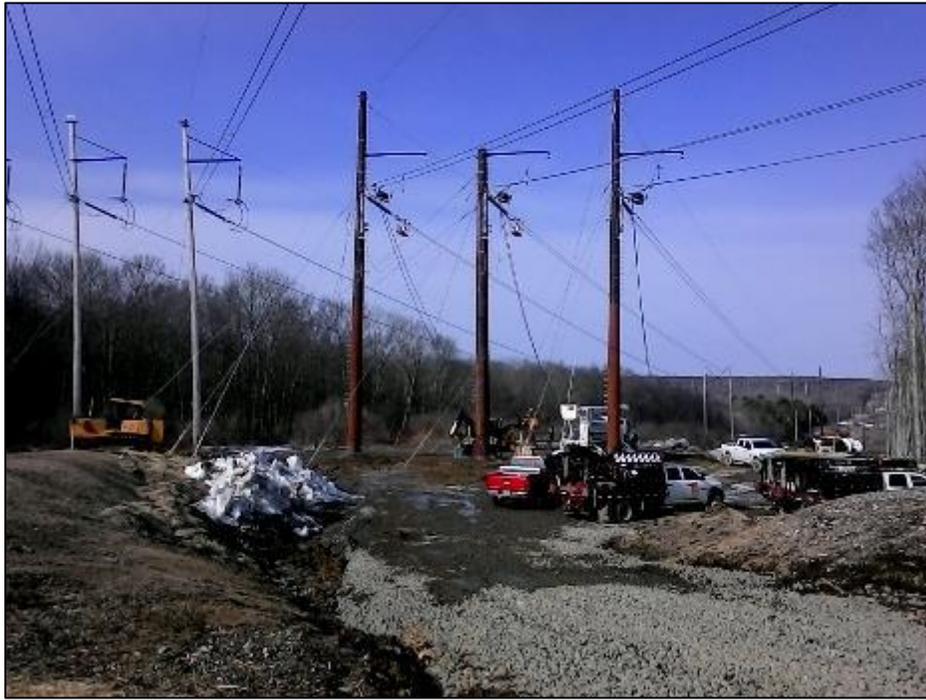
MS29, Str 151: Conductor stringing operations. (Photo 1)

Photo #1: Stringing operations at Str 154. (4/2)

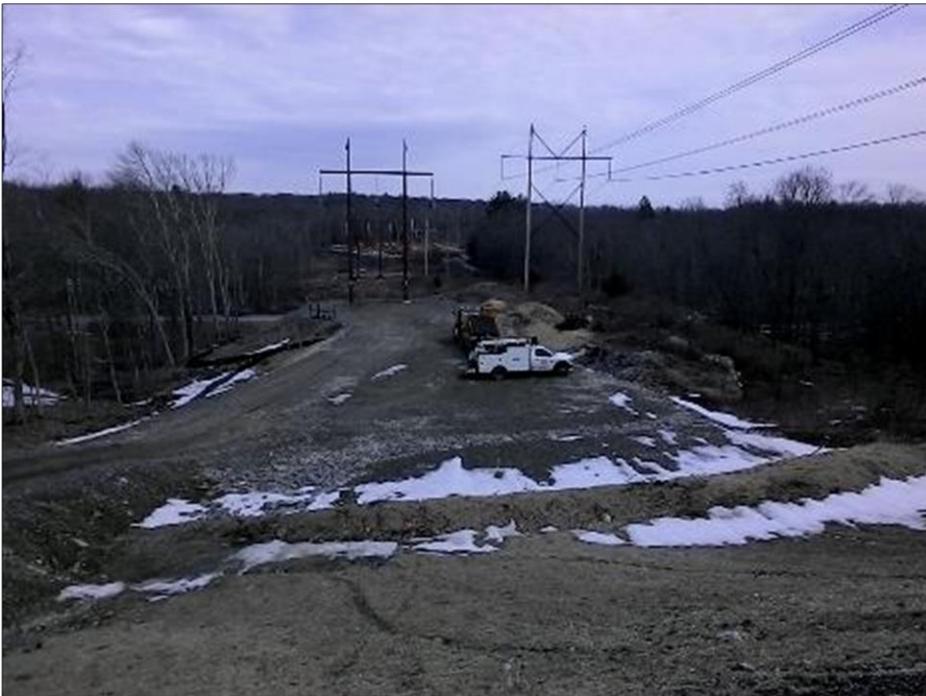
MS35, Str 181: PAR mobilization to area for conductor stringing (Photo 2)

Photo #2: Mobilizing at Str 181 to prepare for stringing operations. (4/2)

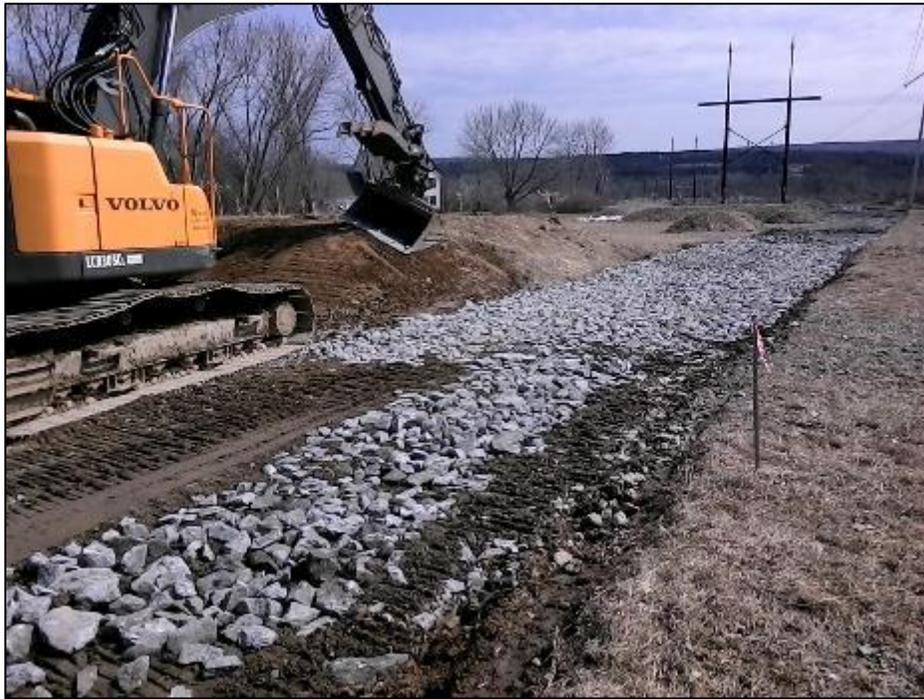
MS42, Str 216: ROW Access road and stabilization repairs. (Photo 3)

Photo #3: Maintenance and repairs on ROW at Str 216. (4/2)

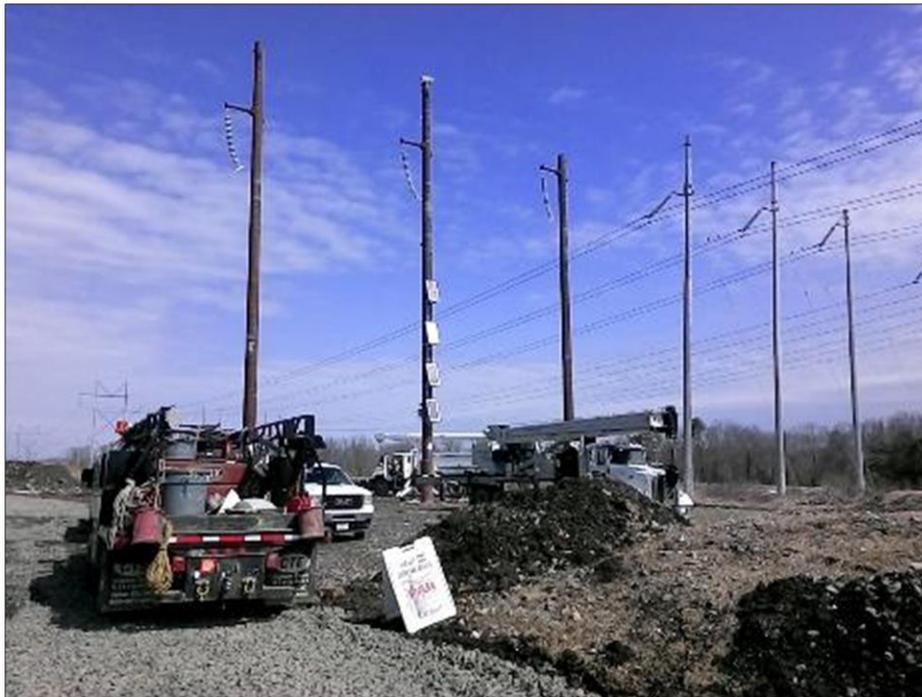
MS45, Str 227: Structure Erection. (Photo 4)

Photo #4: Str 227 erection. (4/2)

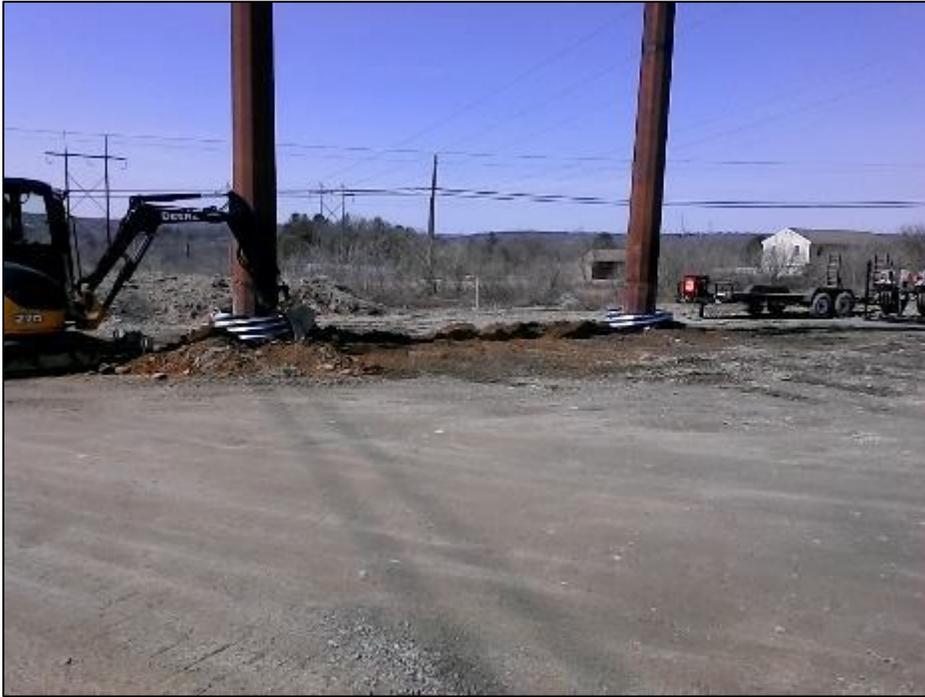
MS48, Str 244: Structure grounding. (Photo 5)

Photo #5: Grounding at Str 244. (4/2)

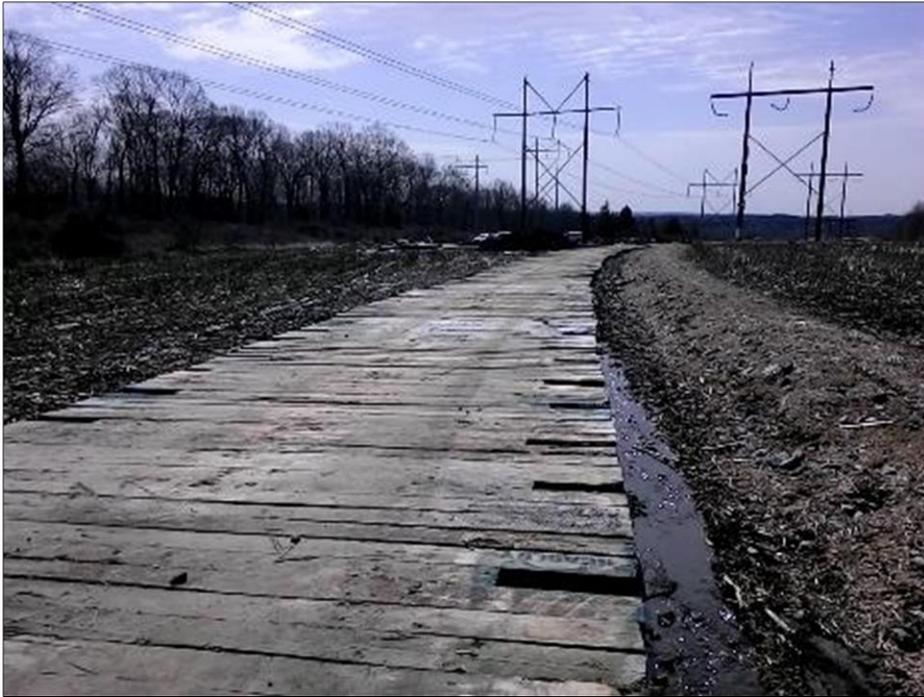
Areas of Inspection		Observation:	Recommended Action:	Corrected Action:
Access Roads and Adjacent Roadways	Interim Week (4/2)	All observed access roads and ROW's appear clean and stable. Many sections were recently re-graded with gravel or reinforced with timber mats. (Photo 6)	Continue to follow this procedure.	NA
	Bi-Week (4/9)	All observed access roads and ROW's appear clean and stable. Sections of access utilizing timber mat reinforcement continuously monitored and maintained by Contractor.	Continue to follow this procedure.	NA
Vegetative Clearing Limits (Including trees to save or danger trees noted.)	Interim Week (4/2)	Mechanized Clearing along IRP ROW complete.	NA	NA
	Bi-Week (4/9)	Mechanized Clearing along IRP ROW complete. Observed minor hand trimming in the vicinity of Str 320, apparently in accordance with D and M documentation.	NA NA	NA NA
Water Crossings	Interim Week (4/2)	All crossings appear to be functioning in accordance with the BMP Manual. No sediment appears to be entering the streams or wetlands.	NA	NA

Photo #6: Timber mats used to stabilize ROW down-line of Str 227. (4/2)

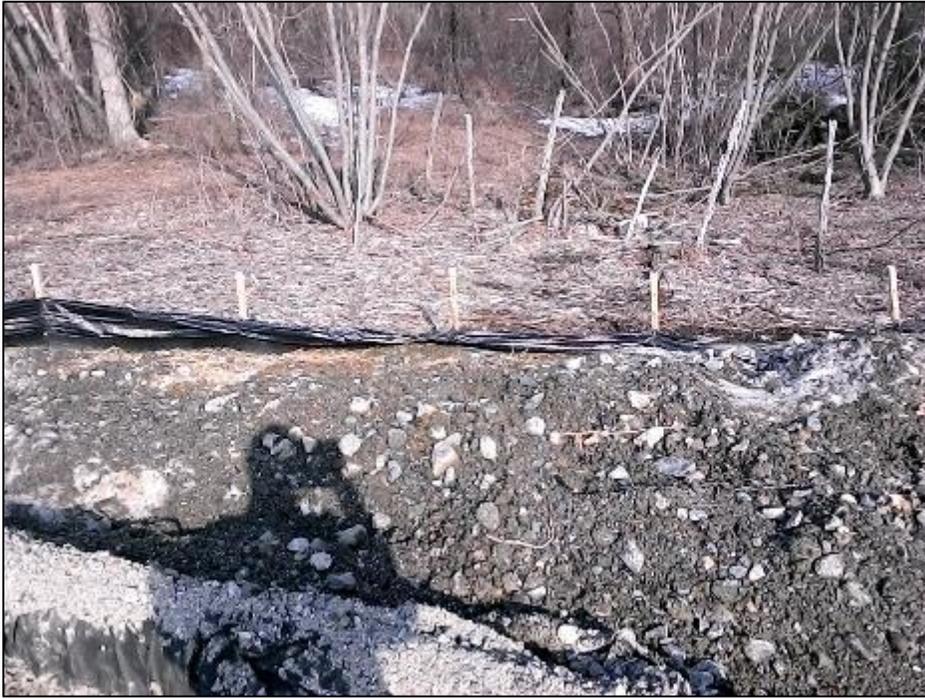
Bi-Week (4/9)	All crossings appear to be functioning in accordance with the BMP Manual. No sediment appears to be entering the streams or wetlands.	NA	NA
Erosion and Sedimentation Controls	Interim Week (4/2)	The observed site controls appear to be functioning properly. Str 154: Silt fence damaged. (Photo 7)	NA Recommend immediate repair.	NA T. Ramborger re-stapled damaged silt fence during inspection. (Photo 8)
	Bi-Week (4/9)	All observed site controls appear to be intact and functioning. Str 151: The contractor installed a supplementary E&S control sediment trap to collect sediment from dewatering activities during slug anchor installation. (Photos 14-15)	NA Continue to follow this procedure as needed.	NA NA
Inland Wetland and Watercourse encroachment and mitigation	Interim Week (4/2)	Mat installations in wetland areas are in accordance with the BMP Manual.	Continue to follow this procedure.	NA

Photo #7: Section of damaged silt fence up-line of Str 154. (4/2)

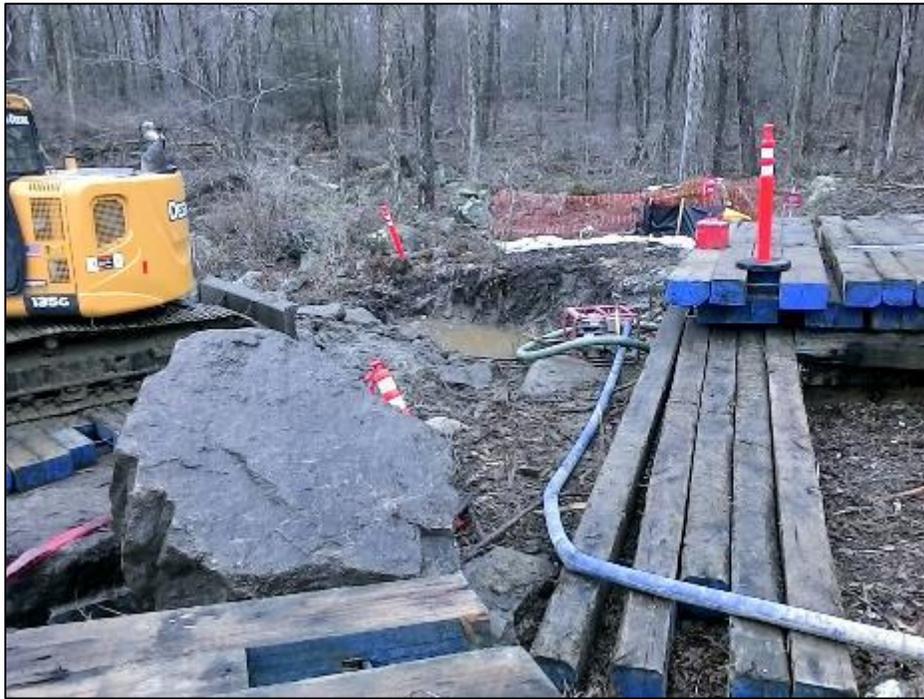
MS35, Str 183: Slug Anchor installation. (Photo 9)

Photo #9: Excavating area to place slug anchor for Str 183.(4/9)

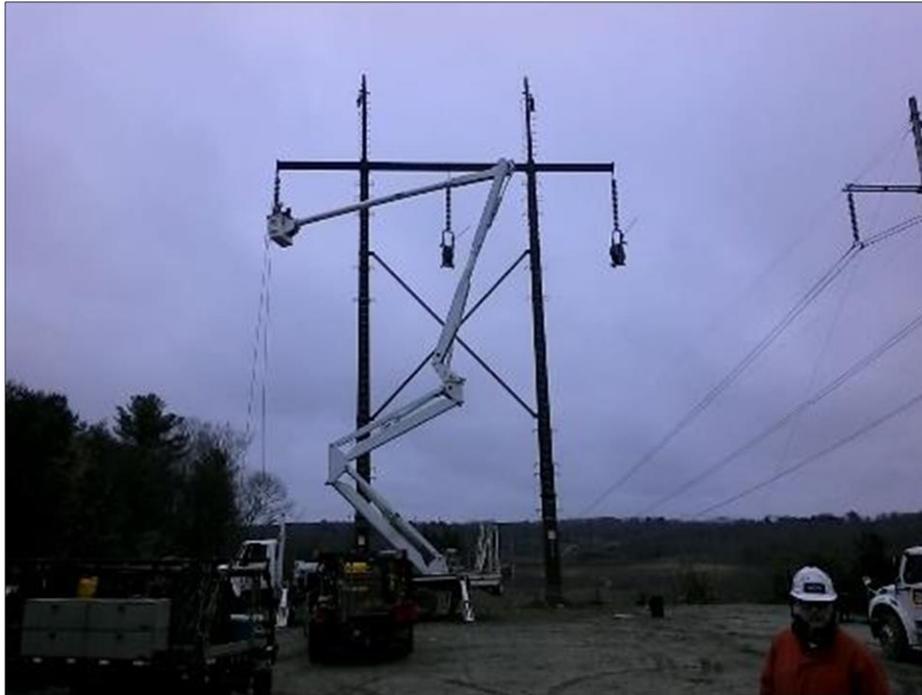
MS41, Str 209: Hanging block for conductor stringing. (Photo 10)

Photo #10: Hanging block on St 209.(4/9)

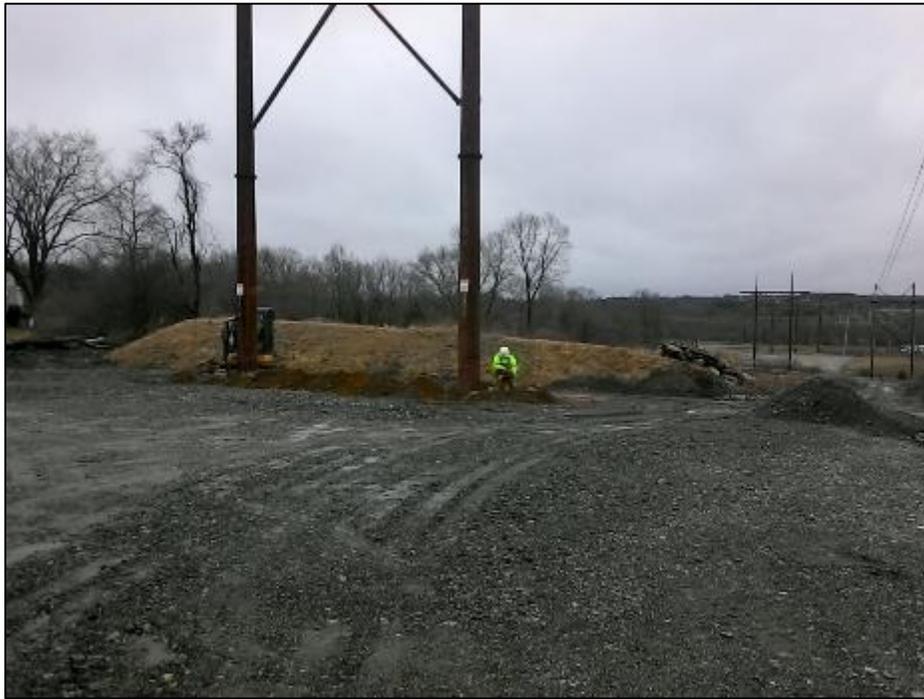
MS42, Str 218: Structure grounding. (Photo 11)

Photo #11: Grounding at Str 218.(4/9)

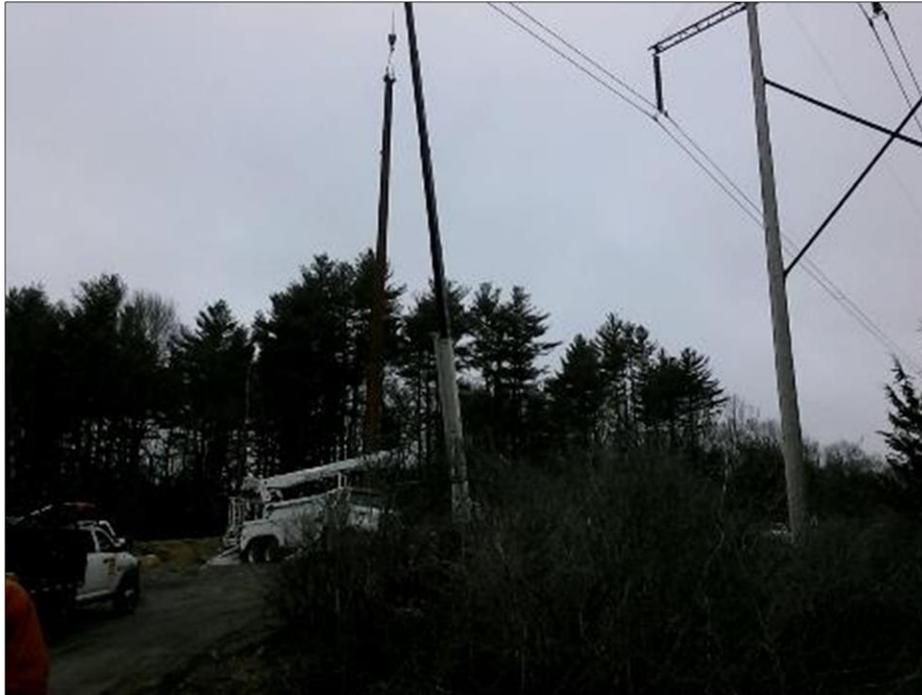
MS55, Str 274: Structure Erection. (Photo 12)

Photo #12: Str 274 erection. (4/9)

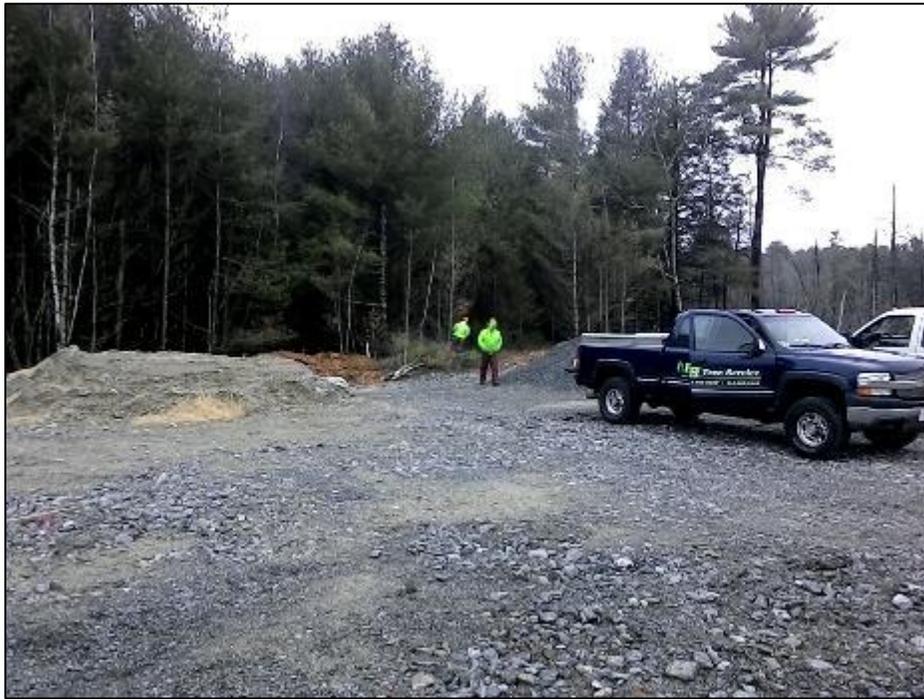
MS63, Str 320: Tree trimming by hand. (Photo 13)

Photo #13: Hand tree trimming at Str 320 pad. (4/9)

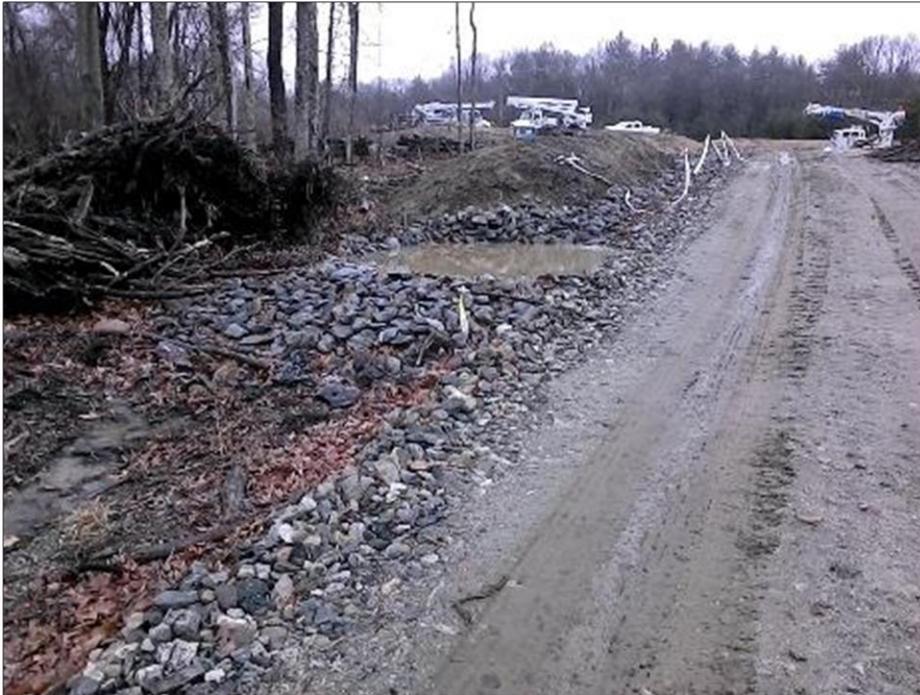
Photo #14: Turbid water seen flowing into sediment trap from slug anchor installation dewatering at Str 151. (4/9)

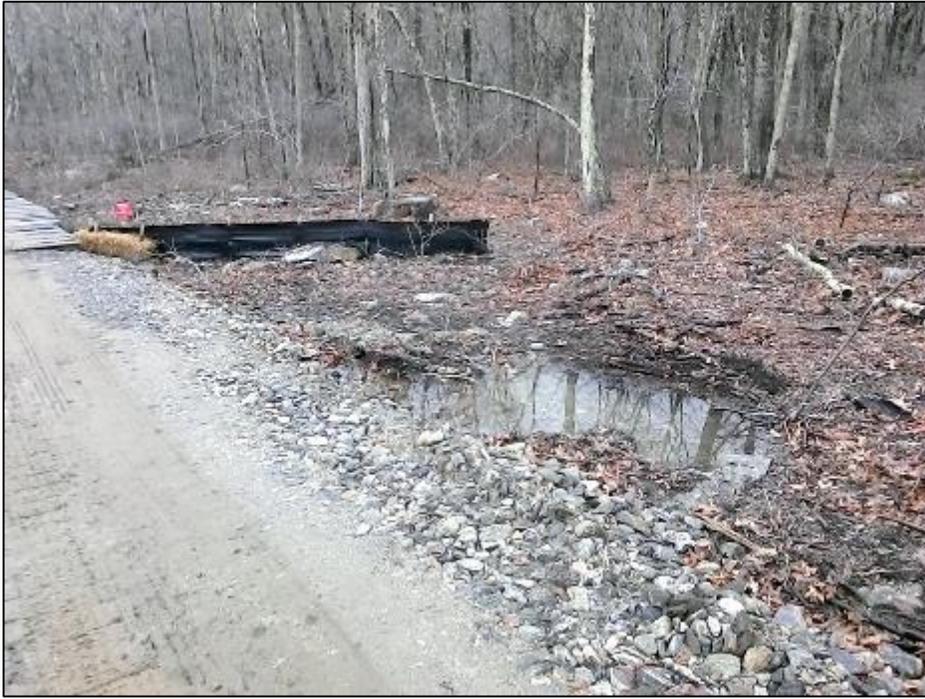
Photo #15: Sediment-free water observed at base of slope discharging from sediment trap. (4/9)
