**Docket No. 424 – Development and Management Plan Inspection**

The Connecticut Light and Power Company Certificate of Environmental Compatibility and Public Need for the Connecticut portion of the Interstate Reliability Project.

**IRP Overhead ROW**

**Interim Week Inspection:**

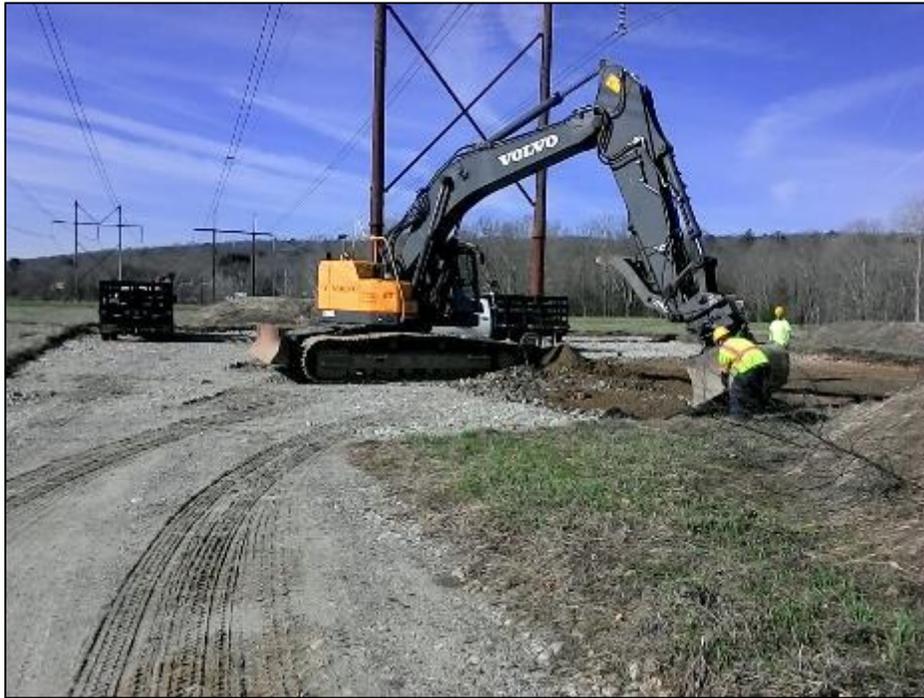
**MS14, Str 76:** Construction pad stone removal for restoration. (Photo 1)

Photo #1: Beginning restoration of Str 76 with pad removal. (4/16)

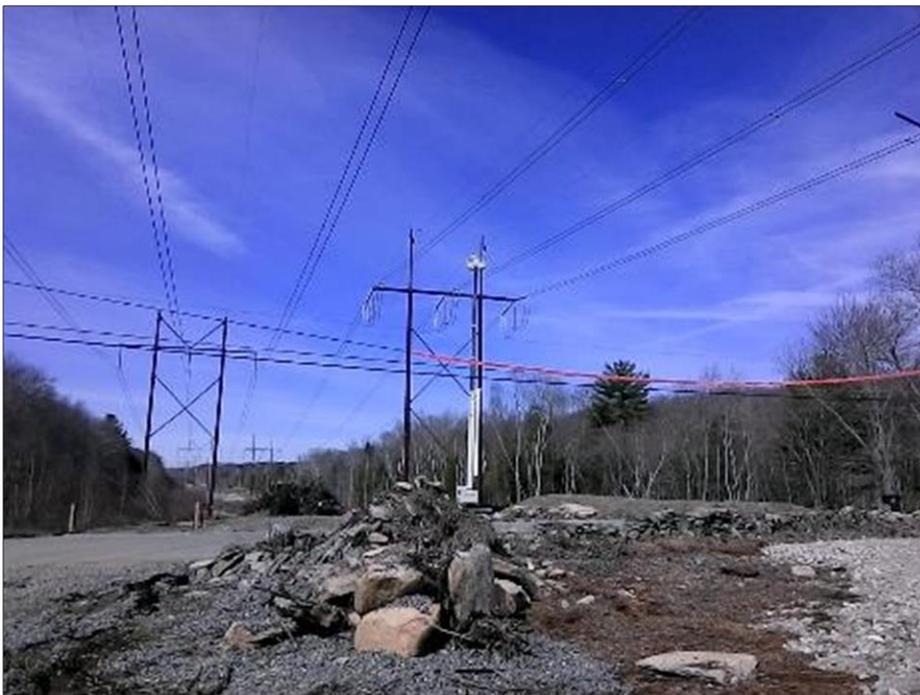
**MS32, Str 166:** Conductor Stringing. (Photo 2)

Photo #2: Stringing operations at Str 166. (4/16)

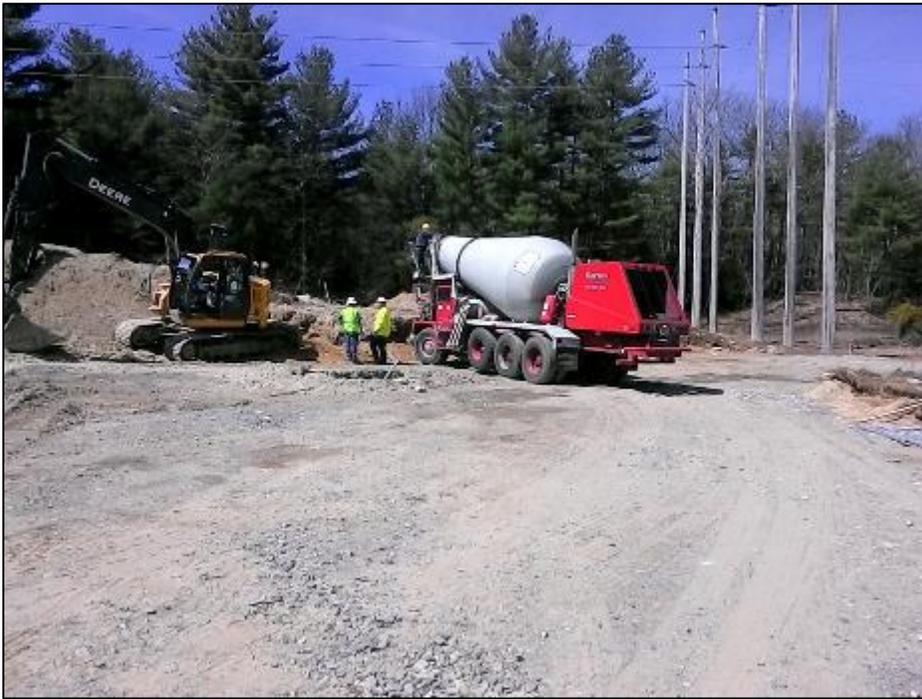
**MS50, Str 255:** Pouring Concrete for Slug Anchors. (Photo 3)

Photo #3: Pouring concrete for slug anchors at Str 255. (4/16)

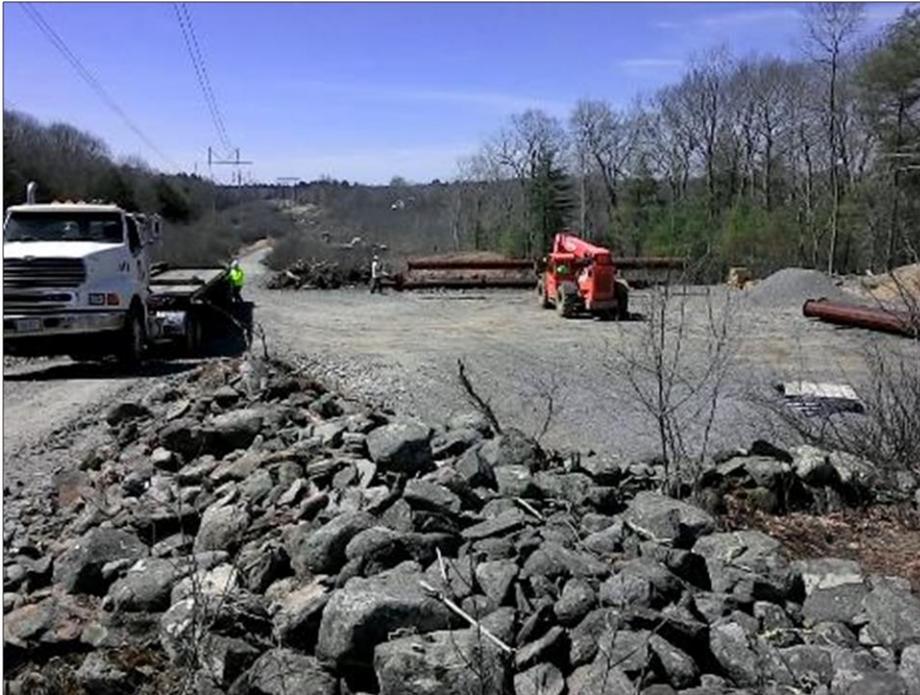
**MS59, Str 300:** Relocating structure steel preparing for erection. (Photo 4)

Photo #4: Moving steel at Str 300 in preparation for structure erection. (4/16)

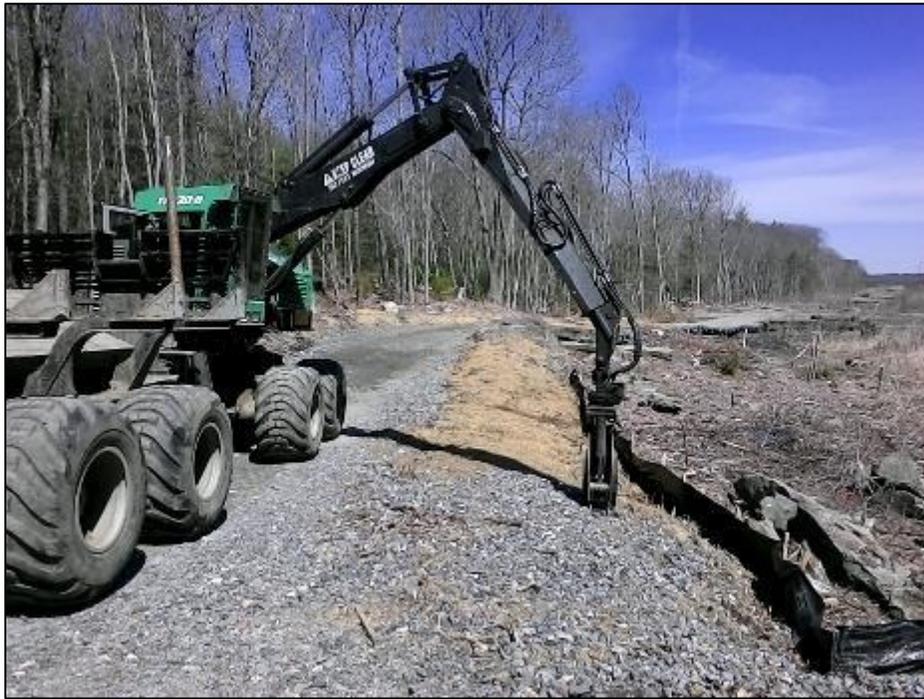
**MS61, Str 310:** Removal of wetland mats. (Photo 5)

Photo #5: Preparing for mat removal at Str 310 for pad reconstruction. (4/16)

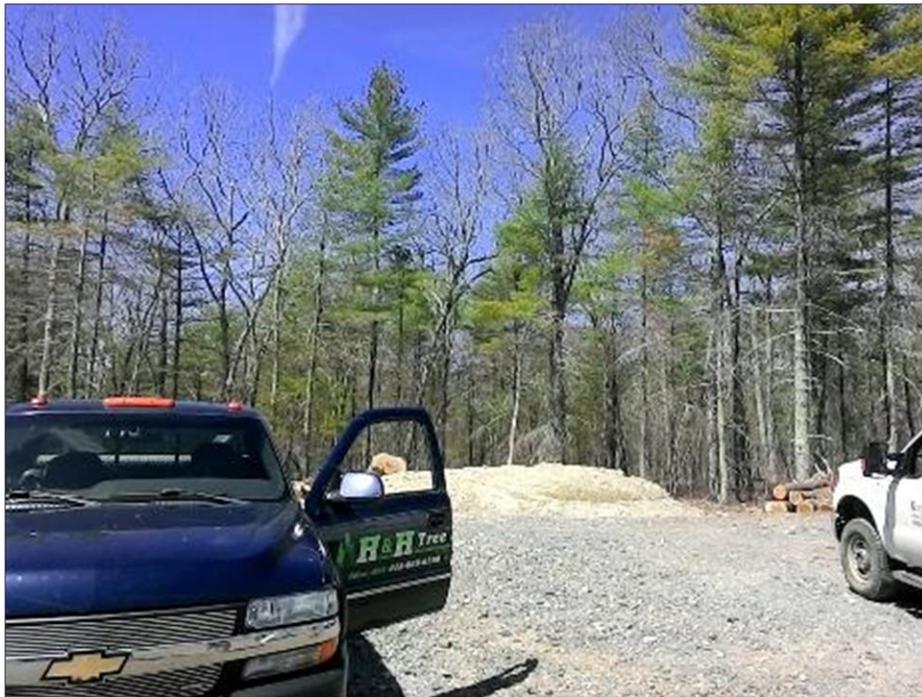
**MS65, Str 332:** Hand Trimming. (Photo 6)

Photo #6: Trimming along ROW at Str 323 pad. (4/16)

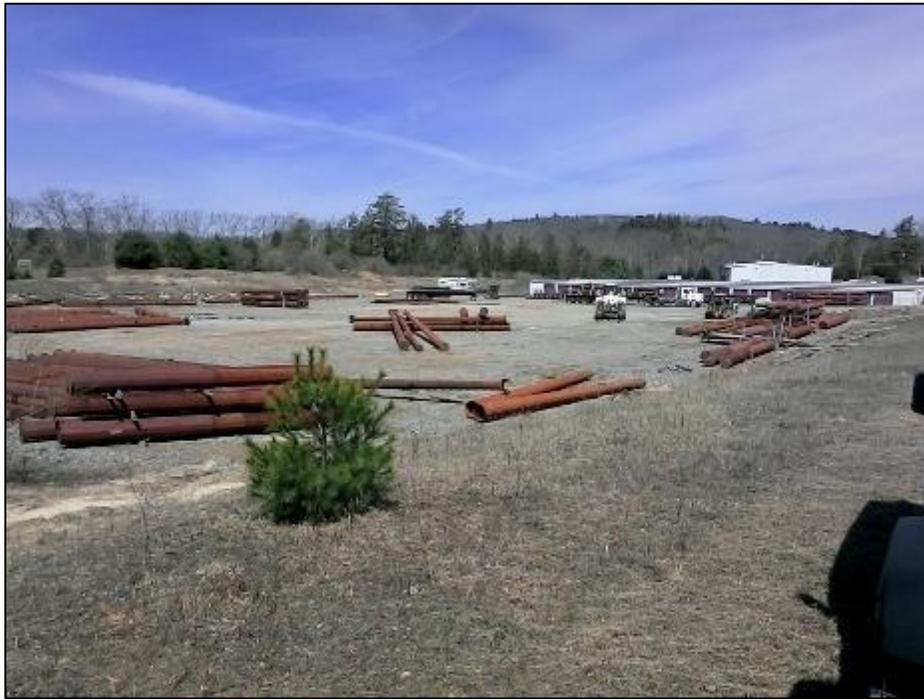
- Visited Nora Lane laydown yard. Area appears stable. (Photo 7)
- Areas of IRP Project considered complete and permanently stabilized:
  - CSSS, LRSS, KSS, Windham Materials Laydown areas 1 and 2, River Road Laydown Area.

Photo #7: Nora Lane laydown yard. (4/16)

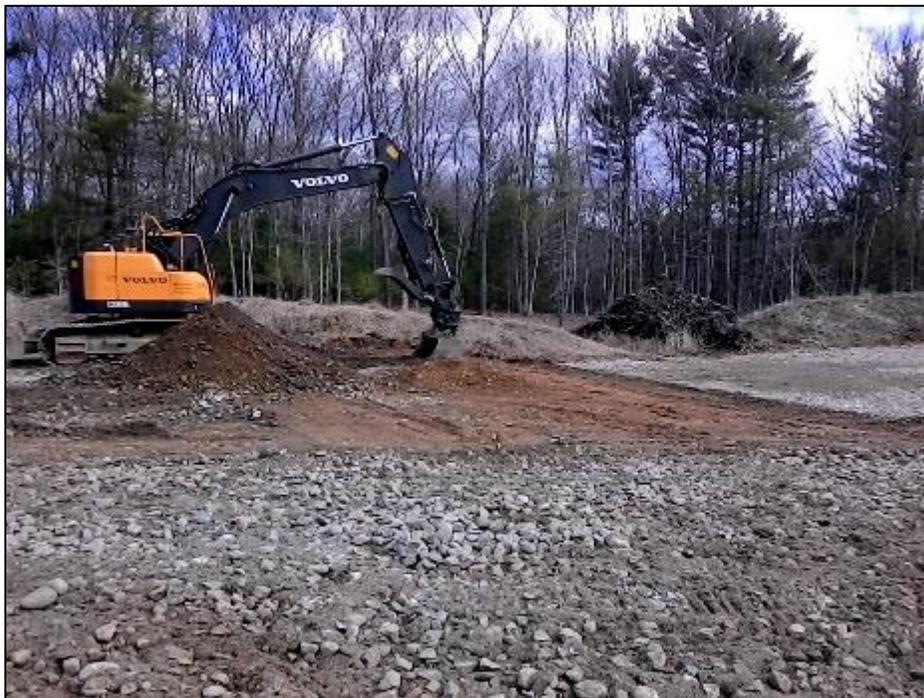
**MS15, Str 80:** Construction pad stone removal for restoration. (Photo 8)

Photo #8: Removing Str 80 pad as part of restoration. (4/23)

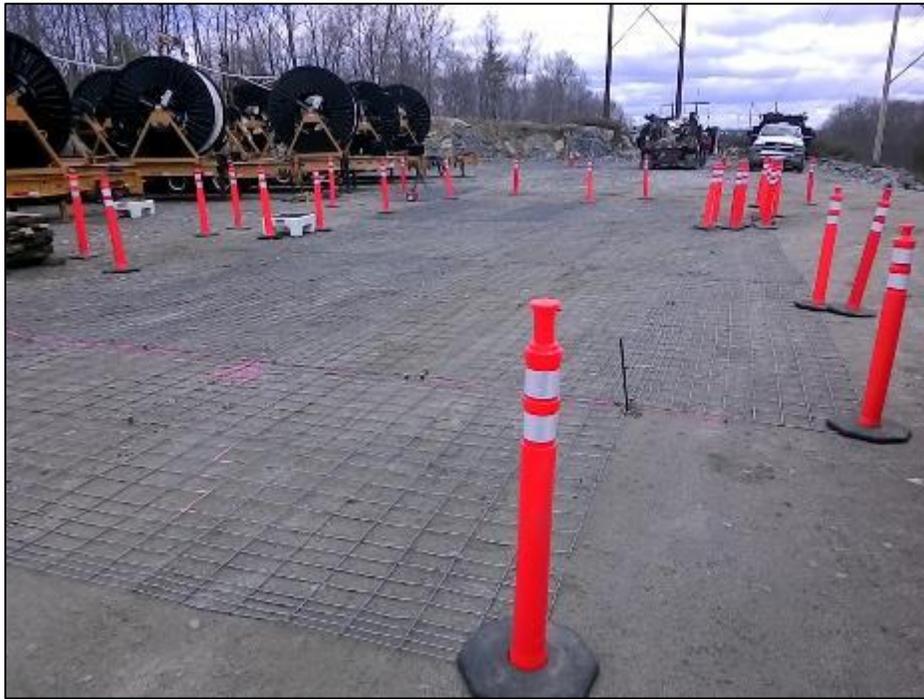
**MS38, Str 197:** Finalizing grounding grid for Pulling Operations. (Photo 9)

Photo #9: Grounding for pulling cable at Str 197. (4/23)

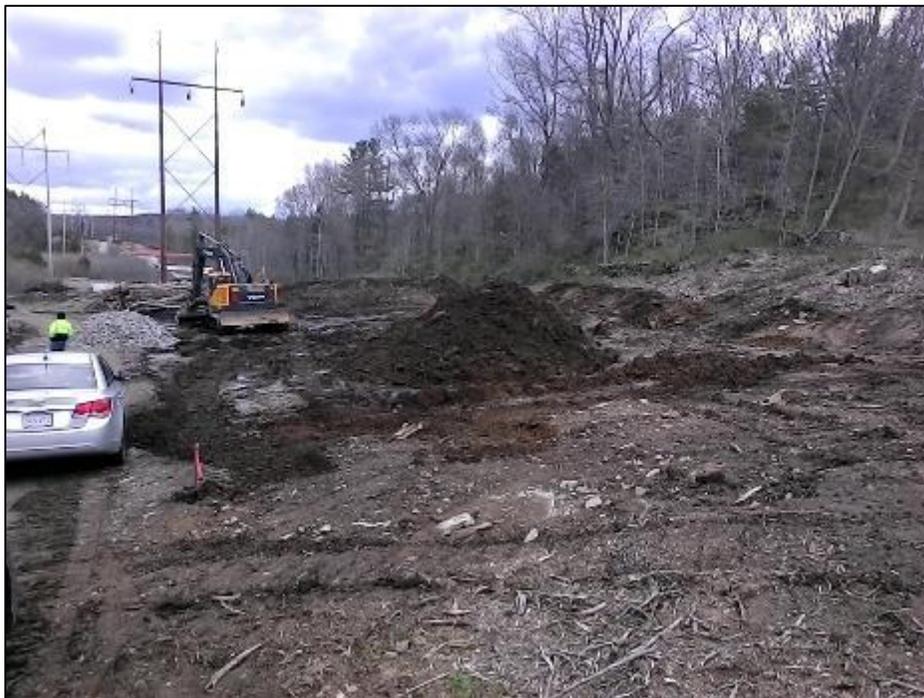
**MS40, Str 207:** Installation of conductor pull pad. (Photo 10)

Photo #10: installation of pull pad between Str 207 & 208. (4/23)

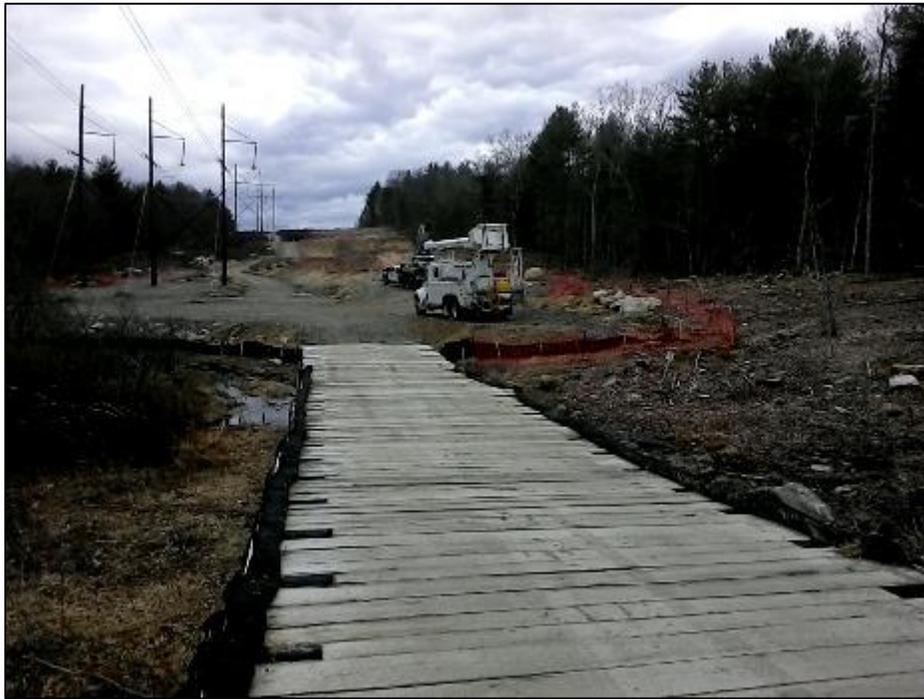
**MS66, Str 337:** Awaiting of delivery of structure Steel. (Photo 11)

Photo #11: Awaiting delivery of structure steel at Str 337 pad. (4/23)

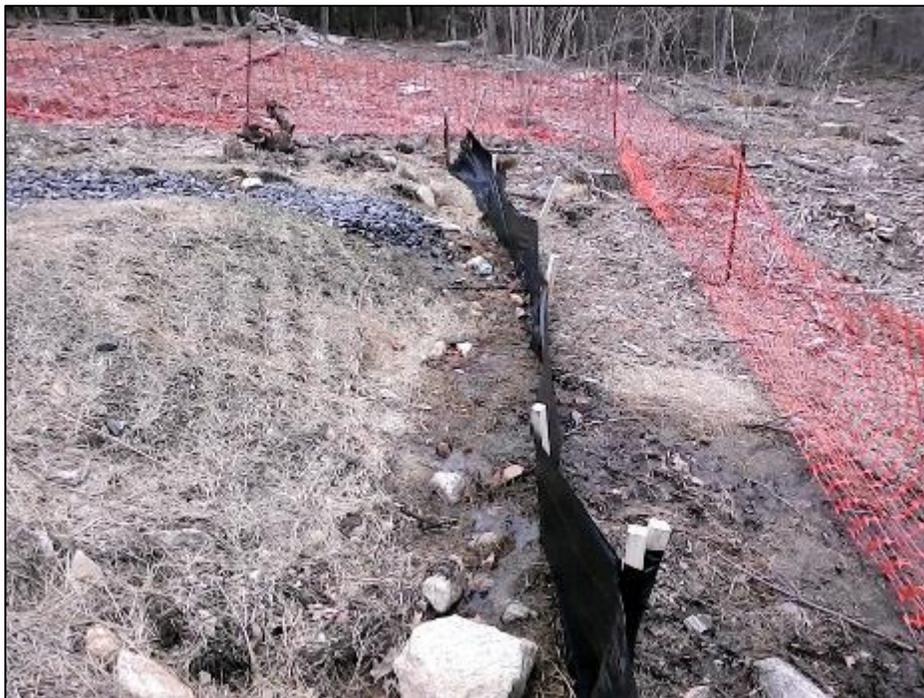
Photo #12: Plunge pool at Str 337 pad allowing for turbidity-free water to discharge from site. (4/23)
