Docket No. 424 – Development and Management Plan Inspection

The Connecticut Light and Power Company Certificate of Environmental Compatibility and Public Need for the Connecticut portion of the Interstate Reliability Project.

IRP Overhead ROW

Interim Week Inspection:

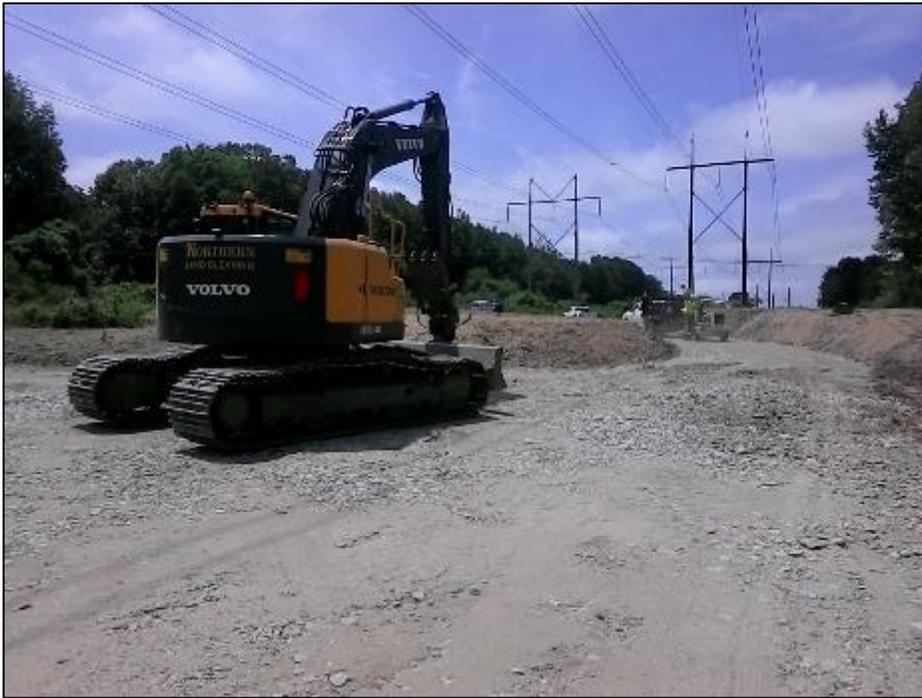
MS6, Str 31: Restoration Operations. (Photo 1)

Photo #1: Removing Str 31 pad and blowing straw on slopes as part of restoration. (5/28)

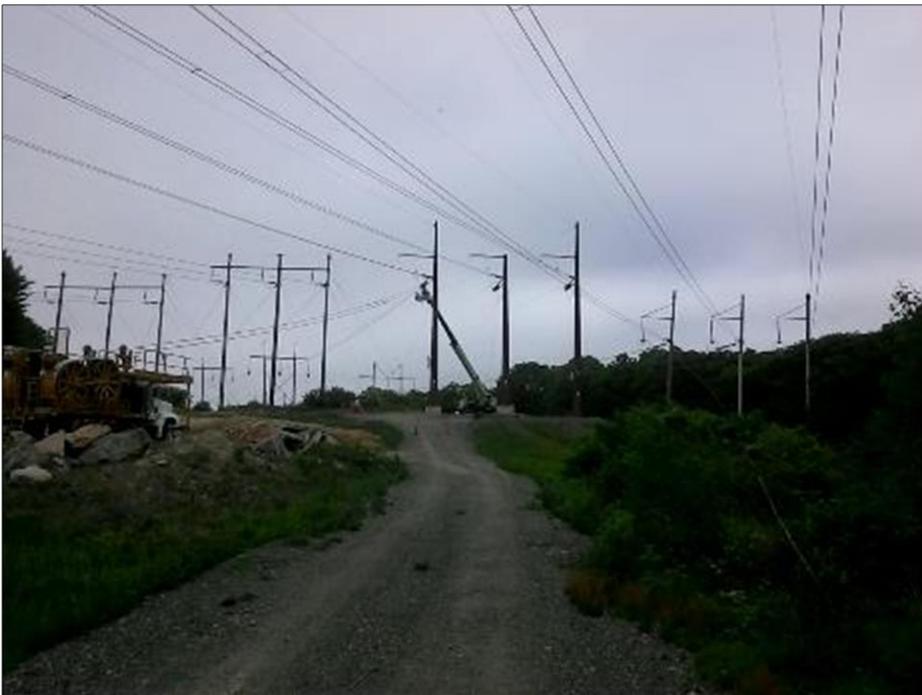
MS48, Str 245: Conductor Installation. (Photo 2)

Photo #2: Pulling conductor from Str 245 up to Str 265. (5/28)

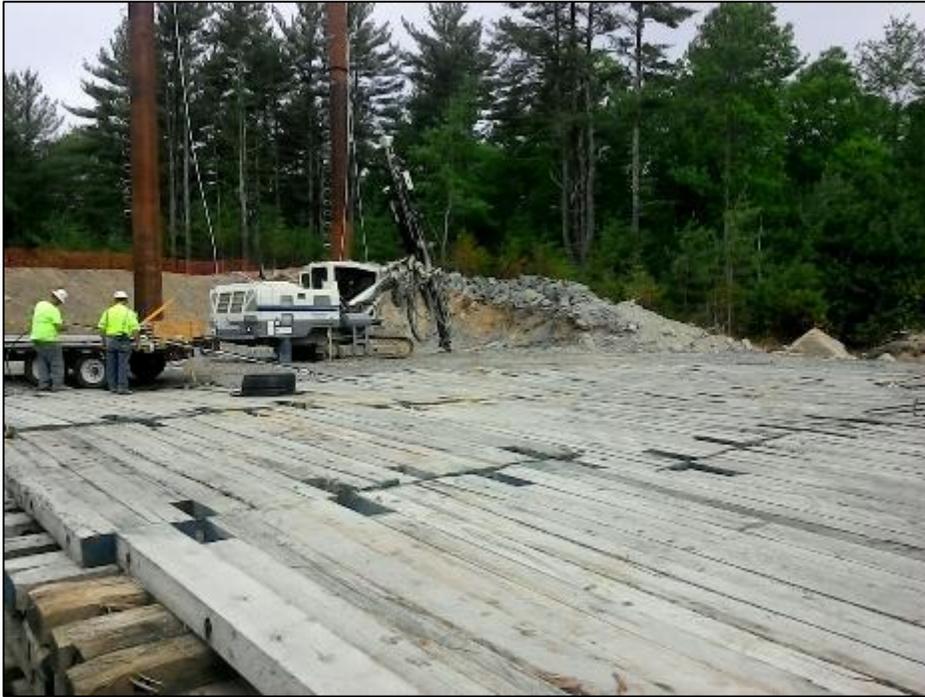
MS60, Str 305: Anchor Installation. (Photo 3)

Photo #3: Drilling holes for anchor installation at Str 305. (5/28)

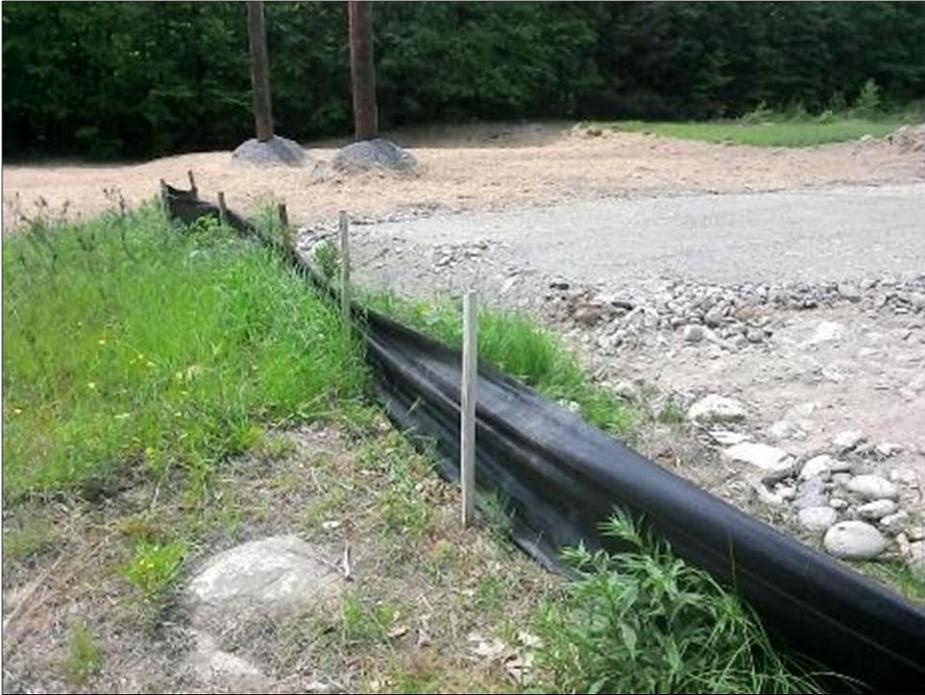
| Erosion and Sedimentation Controls | Interim Week (5/28) | All observed site controls appear to be functioning in accordance with the BMP Manual. No sediment appears to be entering any resource areas. Str 41: Noted section of silt fence with un-stapled segments and a loose stake. (Photo 4) | Continue to follow this procedure. Re-drive loose stake and re-staple all sections as necessary. | NA T. Ramborger hammered loose stake back into the ground and indicated that Northern would be at that location later in the day for E&S repairs. |

Photo #4: Section of un-stapled silt fence at Str 41. (5/28)

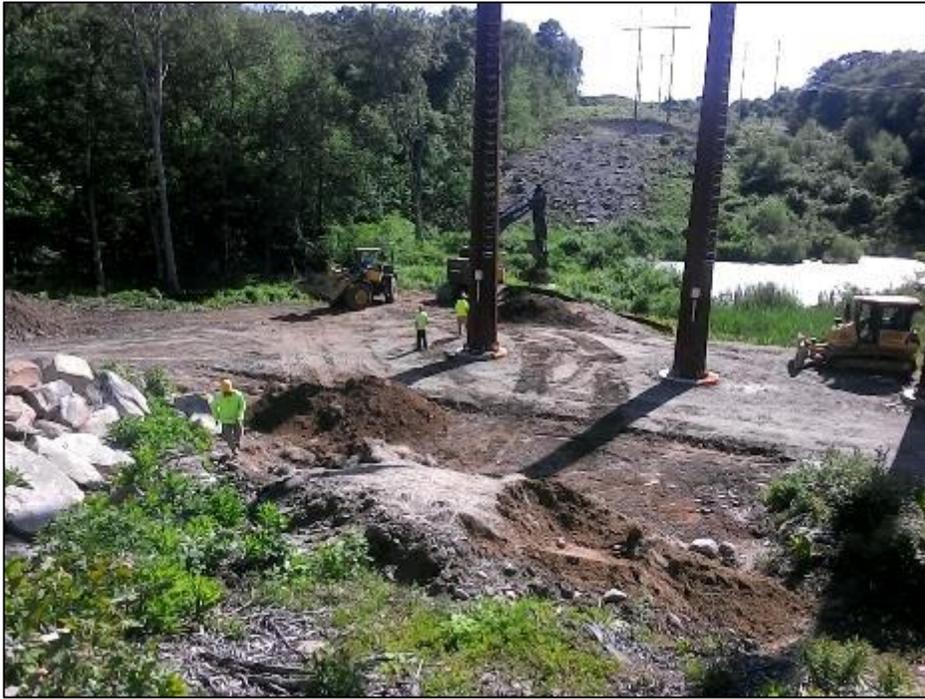
MS9, Str 49: Restoration Operations. (Photo 5)

Photo #5: Pad removal at Str 49. (6/4)

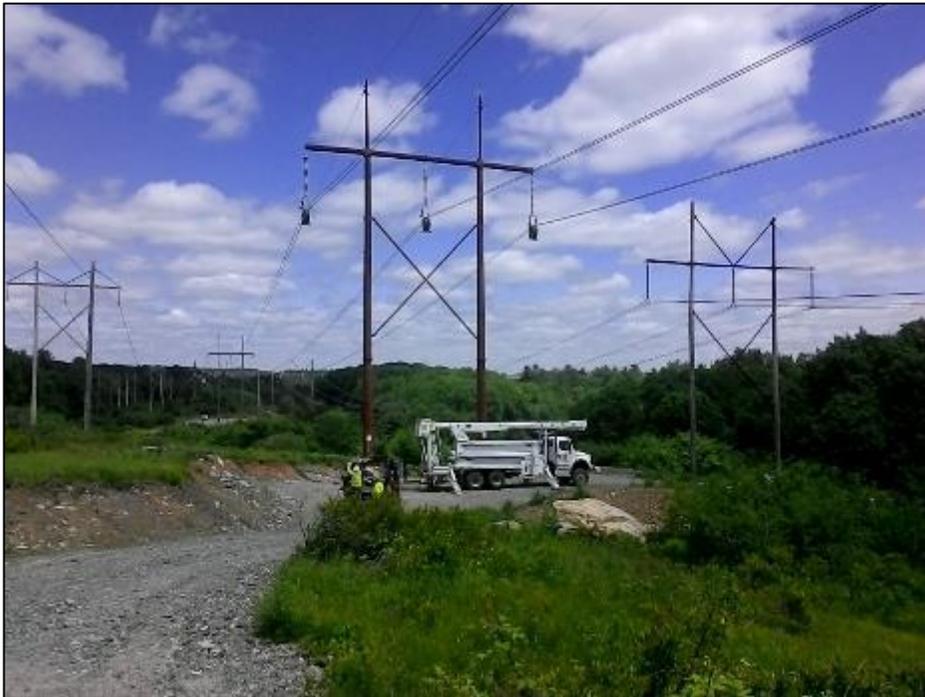
MS49, Str 253: Mounting conductor to insulators (Clipping). (Photo 6)

Photo #6: Preparations for clipping (mounting conductor to insulators) at Str 253. (6/4)

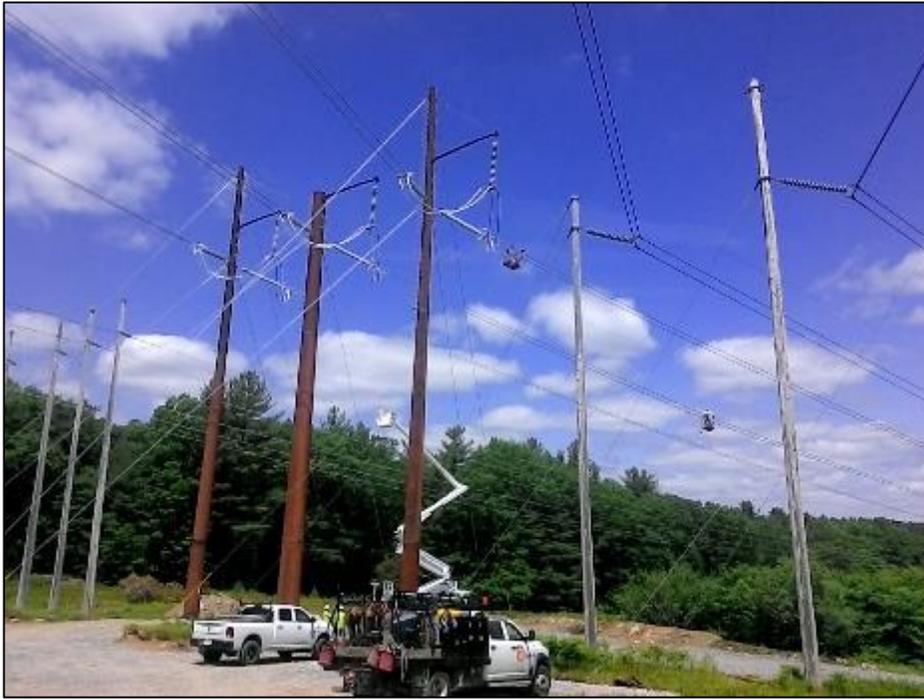
MS50, Str 255: Installing conductor spacers. (Photo 7)

Photo #7: Installing conductor spacers between Str 255 and 256. (6/4)

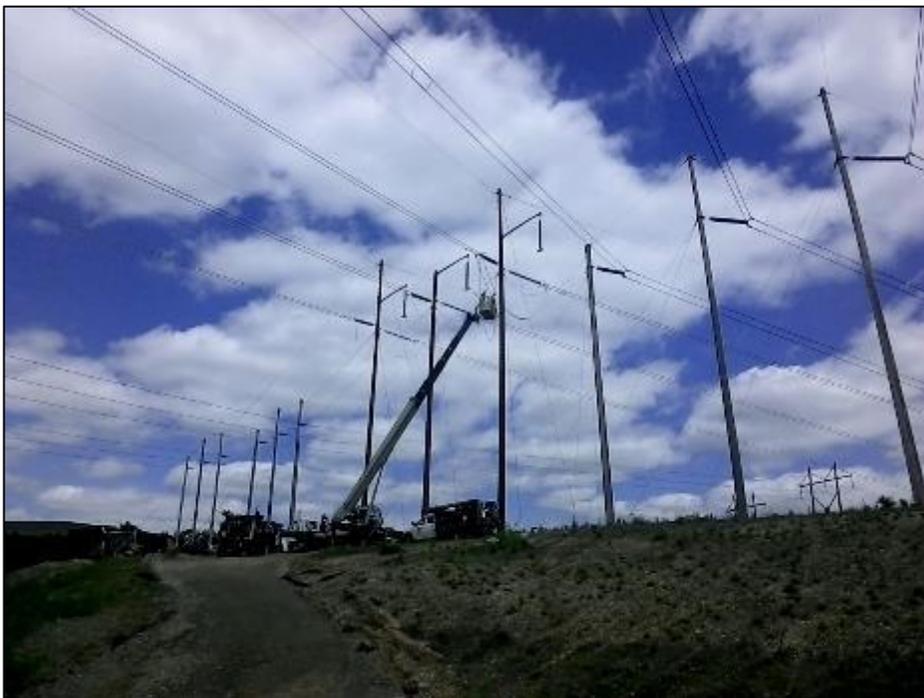
MS52, Str 261: Installing Conductor Jumpers. (Photo 8)

Photo #8: Installing jumpers between continuous runs of conductors on dead-end Str 261. (6/4)
