Docket No. 424 – Development and Management Plan Inspection

The Connecticut Light and Power Company Certificate of Environmental Compatibility and Public Need for the Connecticut portion of the Interstate Reliability Project.

IRP Overhead ROW

Interim Week Inspection:

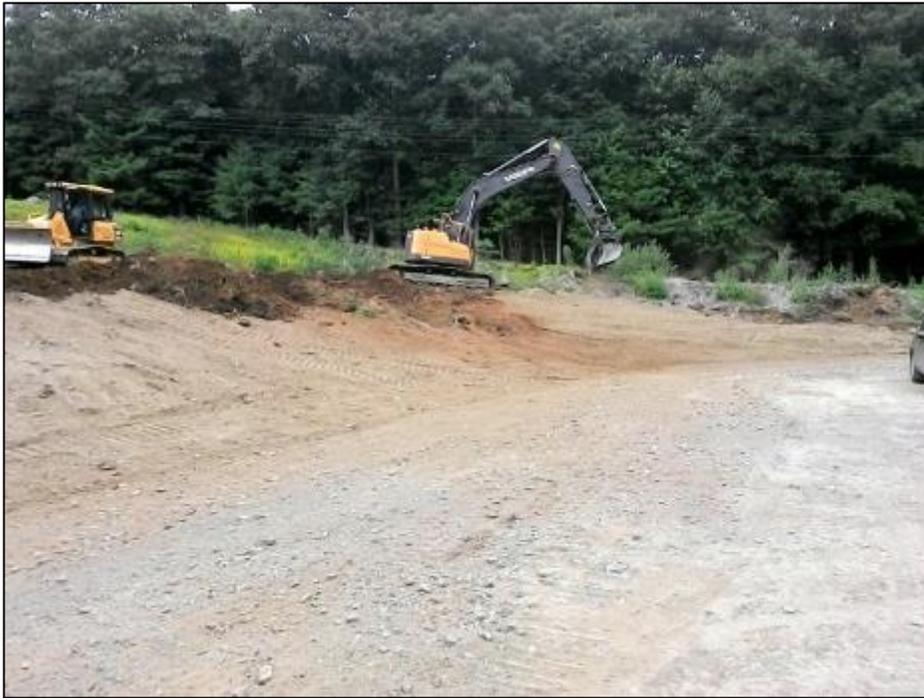
MS55, Str 279: Topsoil replacement and re-grading. (Photo 1)

Photo #1: Str 279 topsoil re-grading. (8/20)

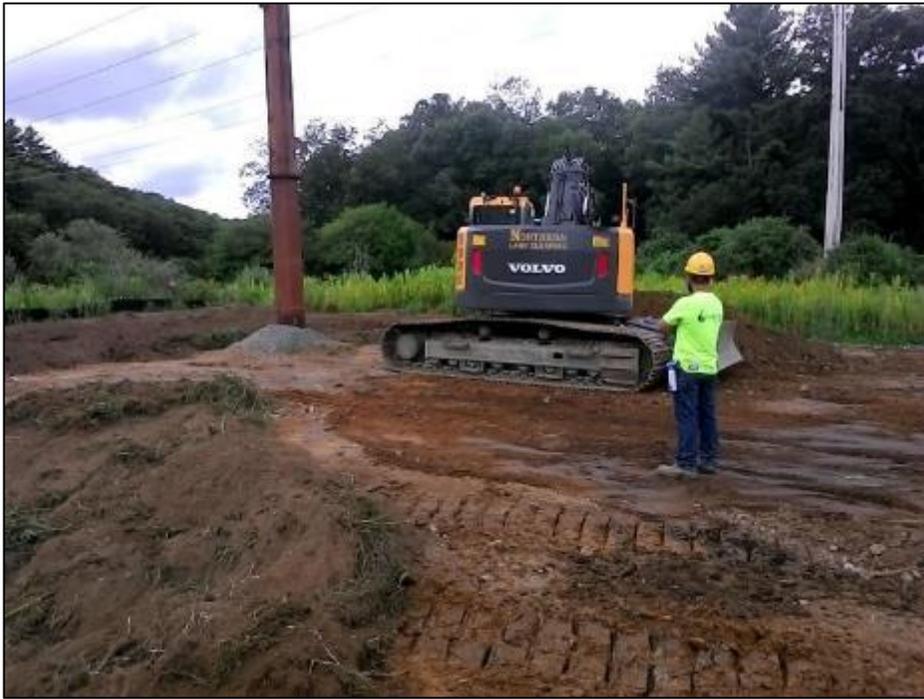
MS50, Str 256: Construction pad reclamation and topsoil replacement. (Photo 3)

Photo #3: Restoration operations at Str 256. (8/20)

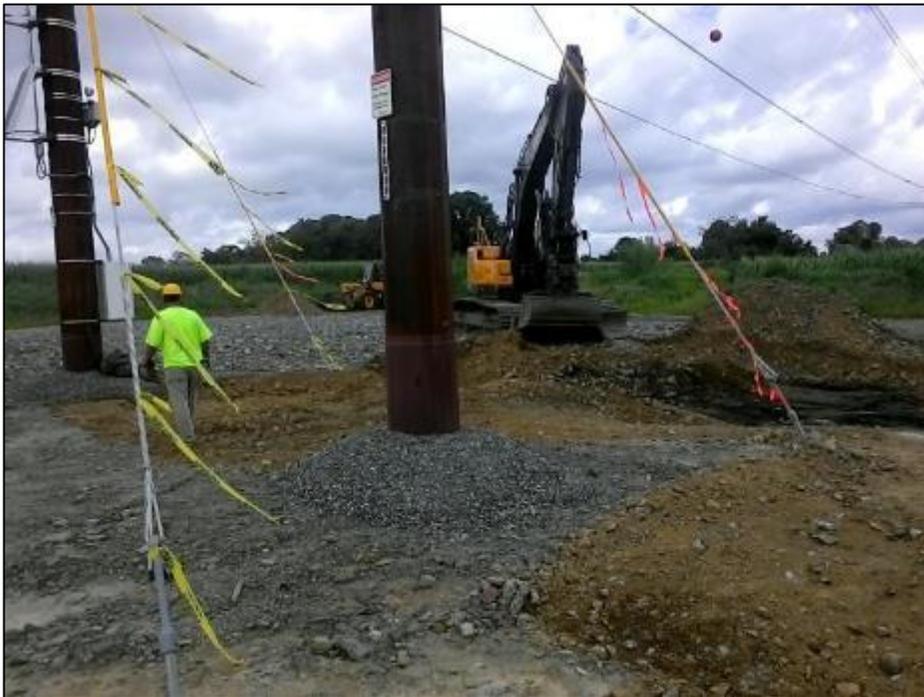
MS47, Str 227: Construction pad reclamation and topsoil replacement (Photo 4)

Photo #4: Str 227 pad stone removal.(8/20)

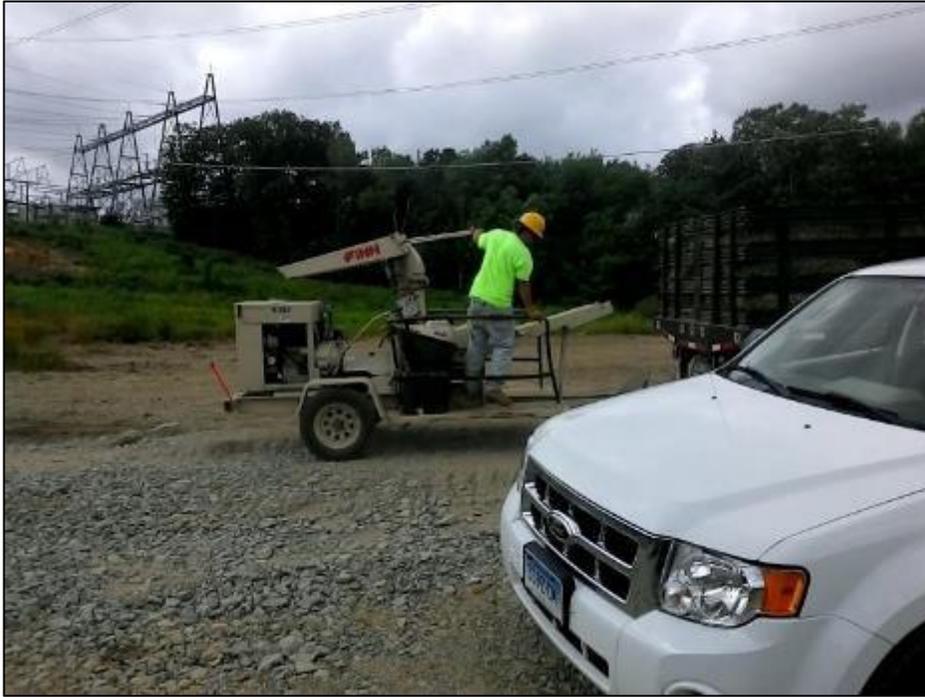
Photo #5: Prepping to stabilize areas with blown straw. (8/20)

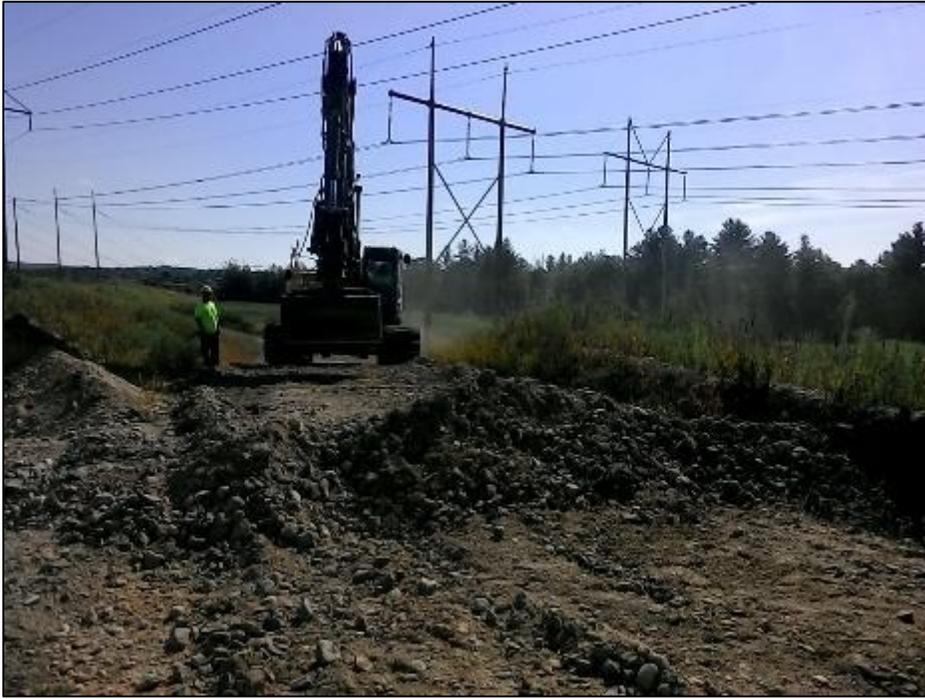
MS52, Str 260: Restoration Operations. (Photo 7)

Photo #7: Road removal at Str 260 as part of restoration operations. (8/26)

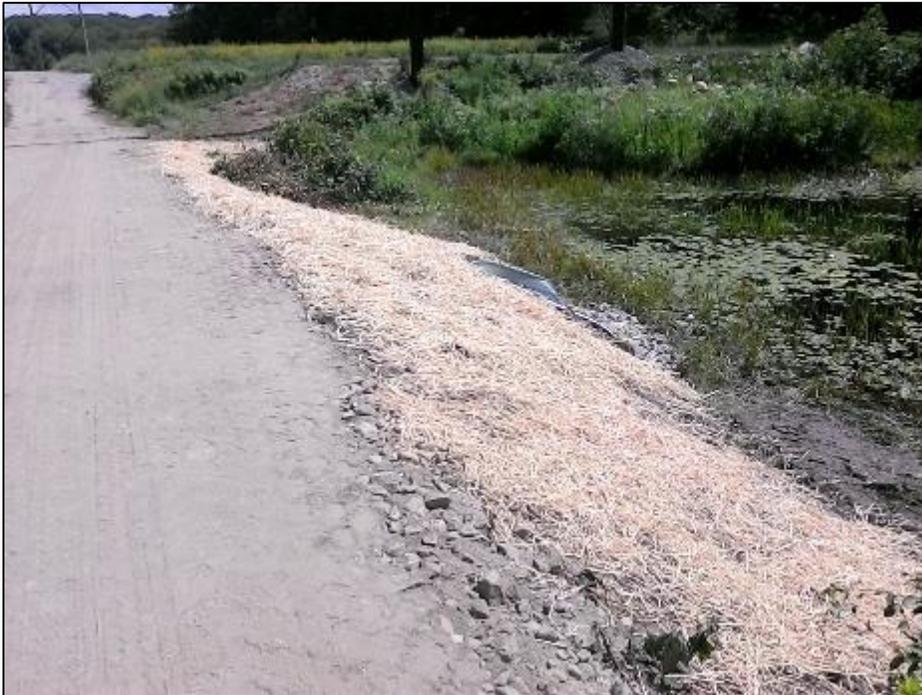
MS22, Str 117: Culvert Installation. (Photo 8)

Photo #8: Culvert installed under access road to Str 120. Disturbed area temporarily stabilized with straw. (8/26)

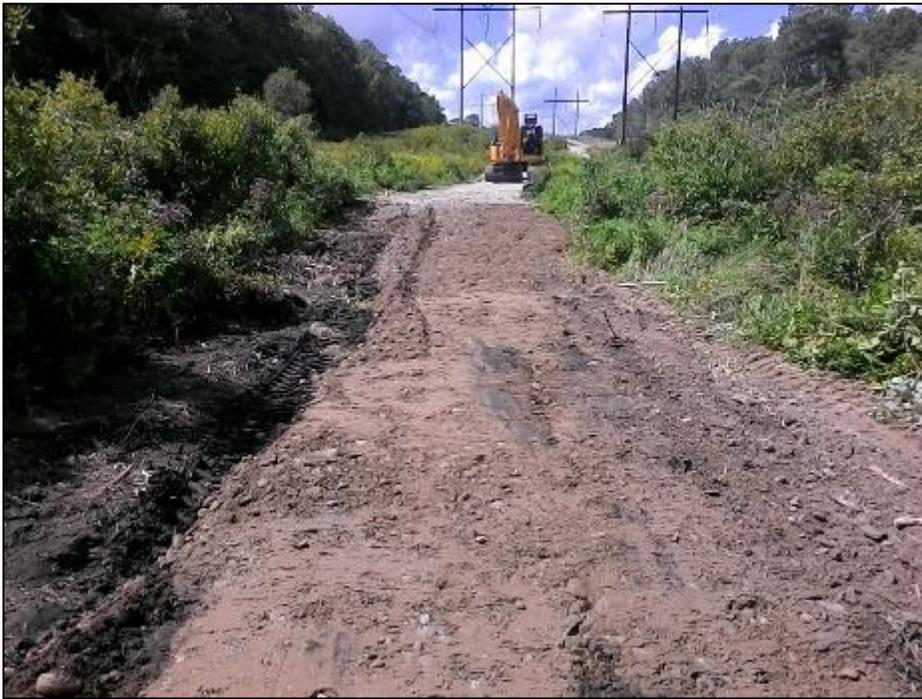
MS23, Str 120: Inspected new culvert (Installed on Tuesday, August 25). (Photo 9)

Photo #9: Area of culvert installation under access road to Str 117 excavated. (8/26)

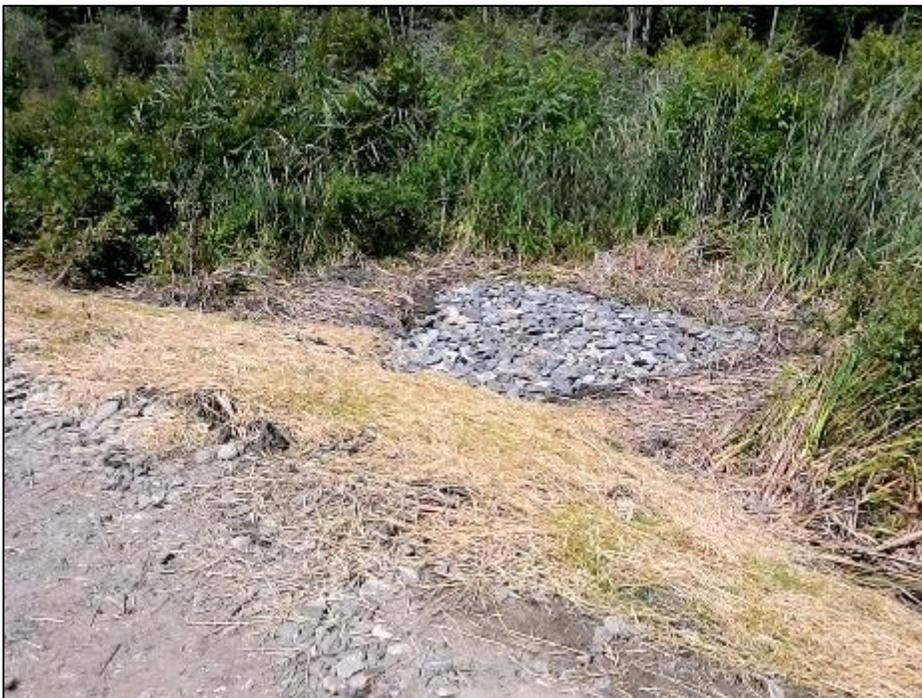
MS9, Str 47: Inspected new culvert (Installed on Thursday, August 13). (Photo 10)

Photo #10: Culvert installed under access road to Str 47. Disturbed area temporarily stabilized with straw. (8/26)
