Docket No. 424 – Development and Management Plan Inspection

The Connecticut Light and Power Company Certificate of Environmental Compatibility and Public Need for the Connecticut portion of the Interstate Reliability Project.

IRP Overhead ROW

Interim Week Inspection:

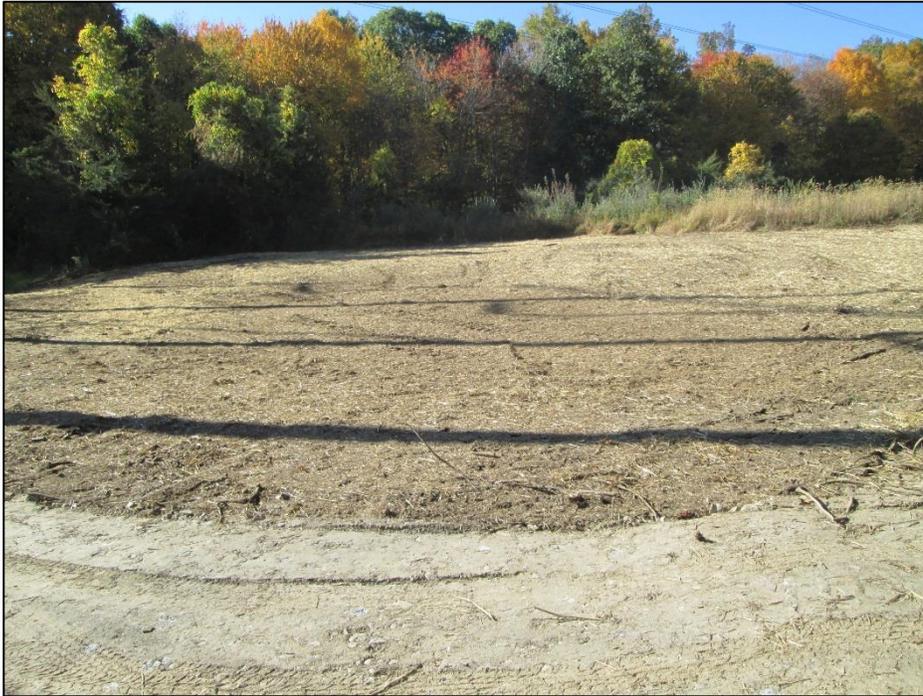
MS14, Str 72: Site fully restored. Seeded and temporarily stabilized with straw. (Photo 1)

Photo #1: Str 72 seeded and temporarily stabilized with straw. (10/15)

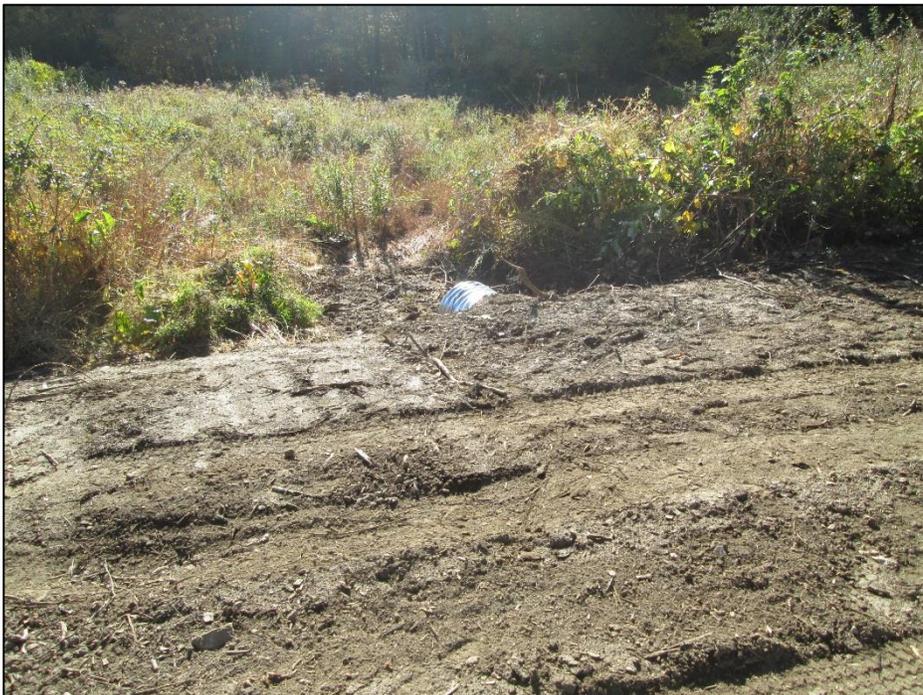
Photo #2: Replacement for existing culvert installed at Str 72. (10/15)

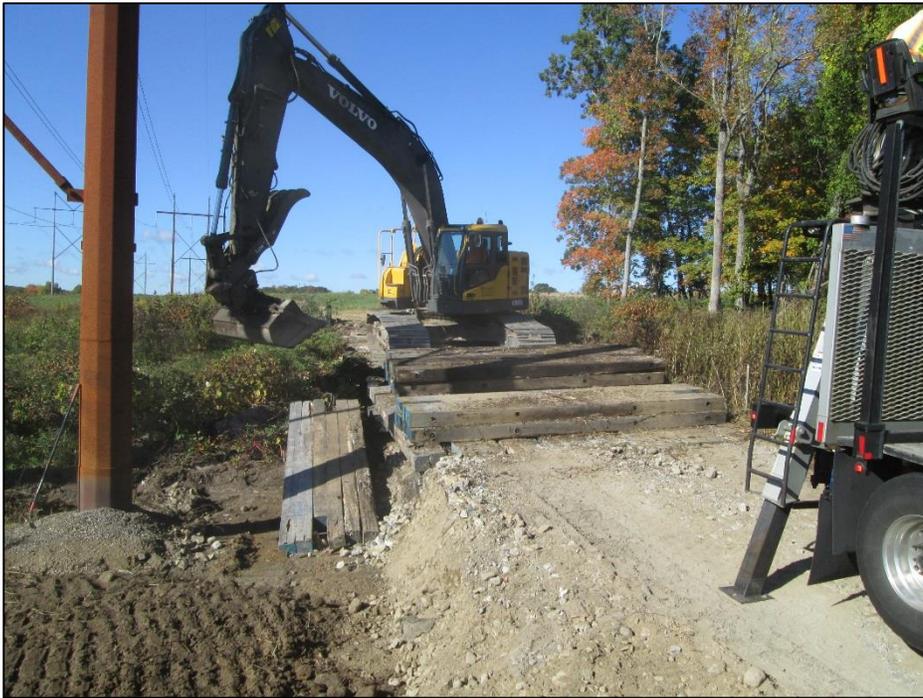
MS10, Str 53: Mat Removal. (Photo 3)

Photo #3: Mat removal at Str 53 as part of restoration operations. (10/15)

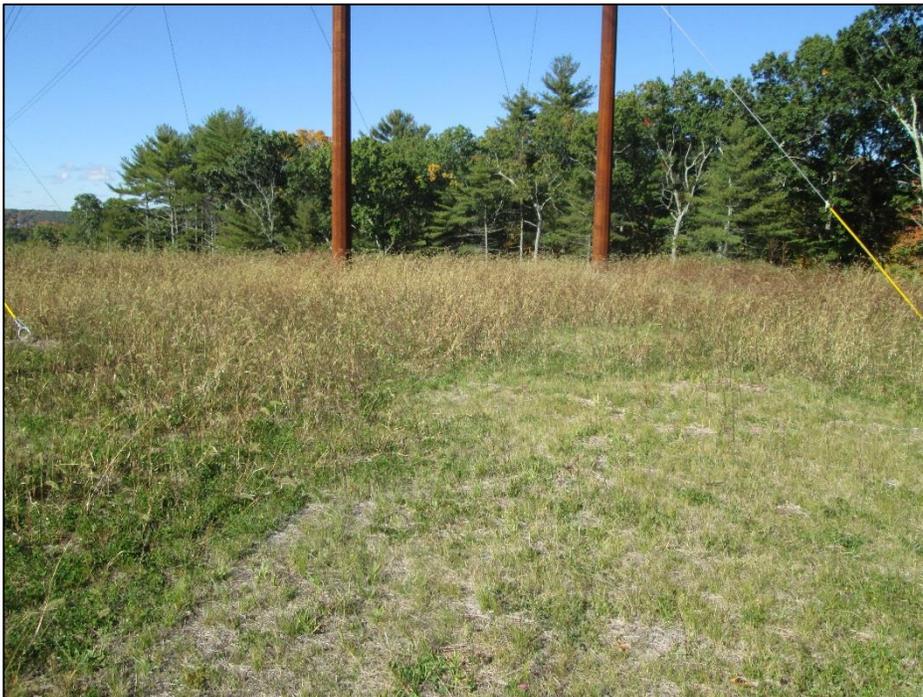
MS17, Str 89: Final Site Inspection. (Photo 4)

Photo #4: Final site inspection of Str 89. (10/15)

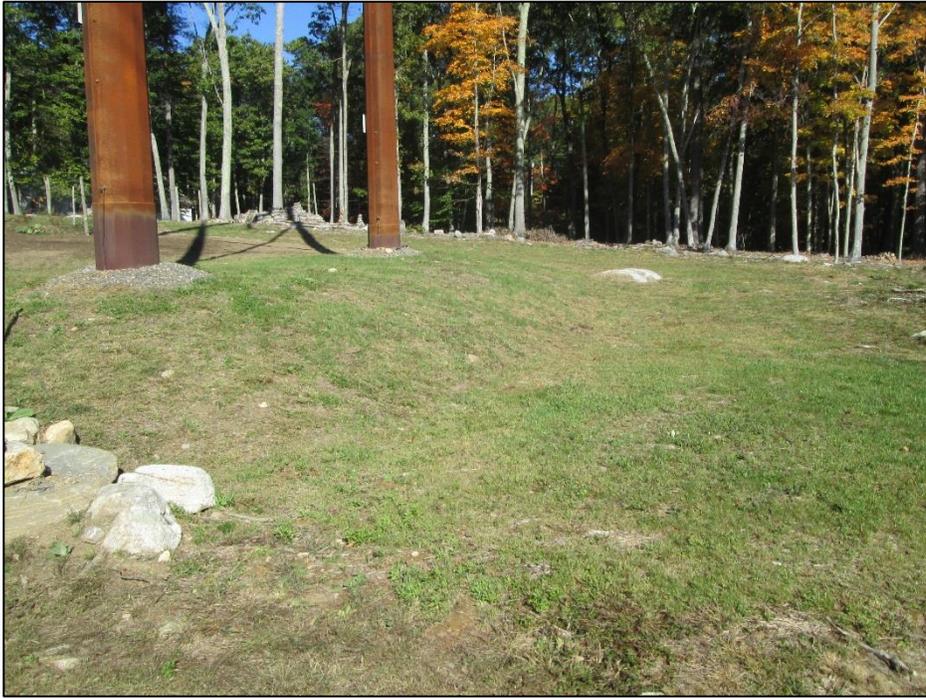
MS17, Str 90: Final Site Inspection. (Photo 5)

Photo #5: Final site inspection of Str 90. (10/15)

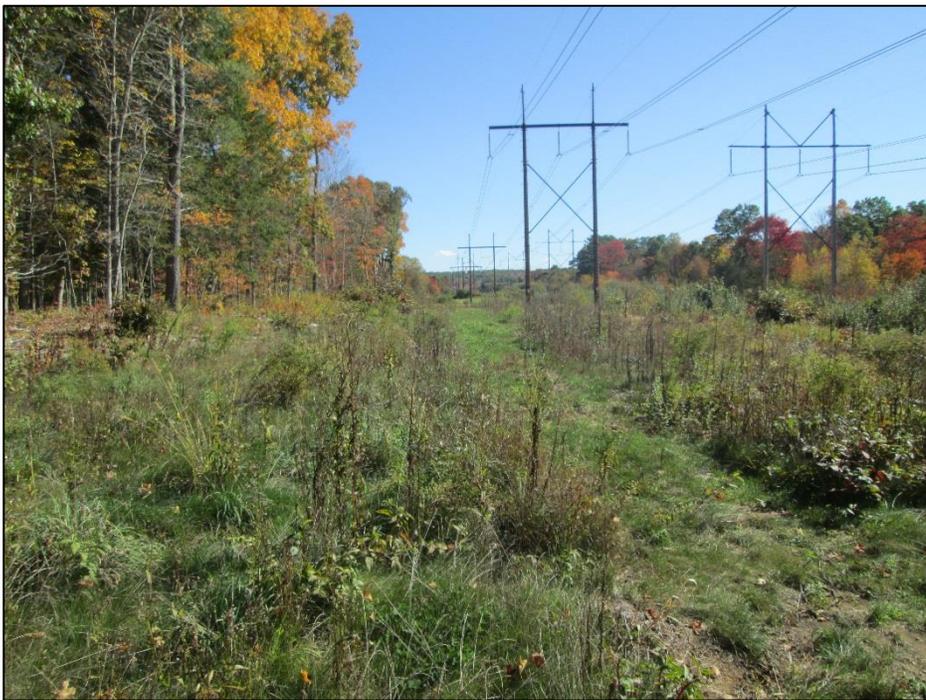
MS18, Str 92-96: Final Site Inspection. (Photo 6)

Photo #6: Final site inspection of Str 92-96. Photo representative of stretch. (10/15)

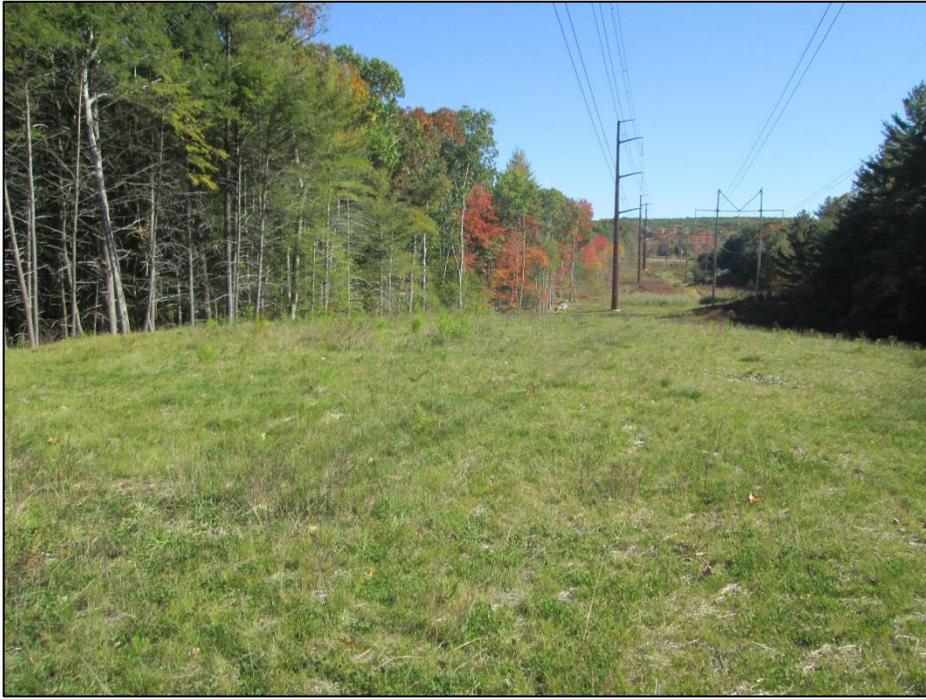
MS18, Str 97: Final Site Inspection. (Photo 7)

Photo #7: Final site inspection of Str 97. (10/15)

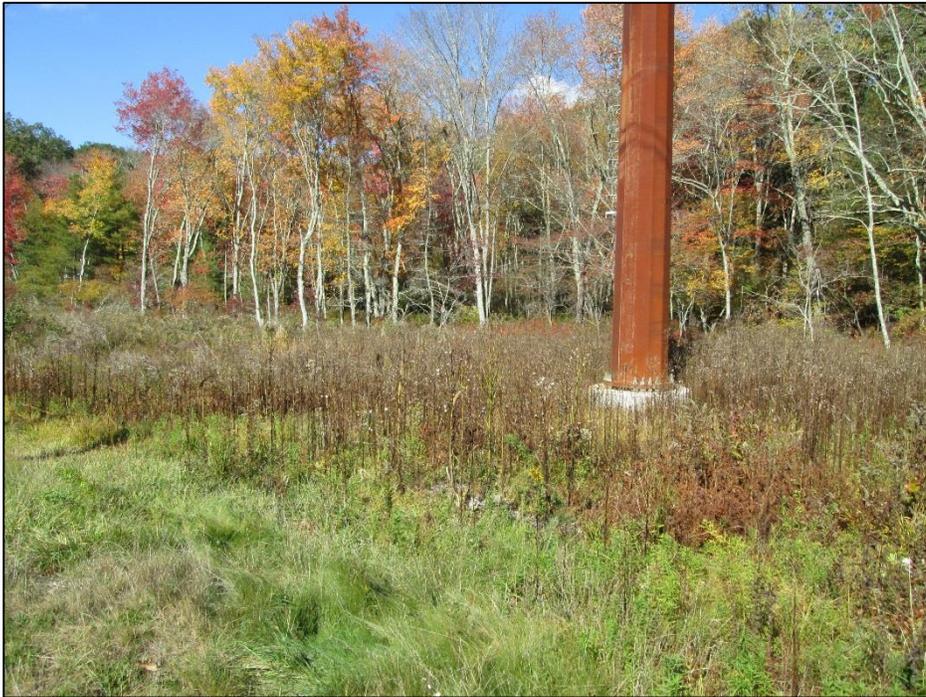
MS19, Str 99: Final Site Inspection. (Photo 8)

Photo #8: Final site inspection of Str 98-101. Photo representative of stretch. (10/15)

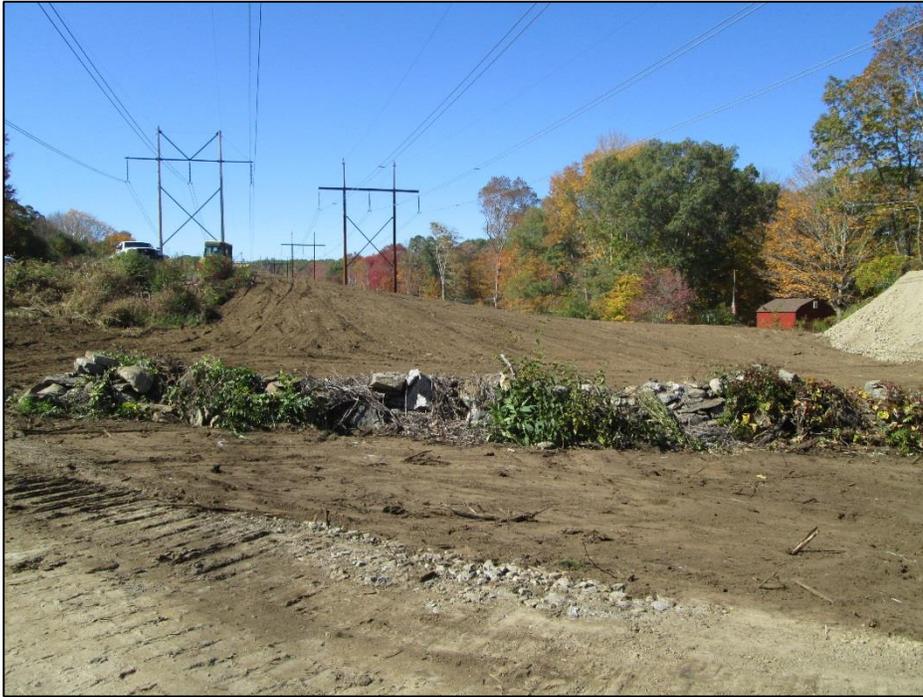
MS35, Str 179: Re-grading and General Earthwork. (Photo 9)

Photo #9: Earthwork and re-grading at Str 179 as part of restoration operations. (10/15)

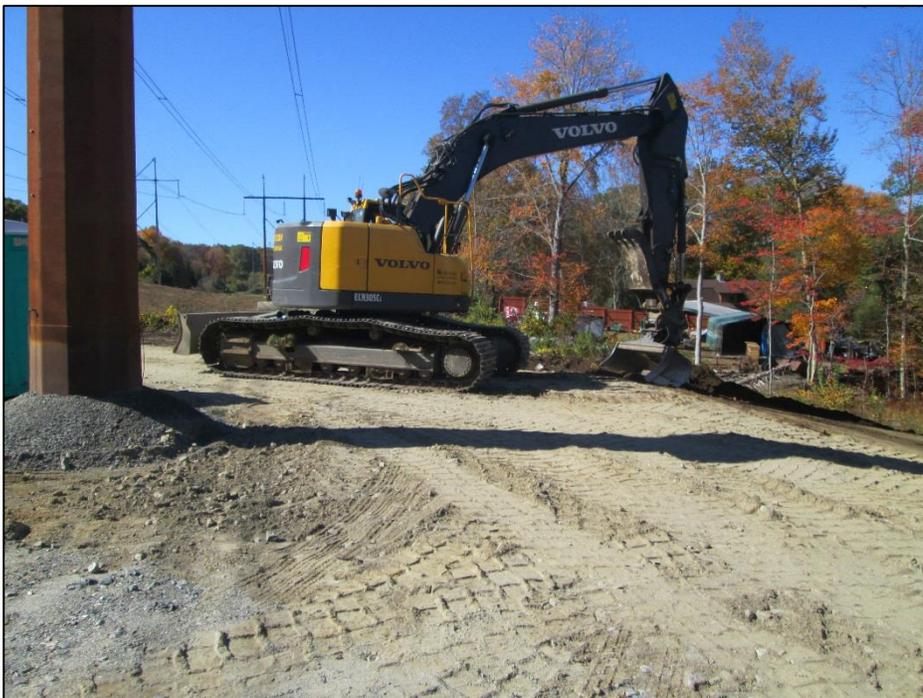
MS35, Str 180: Re-grading and General Earthwork. (Photo 10)

Photo #10: Earthwork and re-grading at Str 180 as part of restoration operations. (10/15)

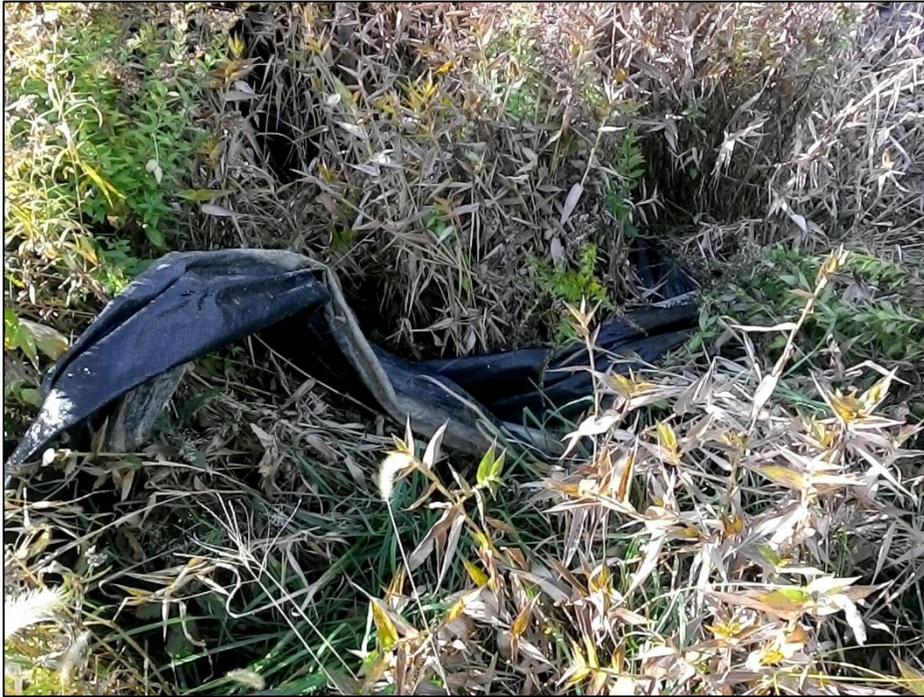
Photo #11: Silt fence fabric and stakes found around Str 2. (10/22)

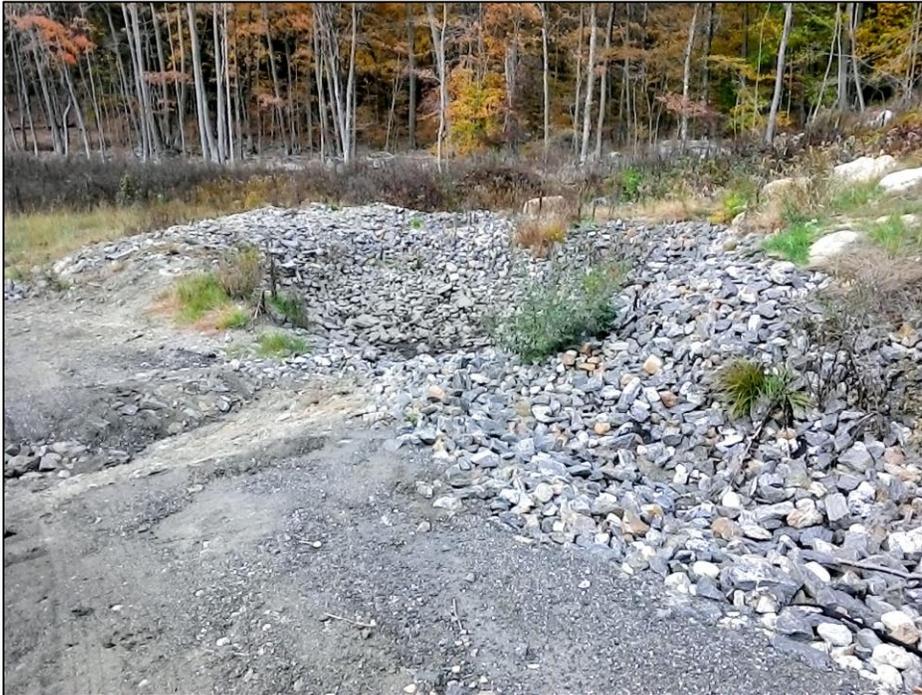
Photo #12: Large sedimentation basin to remain on access road between Str 42 and 43. (10/22)
