**Docket No. 424 – Development and Management Plan Inspection**

The Connecticut Light and Power Company Certificate of Environmental Compatibility and Public Need for the Connecticut portion of the Interstate Reliability Project.

**IRP Overhead ROW**

**Interim Week Inspection:**

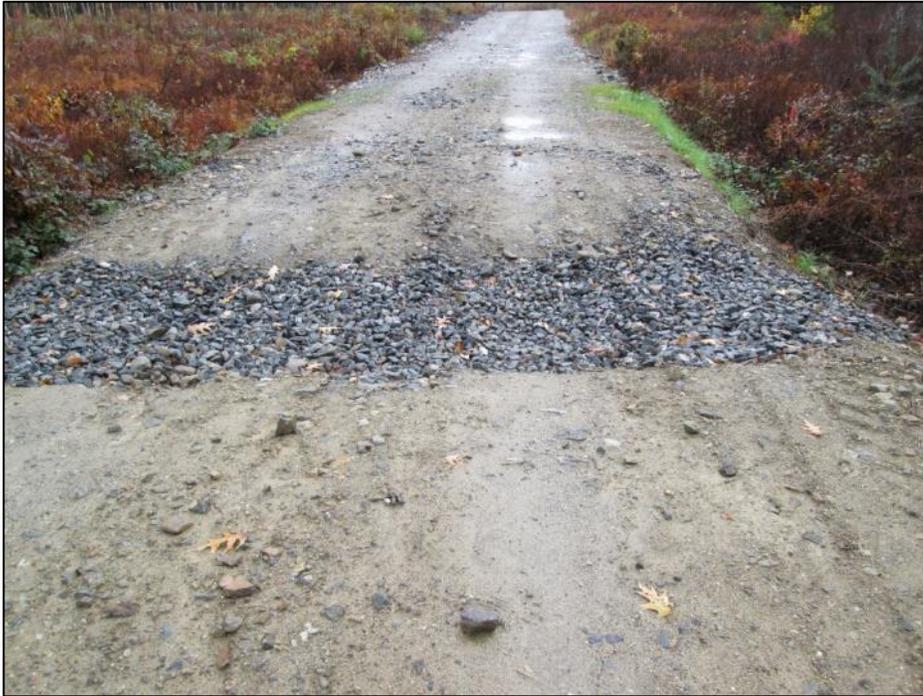
Photo #1: Stone water bar to remain on access road between Str 44 and 45. (10/29)

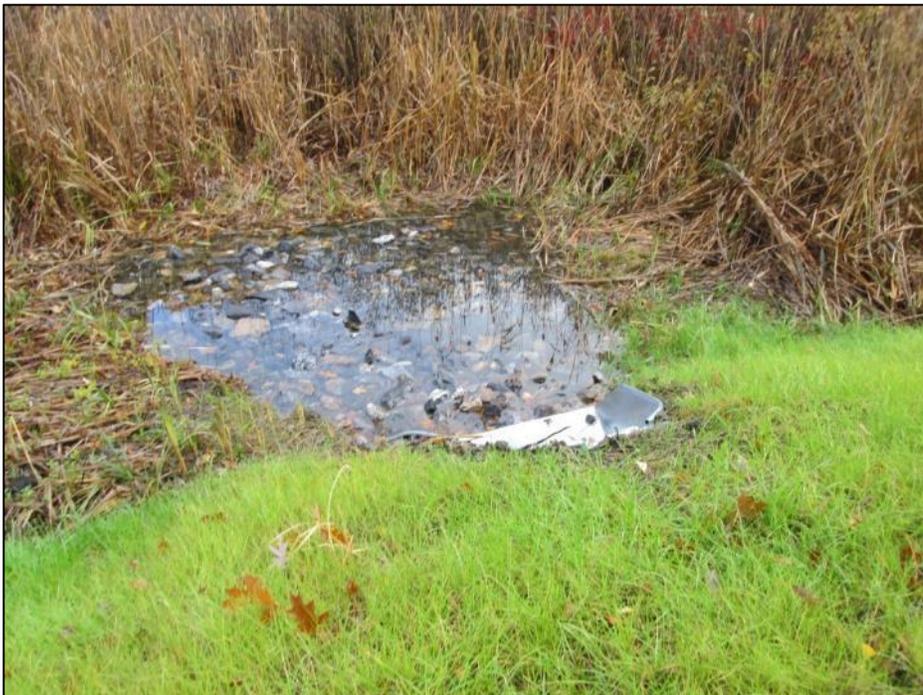
Photo #2: Culvert and rip-rap outlet protection to remain on Str 47 access road. (10/29)

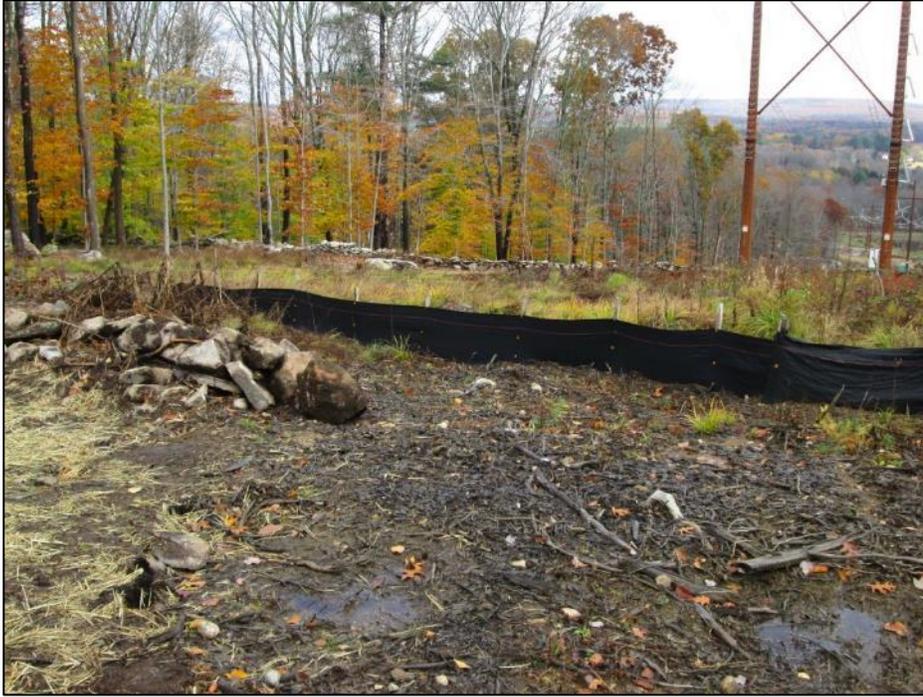
Photo #3: Silt fence left behind along pulling pad between Str 71 and 72. (10/29)

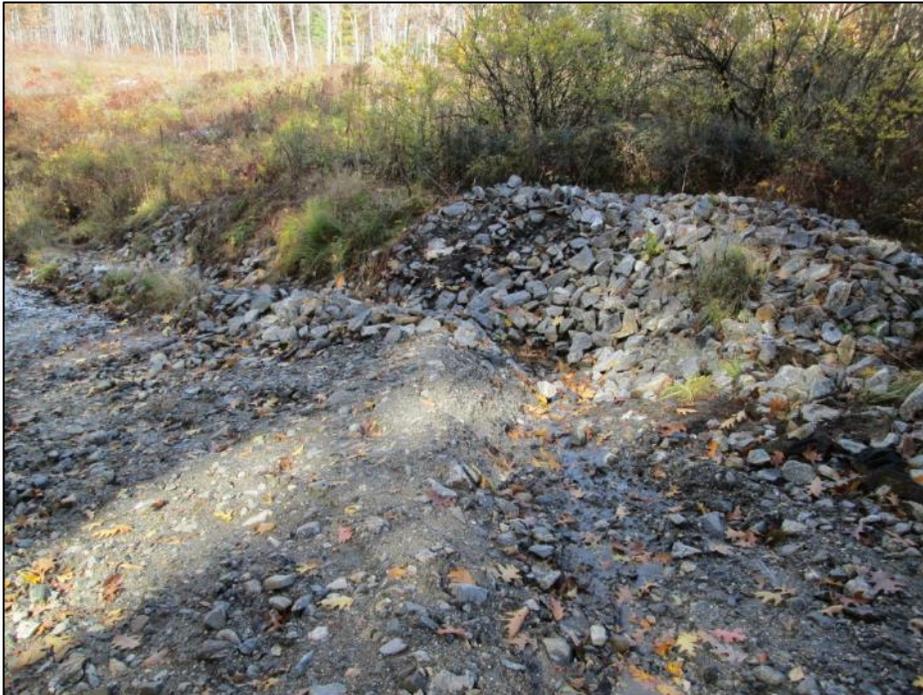
Photo #4: Large sedimentation basin with stone drainage swale to remain on access road between Str 104 and 105. (10/29)

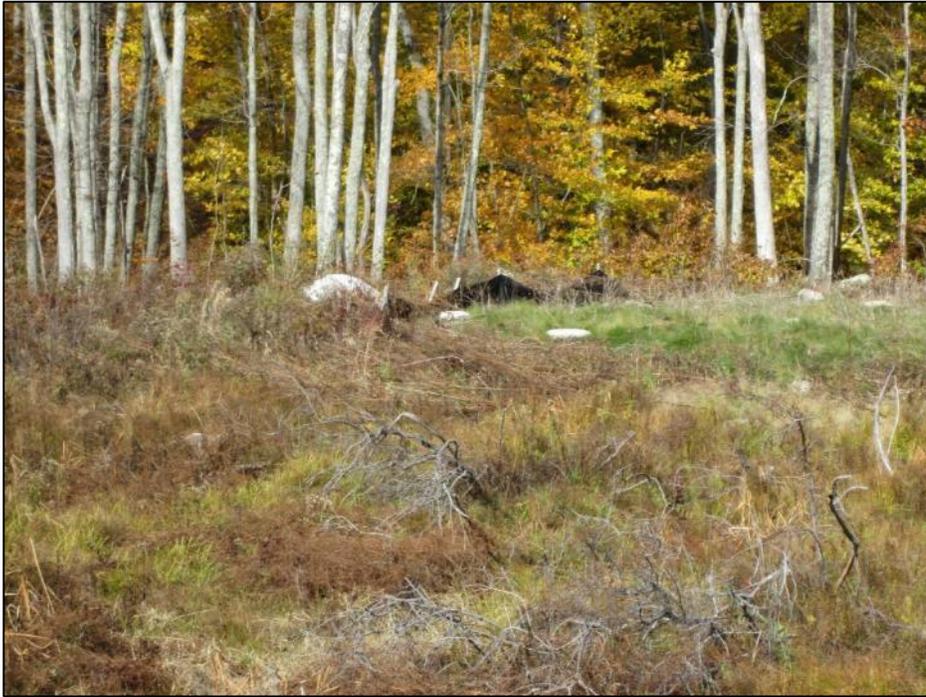
Photo #5: Silt fence left behind at Str 104. (10/29)

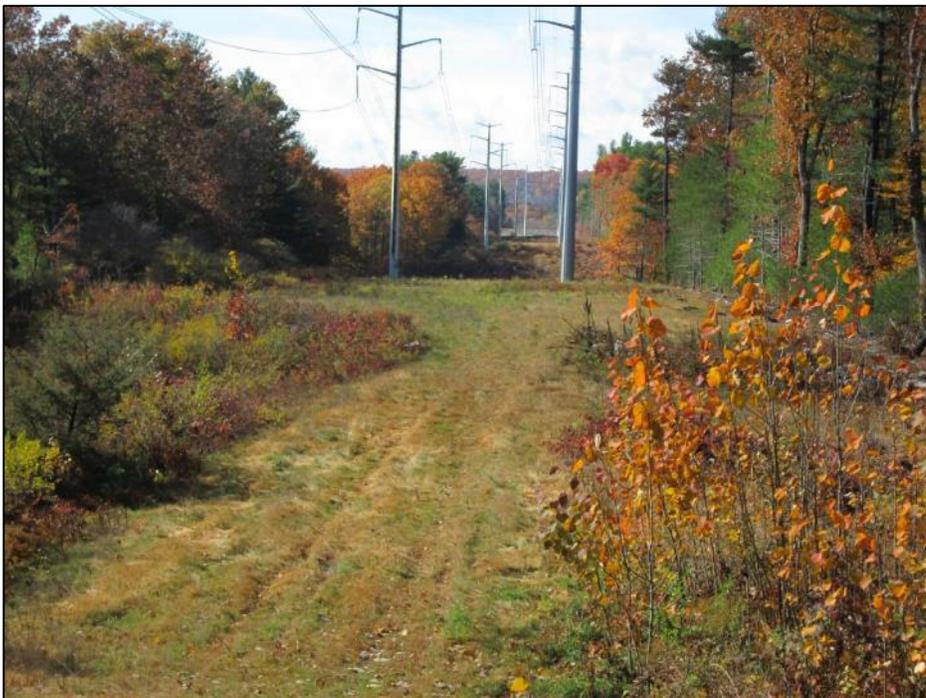
Photo #6: Section of removed and stabilized access road to Str 87. Typical of all observed access road restoration. (10/29)

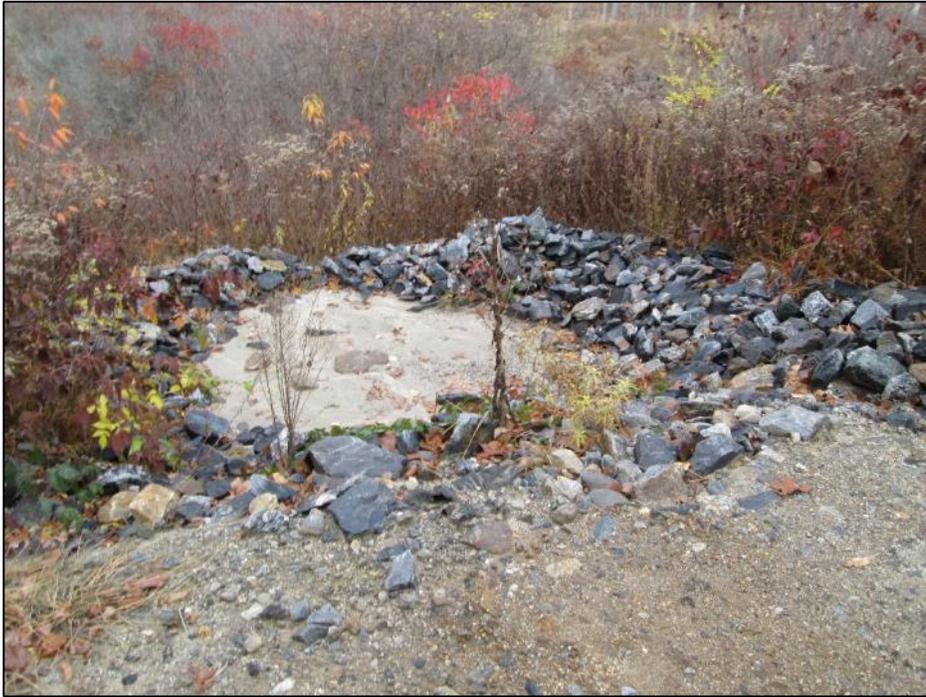
Photo #7: Recommend removing sediment from basin located on Str 113-114 access road. (11/5)

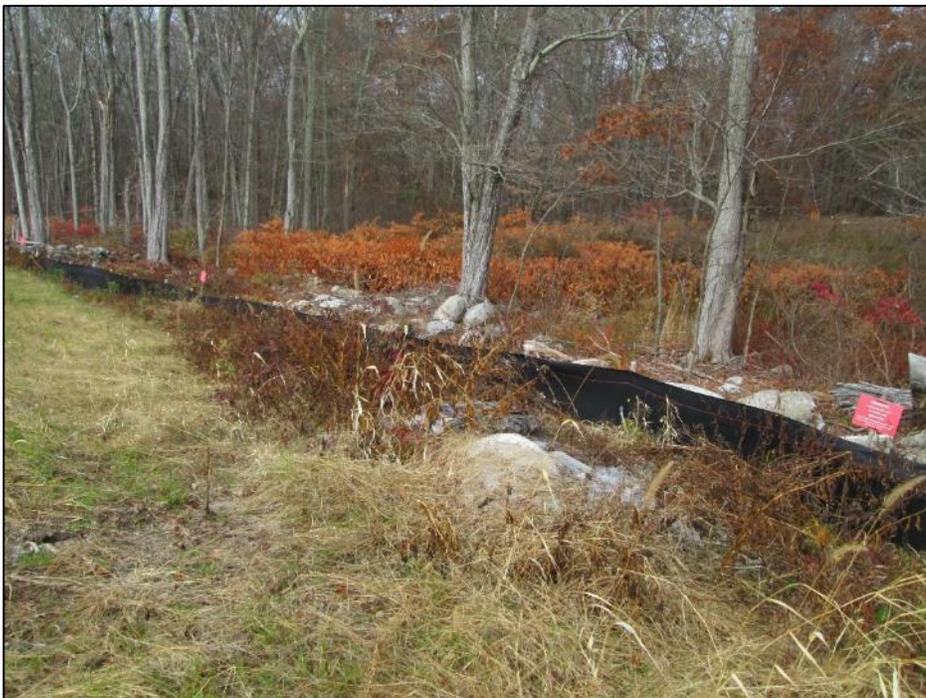
Photo #8: Section of silt fence left behind at Str 123-124. (11/5)

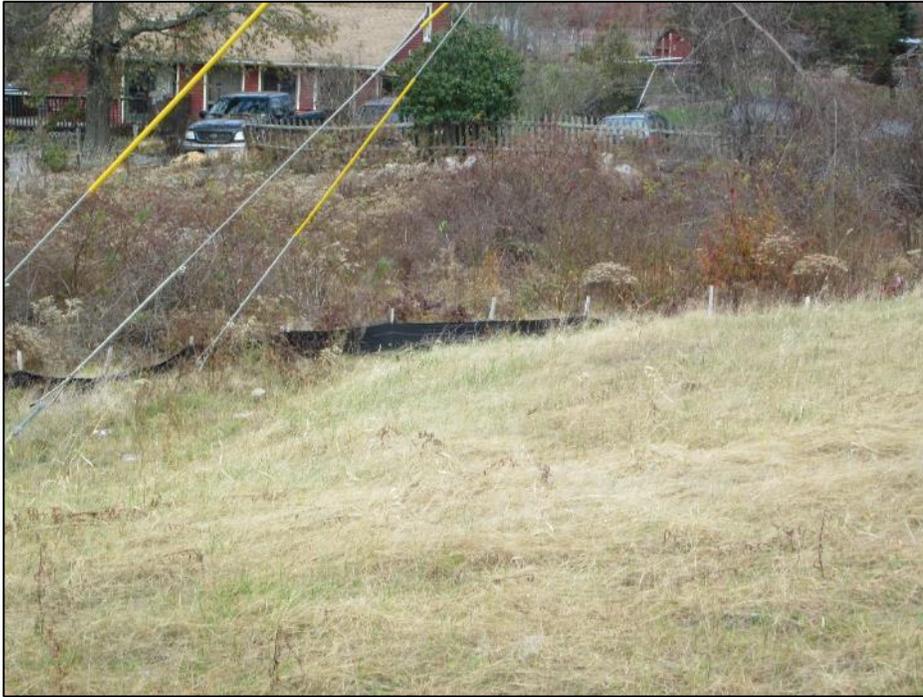
Photo #9: Long section of silt fence left behind at Str 124. (11/5)

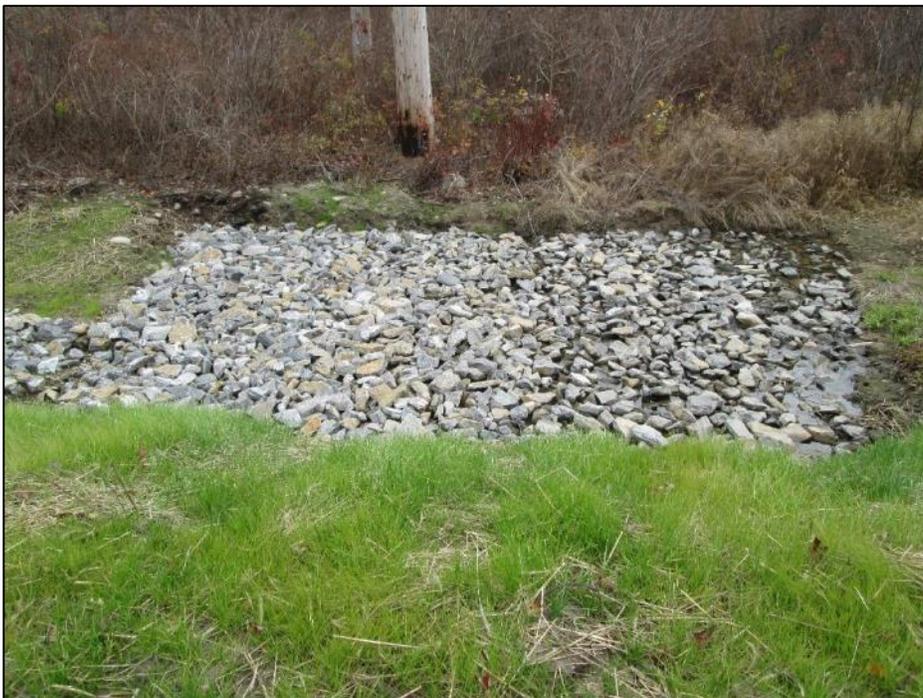
<b>Interim Week (10/29)</b>	All observed access road and wetland crossings encroaching in the wetlands have been removed. No permanent BMP's have been observed in these areas.	Continue to follow this procedure.	NA
<b>Inland Wetland and Watercourse encroachment and mitigation</b>	<b>Bi-Week (11/5)</b>	Str 154: T. Ramborger indicated that his map showed the rip rap outlet control for the culvert (a permanent BMP) to be encroaching in a wetland. (Photo 10)	Location of encroachment may require survey delineation to verify official edge of wetland line. If encroachment into wetland does occur, recommend seeking direction from the CSC for a permanent solution.	Follow-up information from the compliance team provided that the culvert and the corresponding rip rap outlet control have been approved as wetland fill per CT DEEP permit special condition 10. No further action is required.

Photo #10: Str 154: Rip rap outlet protection crosses wetland line according to T. Ramborger's map. (11/5)

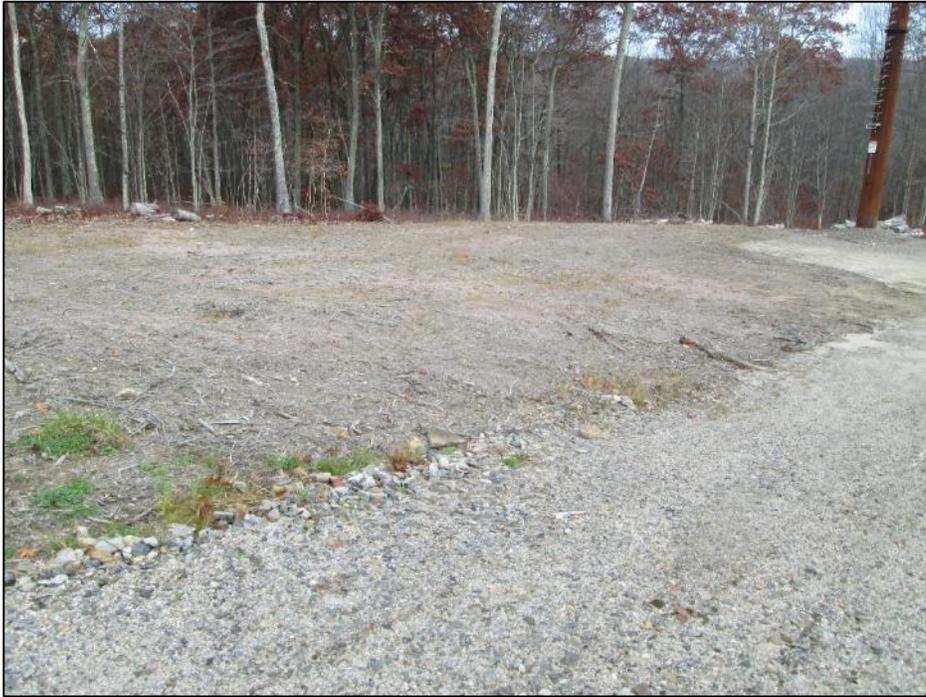
**MS21-23, Str 113-120: Final Site Inspection.** (Site not yet permanently stabilized) (Photo 11)

Photo #11: Str 120: Typical restoration progress for Str 113-120. Site not permanently stabilized. (11/5)

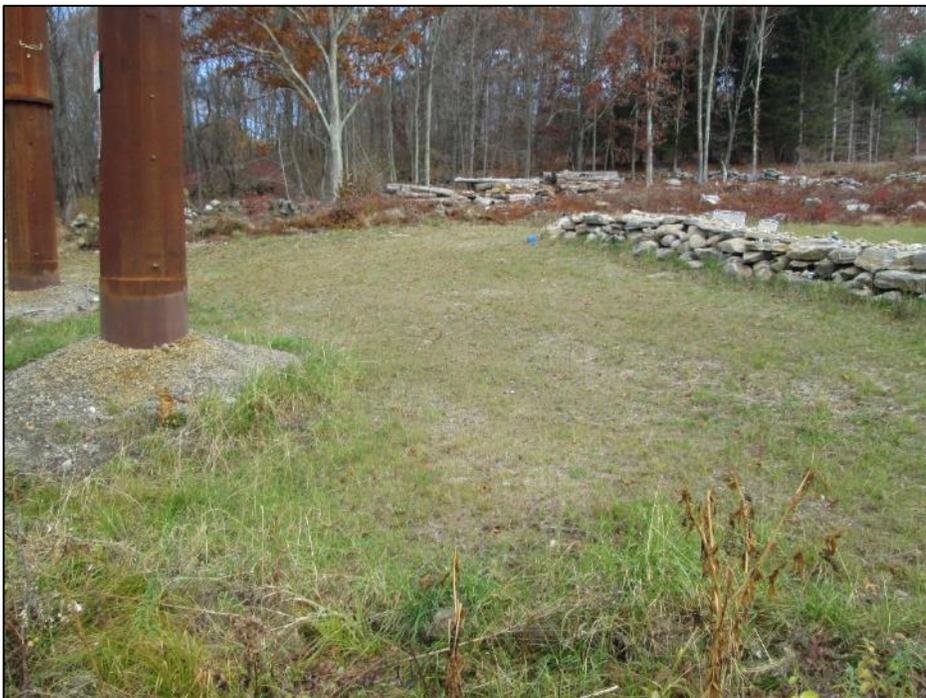
**MS23-24, Str 121-125: Final Site Inspection.** (Photo 12)

Photo #12: Str 121: Typical restoration progress for Str 121-125. Site stabilized. (11/5)

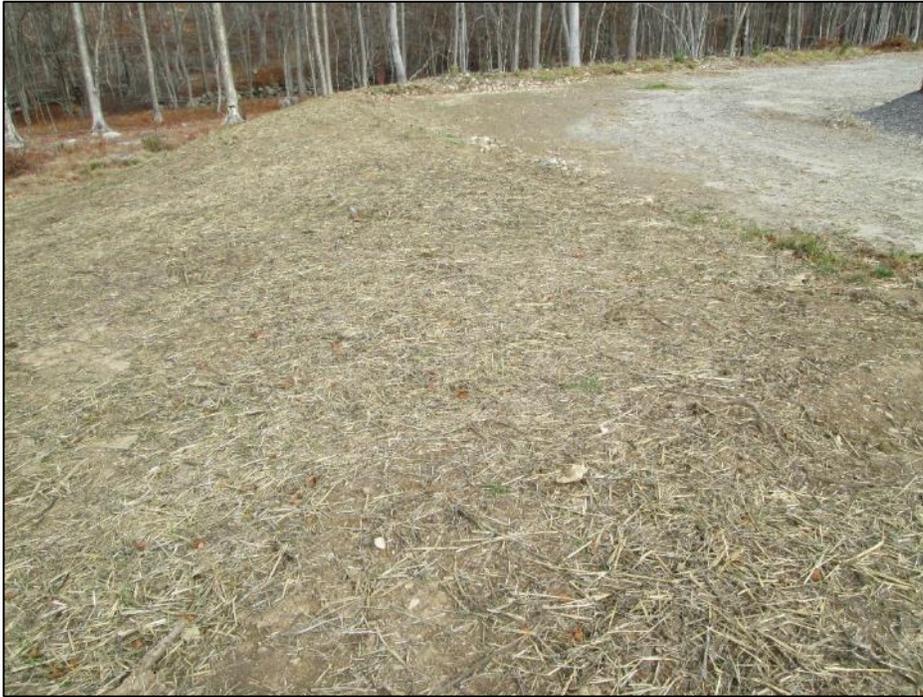
**MS24-27, Str 126-140: Final Site Inspection.** (Site not yet permanently stabilized) (Photo 13)

Photo #13: Str 131: Typical restoration progress for Str 126-140. Site not permanently stabilized. (11/5)

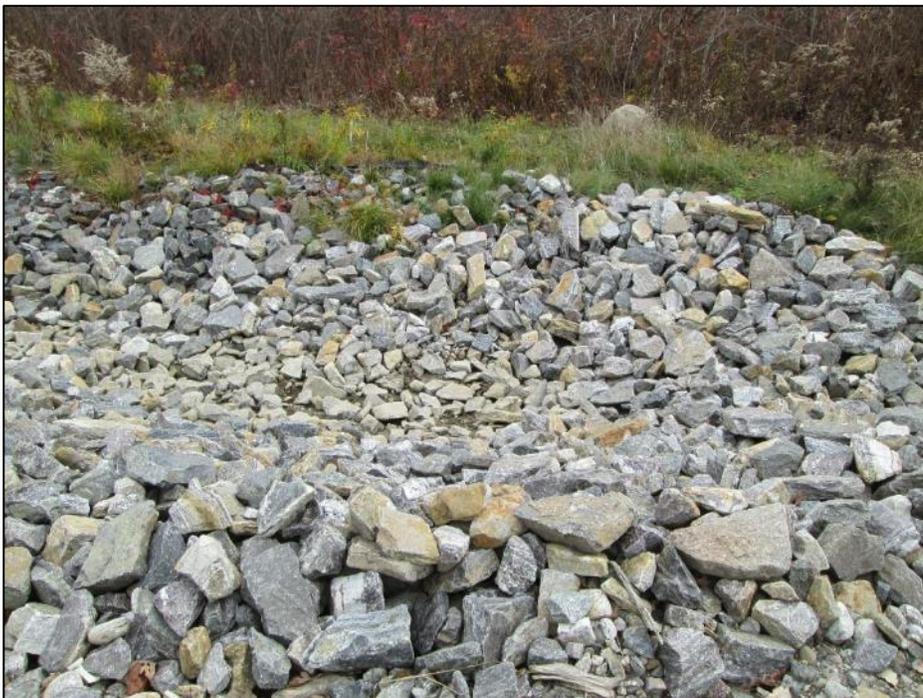
Photo #14: Large stone drainage swale to remain as a permanent BMP at Str 154. (11/5)
