**Docket No. 424 – Development and Management Plan Inspection**

The Connecticut Light and Power Company Certificate of Environmental Compatibility and Public Need for the Connecticut portion of the Interstate Reliability Project.

**IRP Overhead ROW**

**Interim Week Inspection:**

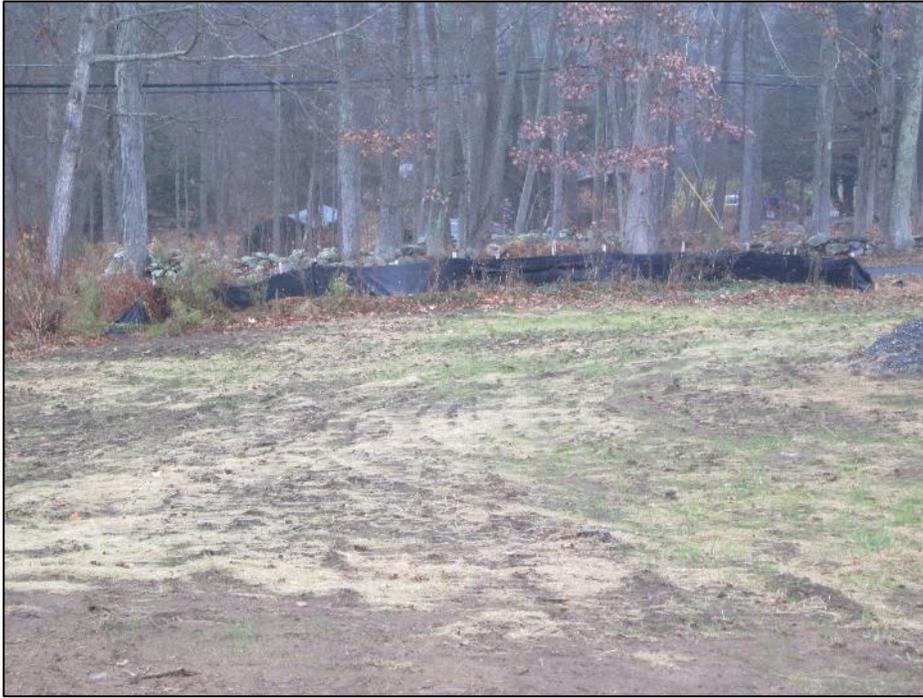
Photo #1: Multiple sections of silt fence left in place at Str 179-181. (11/12)

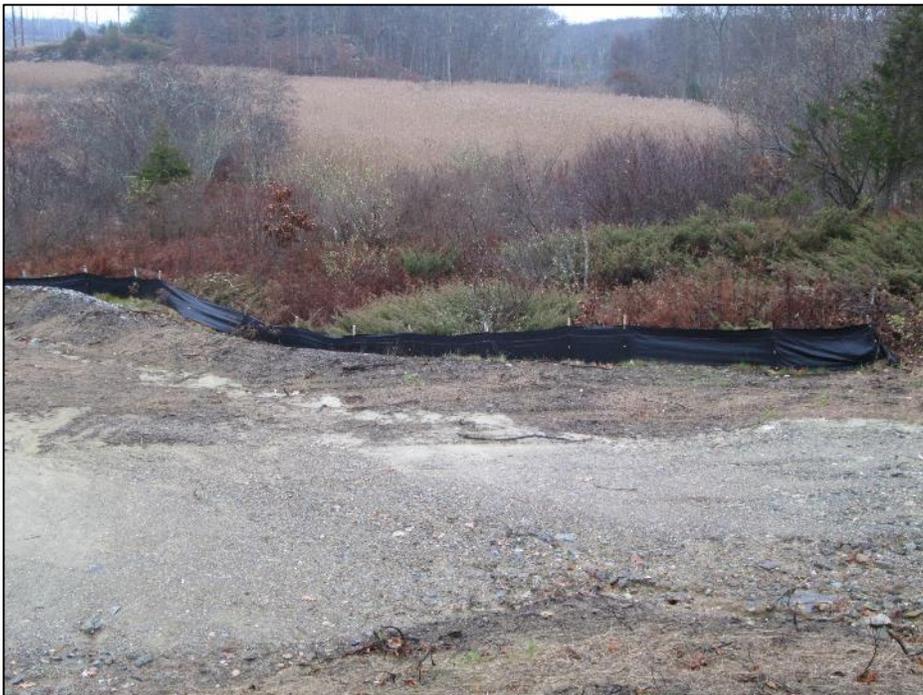
Photo #2: Silt fence left in place at Str 204. (11/12)

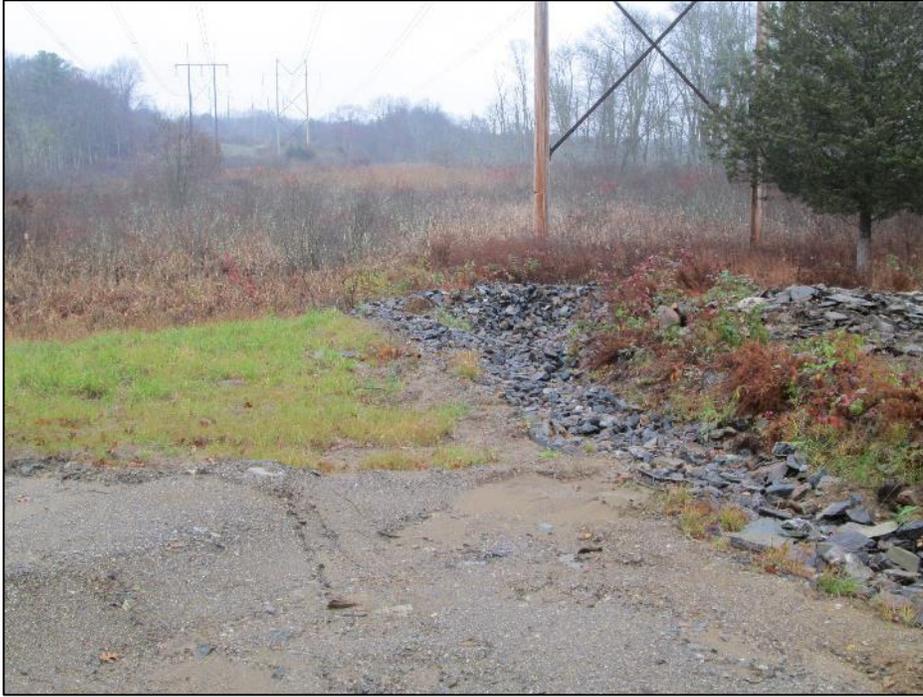
Photo #3: Large sedimentation basin to remain as permanent BMP's at Str 206 . (11/12)

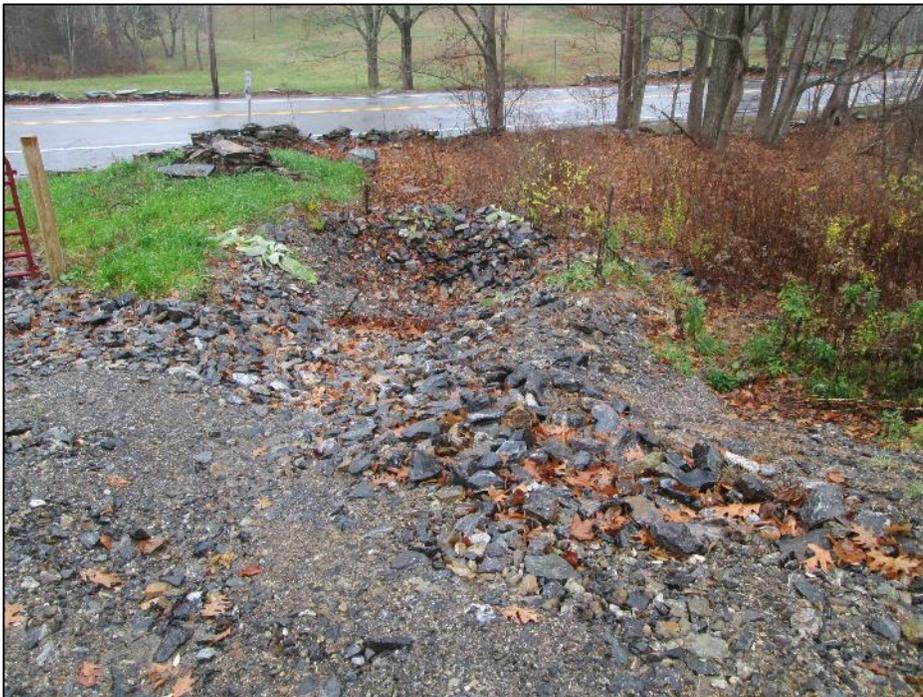
Photo #4: Sedimentation basin to remain as permanent BMP at the bottom of the Str 199 access road. (11/12)

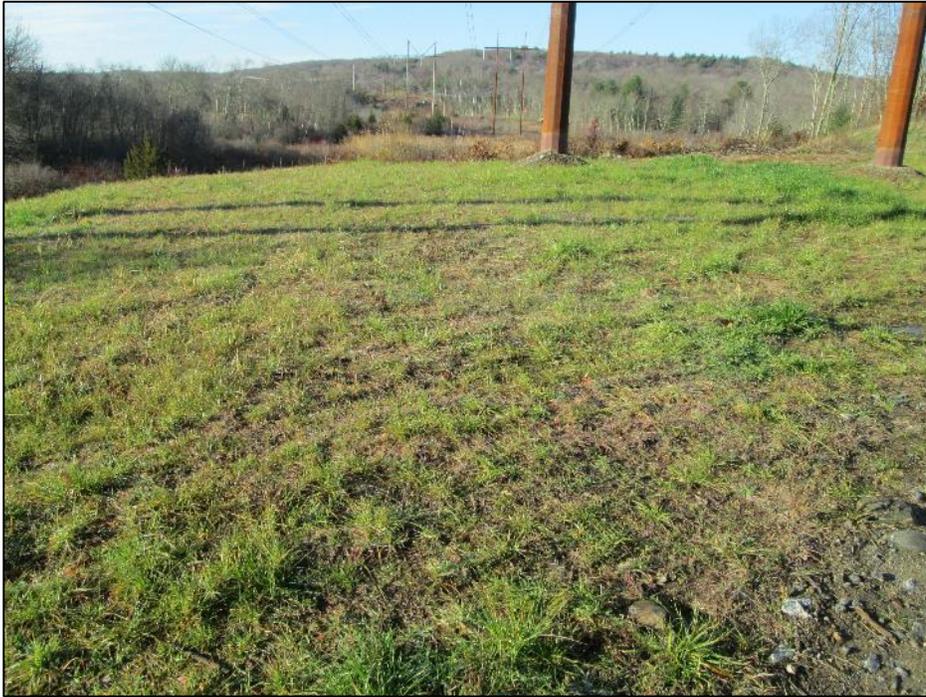
**MS41-42, Str 211-215: Final Site Inspection.** (Site not yet permanently stabilized) (Photo 5)

Photo #5: Str 214 not yet fully stabilized. Typical of Str 211-215. (11/20)

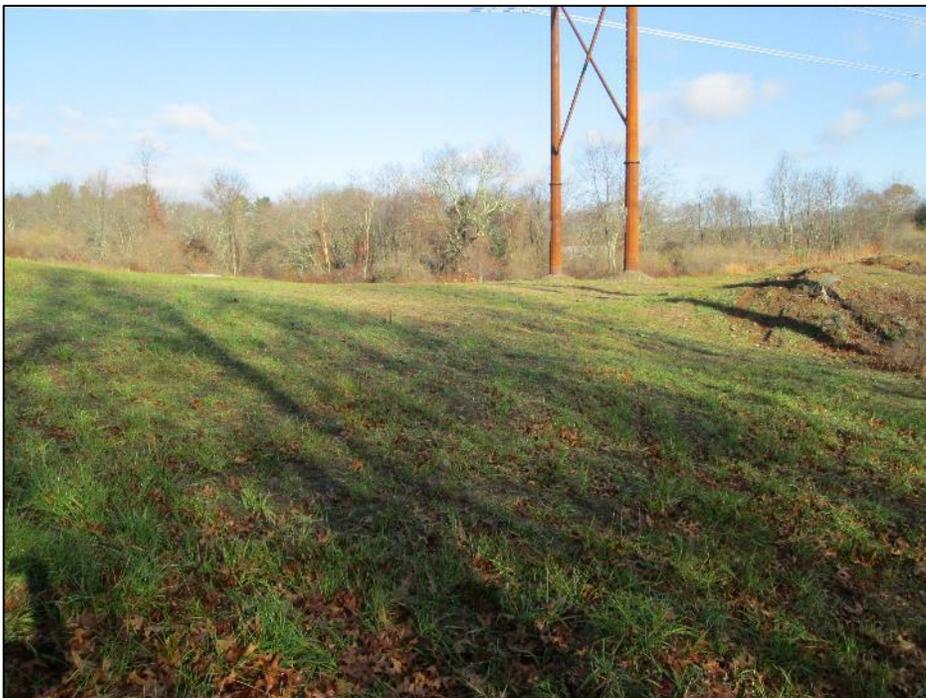
**MS42-43, Str 216-221: Final Site Inspection.** (Photo 6)

Photo #6: Str 220 fully stabilized. Typical of Str 216-221. (11/20)

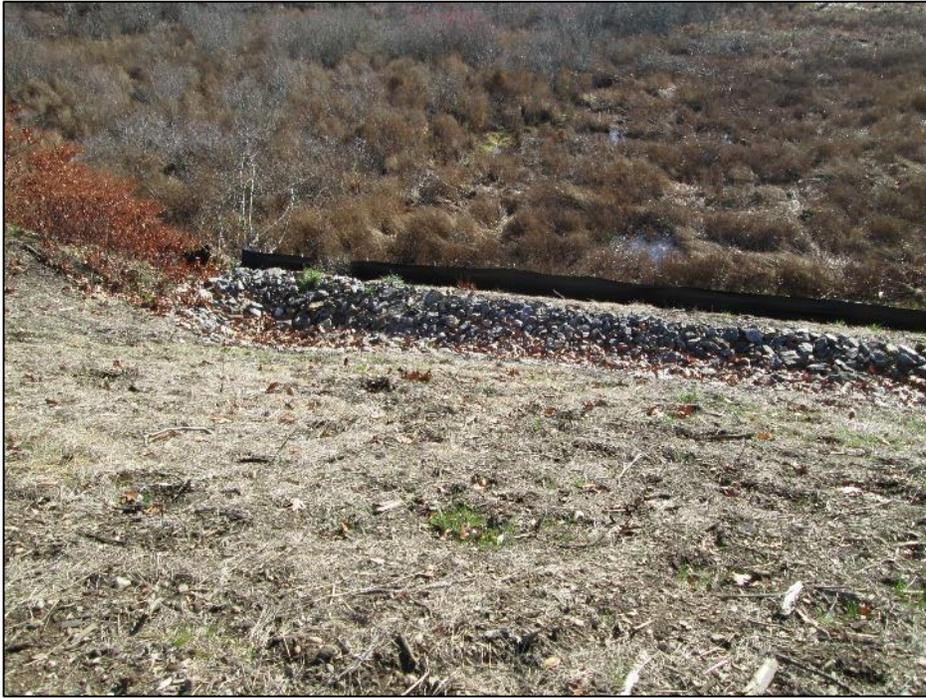
Photo #7: Section of silt fence remaining at Str 241. Remove once stabilization occurs. (11/20)

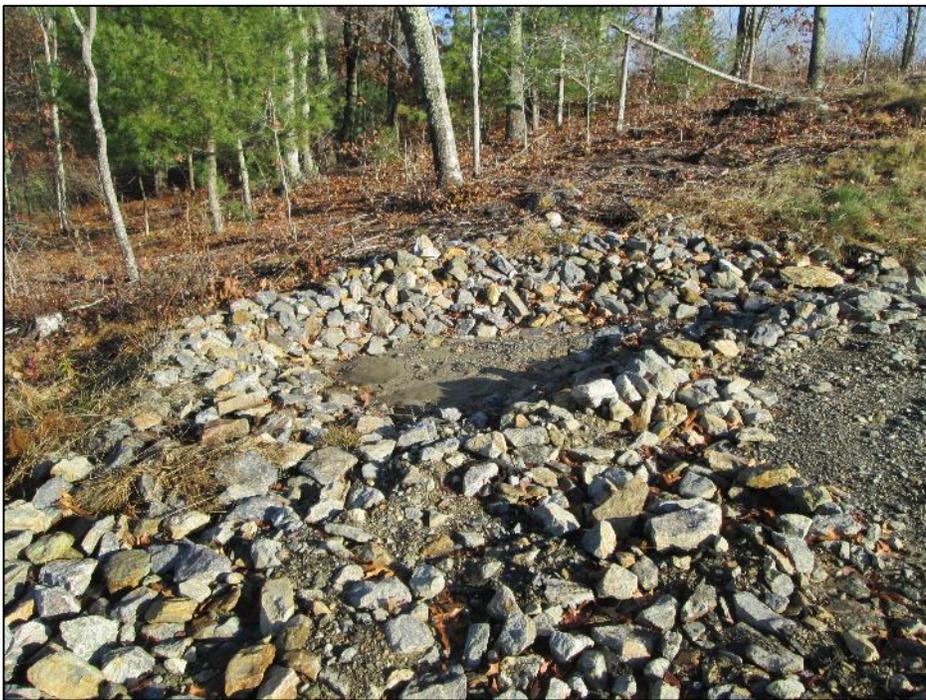
Str 212: Observed permanent sedimentation basin with large deposit of sediment. (Photo 8)	Remove all sediment from basin.	NA
<b>Inland Wetland and Watercourse encroachment and mitigation</b>	<b>Interim Week (11/12)</b>	All observed access road and wetland crossings encroaching in the wetlands have been removed. No permanent BMP's have been observed in these areas.	NA	NA
	<b>Bi-Week (11/20)</b>	All observed access road and wetland crossings encroaching in the wetlands have been removed. No permanent BMP's have been observed in these areas.	NA	NA

Photo #8: Large deposit of sediment in basin at Str 212. (11/20)

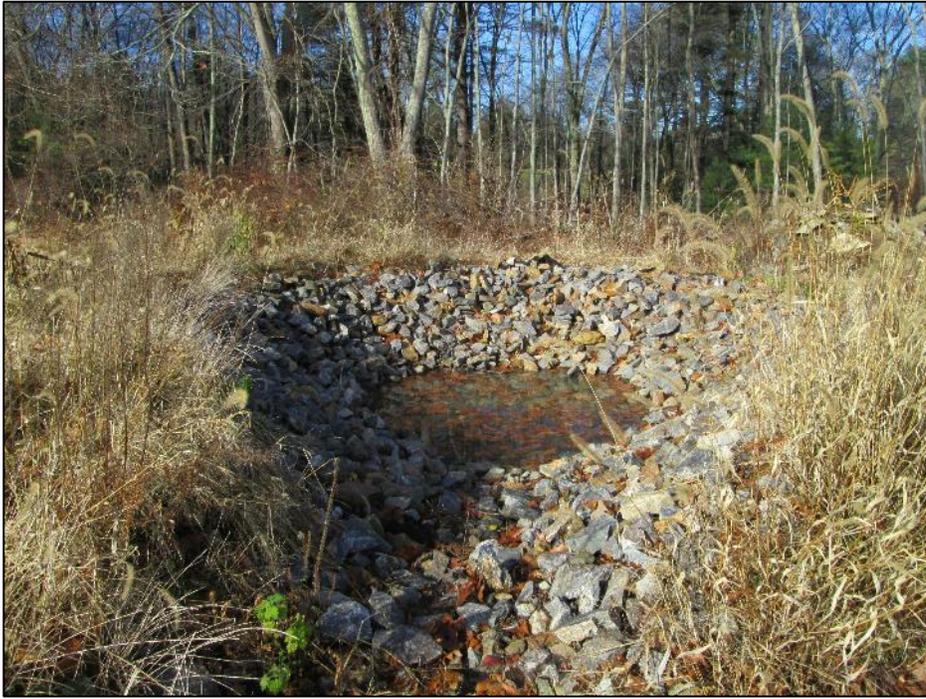
Photo #9: Large sedimentation basin to remain as a permanent BMP at Str 236. (11/20)
