Docket No. 424 – Development and Management Plan Inspection

The Connecticut Light and Power Company Certificate of Environmental Compatibility and Public Need for the Connecticut portion of the Interstate Reliability Project.

IRP Overhead ROW

Date: December 3, 2015

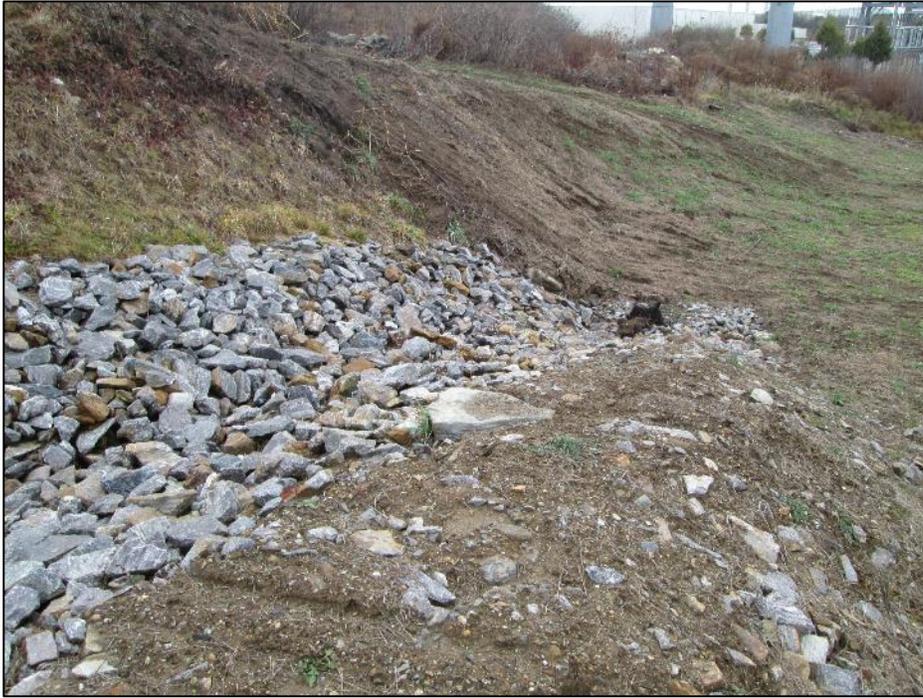
Photo #1: Stone drainage swale to remain as a permanent BMP at Str 272. (12/3)

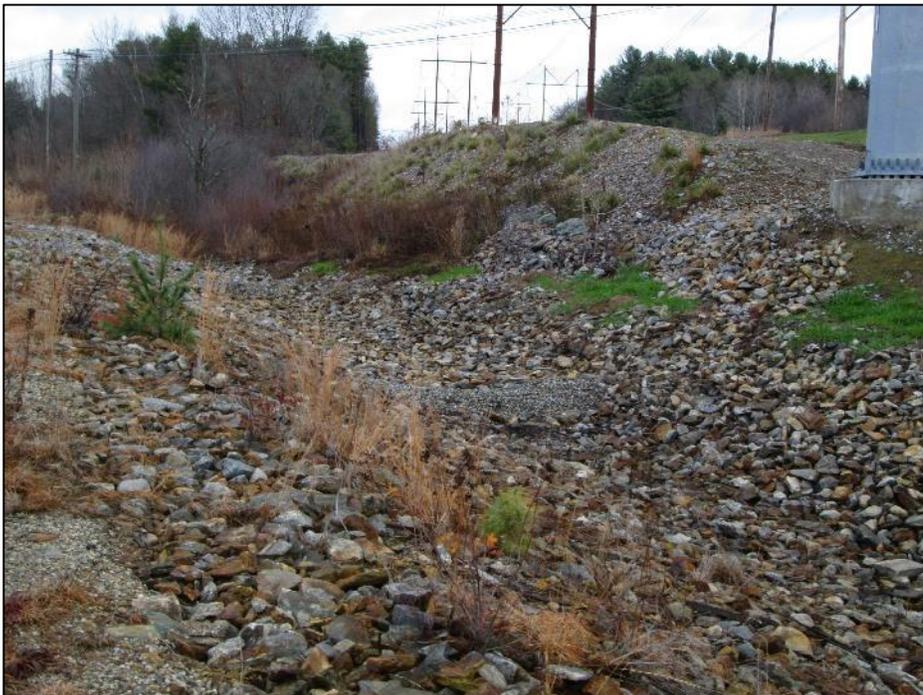
Bi-Week (12/3)	All observed water crossings have been removed.	NA	NA
Erosion and Sedimentation Controls	Interim Week (11/26)	NA	NA	NA
	Bi-Week (12/3)	All silt fence removal at restored and stabilized sites appears to be in accordance with the BMP Manual.	Continue to follow this procedure.	NA
		All observed permanent BMP's appear to be in accordance with the BMP Manual and functioning as designed. Str 277-278: Observed permanent sedimentation basin with large deposit of sediment. (Photo 4)	Continue to follow this procedure. Remove all sediment from basin.	NA T. Ramborger indicated that he has sent Northern a list of the three (3) sedimentation basins that BSC identified as in need of cleaning.
Bi-Week (12/3)	Str 272: Observed stone check dams in the existing stone drainage swale along the Killingly Substation access road. T. Ramborger indicated that the check dams were recently added, although they are unconfirmed as being project-related. (Photo 2)	NA	NA

Photo #2: Stone check dams in existing stone drainage swale. (12/3)

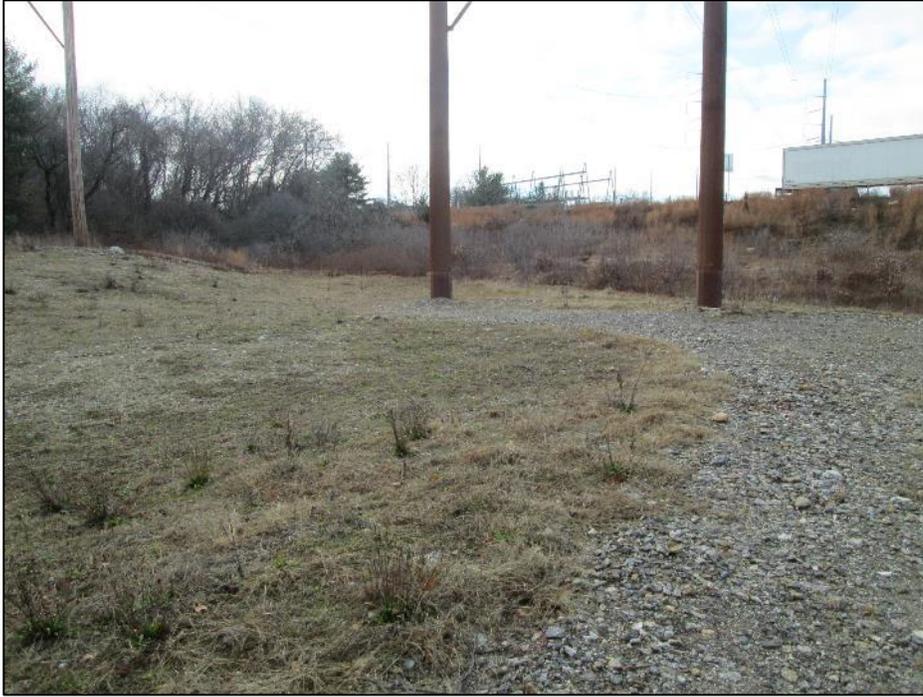
MS53-54, Str 269-273: Final Site Inspection. (Site not yet permanently stabilized) (Photo 3)

Photo #3: Str 269: Typical growth for this area of ROW. Site not yet considered fully stabilized. (12/3)

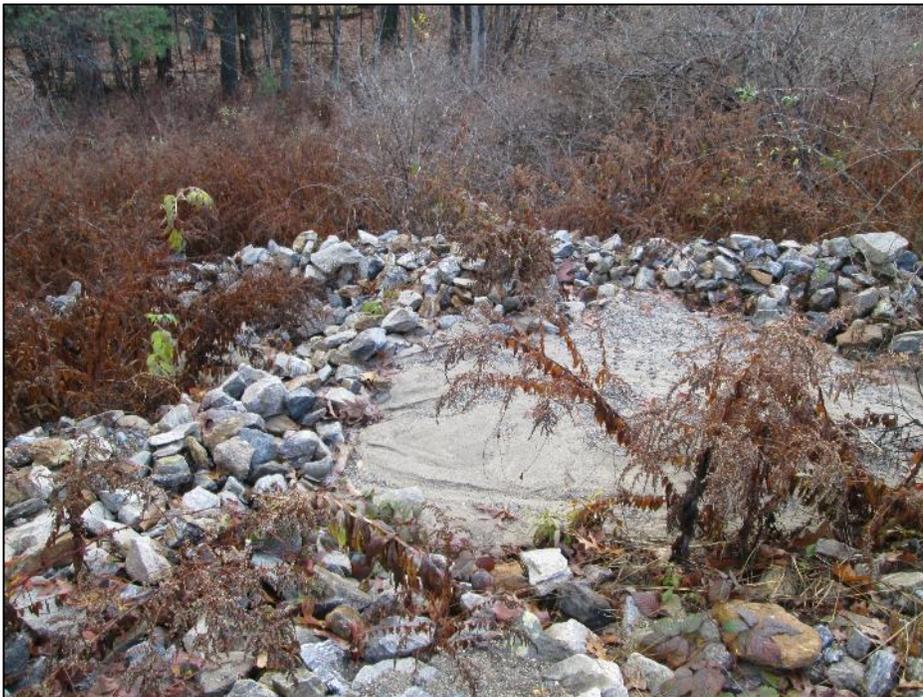
Photo #4: Sedimentation basin to remain on access road between Str 277 and 278. Recommend cleaning all material from basin. (12/3)

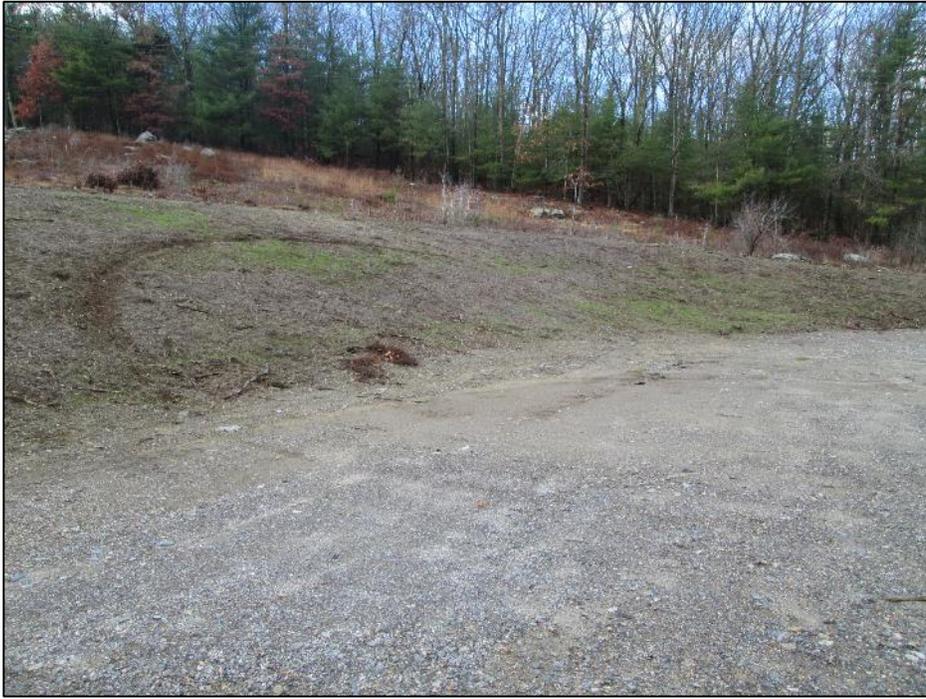
MS55-56, Str 274-281: Final Site Inspection. (Site not yet permanently stabilized) (Photo 5)

Photo #5: Str 279: Typical growth for this area of ROW. Site not yet considered fully stabilized. (12/3)

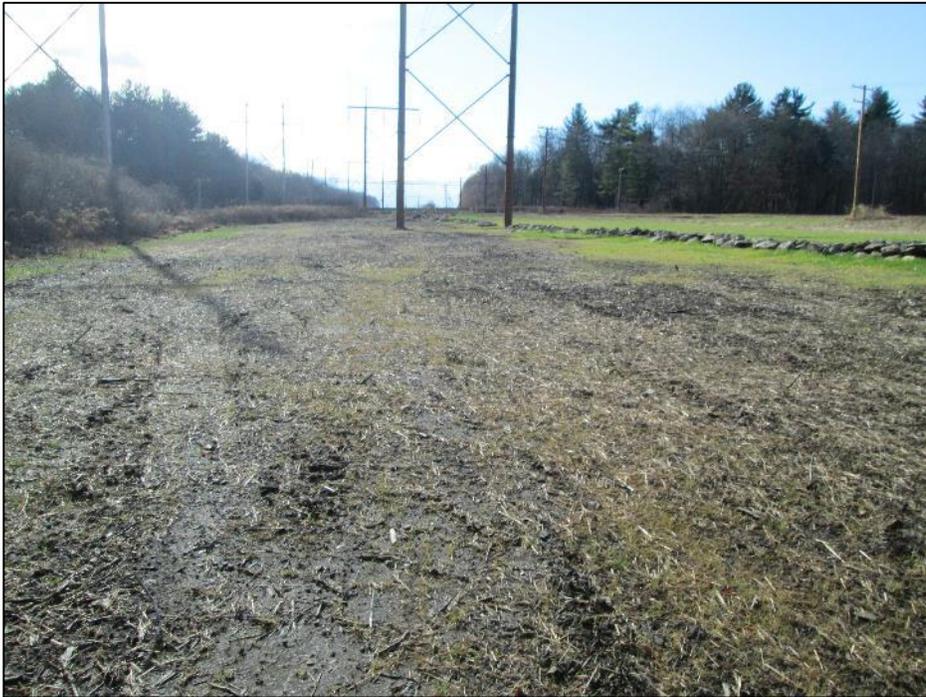
MS57-58, Str 290-294: Final Site Inspection. (Site not yet permanently stabilized) (Photo 6)

Photo #6: Str 290: Typical growth for this area of ROW. Site not yet considered fully stabilized. (12/3)
