Memorandum

To: Dr. Michael Klemens
From: Roger Hurlbut *Roger Hurlbut*
Date: October 17, 2014
Re: BNE Wind Colebrook South

Attached are environmental erosion and sediment control monitoring reports numbers 170, 171 and 172 for the period Oct 3 ,2014 thru October 17, 2014

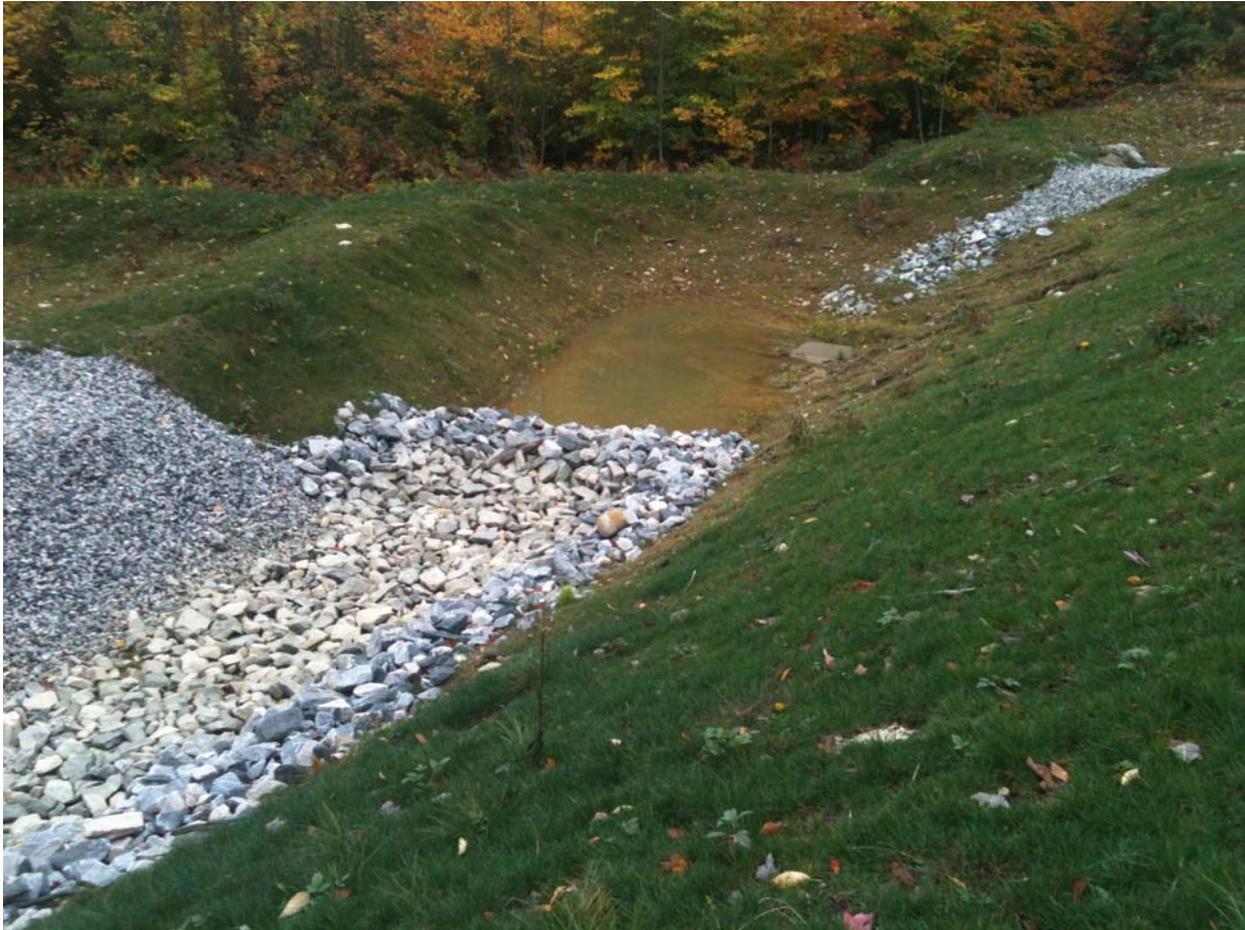
Sediment Basin at Area 1

No work on site & areas are stable
