Infrared Inspection Report

Turner Building Science, LLC

25 Sigourney St.
Hartford, CT 06106

Purpose of Inspection: To identify moisture in the wall and ceiling substrates

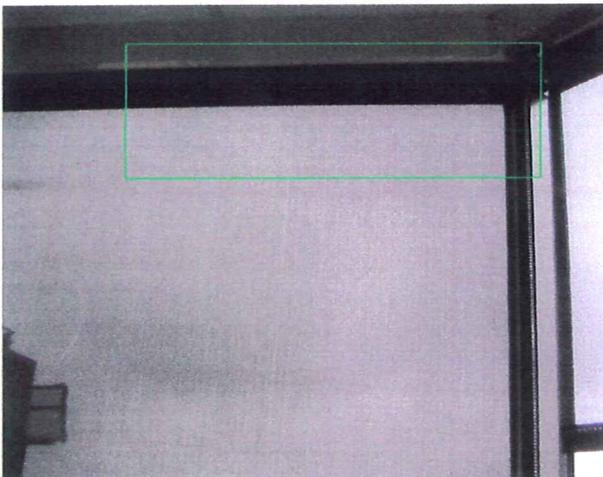
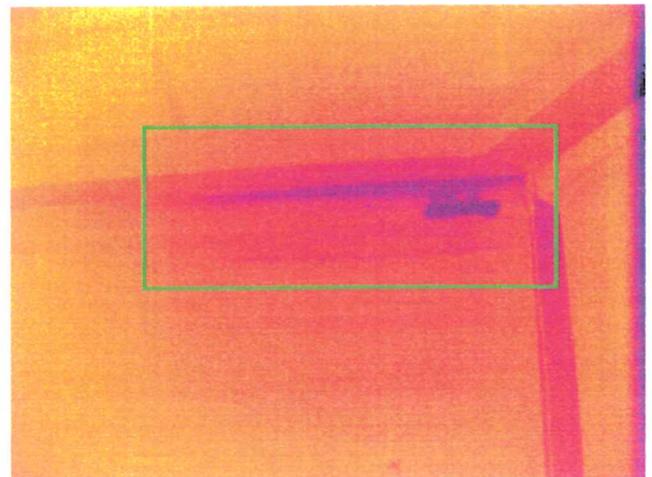
**Area: 18th floor, moisture area #12
Moisture is in blind, dripping from above**

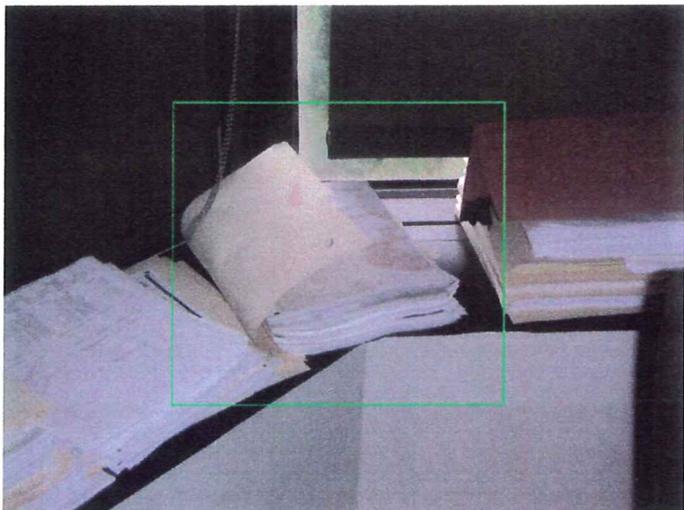
Area: 17th floor, moisture area #21, file is wet but wall/ceiling does not show IR moisture intrusion

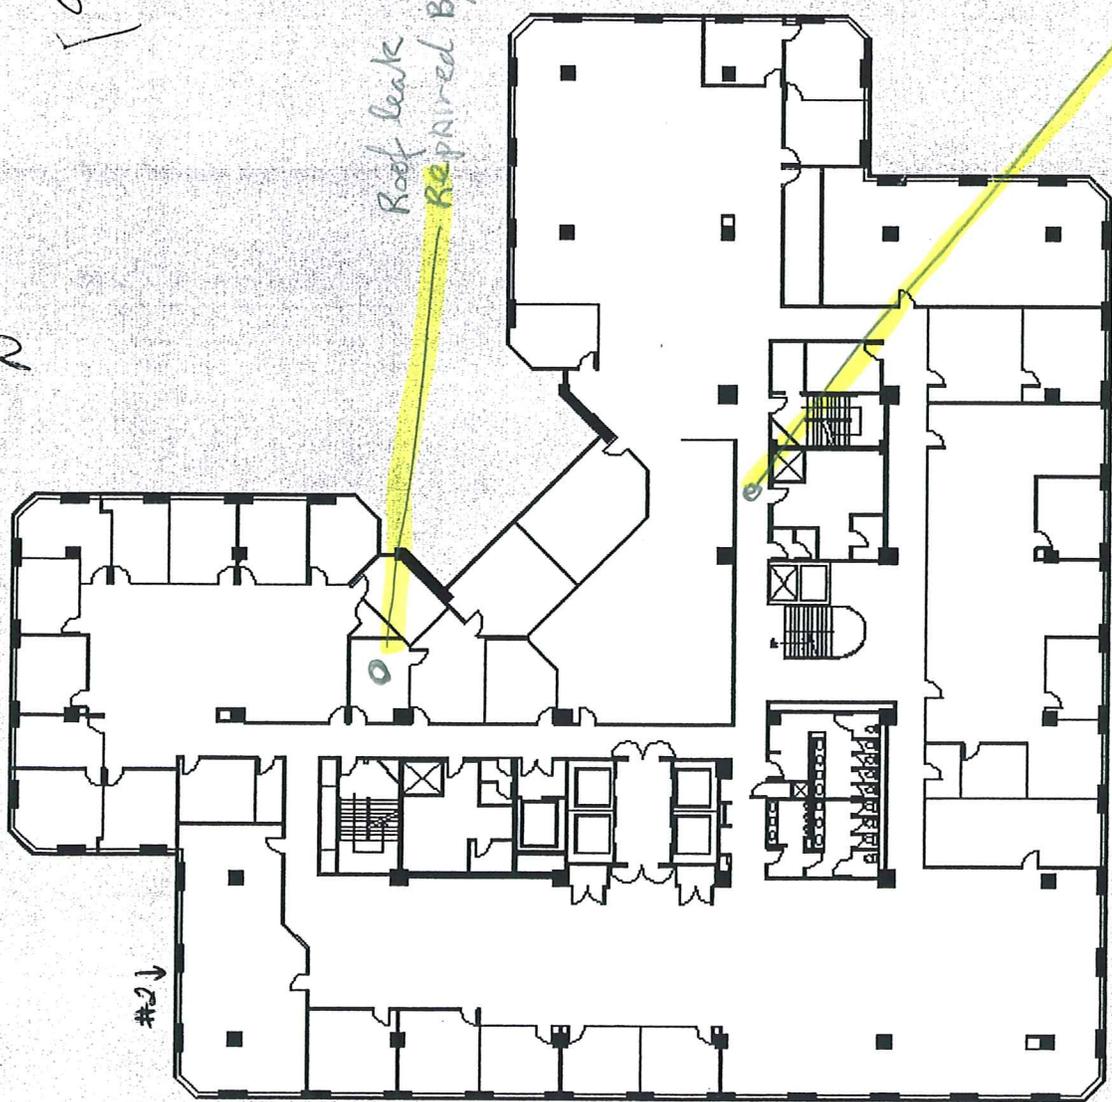
18th Floor

Roof leak
Repaired By Silktown Roofing
11/01/05

Roof leak
Repair by Silktown Roofing
11/01/05
